Expertise

Protocol number: 46104997  
Order No. / Reference: 26494973  
Inspection date: 23 Jun 2026

Manufacturer: Skoda  
VIN: TMBLJ7NS3P8033423

Model: Kodiah 2.0 TDI 4x4 DSG Ambition

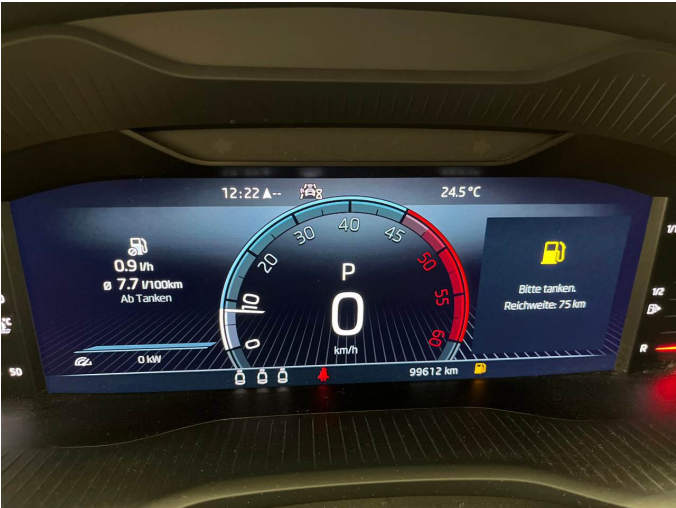
Figure 7: Instrument cluster

| Vehicle details | |
|---|---|
| Mileage (Read) | 99,612 km |

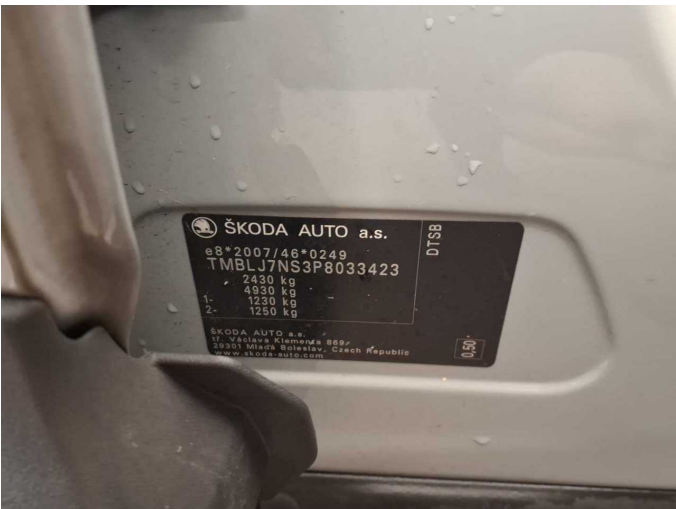
Figure 11: VIN

| VIN comparison | The vehicle identification number (VIN) was read from the vehicle and its conformity with the submitted documents was confirmed by the undersigned during the inspection. |

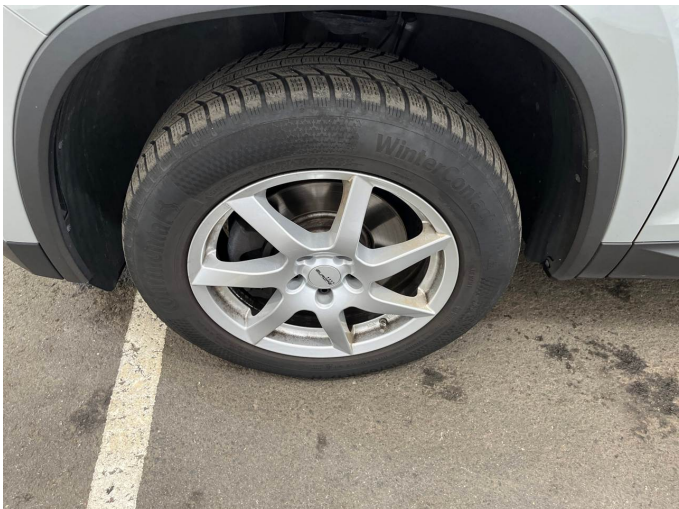
Figure 12: Mounted tyres

| # | Tyre size | Type of tyre | Manufacturer | Tread depth |
|---|---|---|---|---|
| 1) | 215/65 R17 99H | Winter tyres on Light alloy | Continental | 4mm / 4mm |
| 2) | 215/65 R17 99H | Winter tyres on Light alloy | Continental | 6mm / 6mm |

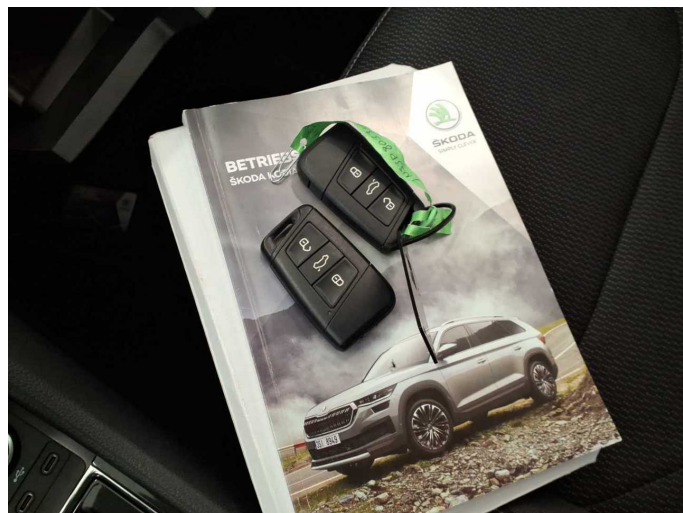
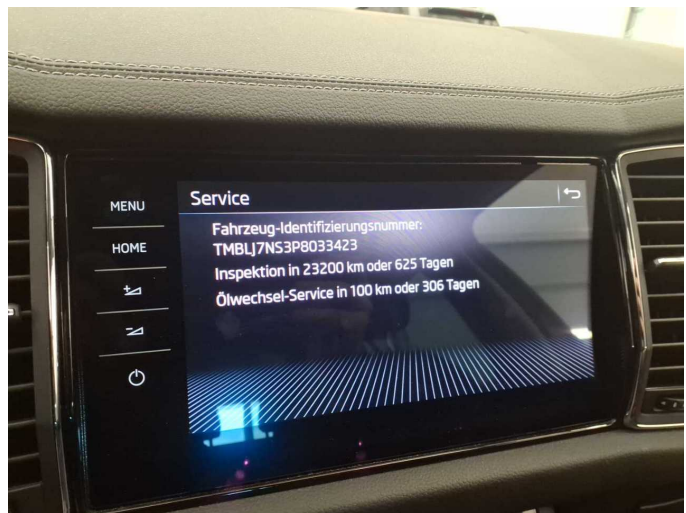
Figure 13: Documents

| Documents submitted | At the time of the inspection, the vehicle registration certificate Part 2 (title) was available, but the vehicle registration certificate Part 1 (document) was not. (Copy) |

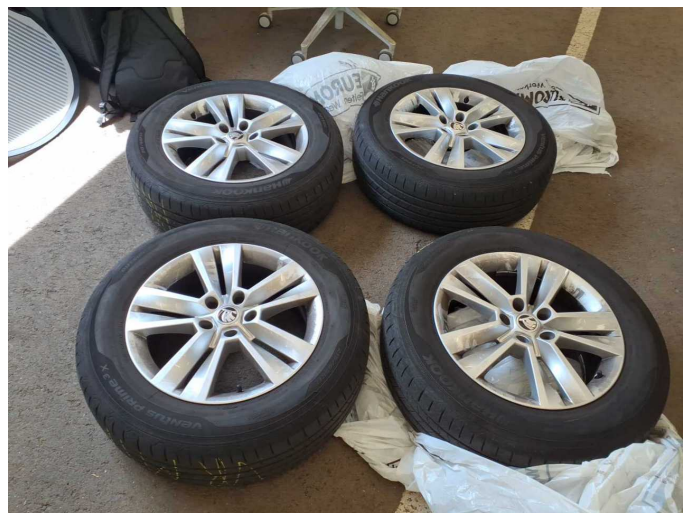
Figure 15: Additional tyres

| # | Tyre size | Type of tyre | Manufacturer | Tread depth |
|---|---|---|---|---|
| 1) | 215/65 R17 99V | Summer tyres on Light alloy | Hankook | 6mm / 6mm |
| 2) | 215/65 R17 99V | Summer tyres on Light alloy | Hankook | 6mm / 6mm |

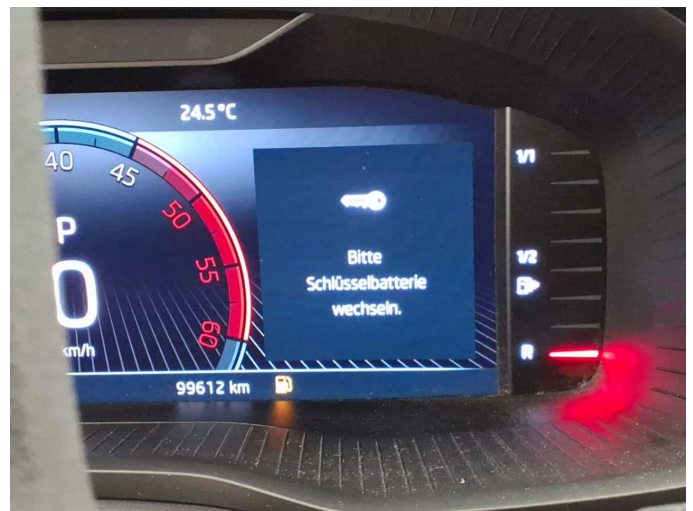
Damage 1: Equipment: Vehicle key with remote control (Batterie) - Empty - Replace

| No. | Component group | Description |
|---|---|---|
| 1 | Equipment | Vehicle key with remote control (Batterie) - Empty - Replace |
