Expertise

Protocol number: 46002950  
Order No. / Reference: 26464457  
Inspection date: 17 Jun 2026

Manufacturer: Mercedes-Benz  
VIN: W1N1671541A684162

Model: GLE 350 e 4Matic 9G-TRONIC Exclusive

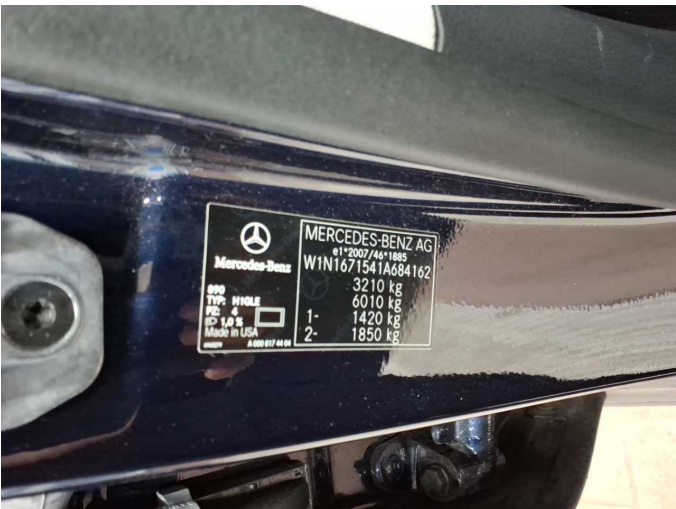
Figure 11: VIN

| VIN comparison | The vehicle identification number (VIN) was read from the vehicle and its conformity with the submitted documents was confirmed by the undersigned during the inspection. |

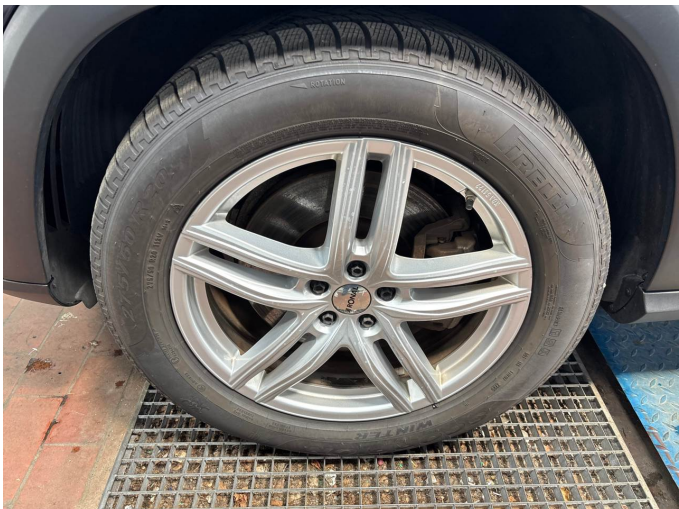
Figure 12: Mounted tyres

| # | Tyre size | Type of tyre | Manufacturer | Tread depth |
|---|---|---|---|---|
| 1) | 275/50 R20 113V | Winter tyres on Light alloy | Pirelli | 5mm / 5mm |
| 2) | 275/50 R20 113V | Winter tyres on Light alloy | Pirelli | 5mm / 5mm |

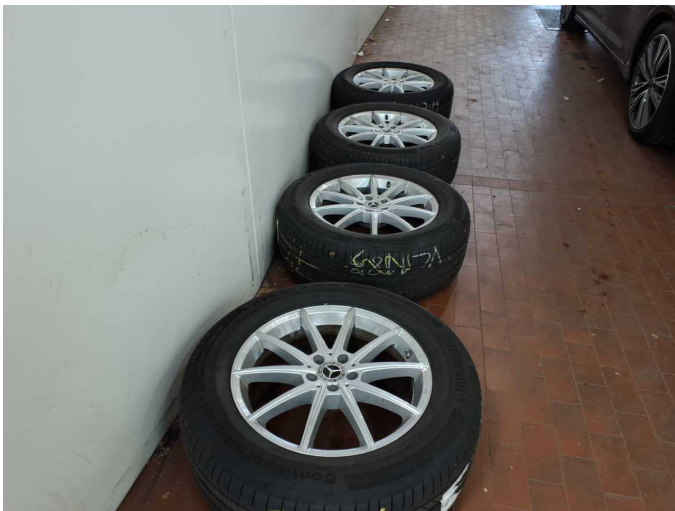
Figure 15: Additional tyres

| # | Tyre size | Type of tyre | Manufacturer | Tread depth |
|---|---|---|---|---|
| 1) | 275/55 R19 111W | Summer tyres on Light alloy | Continental | 4mm / 4mm |
| 2) | 275/55 R19 111W | Summer tyres on Light alloy | Continental | 4mm / 4mm |

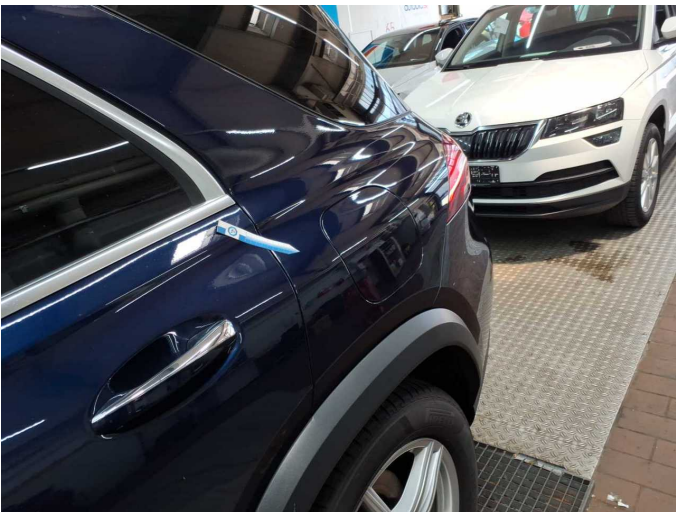
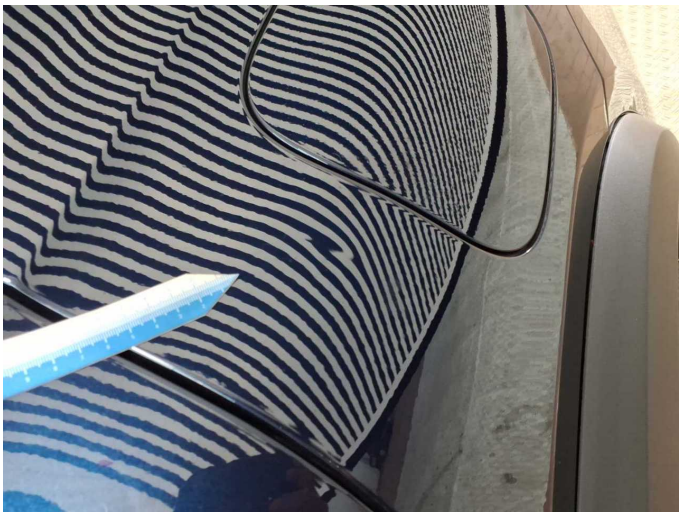
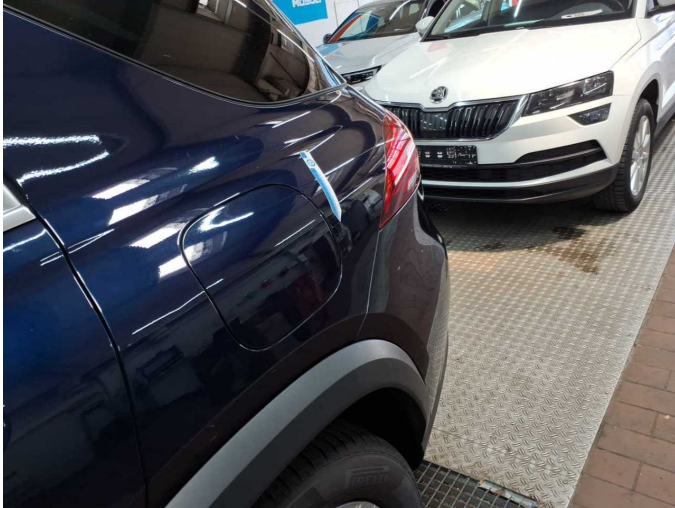
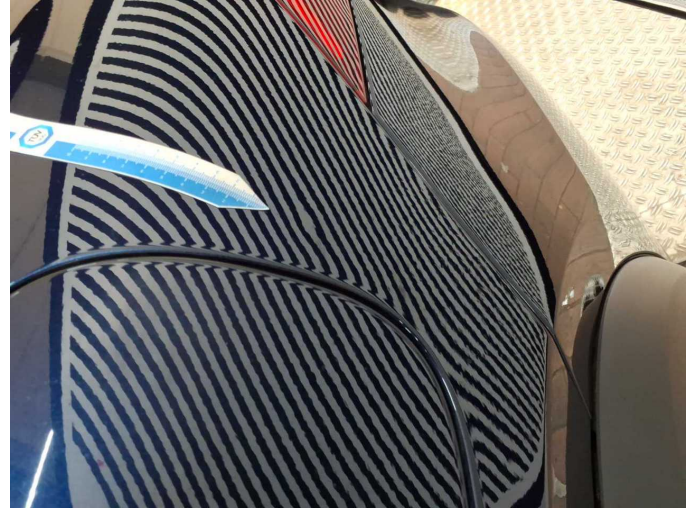
| No. | Component group | Description |
|---|---|---|
| 1 | Side panel - rear left side | Side panel - dent(s) - Smooth repair work |

Damage 1: Side panel - rear left side: Side panel - dent(s) - Smooth repair work

**Damage 1:** Side panel - rear left side: Side panel - dent(s) - Smooth repair work

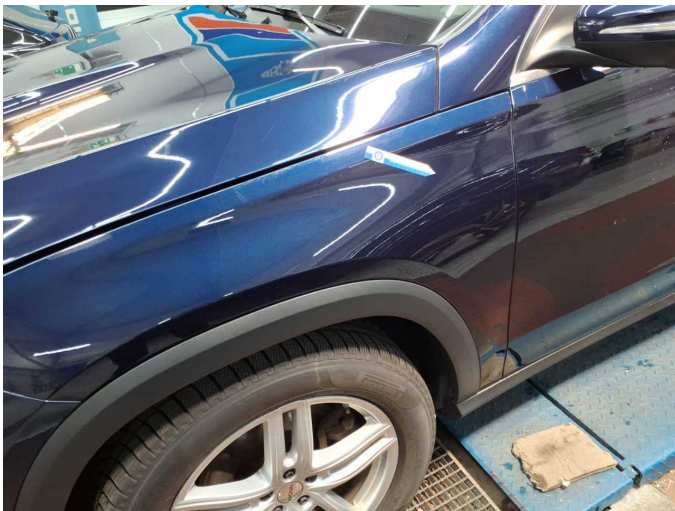
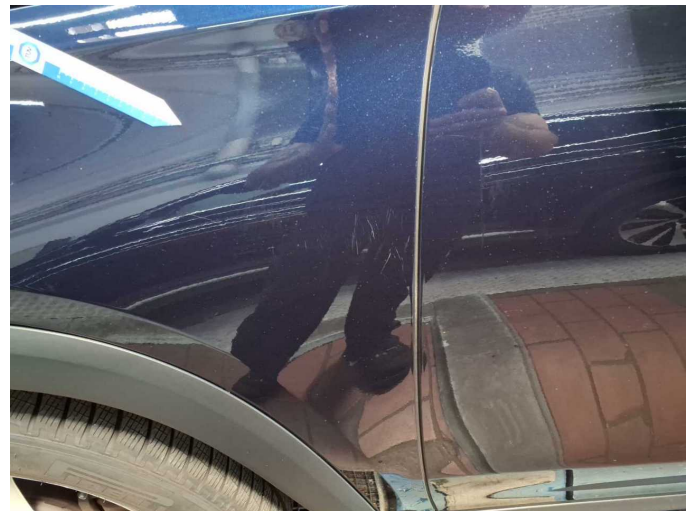
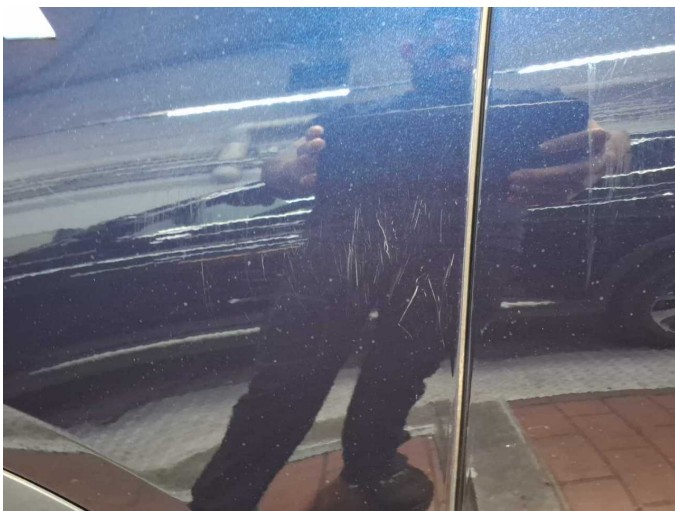
| No. | Component group | Description |
|---|---|---|
| 2 | Mudguard - left side | Mudguard - left side - Scratch(es) - Paint |

**Damage 2:** Mudguard - left side: Mudguard - left side - Scratch(es) - Paint

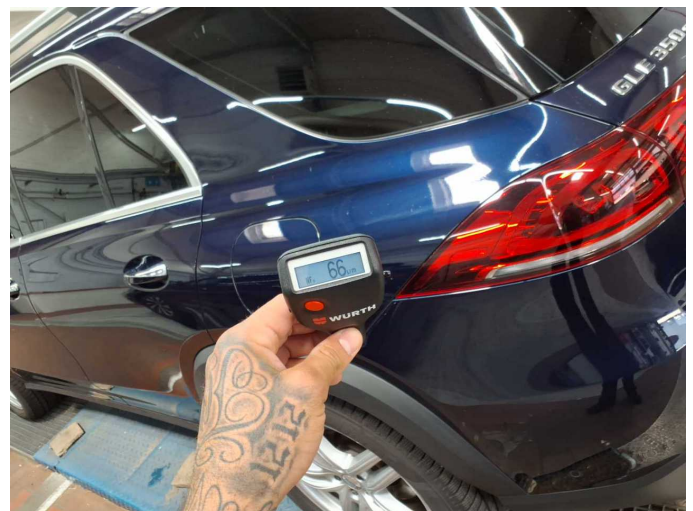
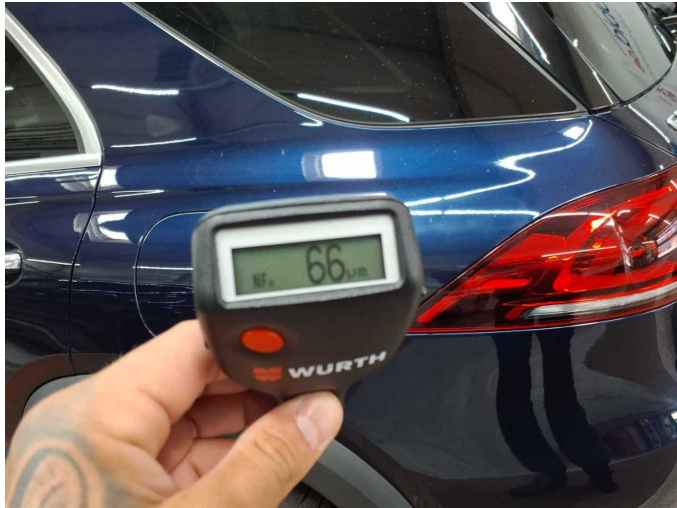
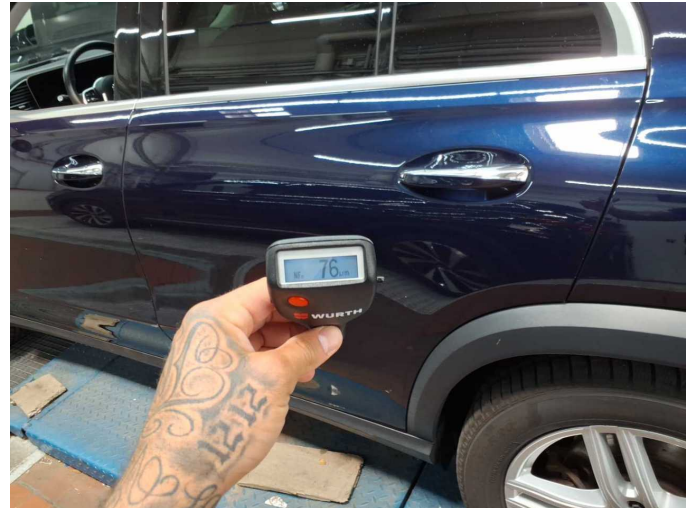
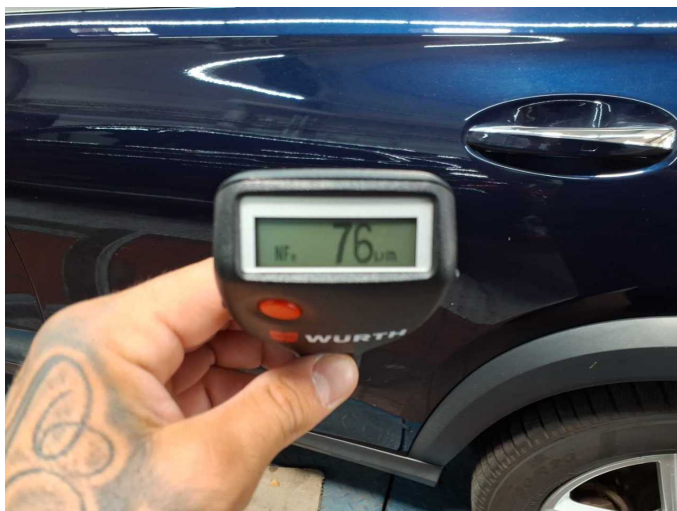
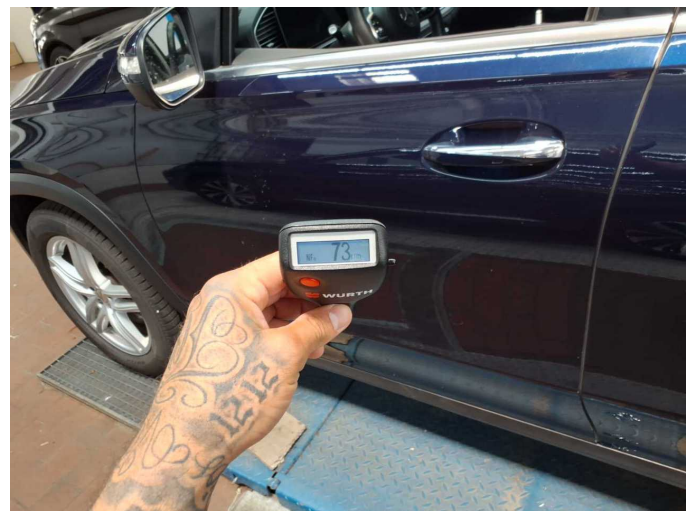
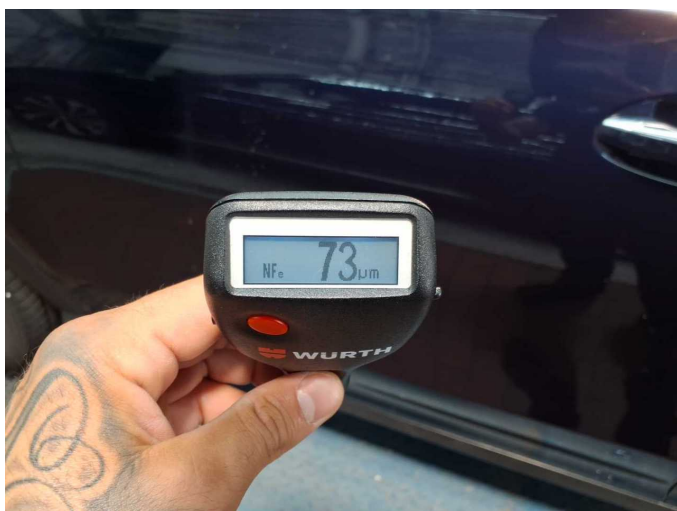
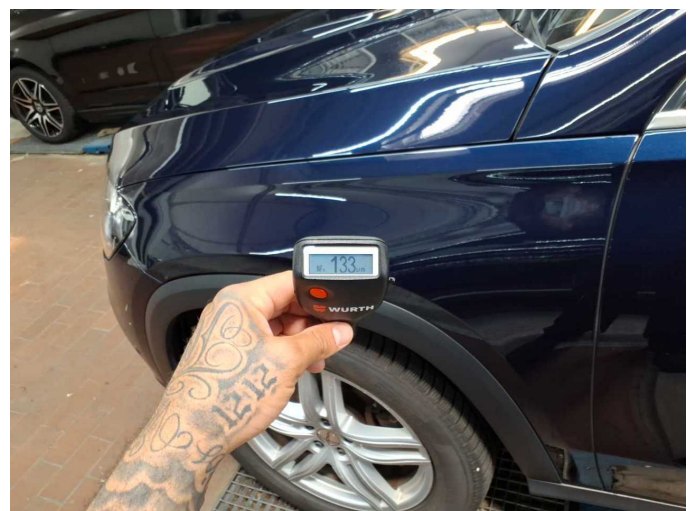
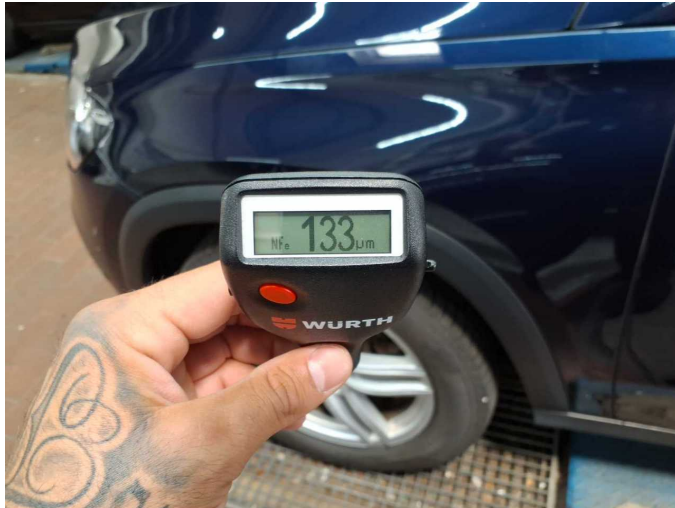
| No. | Previous damage | Extent of damage (Net) |
|---|---|---|
| 2 | Side - left, Provided by user / customer, from 12 May 2022 | 2.266,03 € |

**Previous damage 2:** Side - left

Previous damage 2: Side - left

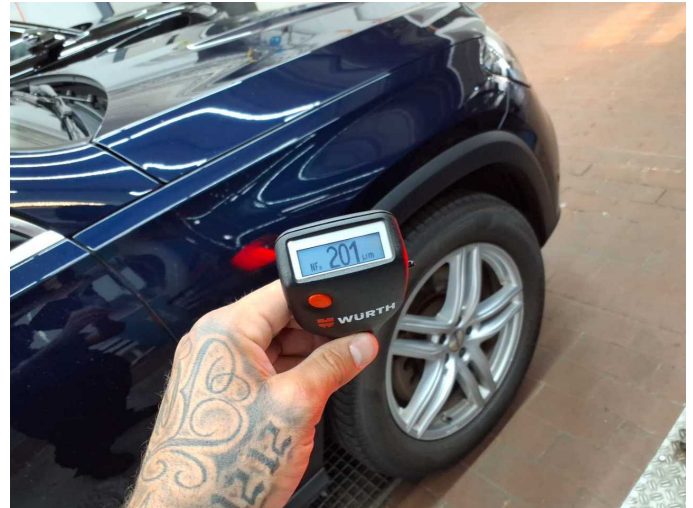
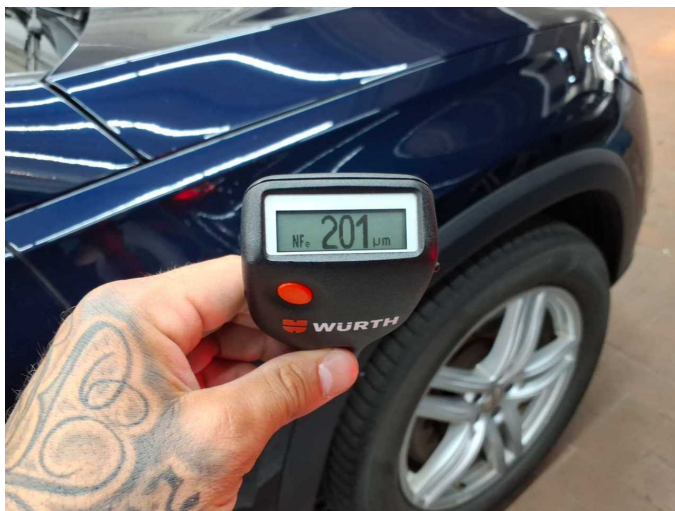
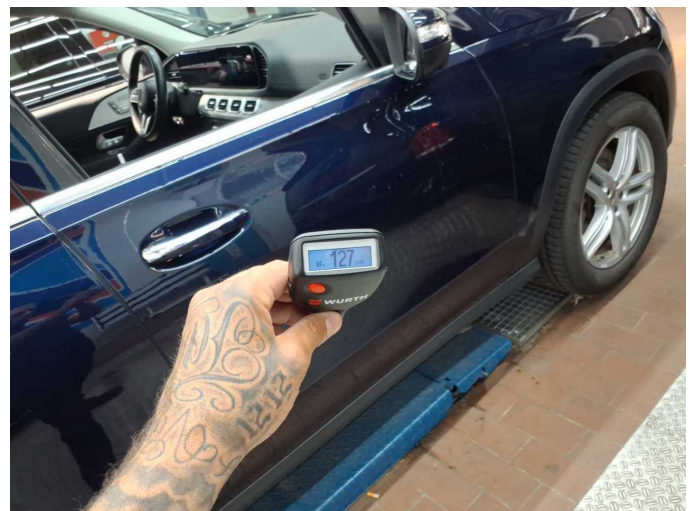
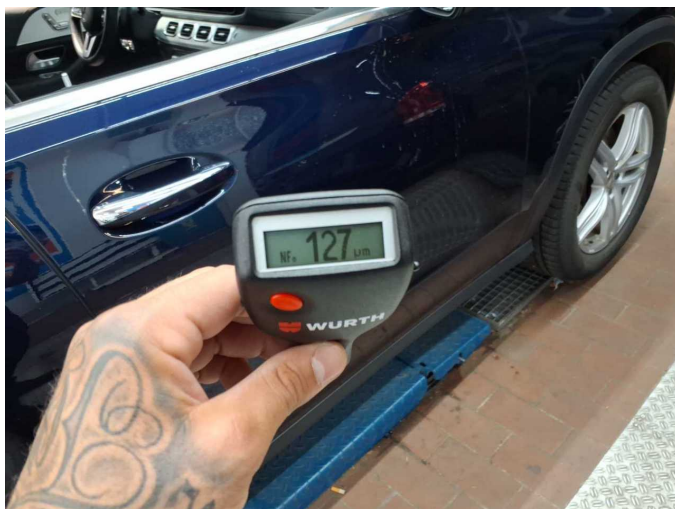
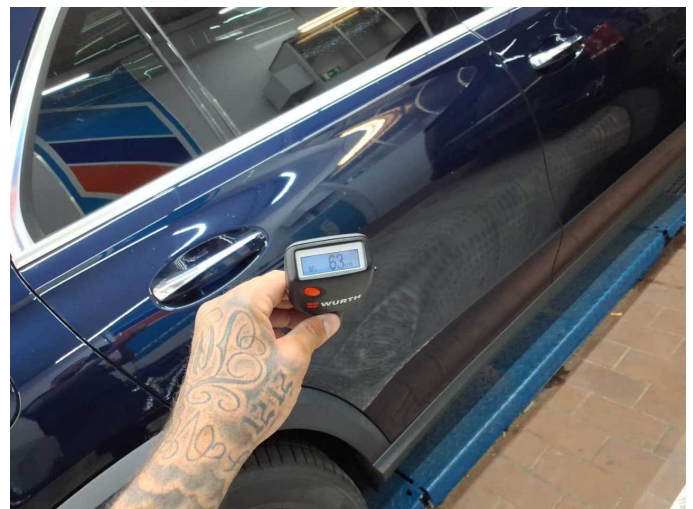
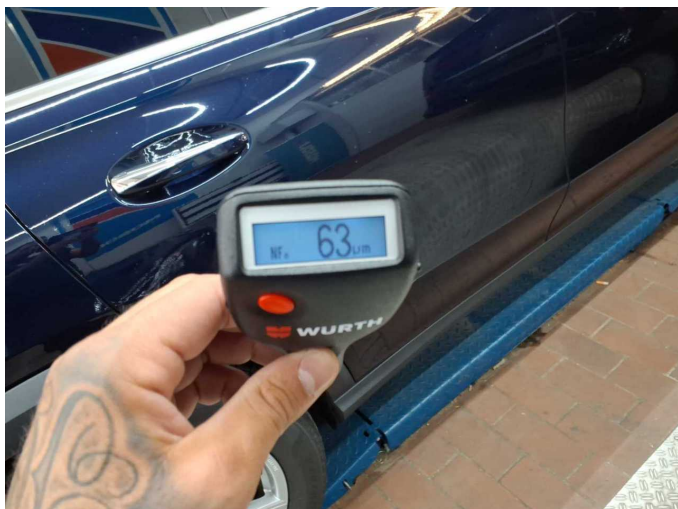
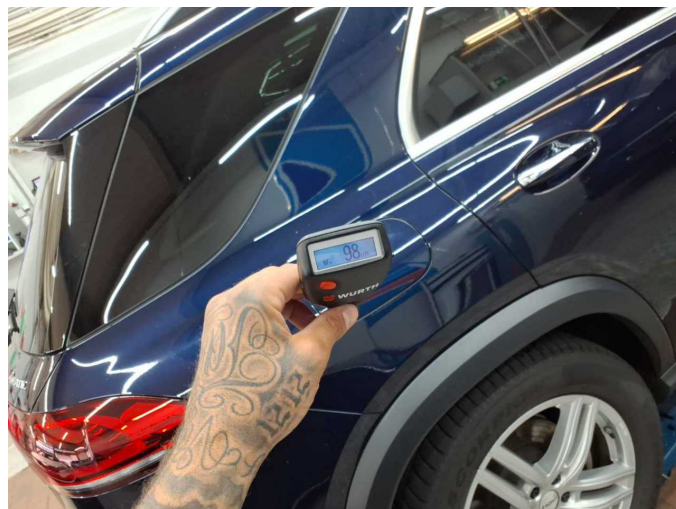
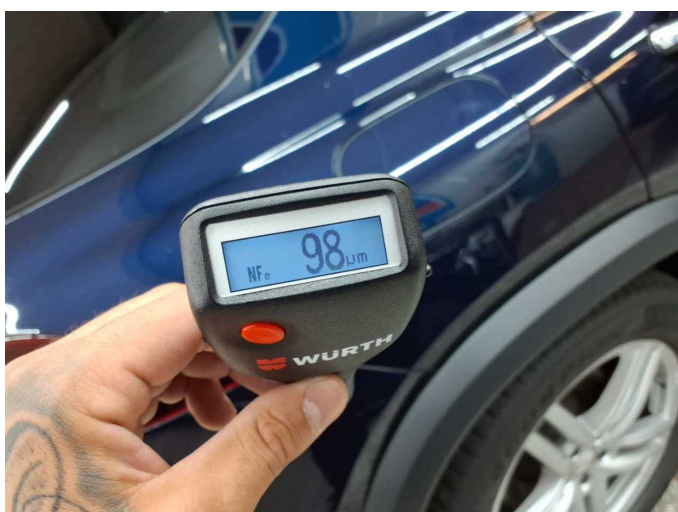
| No. | Previous damage | Extent of damage (Net) |
|---|---|---|
| 3 | Side right, Provided by user / customer, from 19 Nov 2025 | 3.128,90 € |

Previous damage 3: Side right

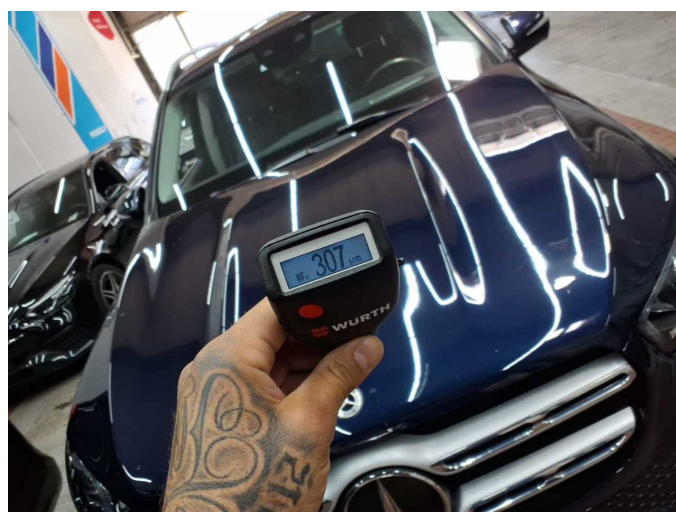
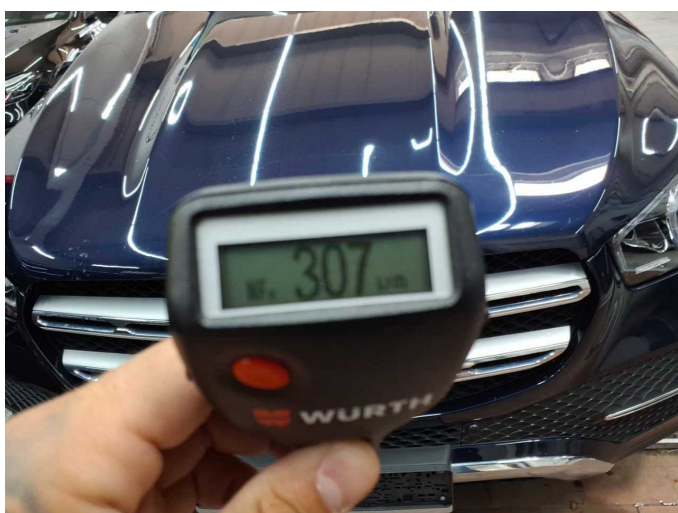
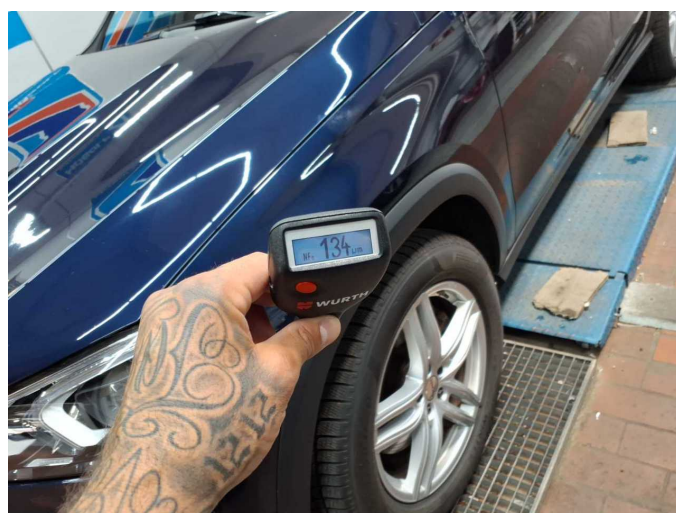
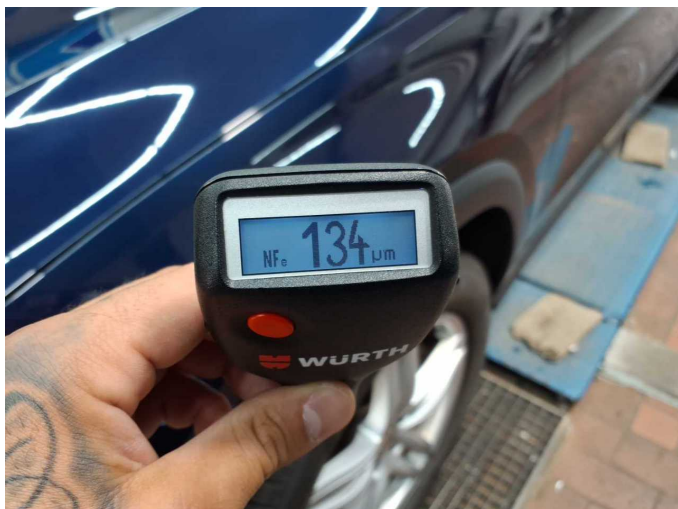
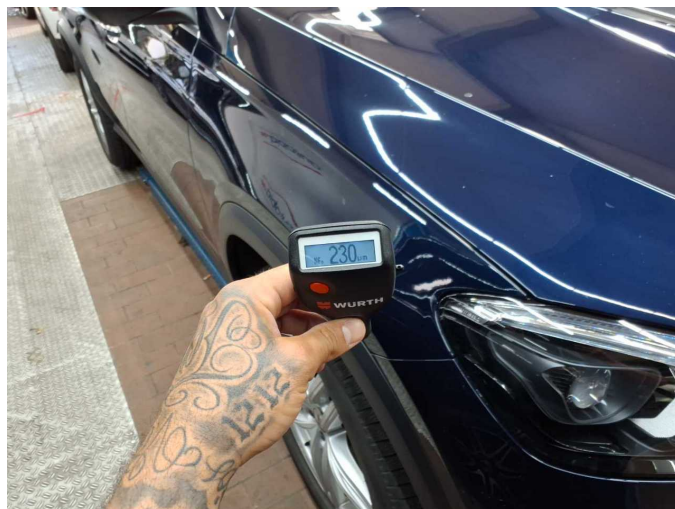
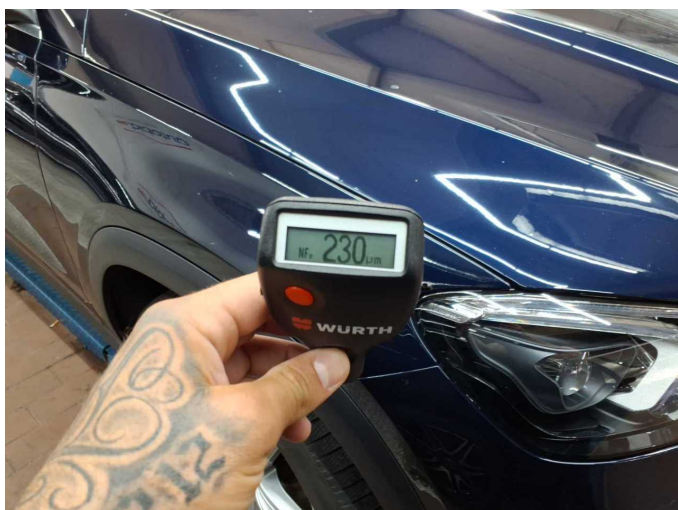
| No. | Previous damage | Extent of damage (Net) |
|---|---|---|
| 4 | Front, Provided by user / customer, from 7 Oct 2023 | 4.735,99 € |

Previous damage 4: Front

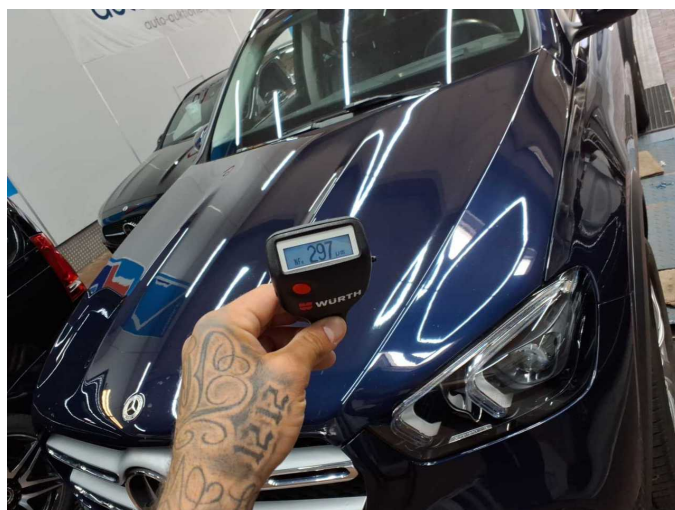
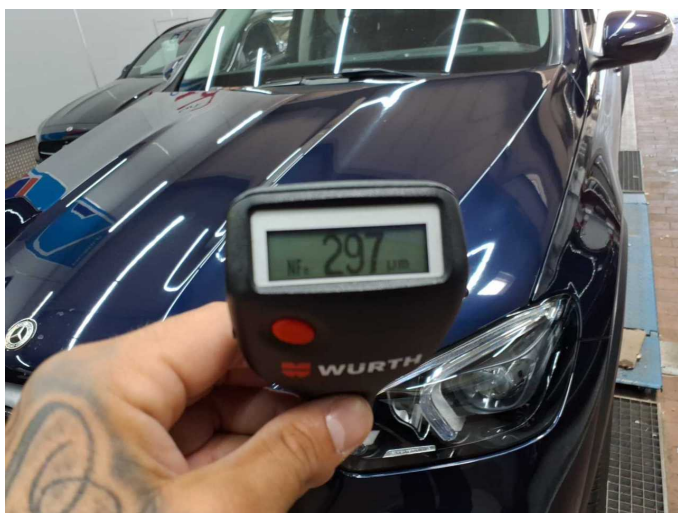
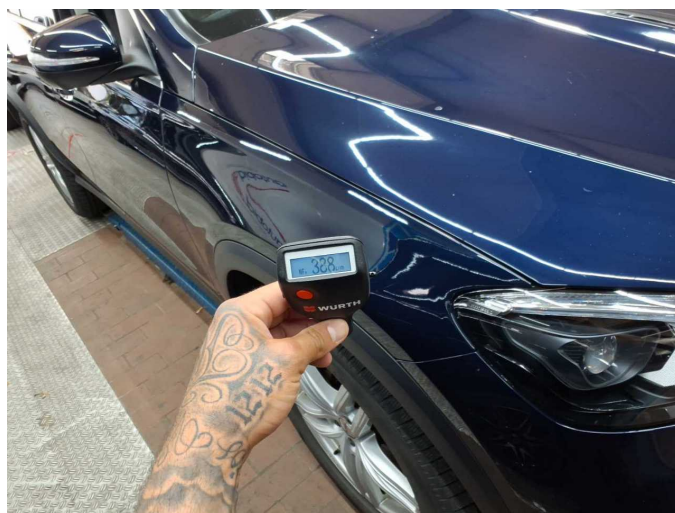
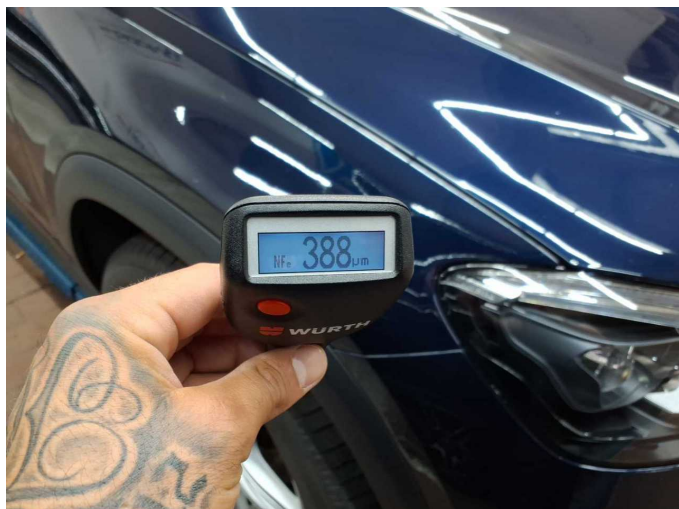
| No. | Repainting |
|---|---|
| 1 | Mudguard - right side, Bonnet, Professionally carried out |

| Mudguard - right side | 388 µm | Bonnet | 297 µm |

Repainting 1: Mudguard - right side, Bonnet

**Repainting 1:** Mudguard - right side, Bonnet
