Expertise

Protocol number: 46565323  
Order No. / Reference: 26588025  
Inspection date: 17 Jul 2026

Manufacturer: Peugeot

Model: 5008 BlueHDi 130 EAT8 GT

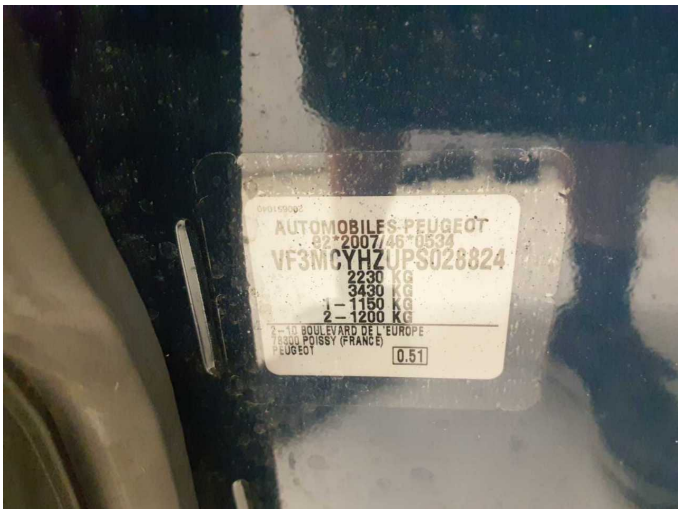
Figure 11: VIN

| VIN comparison | The vehicle identification number (VIN) was read from the vehicle and its conformity with the submitted documents was confirmed by the undersigned during the inspection. |

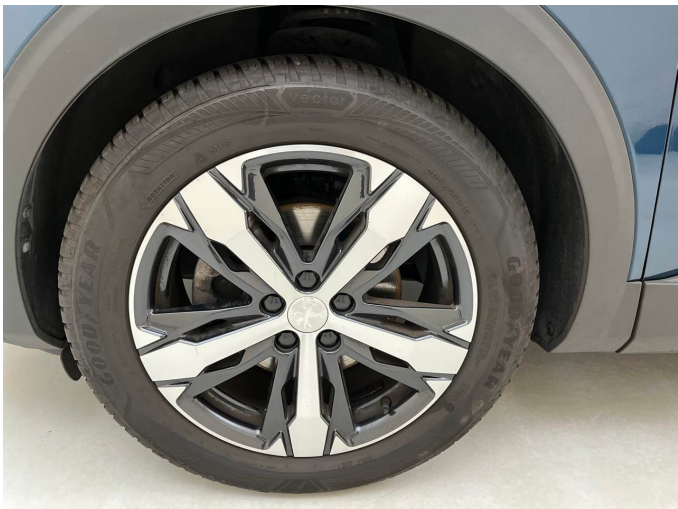
Figure 12: Mounted tyres

| # | Tyre size | Type of tyre | Manufacturer | Tread depth |
|---|---|---|---|---|
| 1) | 225/55 R18 102V | All-season tyres on Light alloy | Goodyear | 5mm / 5mm |
| 2) | 225/55 R18 102V | All-season tyres on Light alloy | Goodyear | 5mm / 5mm |

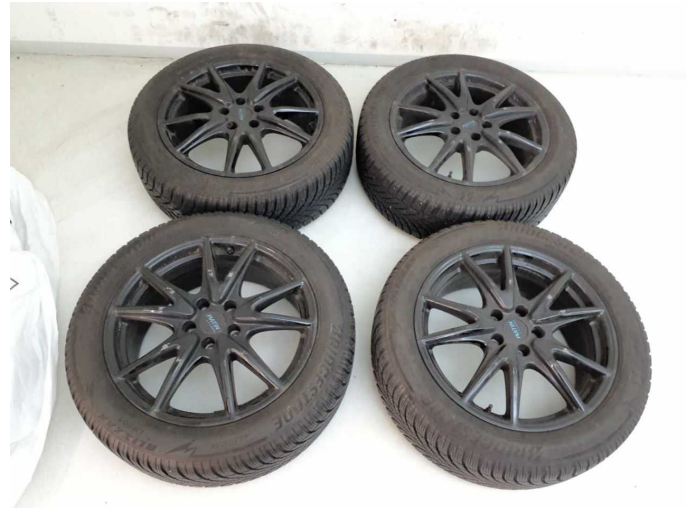
Figure 14: Additional tyres

| # | Tyre size | Type of tyre | Manufacturer | Tread depth |
|---|---|---|---|---|
| 1) | 215/55 R18 99V | Winter tyres on Light alloy | Bridgestone | 6mm / 6mm |
| 2) | 215/55 R18 99V | Winter tyres on Light alloy | Bridgestone | 6mm / 6mm |

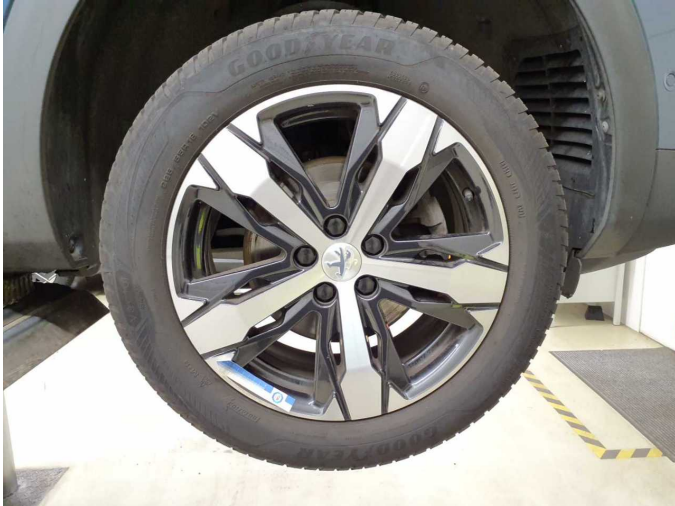
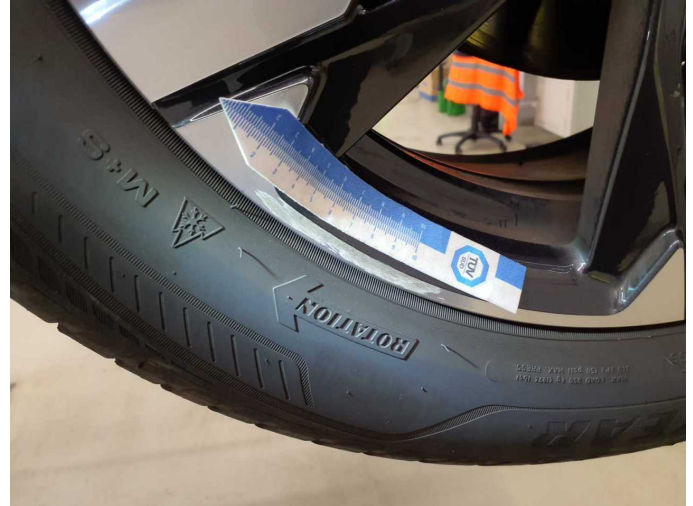
| No. | Component group | Description |
|---|---|---|
| 1 | Wheel / tyres | Alloy rim - front right side - Scratched - Replace |

**Damage 1:** Wheel / tyres: Alloy rim - front right side - Scratched - Replace

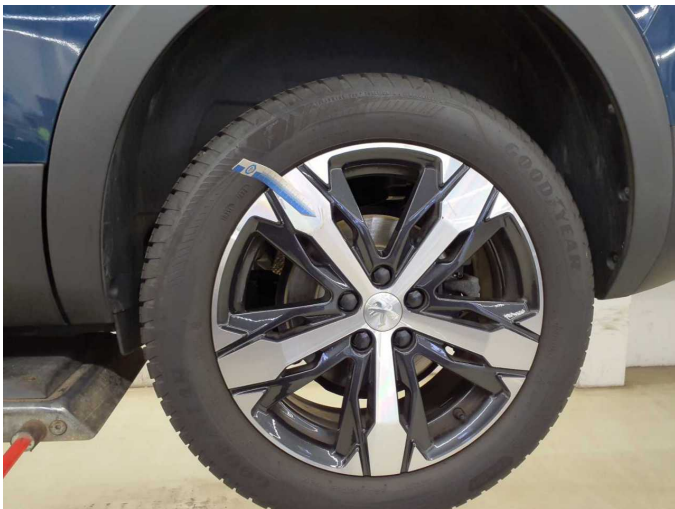
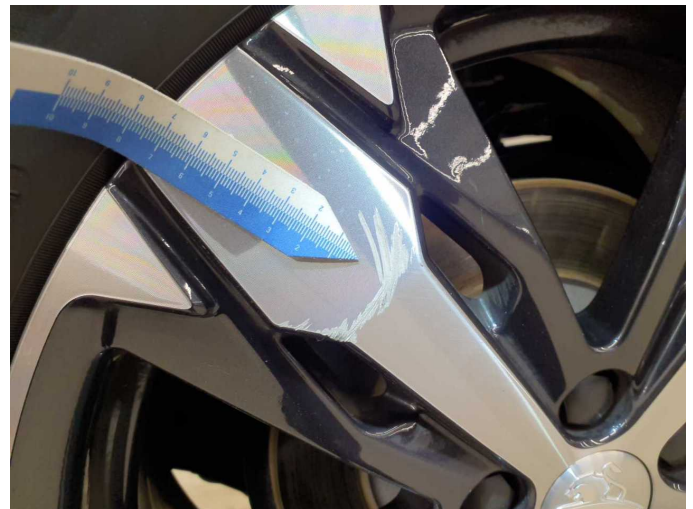
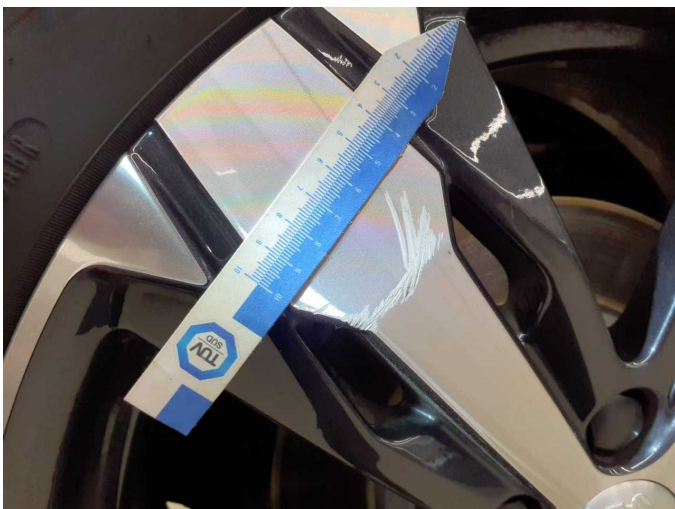
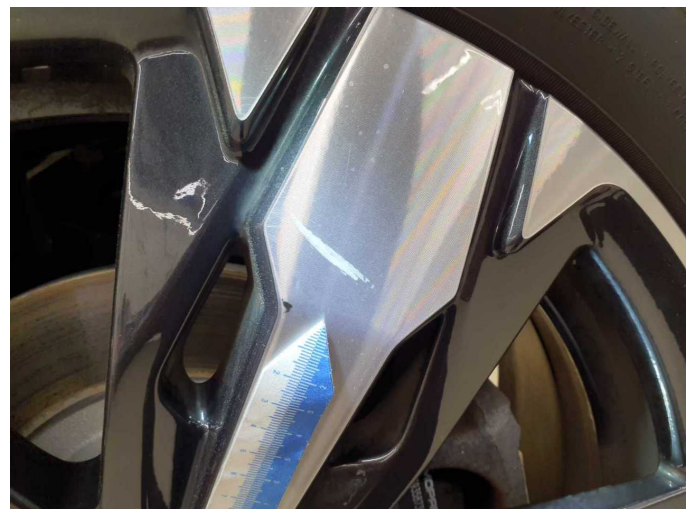
| No. | Component group | Description |
|---|---|---|
| 2 | Wheel / tyres | Alloy rim - rear left side - Scratched - Replace |

**Damage 2:** Wheel / tyres: Alloy rim - rear left side - Scratched - Replace

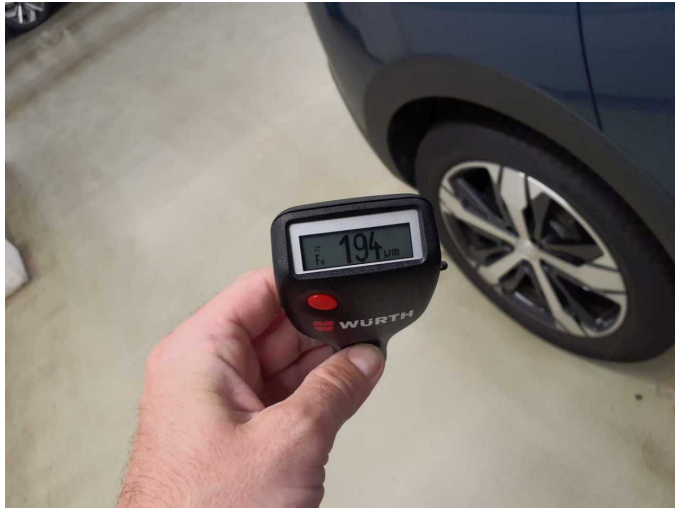
| Side panel - rear right side | 194 µm | Door - rear right side | 530 µm |

**Side panel - rear right side: 194 µm**

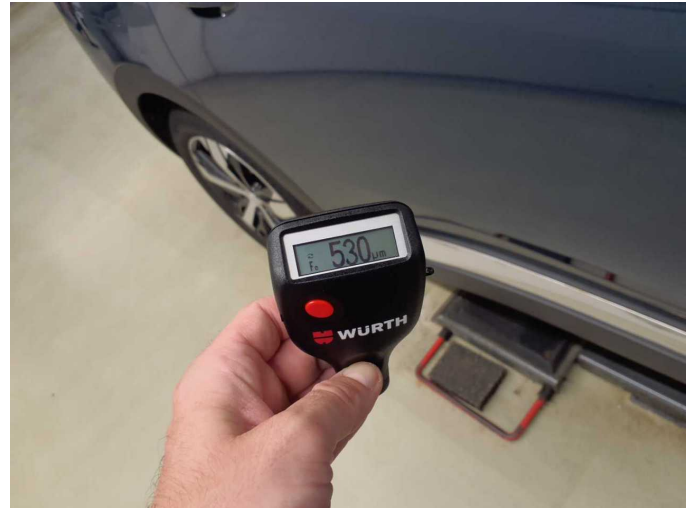
**Door - rear right side: 530 µm**

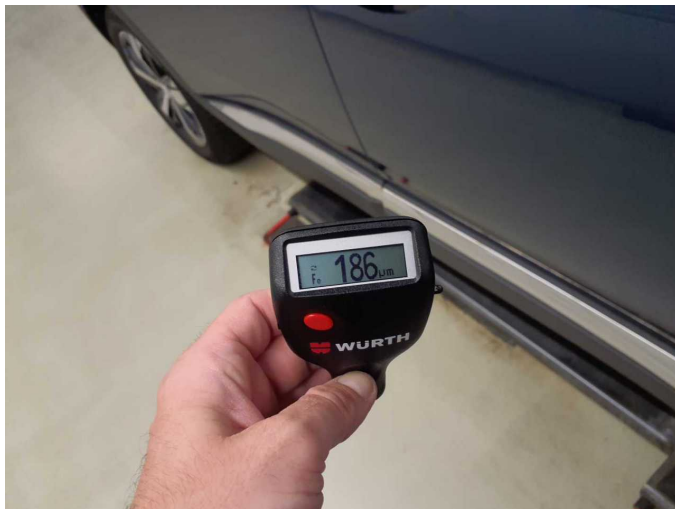
| Door - front right side | 186 µm | | |

**Door - front right side: 186 µm**
