Expertise

Protocol number: 46354219  
Order No. / Reference: 26600861  
Inspection date: 7 Jul 2026

| Manufacturer: Ford | Model: S-Max 2.0 EcoBlue Allrad Aut. ST-LINE |

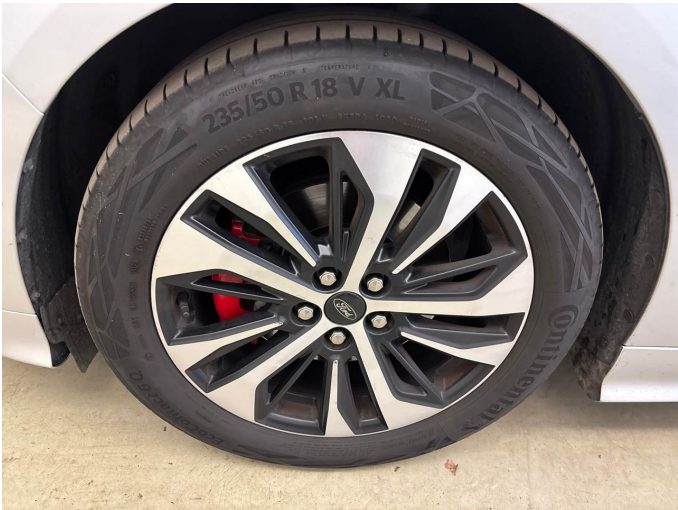
Figure 12: Mounted tyres

| # | Tyre size | Type of tyre | Manufacturer | Tread depth |
|---|---|---|---|---|
| 1) | 235/50 R18 101V | Summer tyres on Light alloy | Continental | 4mm / 4mm |
| 2) | 235/50 R18 101V | Summer tyres on Light alloy | Continental | 4mm / 4mm |

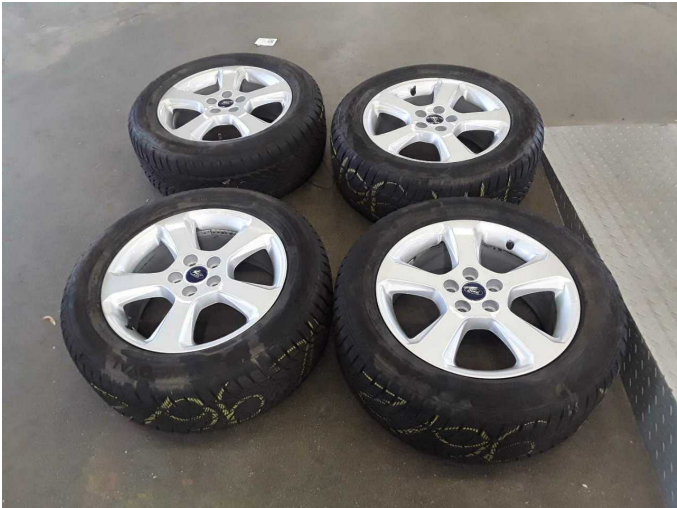
Figure 16: Additional tyres

| # | Tyre size | Type of tyre | Manufacturer | Tread depth |
|---|---|---|---|---|
| 1) | 235/55 R17 103V | Winter tyres on Light alloy | Uniroyal | 5mm / 5mm |
| 2) | 235/55 R17 103V | Winter tyres on Light alloy | Uniroyal | 6mm / 6mm |

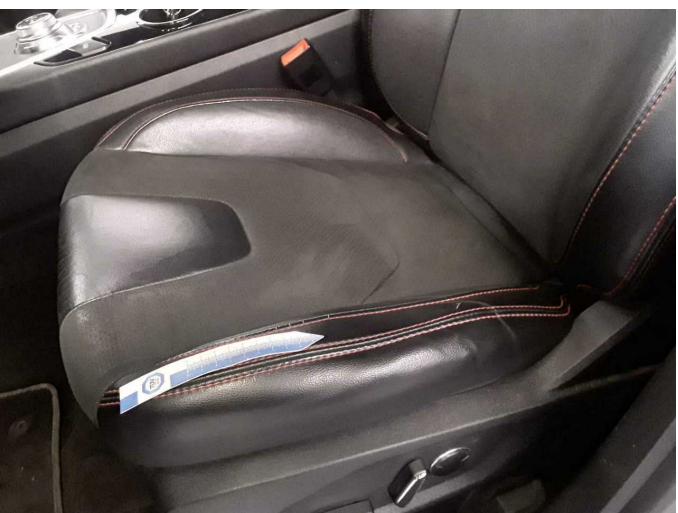
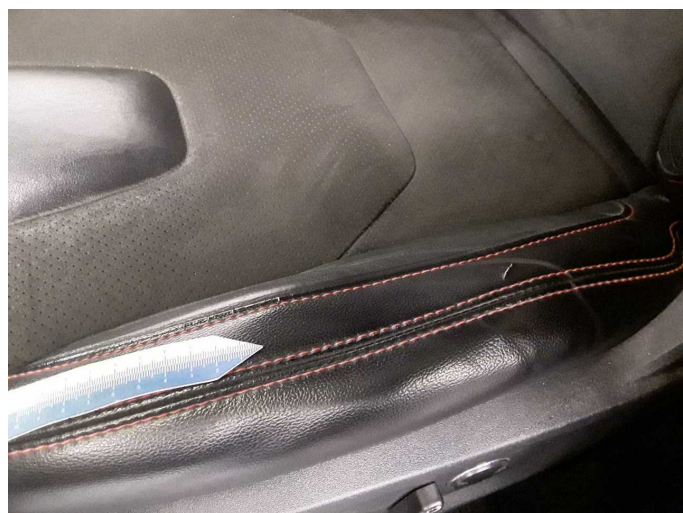
Damage 1: Seat - front: Seat cover - left side - Porous / cracked - Smart repair

| No. | Component group | Description |
|---|---|---|
| 1 | Seat - front | Seat cover - left side - Porous / cracked - Smart repair |

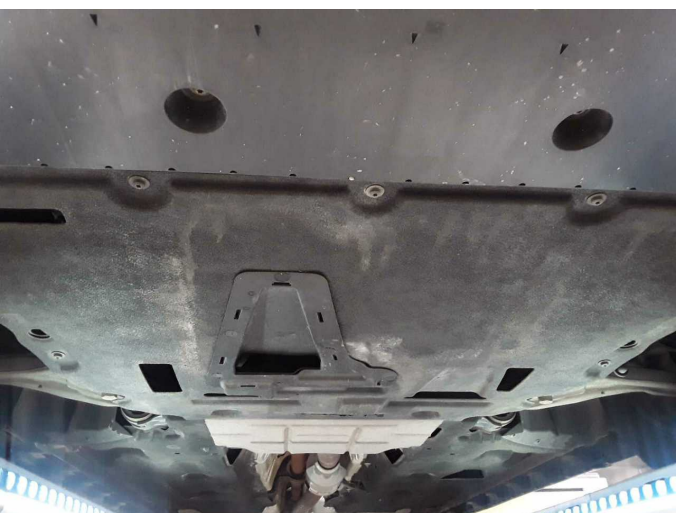
Damage 2: Engine: Engine - Leaking - Perform diagnosis

| No. | Component group | Description |
|---|---|---|
| 2 | Engine | Engine - Leaking - Perform diagnosis |

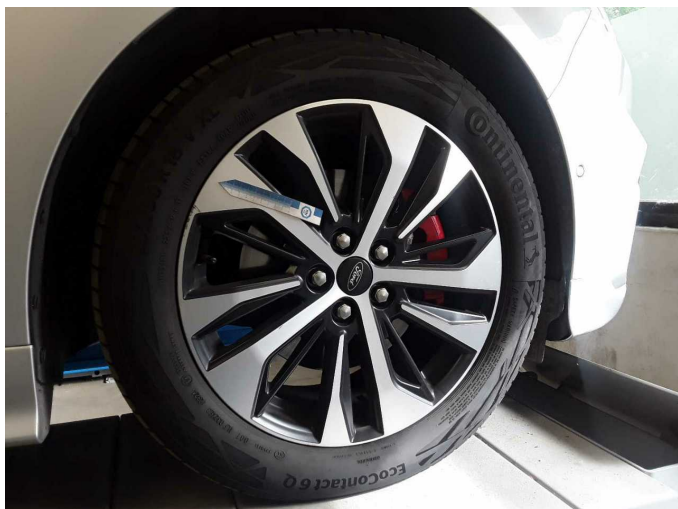
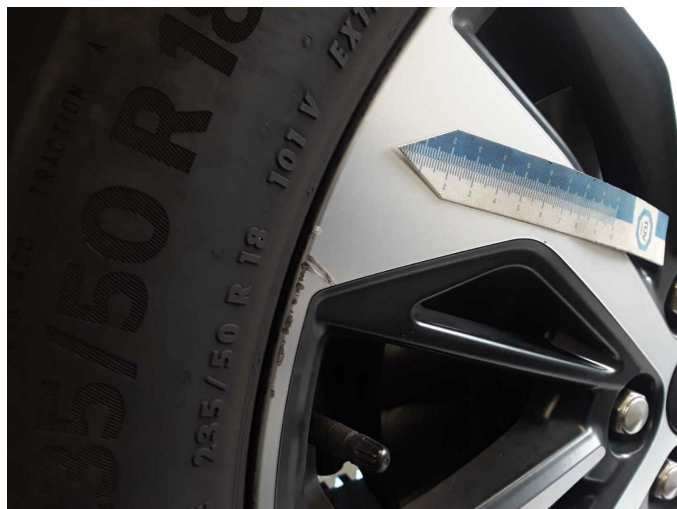
**Damage 3:** Wheel / tyres: Alloy rim - front right side - Scratch(es) - Loss in value

| No. | Component group | Description |
|---|---|---|
| 3 | Wheel / tyres | Alloy rim - front right side - Scratch(es) - Loss in value |

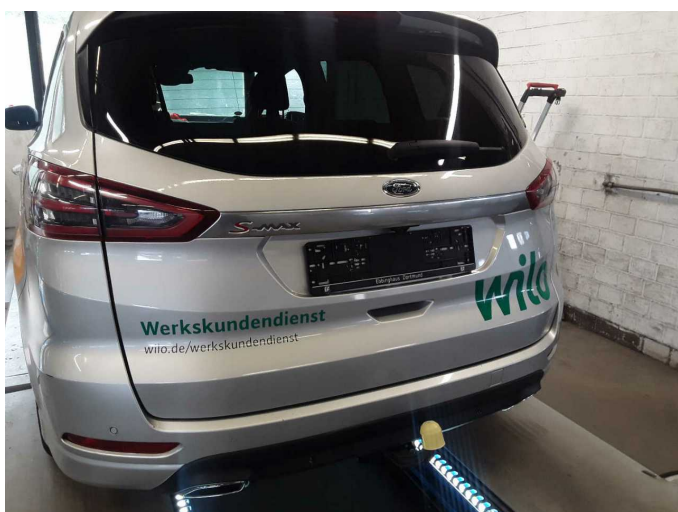
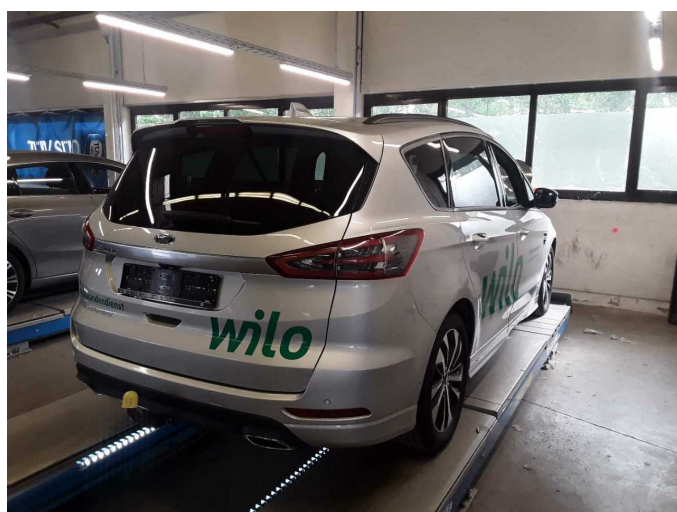
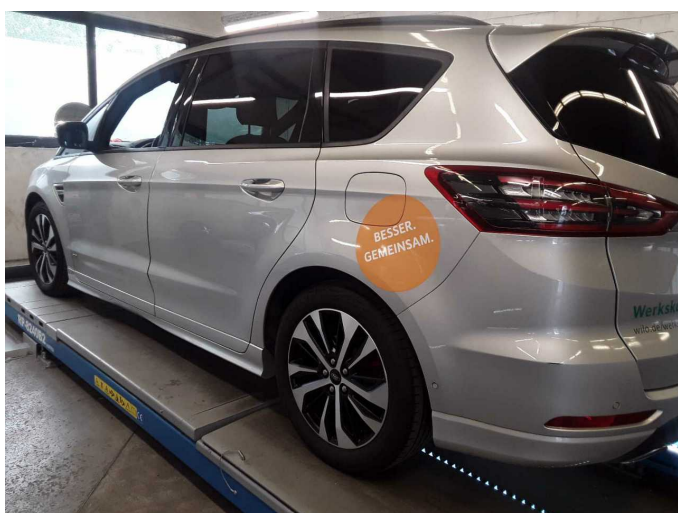
**Damage 4:** Body: Body - Glued / labelled - De-glue / neutralise

| No. | Component group | Description |
|---|---|---|
| 4 | Body | Body - Glued / labelled - De-glue / neutralise |

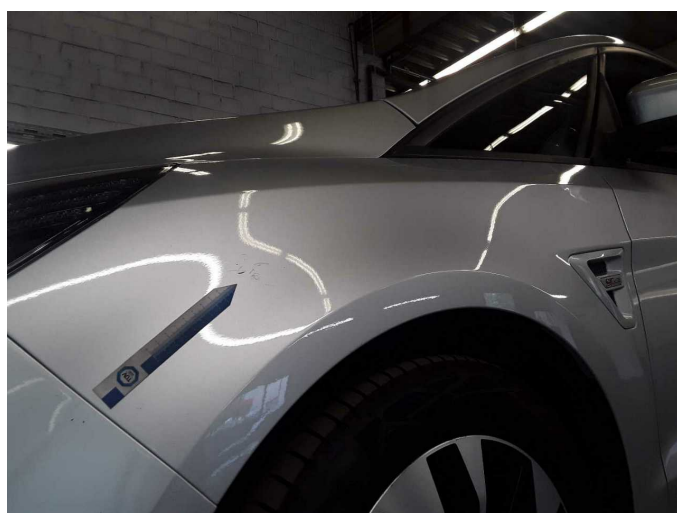
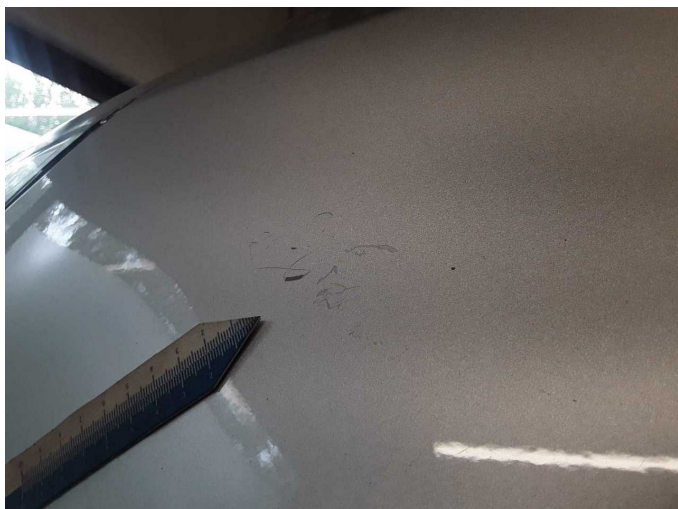
**Damage 5:** Mudguard - left side: Mudguard - left side - Scratch(es) - Paint

| No. | Component group | Description |
|---|---|---|
| 5 | Mudguard - left side | Mudguard - left side - Scratch(es) - Paint |

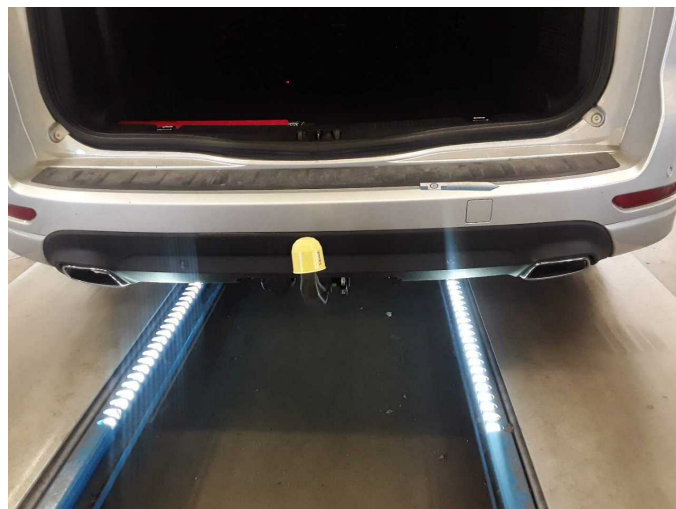
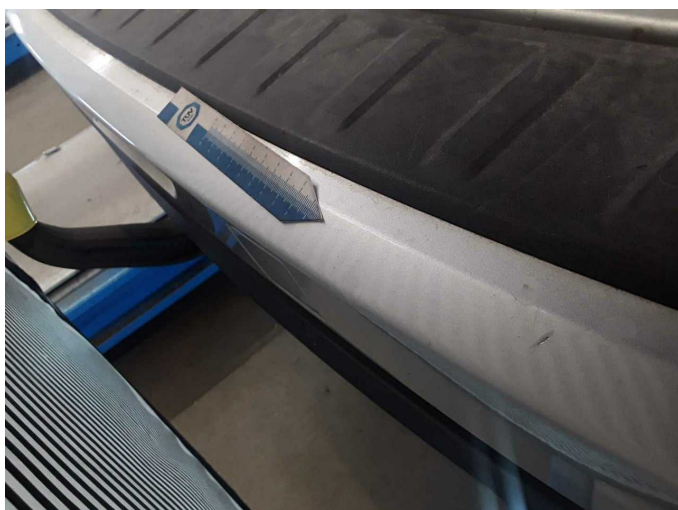
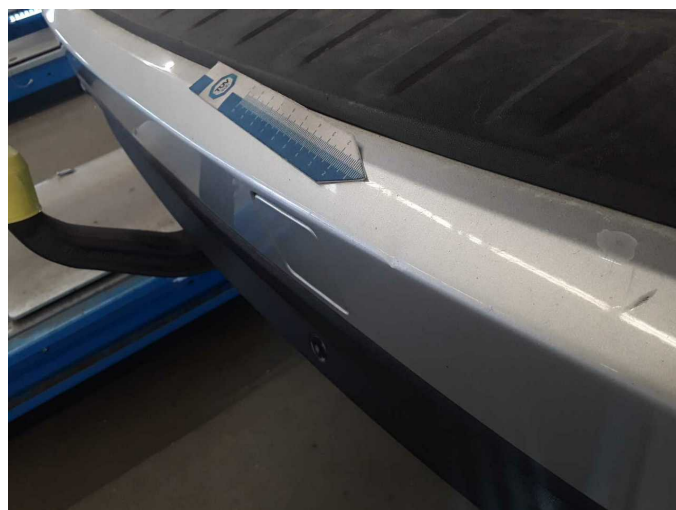
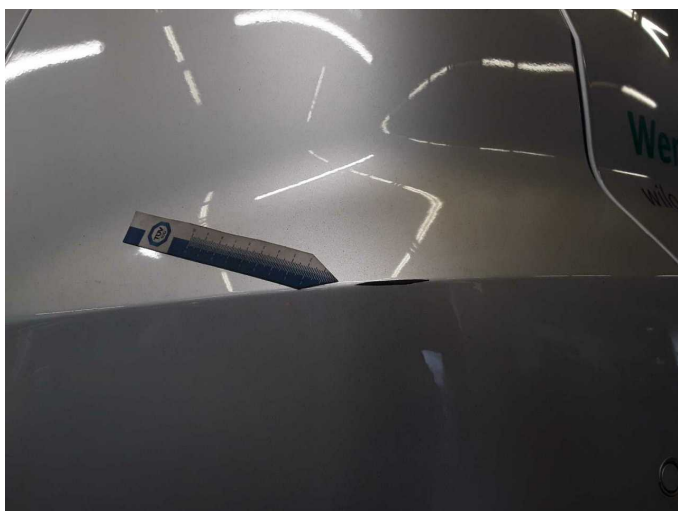
**Damage 6:** Rear bumper: Rear bumper - Dent / paintcoat damage - Repair and paint

| No. | Component group | Description |
|---|---|---|
| 6 | Rear bumper | Rear bumper - Dent / paintcoat damage - Repair and paint |

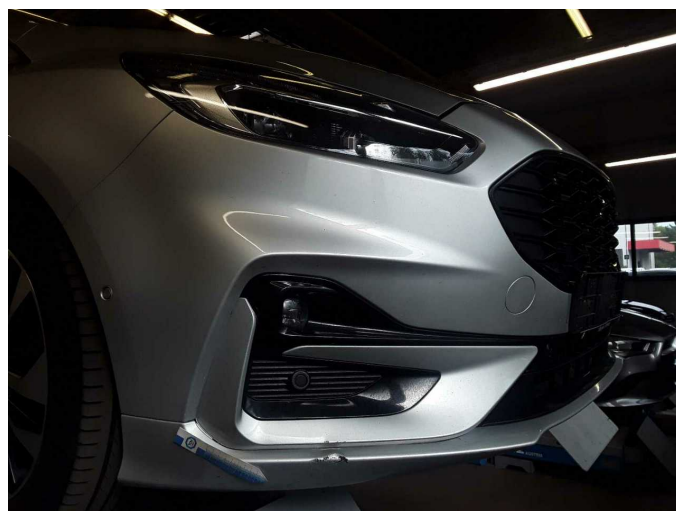
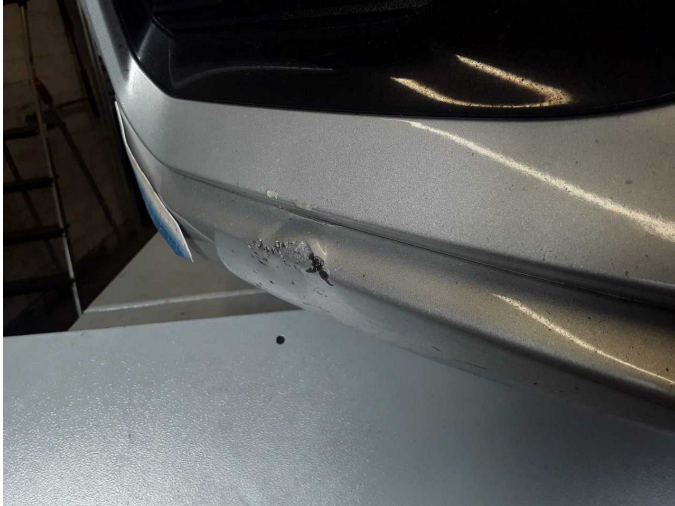
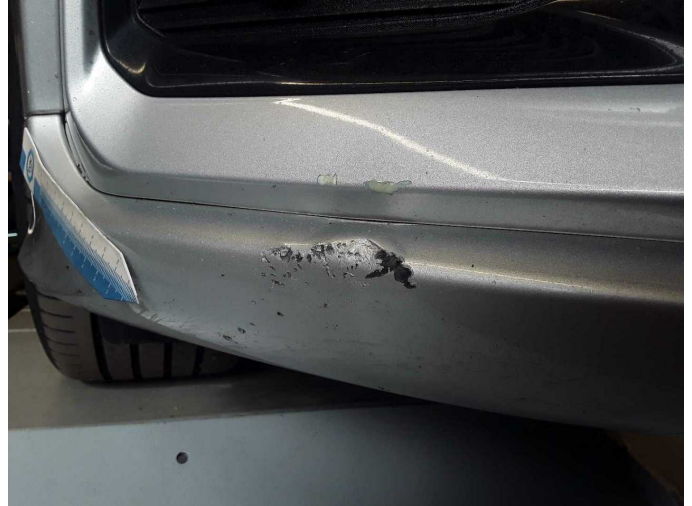
**Damage 7:** Front bumper: Front bumper - Deformed - Repair and paint

| No. | Component group | Description |
|---|---|---|
| 7 | Front bumper | Front bumper - Deformed - Repair and paint |

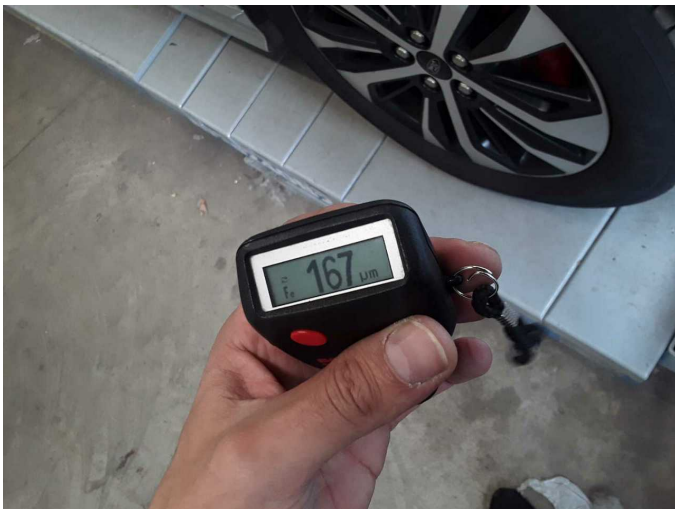
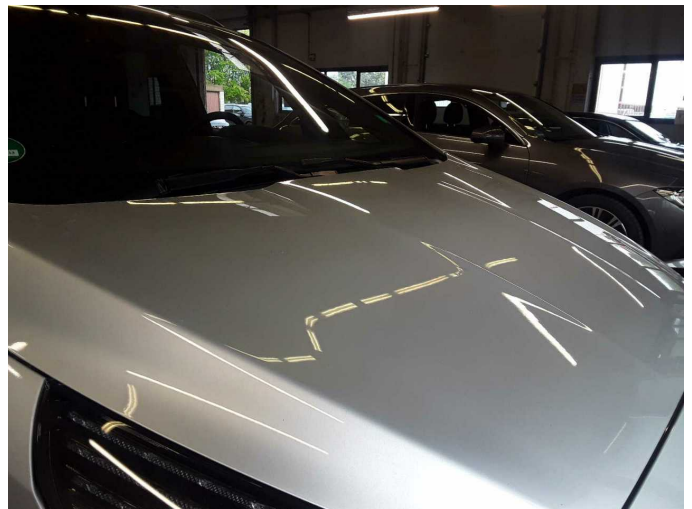
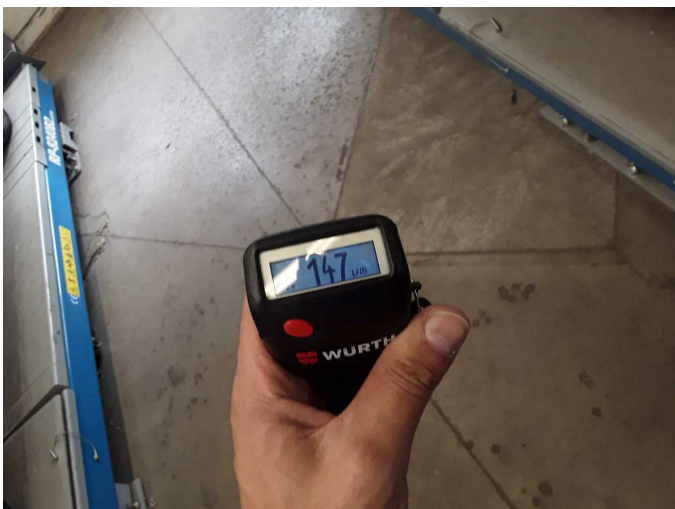
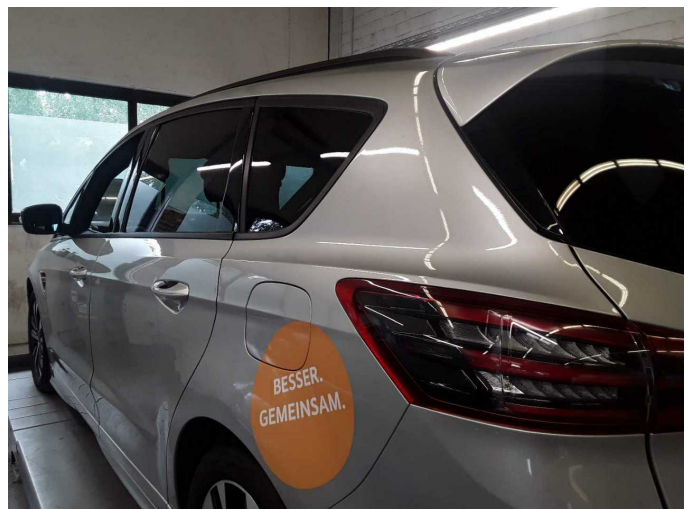
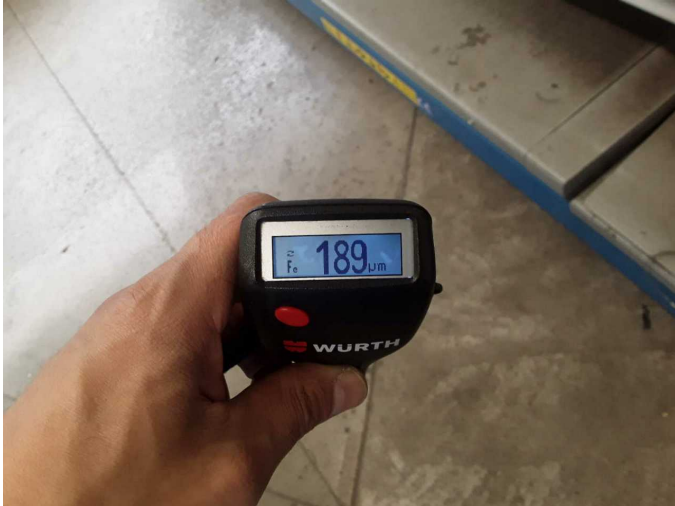
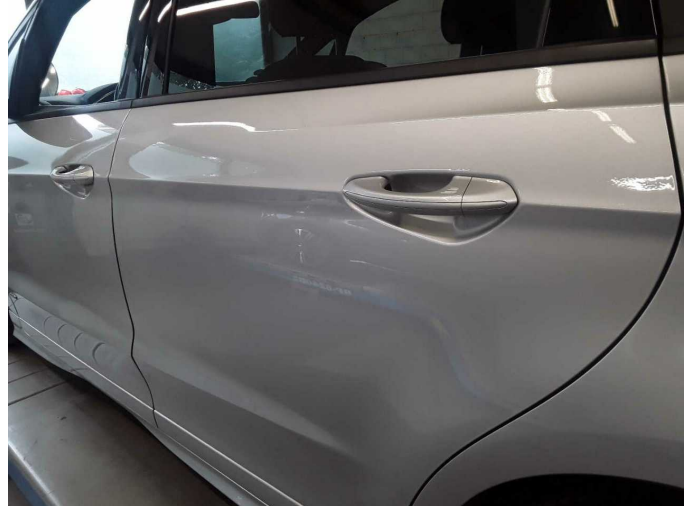
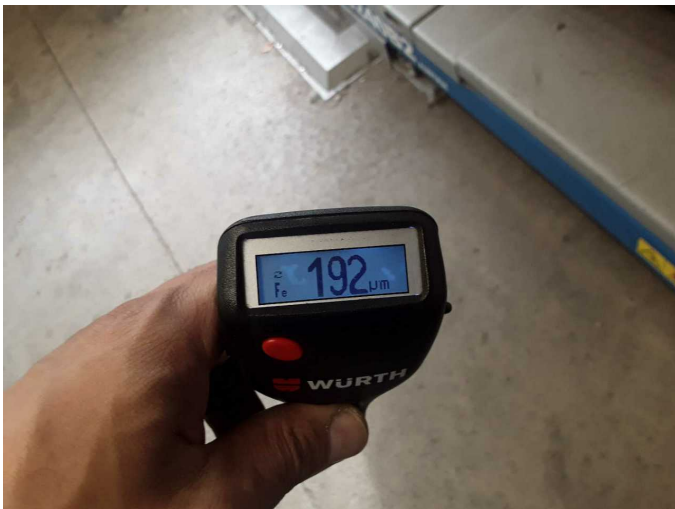
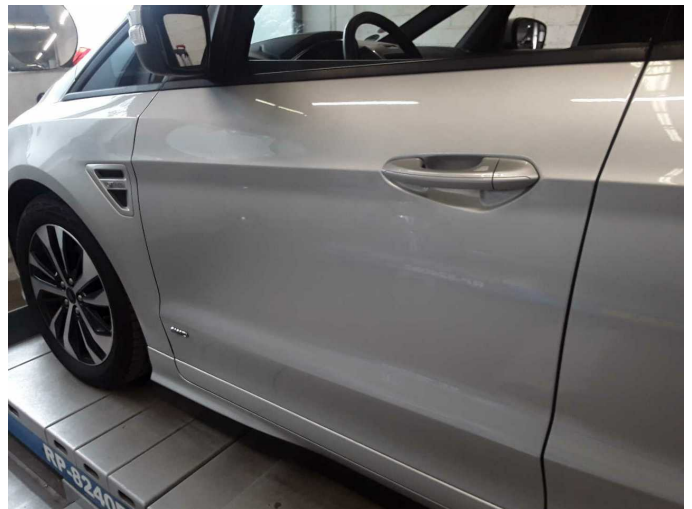
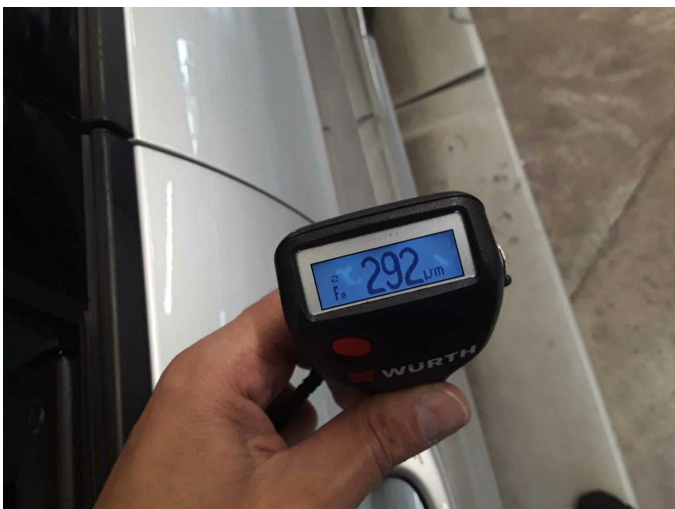
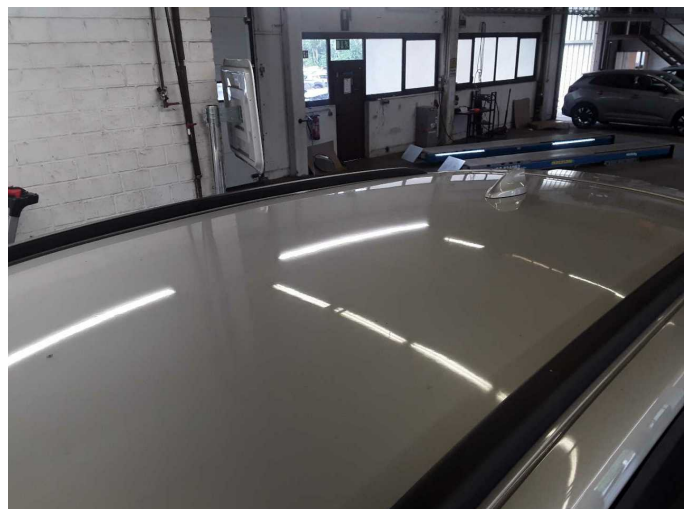
| No. | Repainting |
|---|---|
| 1 | Roof, Bonnet, Side panel - rear left side, Door - rear left side, Door - front left side, Professionally carried out, Invoice of repair done Non-existent |

**Repainting 1:** Roof, Bonnet, Side panel - rear left side, Door - rear left side, Door - front left side
