## Expertise

Protocol number: 45918210  
Order No. / Reference: 26427471  
Inspection date: 12 Jun 2026

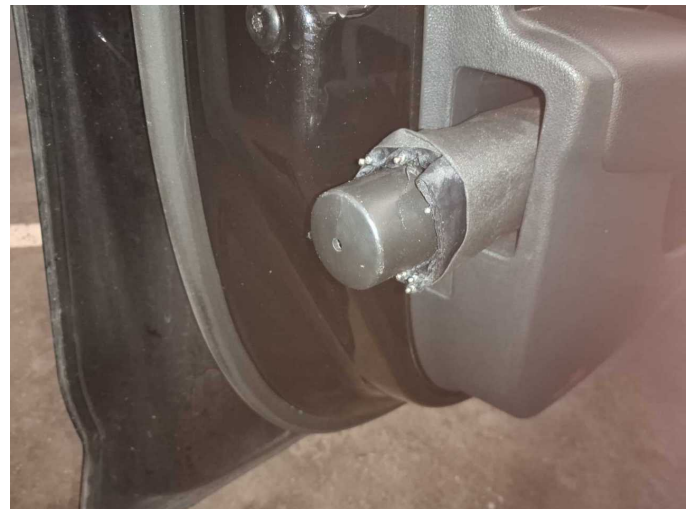
Damage 1: Equipment: Umbrella - Differs from the original configuration - Replace

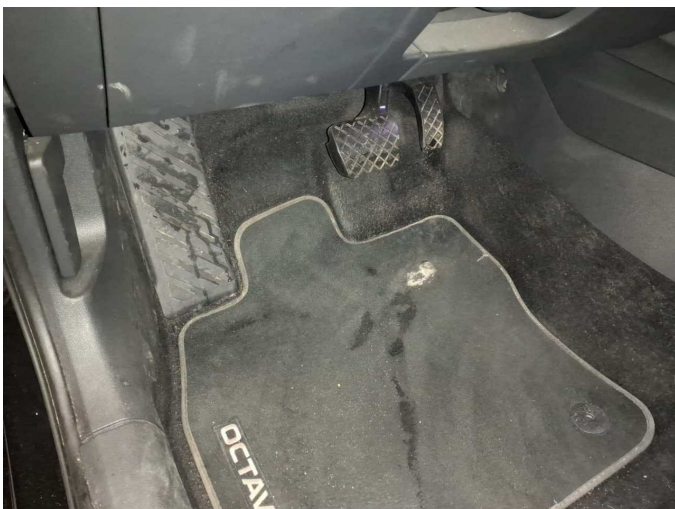
Damage 2: Trim / covers: Floor mats - Broken / torn - Replace

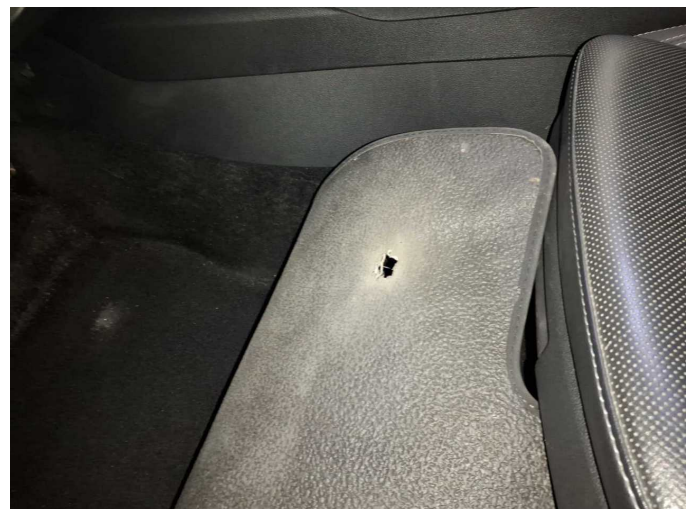
Damage 2: Trim / covers: Floor mats - Broken / torn - Replace

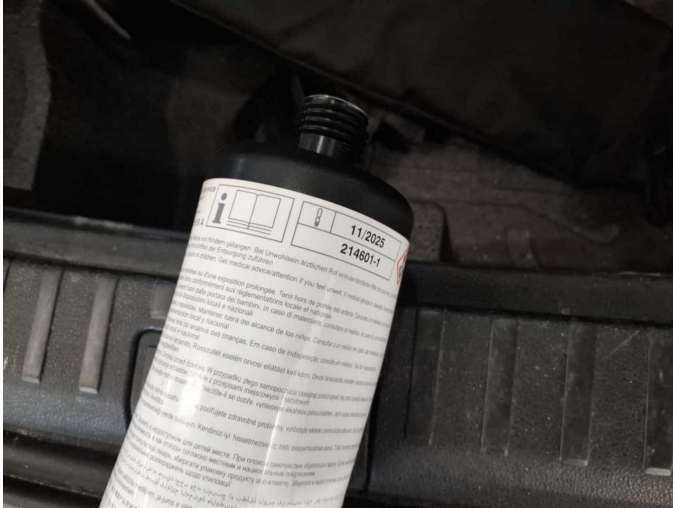
**Damage 3:** Equipment: Tirefit filler - Expired - Replace

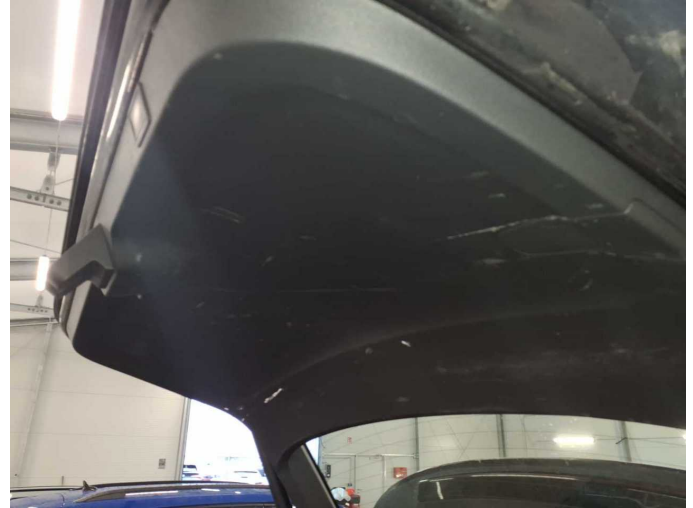
**Damage 4:** Boot lid / rear door: Trim - standard - lower - Scratch(es) - Replace

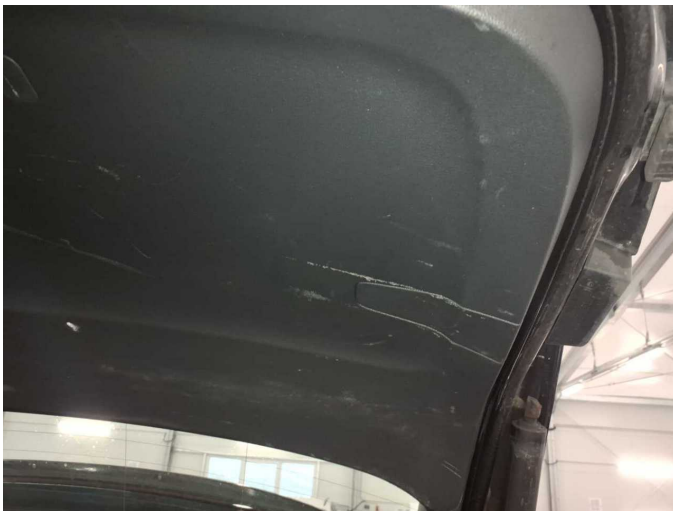
**Damage 4:** Boot lid / rear door: Trim - standard - lower - Scratch(es) - Replace

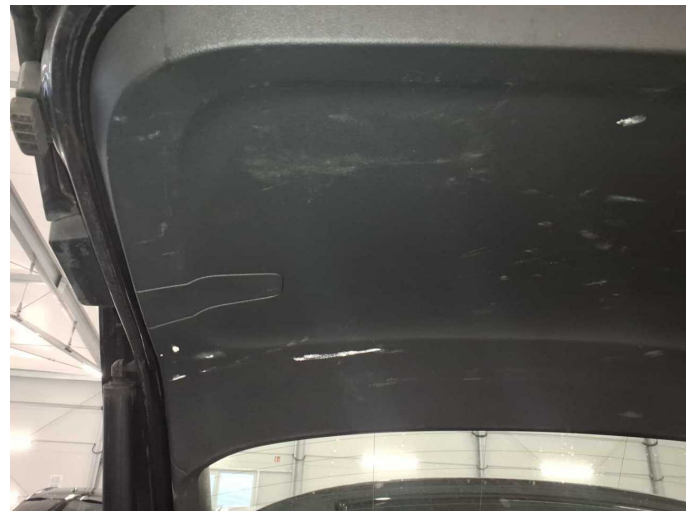
**Damage 4:** Boot lid / rear door: Trim - standard - lower - Scratch(es) - Replace

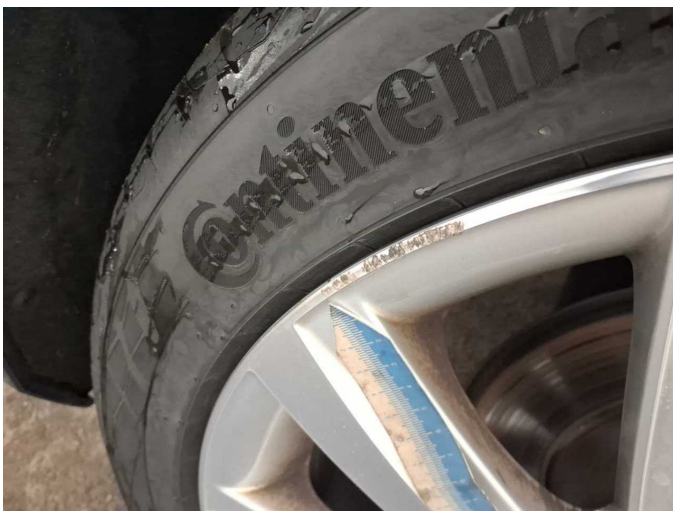
**Damage 5:** Wheel / tyres: Alloy rim - rear right side - Scratch(es) - Loss in value

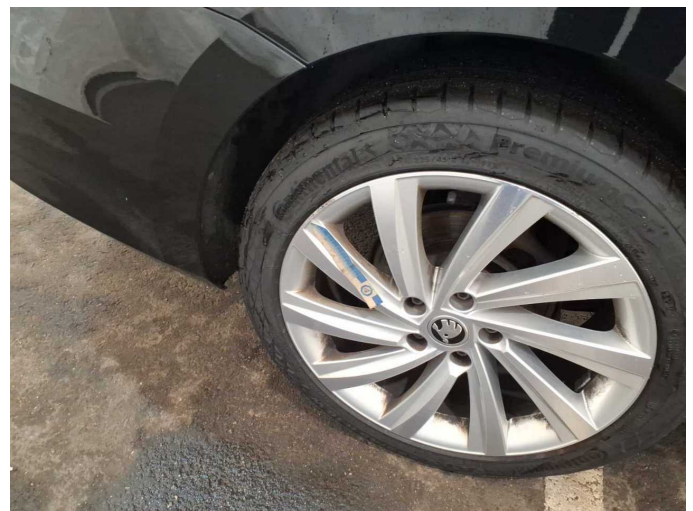
**Damage 5:** Wheel / tyres: Alloy rim - rear right side - Scratch(es) - Loss in value

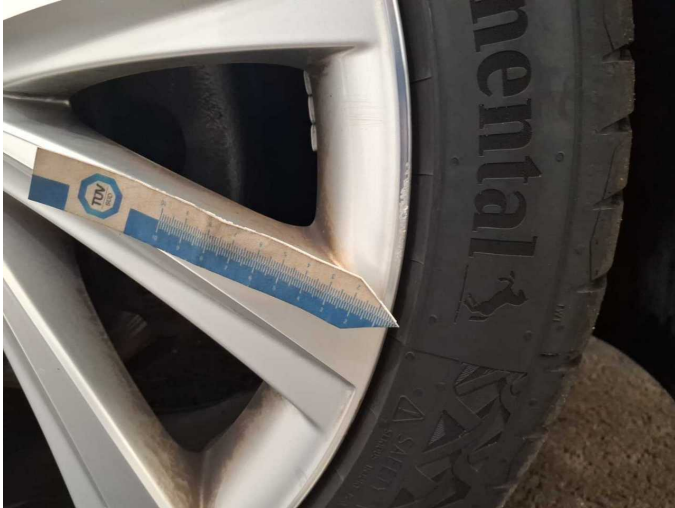
**Damage 6:** Wheel / tyres: Alloy rim - front right side - Scratch(es) - Loss in value

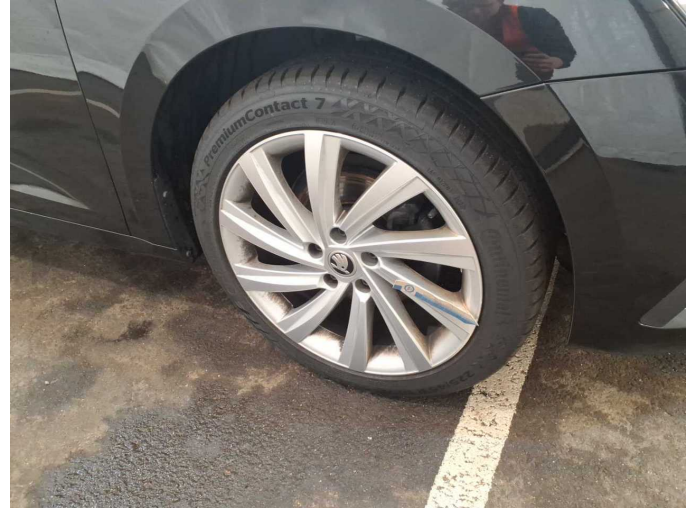
**Damage 6:** Wheel / tyres: Alloy rim - front right side - Scratch(es) - Loss in value

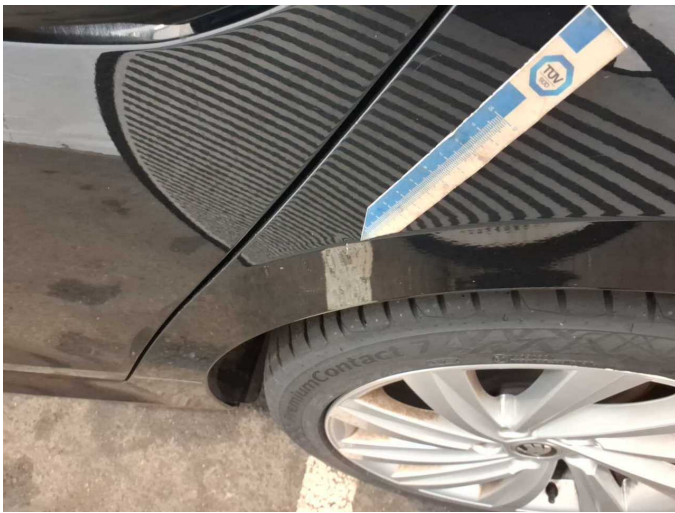
**Damage 7:** Side panel - rear left side: Side panel - Dent / paintcoat damage - Smart repair

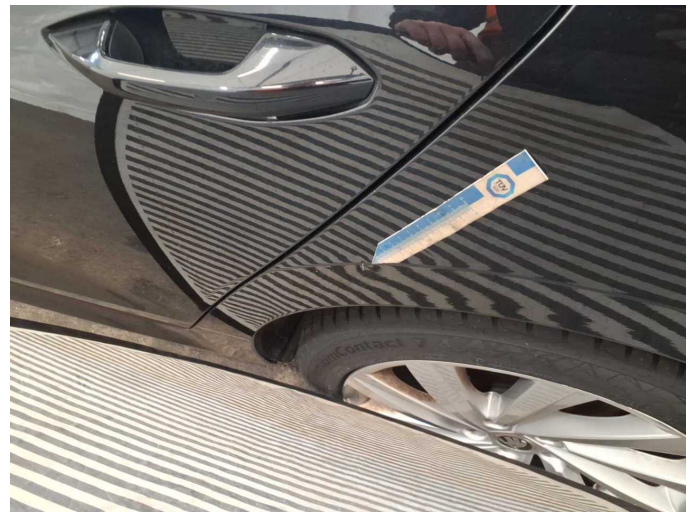
**Damage 7:** Side panel - rear left side: Side panel - Dent / paintcoat damage - Smart repair

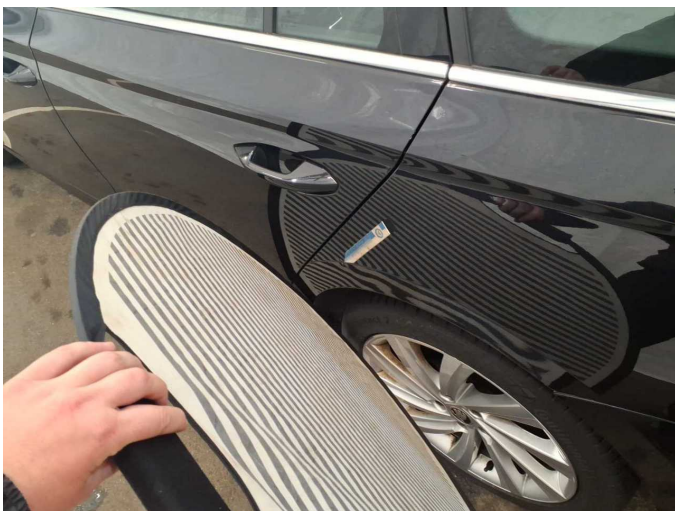
**Damage 7:** Side panel - rear left side: Side panel - Dent / paintcoat damage - Smart repair

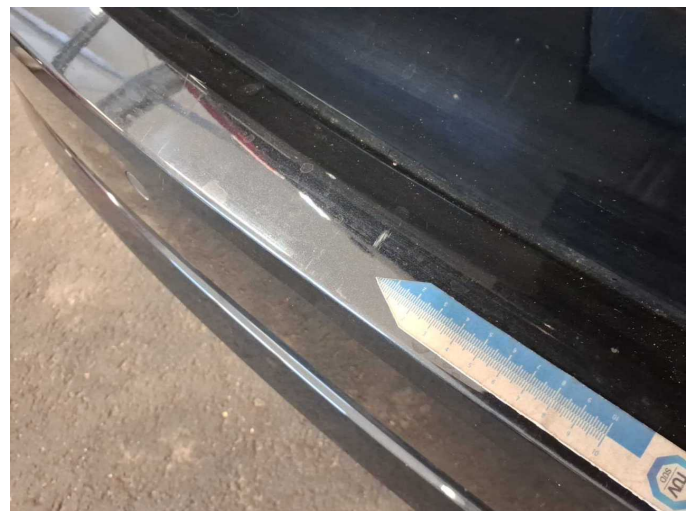
**Damage 8:** Rear bumper: Rear bumper - Scratch(es) - Paint

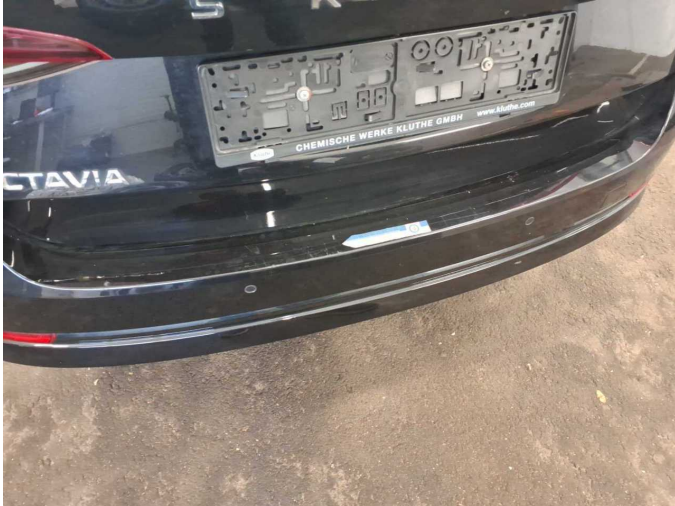
**Damage 8:** Rear bumper: Rear bumper - Scratch(es) - Paint

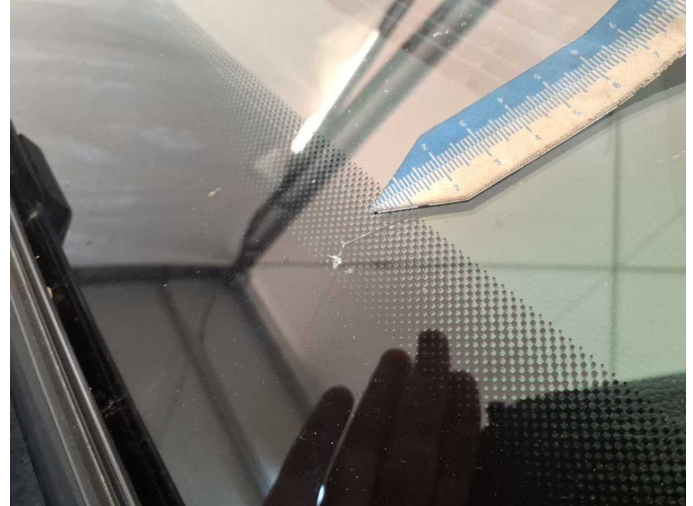
**Damage 9:** Vehicle glazing: Windscreen - Broken / torn - Replace

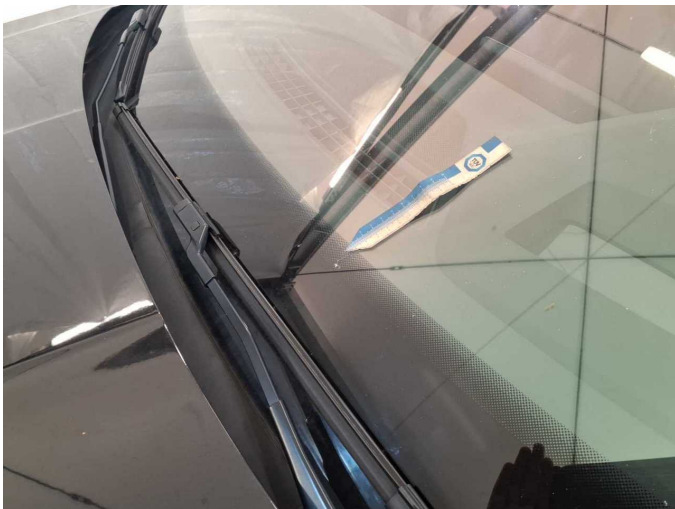
**Damage 9:** Vehicle glazing: Windscreen - Broken / torn - Replace

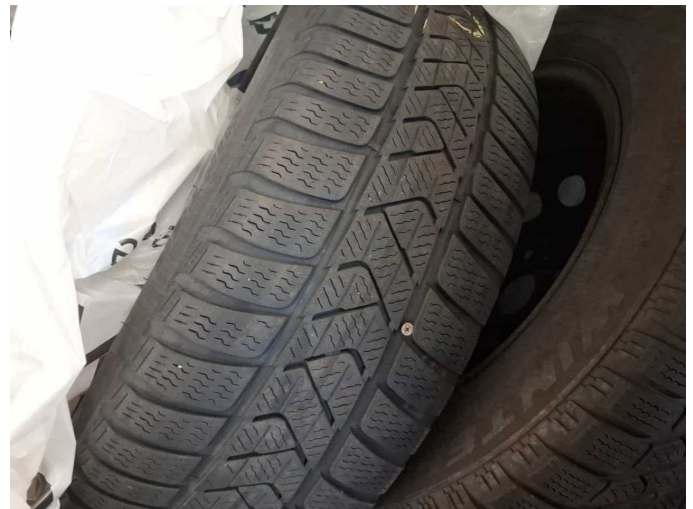
**Wear and tear 3:** 2nd wheel set: 1 tyre (Schraube im reifen) - Damaged - No deduction

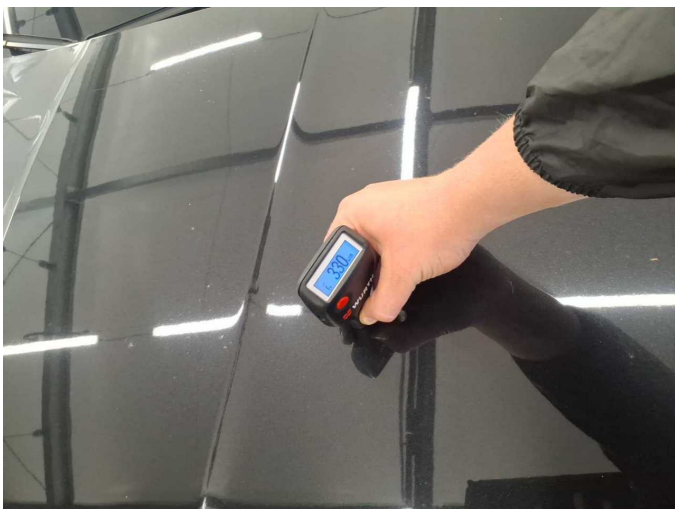
**Repainting 1:** Bonnet
