Expertise

Protocol number: 46796702  
Order No. / Reference: 26787944  
Inspection date: 30 Jul 2026

Manufacturer: Skoda  
VIN: TMBJJ9NSXP8021482

Model: Kodiahq 2.0 TDI DSG L&K

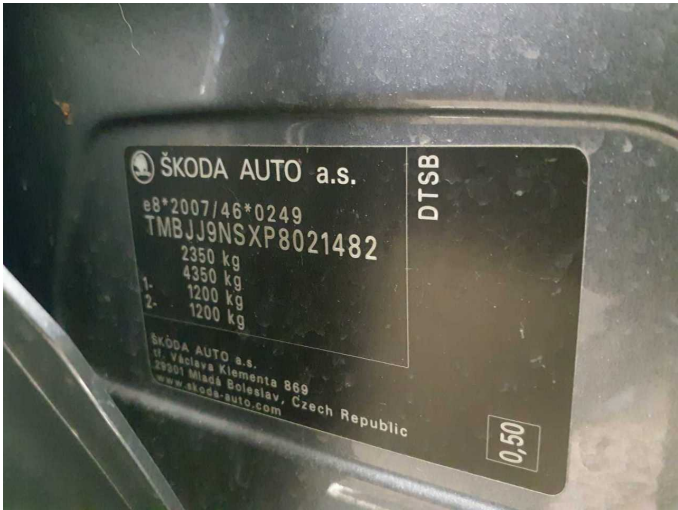
Figure 11: VIN

| VIN comparison | The vehicle identification number (VIN) was read from the vehicle and its conformity with the submitted documents was confirmed by the undersigned during the inspection. |

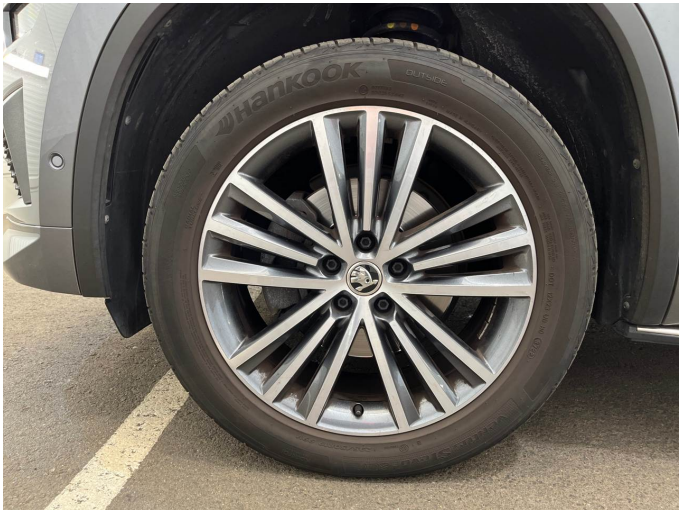
Figure 12: Mounted tyres

| # | Tyre size | Type of tyre | Manufacturer | Tread depth |
|---|---|---|---|---|
| 1) | 235/50 R19 99V | Summer tyres on Light alloy | Hankook | 5mm / 5mm |
| 2) | 235/50 R19 99V | Summer tyres on Light alloy | Hankook | 6mm / 6mm |

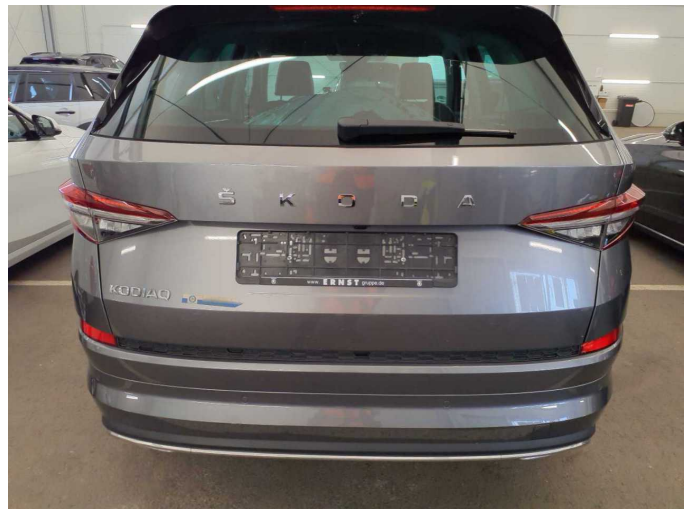
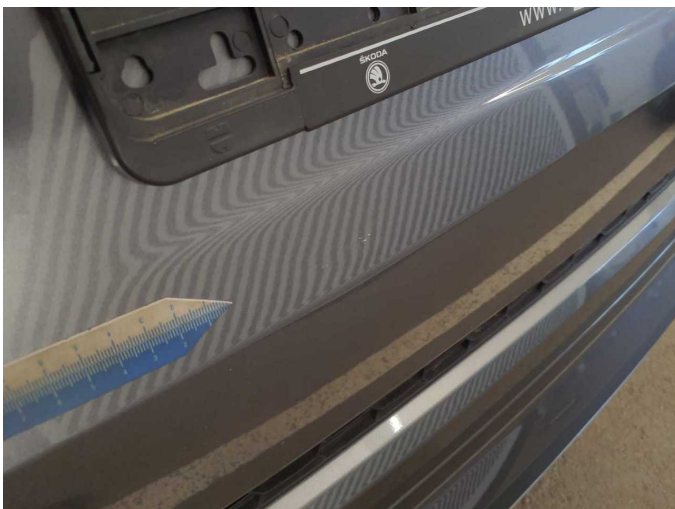
| No. | Component group | Description |
|---|---|---|
| 1 | Boot lid / rear door | Boot lid - dent(s) - Smart repair |

**Damage 1:** Boot lid / rear door: Boot lid - dent(s) - Smart repair

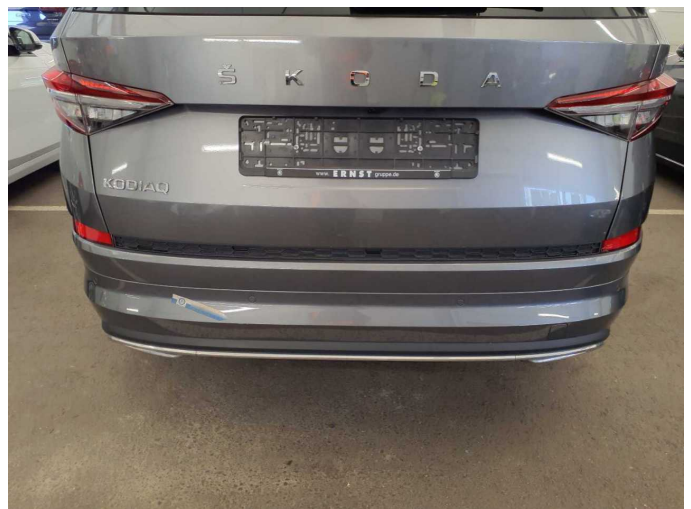
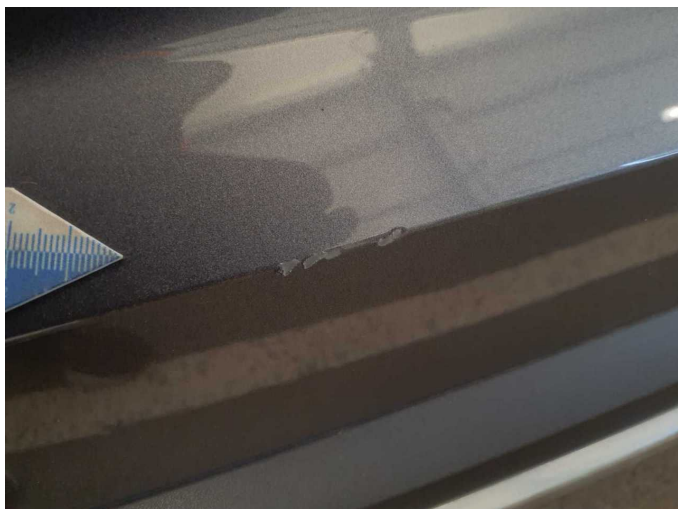
| No. | Component group | Description |
|---|---|---|
| 2 | Rear bumper | Rear bumper - Scratch(es) - Smart repair |

**Damage 2:** Rear bumper: Rear bumper - Scratch(es) - Smart repair

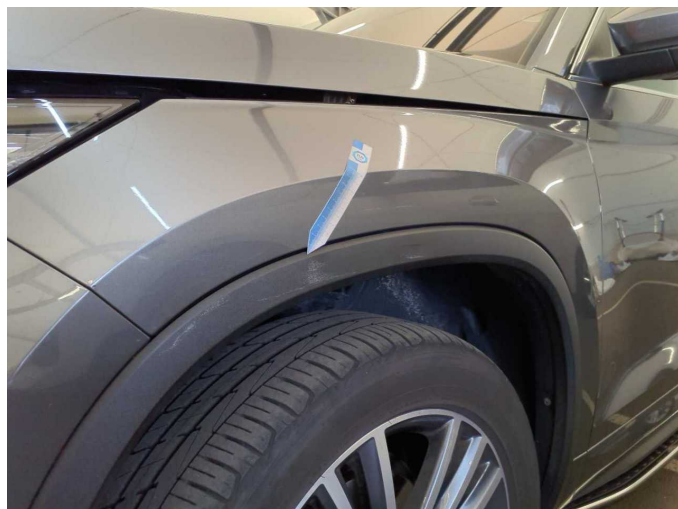
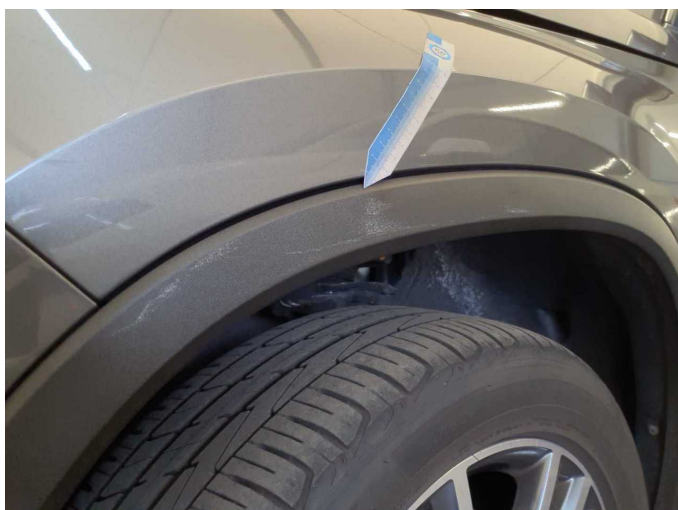
| No. | Component group | Description |
|---|---|---|
| 3 | Mudguard - left side | Wheel well extension - Scratch(es) - Replace |

**Damage 3:** Mudguard - left side: Wheel well extension - Scratch(es) - Replace

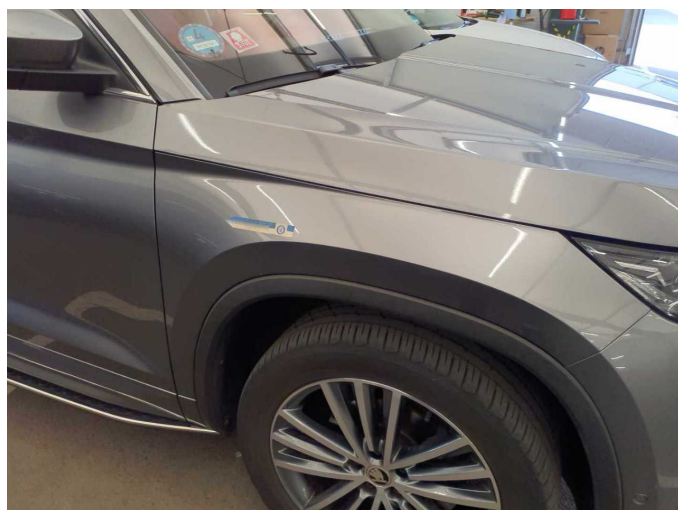
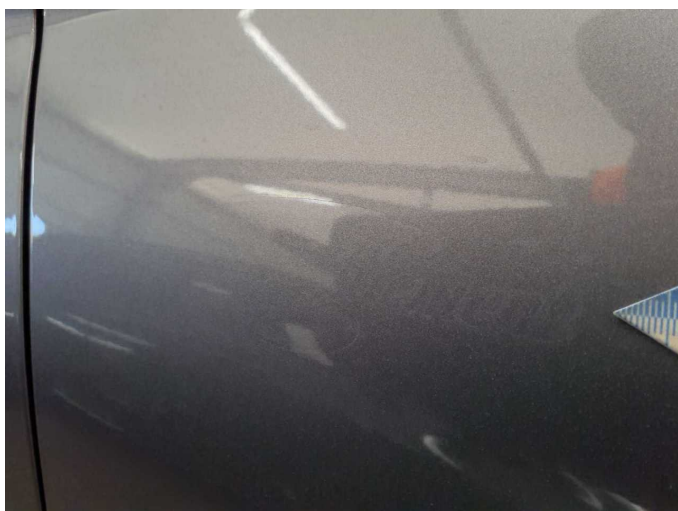
| No. | Component group | Description |
|---|---|---|
| 4 | Mudguard - right side | Mudguard - right side (Schriftzug) - Missing - Replace |

**Damage 4:** Mudguard - right side: Mudguard - right side (Schriftzug) - Missing - Replace

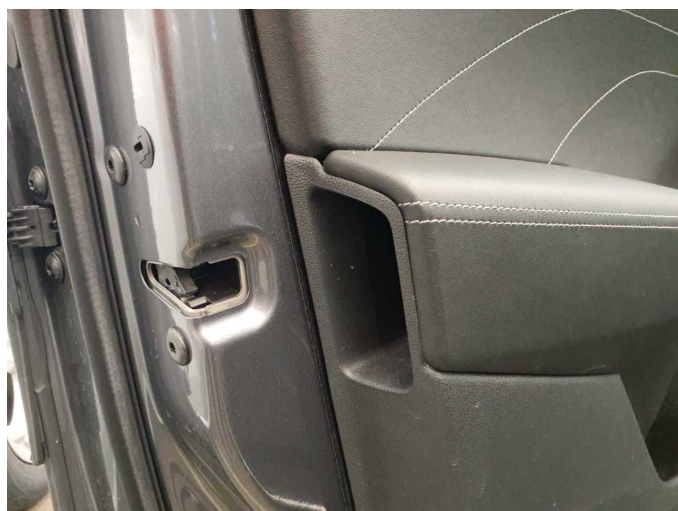
Equipment - Umbrella

**Missing part 1:** Equipment: Umbrella - Missing - Replace
