Expertise

Protocol number: 46091265  
Order No. / Reference: 26539454  
Inspection date: 23 Jun 2026

Manufacturer: Volkswagen

Model: Passat Variant 2.0 TDI SCR Business

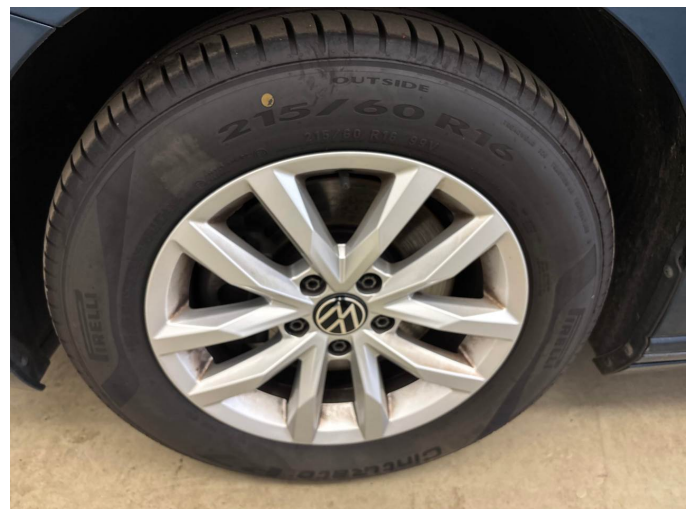
| # | Tyre size | Type of tyre | Manufacturer | Tread depth |
|---|---|---|---|---|
| 1) | 215/60 R16 99V | Summer tyres on Light alloy | Pirelli | 4mm / 4mm |
| 2) | 215/60 R16 99V | Summer tyres on Light alloy | Pirelli | 4mm / 4mm |

Figure 12: Mounted tyres

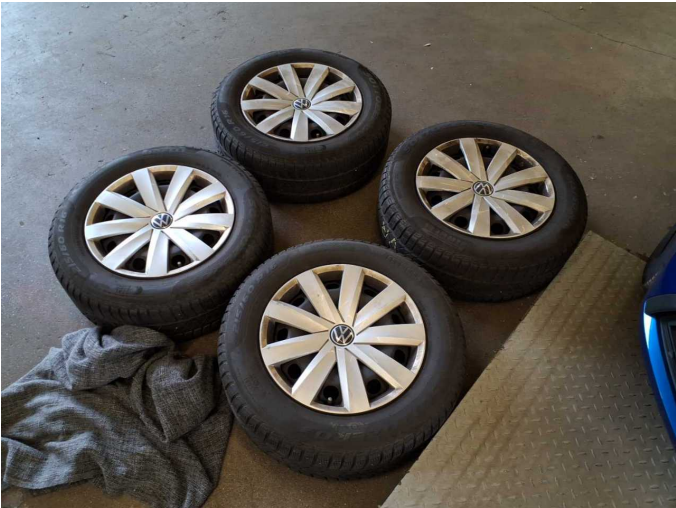
| # | Tyre size | Type of tyre | Manufacturer | Tread depth |
|---|---|---|---|---|
| 1) | 215/60 R16 95H | Winter tires (with run-flat tires) on Steel rim with wheel cover | Pirelli | 5mm / 5mm |
| 2) | 215/60 R16 95H | Winter tires (with run-flat tires) on Steel rim with wheel cover | Pirelli | 5mm / 5mm |

Figure 15: Additional tyres

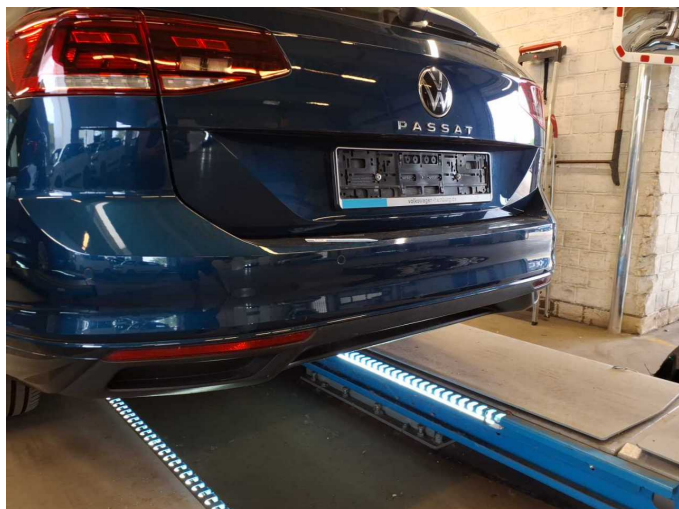
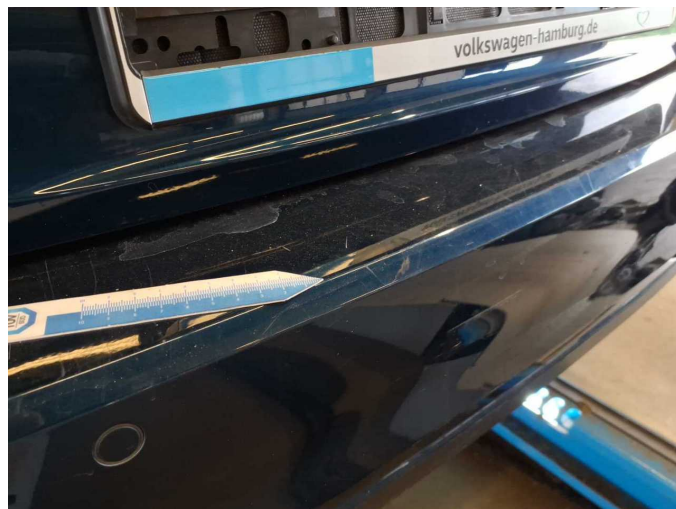
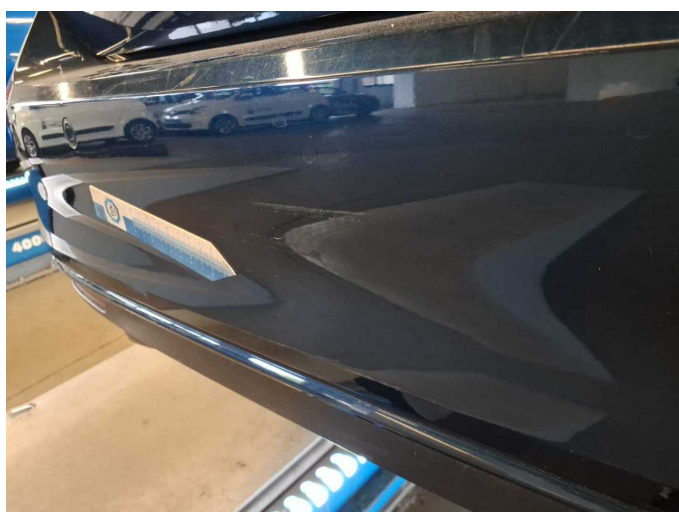
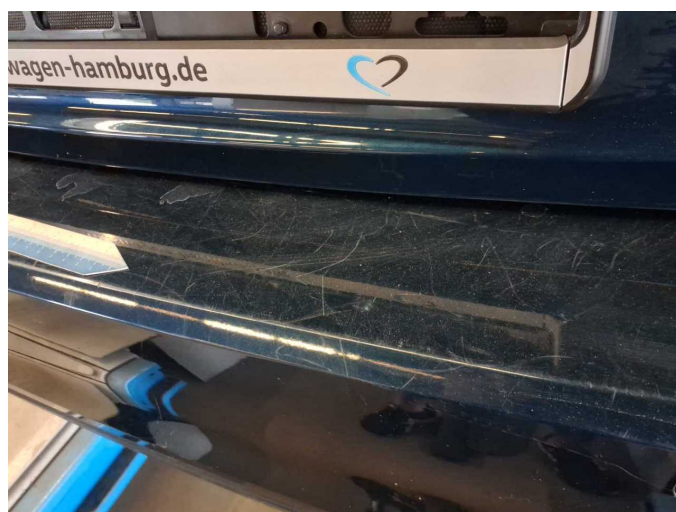
| No. | Component group | Description |
|---|---|---|
| 1 | Rear bumper | Rear bumper - Scratch(es) - Paint |

**Damage 1:** Rear bumper: Rear bumper - Scratch(es) - Paint

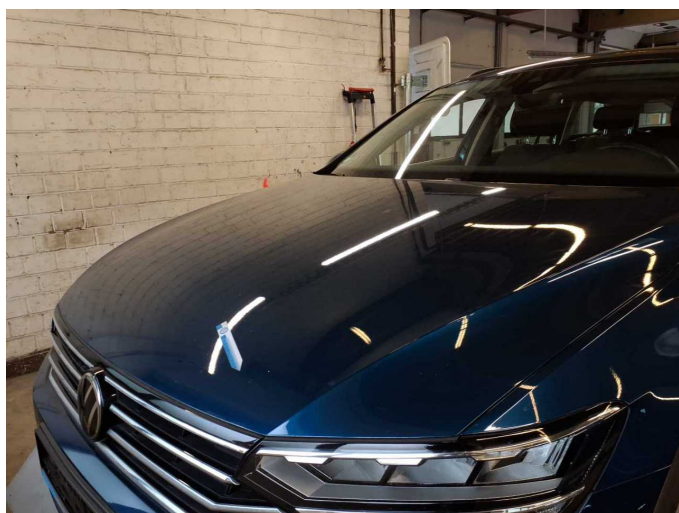
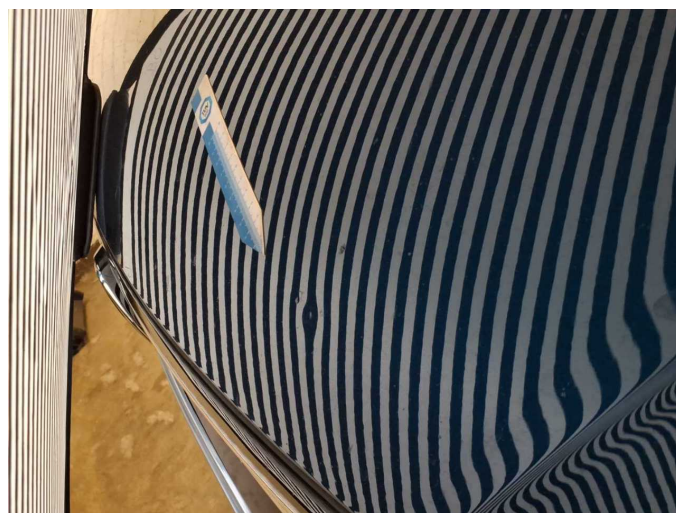
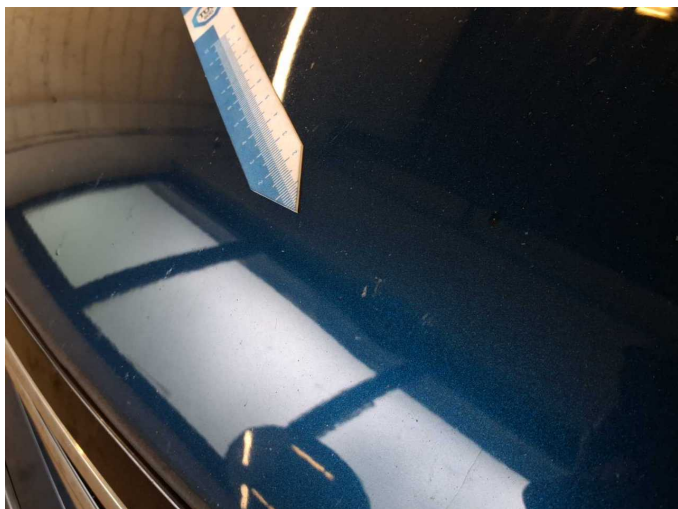
| No. | Component group | Description |
|---|---|---|
| 2 | Bonnet | Bonnet - Dent / paintcoat damage - Repair and paint |

**Damage 2:** Bonnet: Bonnet - Dent / paintcoat damage - Repair and paint

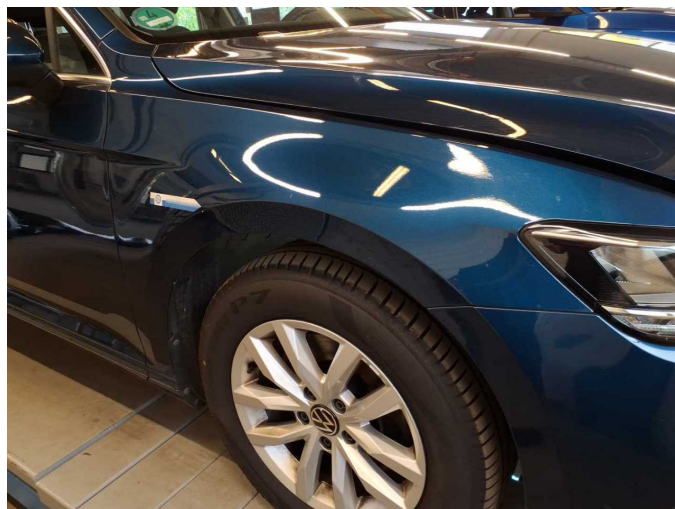
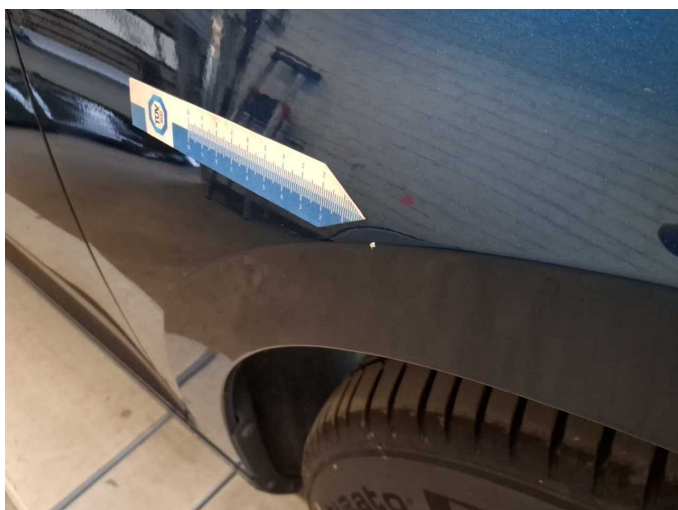
| No. | Component group | Description |
|---|---|---|
| 1 | Mudguard - right side | Mudguard - right side - Stone chips - No deduction |

**Wear and tear 1:** Mudguard - right side: Mudguard - right side - Stone chips - No deduction

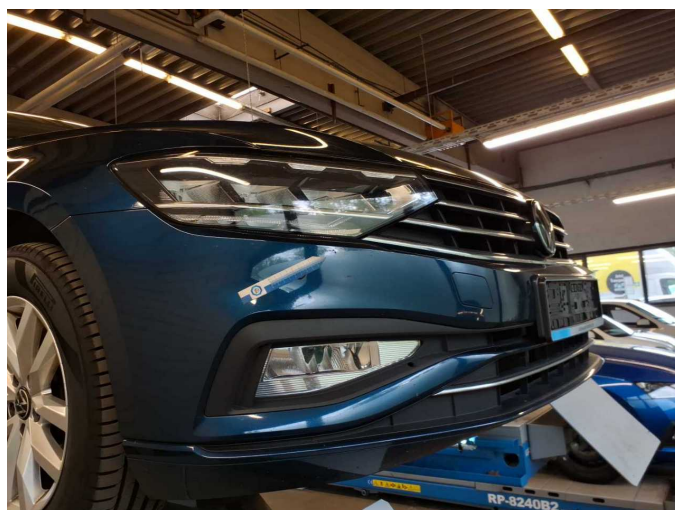
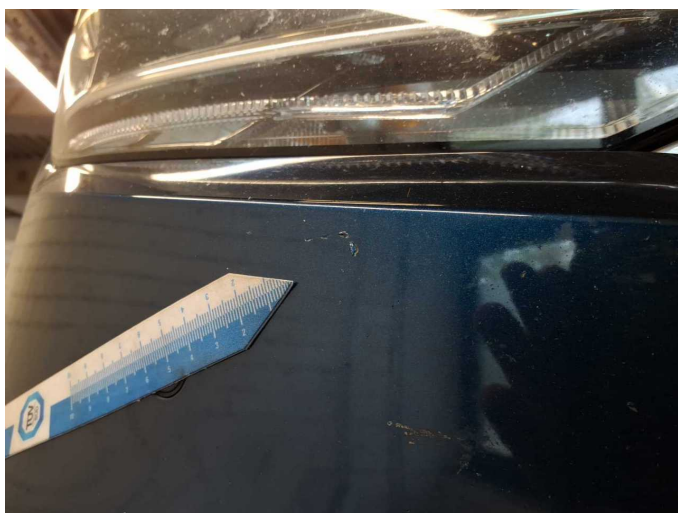
| No. | Component group | Description |
|---|---|---|
| 2 | Front bumper | Front bumper - Stone chips - No deduction |

**Wear and tear 2:** Front bumper: Front bumper - Stone chips - No deduction

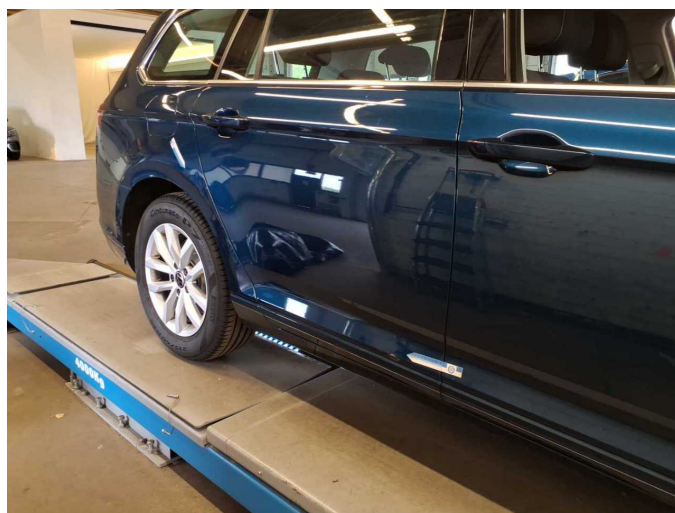
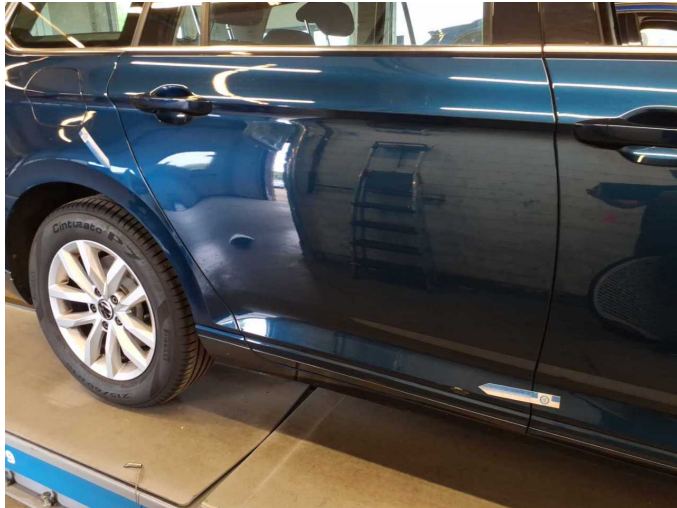
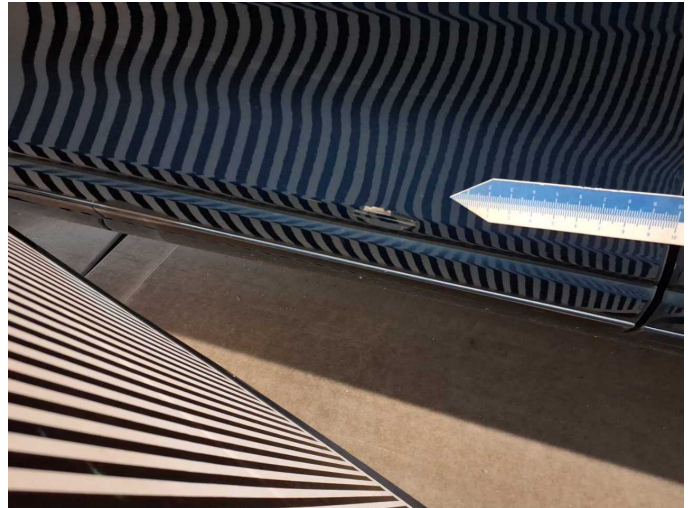
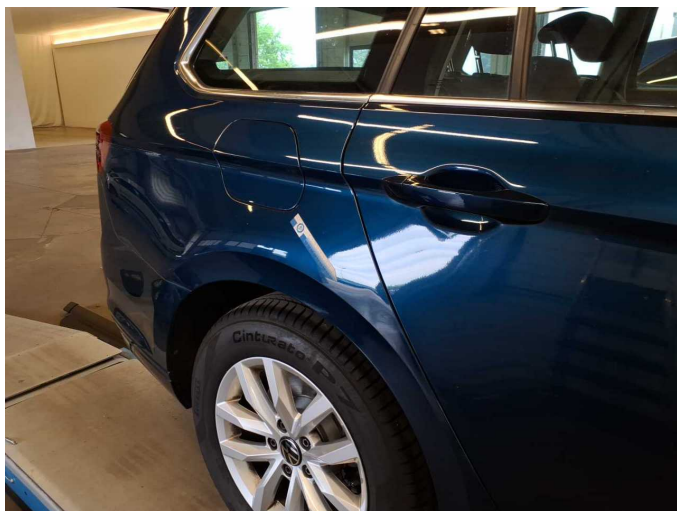
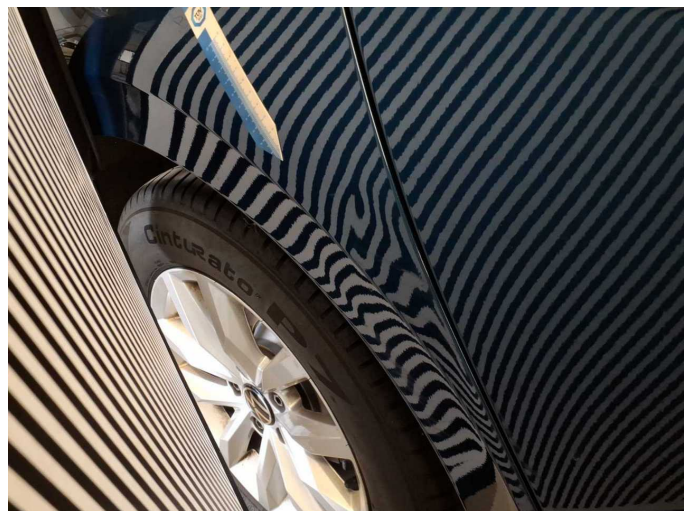
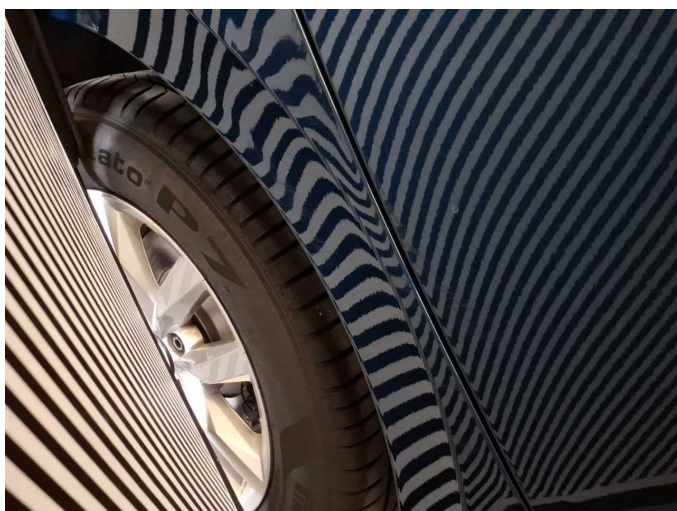
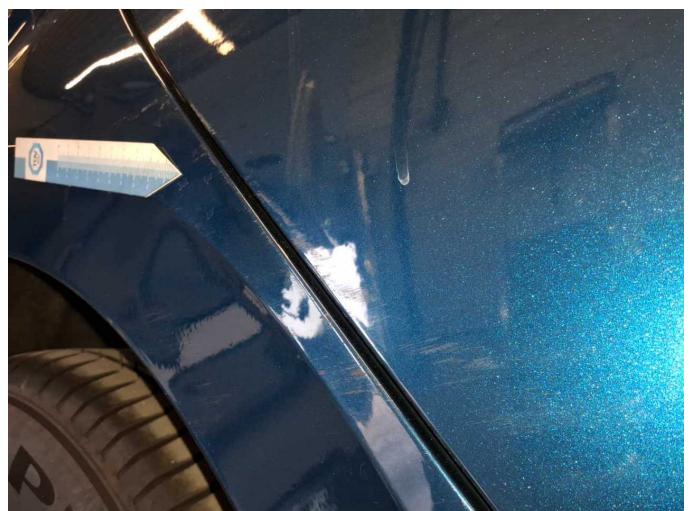
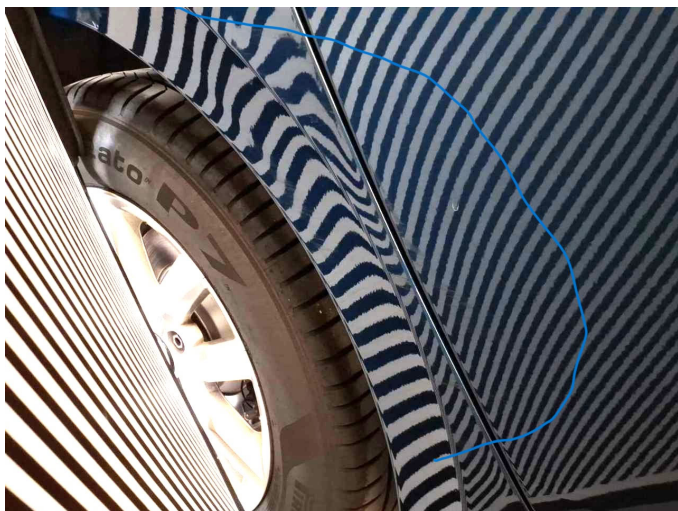
1 Side right

**Accident 1:** Side right

**Accident 1: Side right**

Der kalkulierte Unfall wurde nach bestem Wissen und Gewissen unter eingeschränkten Besichtigungsbedingung im demontagefreien Zustand erstellt. Es können aufgrund verdeckter Beschädigung, Mehrkosten und somit Abweichung der für den Unfall ausgewiesenen Reparaturkosten nicht ausgeschlossen werden.
