Expertise

Protocol number: 46479762  
Order No. / Reference: 26595673  
Inspection date: 10 Jul 2026

Manufacturer: Peugeot

Model: 208 Elektromotor 136 Allure

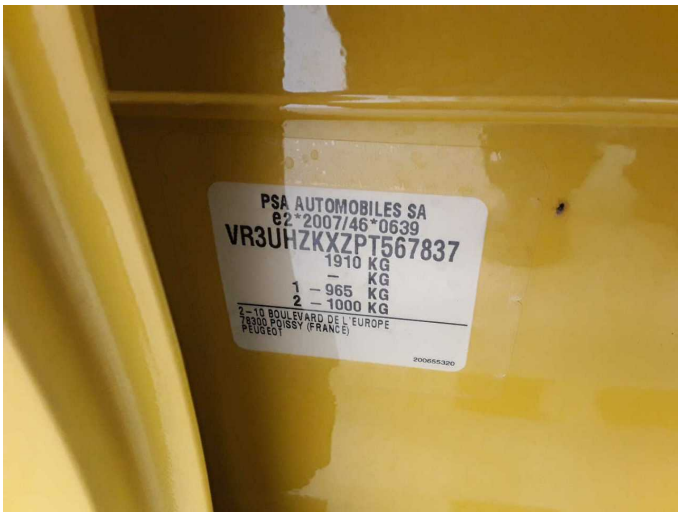
Figure 11: VIN

| VIN comparison | The vehicle identification number (VIN) was read from the vehicle and its conformity with the submitted documents was confirmed by the undersigned during the inspection. |

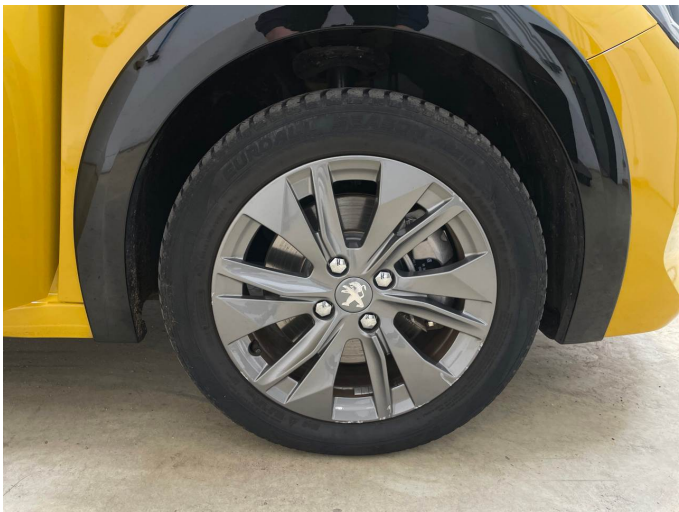
Figure 12: Mounted tyres

| Tyres | | | | |
|---|---|---|---|---|
| 1) | 195/55 R16 87V | All-season tyres on Light alloy | Falken | 6mm / 6mm |
| 2) | 195/55 R16 87V | All-season tyres on Light alloy | Falken | 6mm / 6mm |

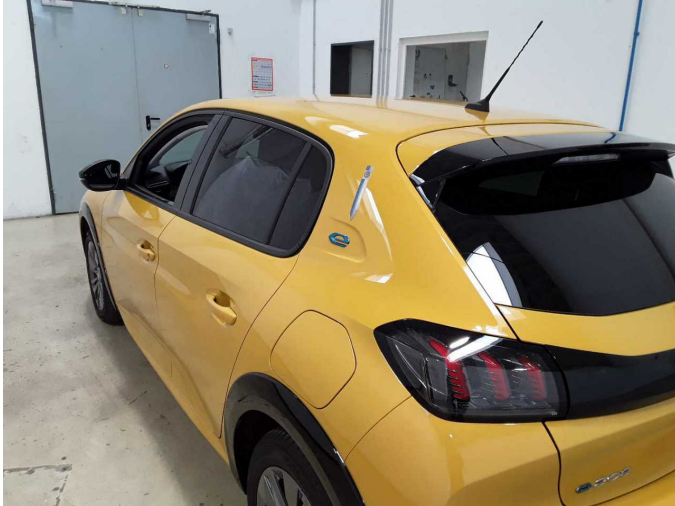
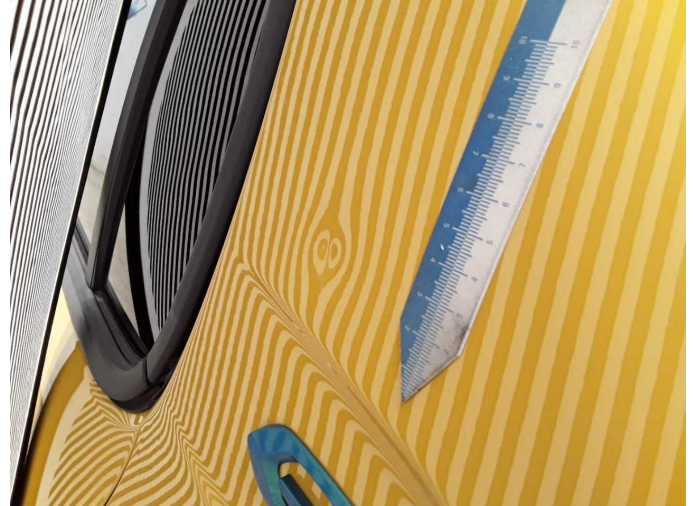
| No. | Component group | Description |
|---|---|---|
| 2 | Side panel - rear left side | Side panel - dent(s) - Smart repair |

**Damage 2:** Side panel - rear left side: Side panel - dent(s) - Smart repair

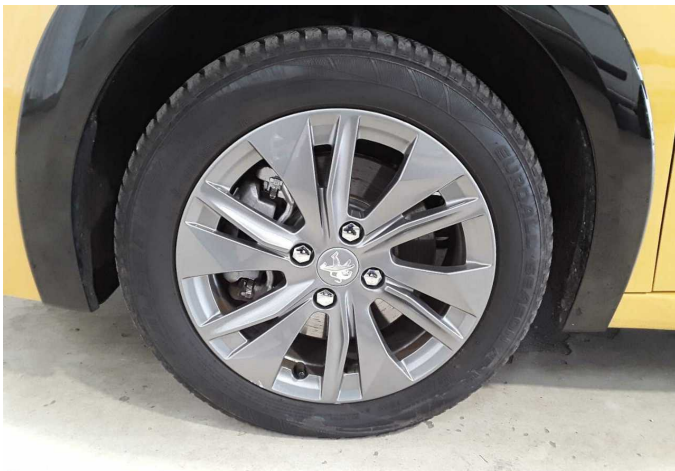
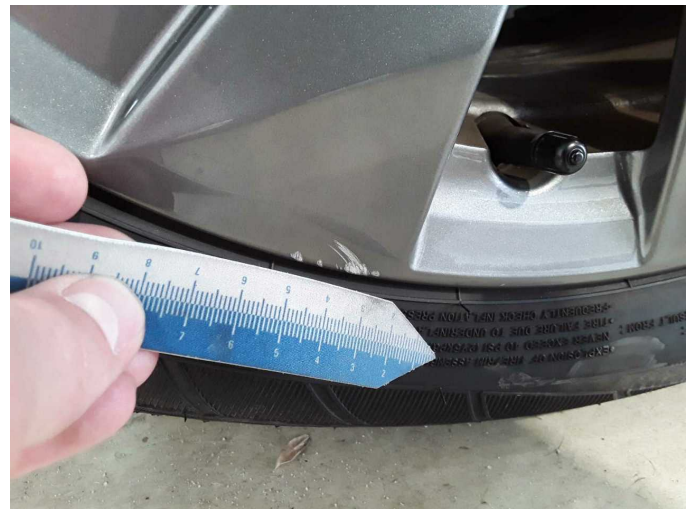
| No. | Component group | Description |
|---|---|---|
| 3 | Wheel / tyres | Alloy rim - front left side - Scratch(es) - Loss in value |

**Damage 3:** Wheel / tyres: Alloy rim - front left side - Scratch(es) - Loss in value

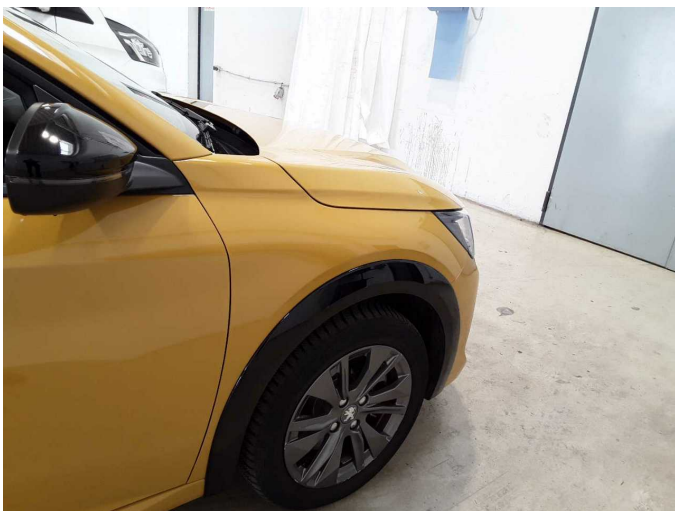
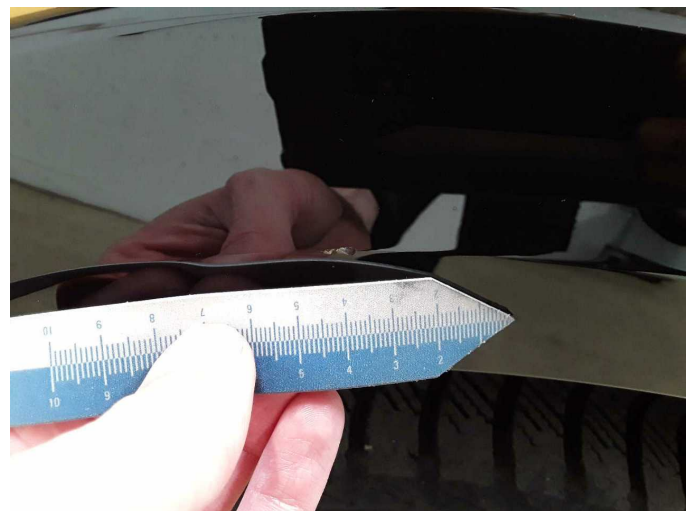
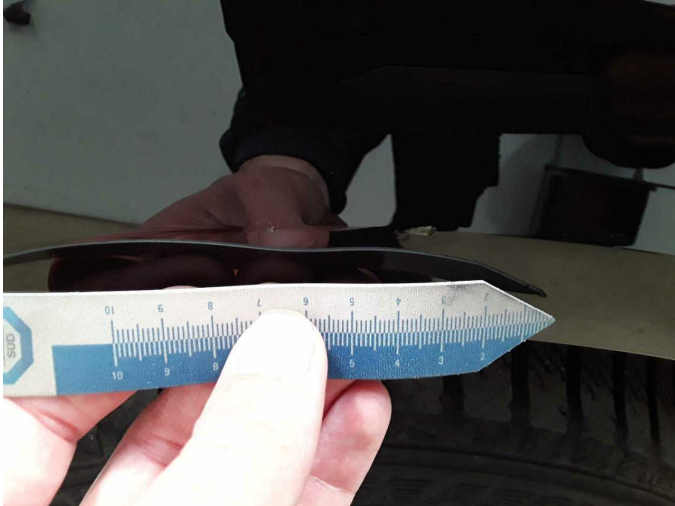
| No. | Component group | Description |
|---|---|---|
| 4 | Mudguard - right side | Wheel well extension - Scratch(es) - Replace |

**Damage 4:** Mudguard - right side: Wheel well extension - Scratch(es) - Replace

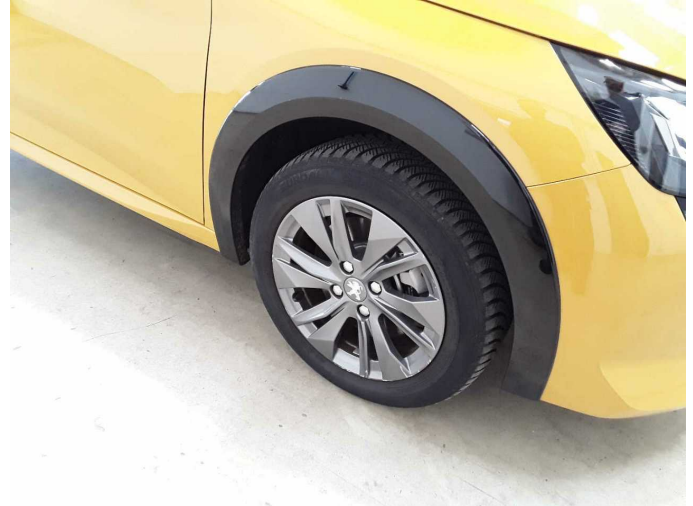
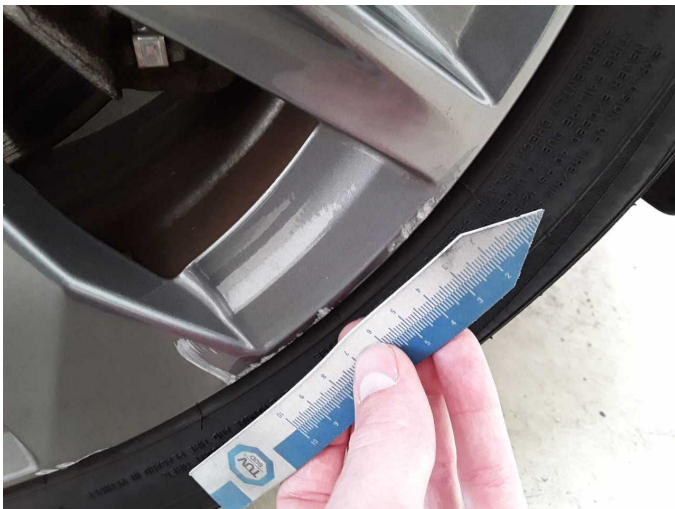
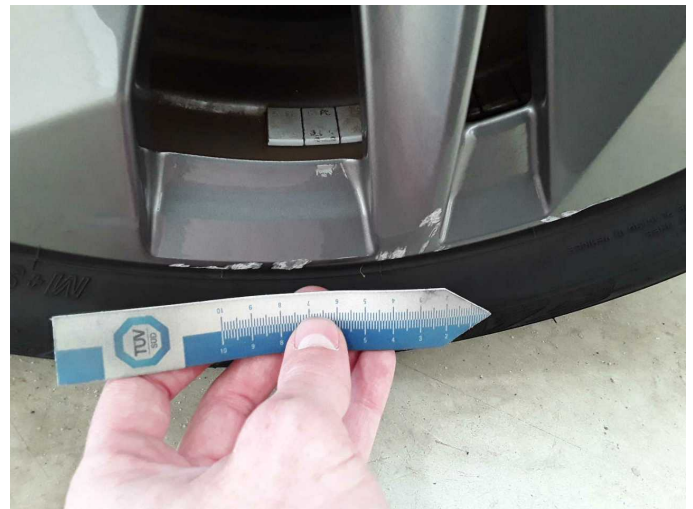
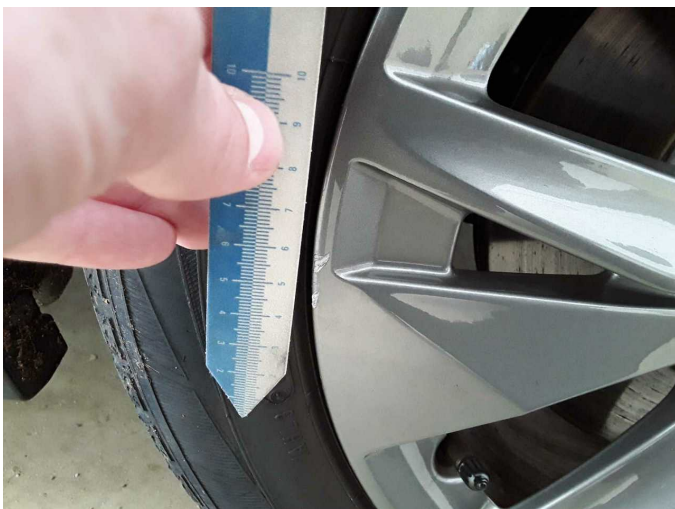
| No. | Component group | Description |
|---|---|---|
| 5 | Wheel / tyres | Alloy rim - front right side - Scratch(es) - Replace |

**Damage 5:** Wheel / tyres: Alloy rim - front right side - Scratch(es) - Replace
