Expertise

Protocol number: 45946103
Order No. / Reference: 26423315
Inspection date: 10 Jun 2026

Model: Kodiaq 2.0 TDI 4x4 DSG Sportline

VIN: TMBLN7NS2P8046345

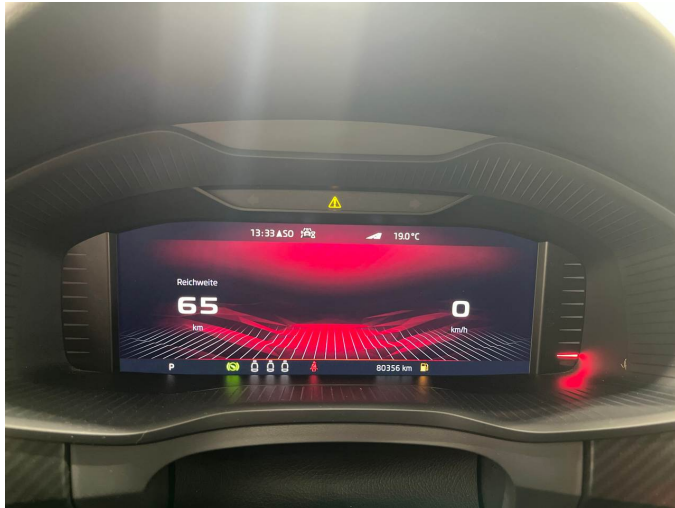
Figure 7: Instrument cluster

Mileage (Read) 80,356 km

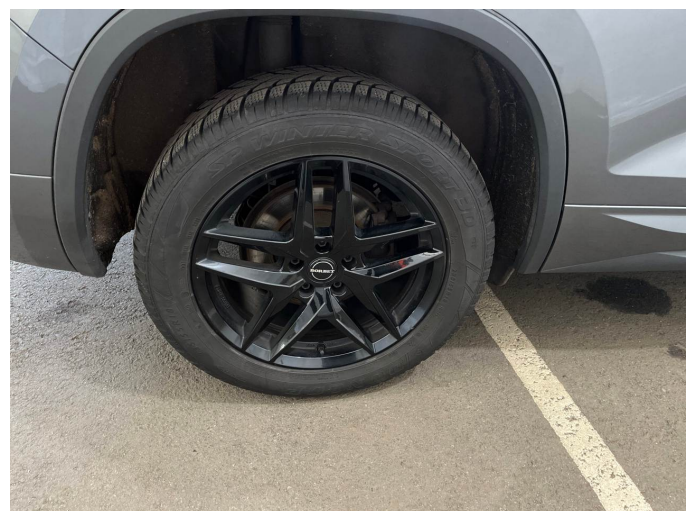
Figure 12: Mounted tyres

#	Tyre size	Type of tyre	Manufacturer	Tread depth
1)	235/55 R18 100H	Winter tyres on Light alloy	Dunlop	5mm / 5mm
2)	235/55 R18 100H	Winter tyres on Light alloy	Dunlop	5mm / 6mm

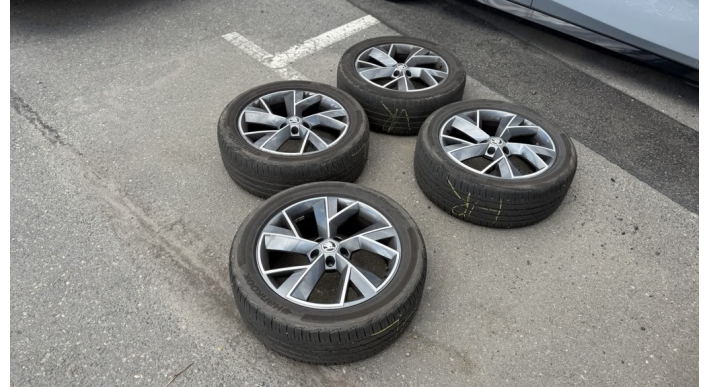
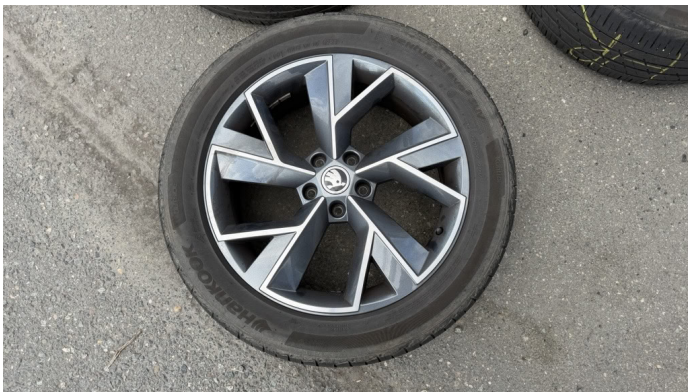
Figure 14: Additional tyres

#	Tyre size	Type of tyre	Manufacturer	Tread depth
1)	235/50 R19 99V	Summer tyres on Light alloy	Hankook	5mm / 5mm
2)	235/50 R19 99V	Summer tyres on Light alloy	Hankook	5mm / 5mm

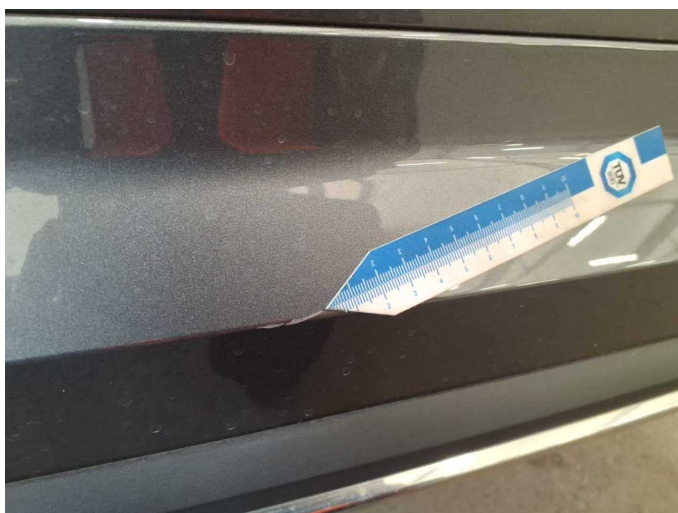
Damage 3: Rear bumper: Rear bumper - Scratch(es) - Smart repair

No.	Component group	Description
1	Misc.	Inspection / maintenance (Nachweise 1. & 2. Inspektion fehlen) - Incomplete - No deduction
2	Misc.	Main inspection - No evidence - No deduction
3	Rear bumper	Rear bumper - Scratch(es) - Smart repair
