Expertise

Protocol number: 46454030  
Order No. / Reference: 26664701  
Inspection date: 9 Jul 2026

Manufacturer: Skoda  
VIN: TMBJR0NX9TY062535

Model: Octavia Combi 1.5 TSI mHEV DSG Sportline

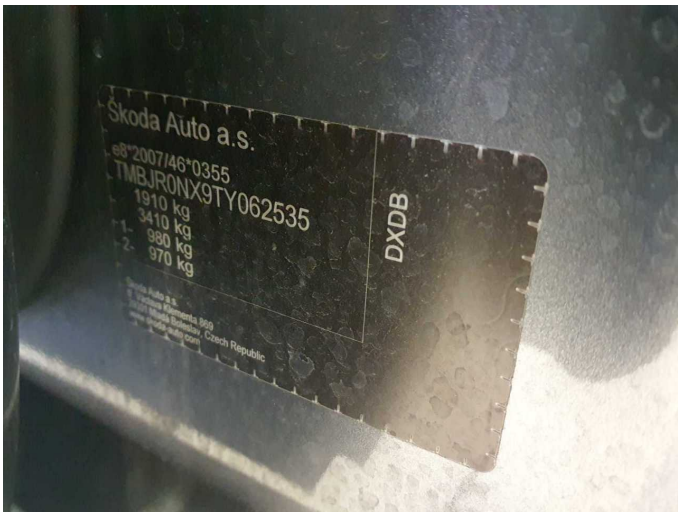
Figure 11: VIN

| VIN comparison | The vehicle identification number (VIN) was read from the vehicle and its conformity with the submitted documents was confirmed by the undersigned during the inspection. |

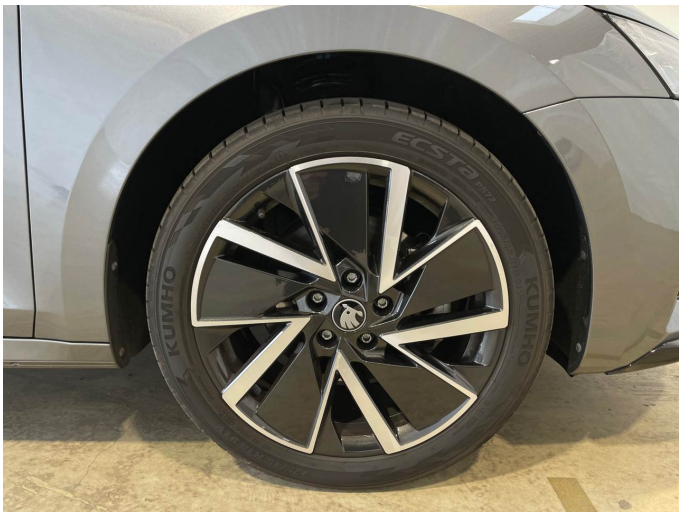
Figure 12: Mounted tyres

| # | Tyre size | Type of tyre | Manufacturer | Tread depth |
|---|---|---|---|---|
| 1) | 225/45 R18 91Y | Summer tyres on Light alloy | Kumho | 6mm / 6mm |
| 2) | 225/45 R18 91Y | Summer tyres on Light alloy | Kumho | 6mm / 6mm |

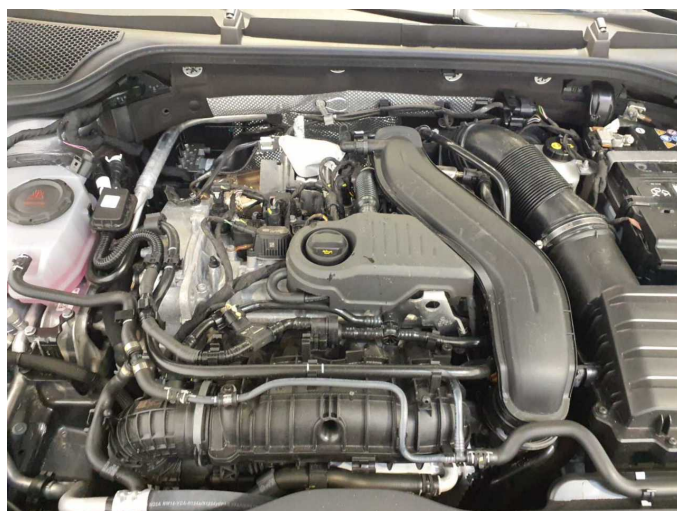
| No. | Component group | Description |
|---|---|---|
| 1 | Engine | Engine cover - Broken / torn - Replace |

**Damage 1:** Engine: Engine cover - Broken / torn - Replace

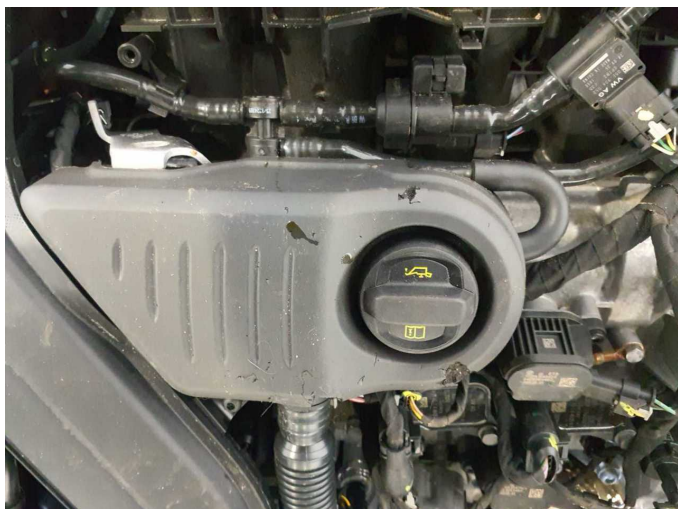
**Damage 1:** Engine: Engine cover - Broken / torn - Replace

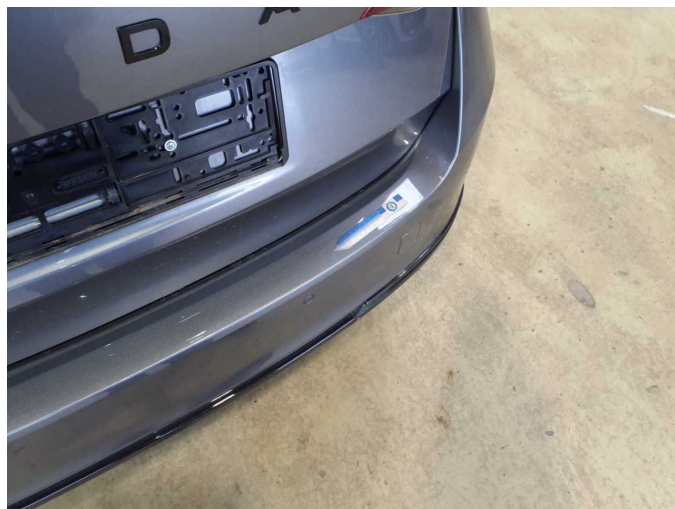
| No. | Component group | Description |
|---|---|---|
| 2 | Rear bumper | Rear bumper - Scratch(es) - Paint |

**Damage 2:** Rear bumper: Rear bumper - Scratch(es) - Paint

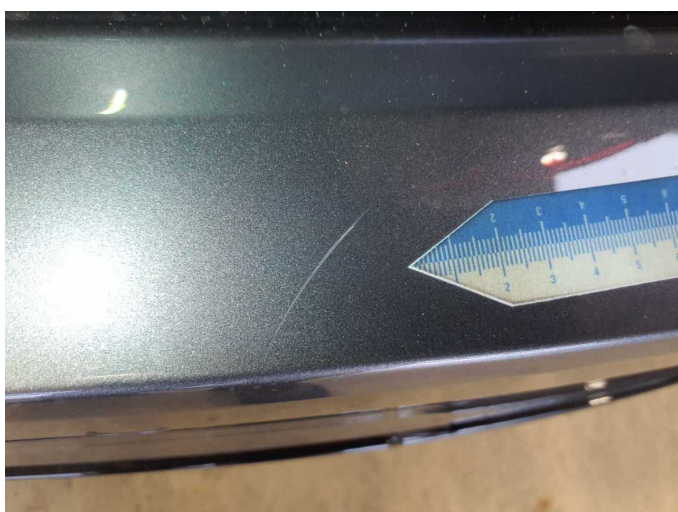
**Damage 2:** Rear bumper: Rear bumper - Scratch(es) - Paint

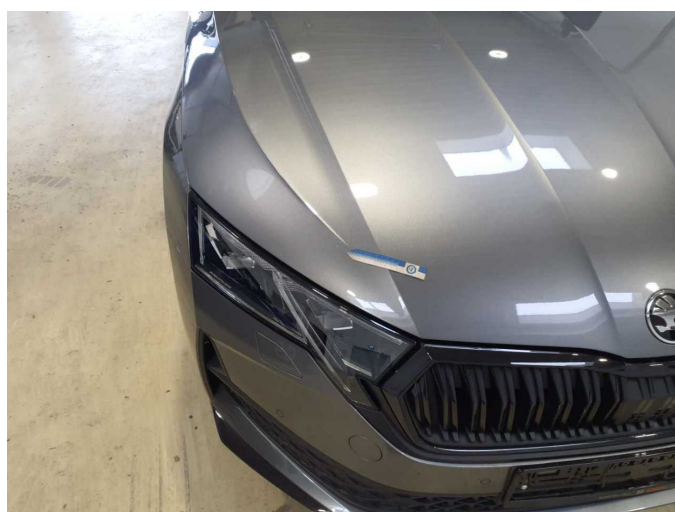
| No. | Component group | Description |
|---|---|---|
| 3 | Bonnet | Bonnet - Dent / paintcoat damage - Repair and paint |

**Damage 3:** Bonnet: Bonnet - Dent / paintcoat damage - Repair and paint

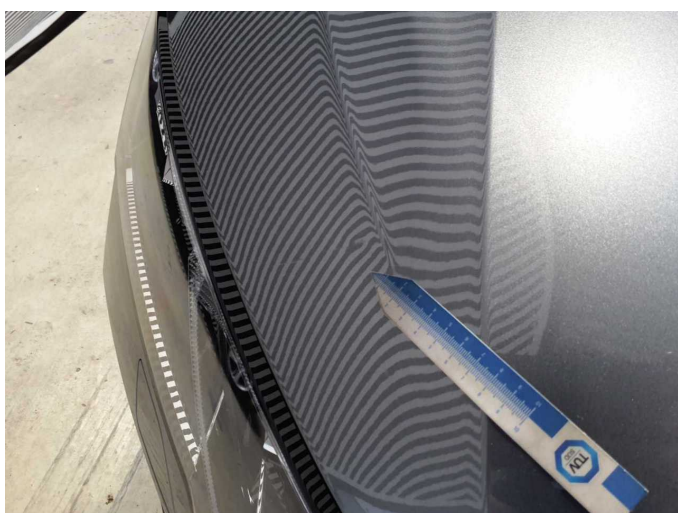
**Damage 3:** Bonnet: Bonnet - Dent / paintcoat damage - Repair and paint
