Expertise

Protocol number: 46738558  
Order No. / Reference: 26800983  
Inspection date: 27 Jul 2026

Manufacturer: Volkswagen

Model: ID.3 Pro S (5-Sitzer)

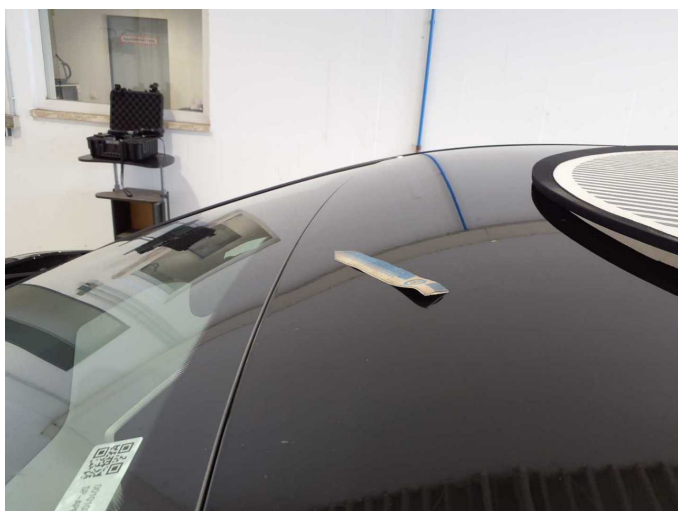
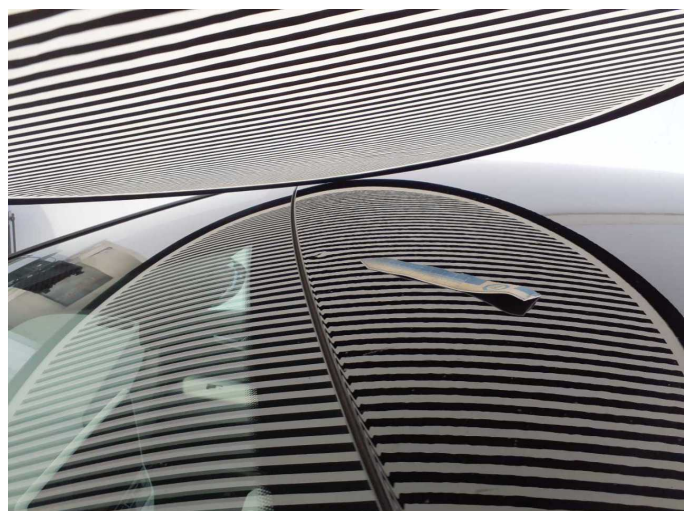
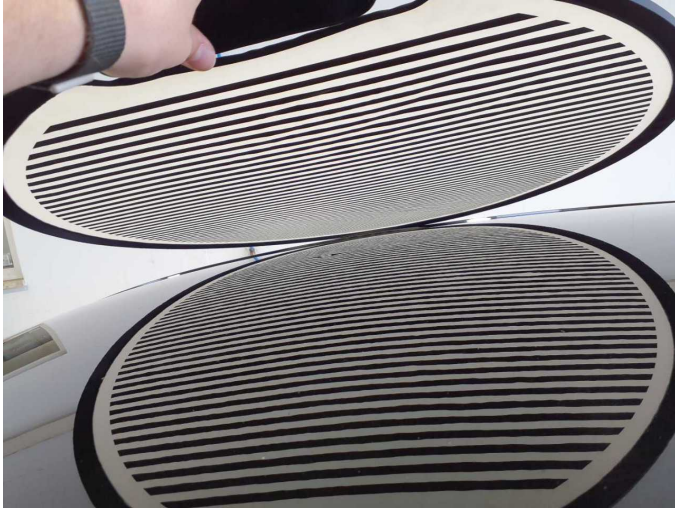
| No. | Component group | Description |
|---|---|---|
| 1 | Roof | Roof - dent(s) - Smooth repair work |

Damage 1: Roof: Roof - dent(s) - Smooth repair work

**Damage 1:** Roof: Roof - dent(s) - Smooth repair work

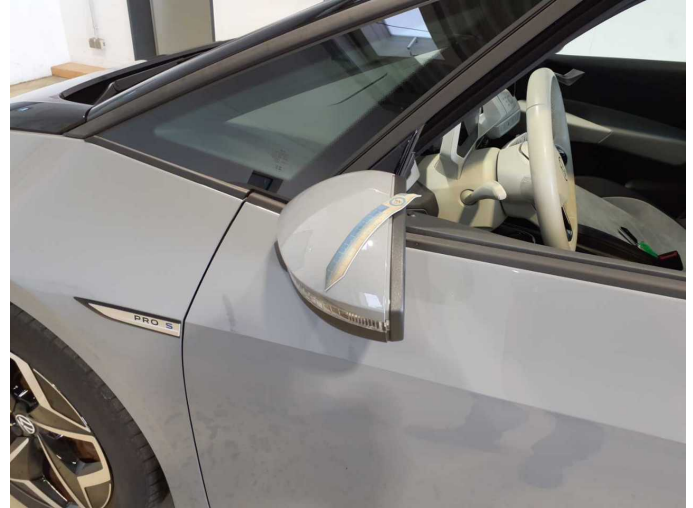
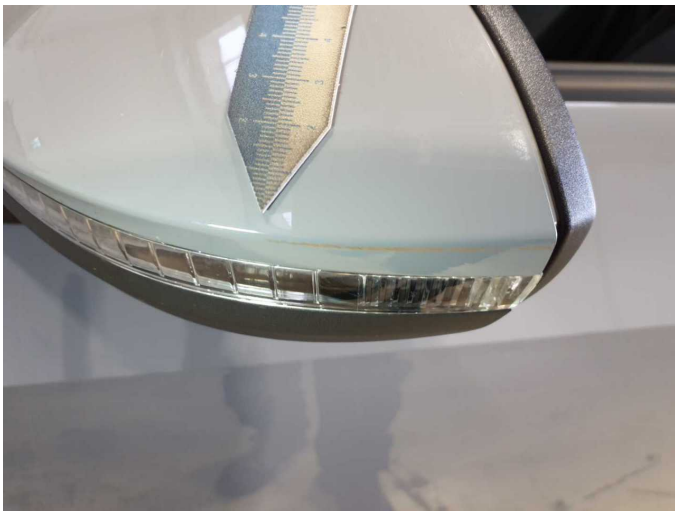
| No. | Component group | Description |
|---|---|---|
| 2 | Wing mirror - left side | Cap - Scratch(es) - Smart repair |

**Damage 2:** Wing mirror - left side: Cap - Scratch(es) - Smart repair

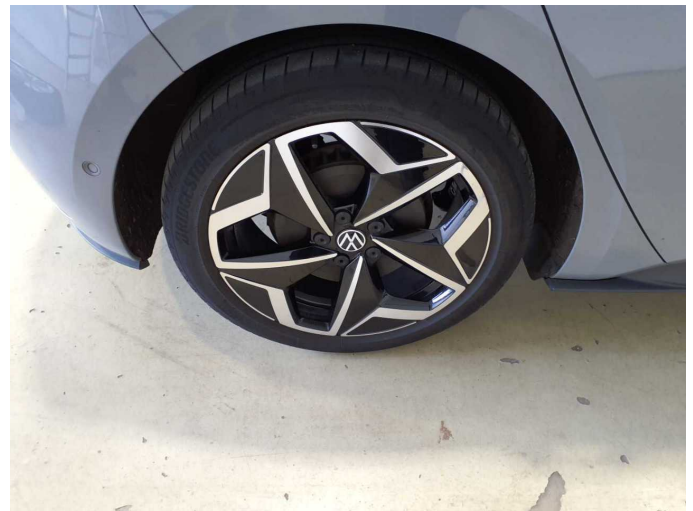
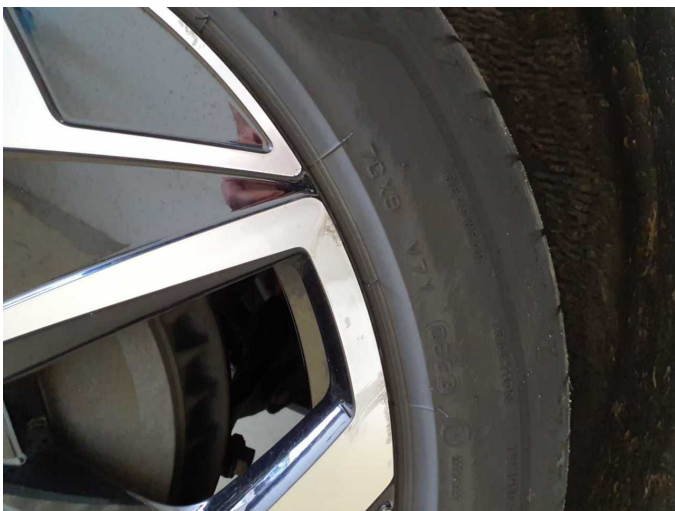
| No. | Component group | Description |
|---|---|---|
| 3 | Wheel / tyres | Alloy rim - rear right side - Scratch(es) - Loss in value |

**Damage 3:** Wheel / tyres: Alloy rim - rear right side - Scratch(es) - Loss in value

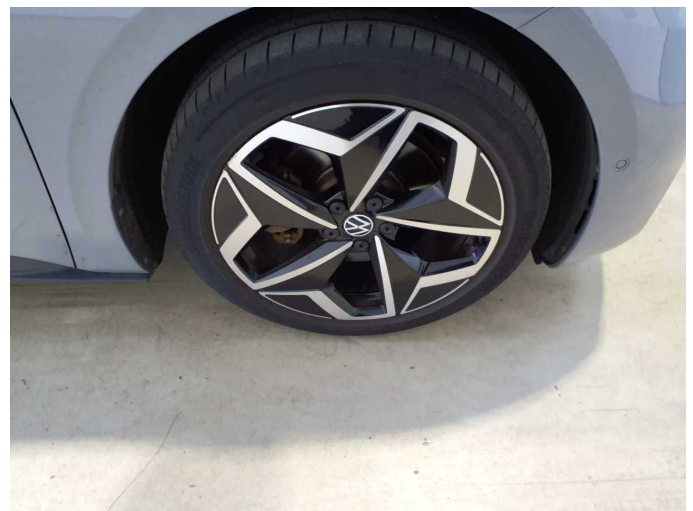
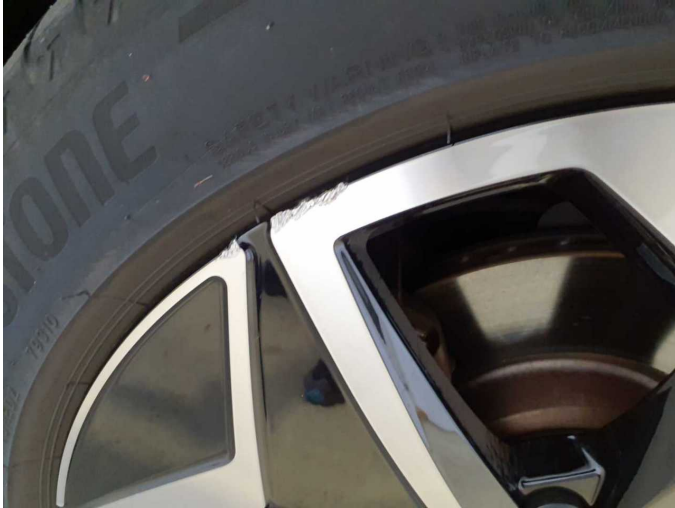
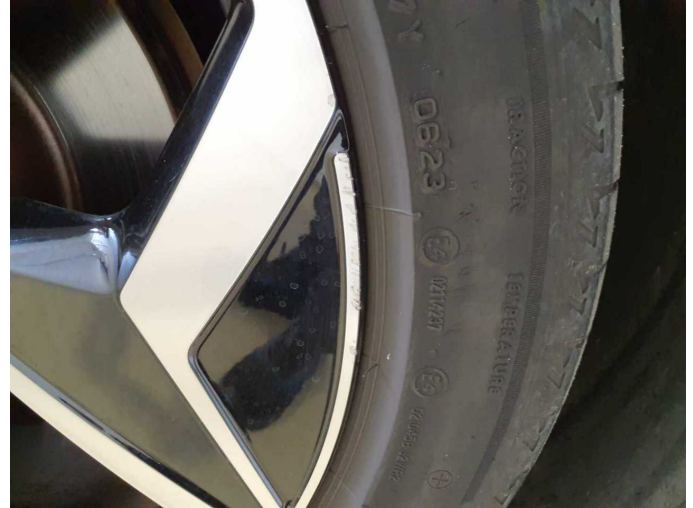
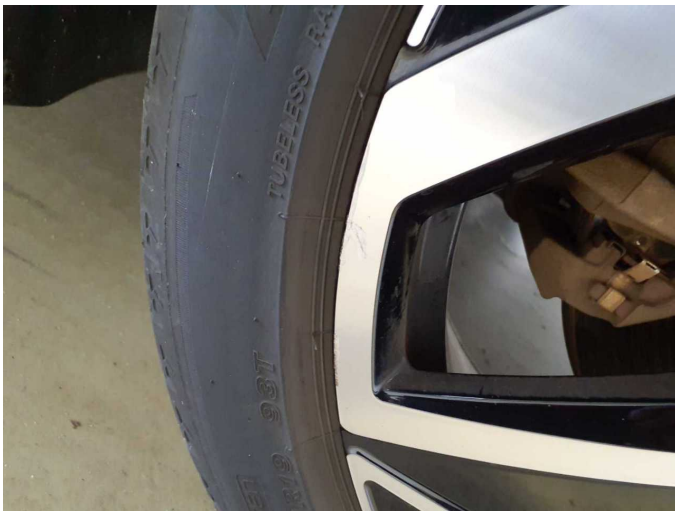
| No. | Component group | Description |
|---|---|---|
| 4 | Wheel / tyres | Alloy rim - front right side - Scratch(es) - Replace |

**Damage 4:** Wheel / tyres: Alloy rim - front right side - Scratch(es) - Replace

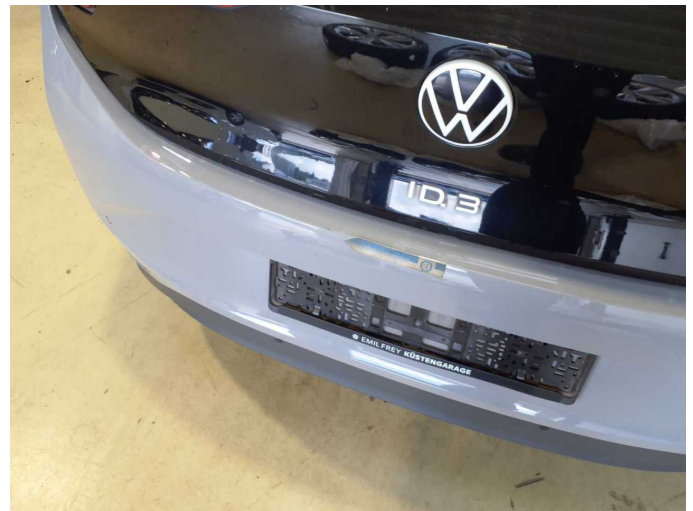
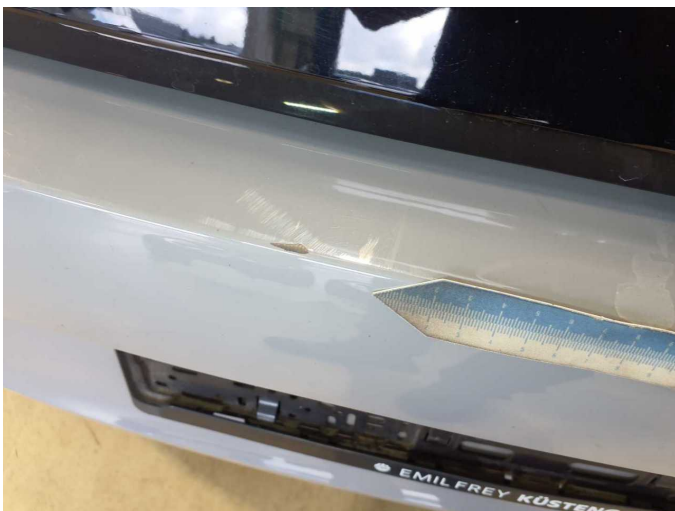
| No. | Component group | Description |
|---|---|---|
| 5 | Rear bumper | Rear bumper - Scratch(es) - Paint |

**Damage 5:** Rear bumper: Rear bumper - Scratch(es) - Paint

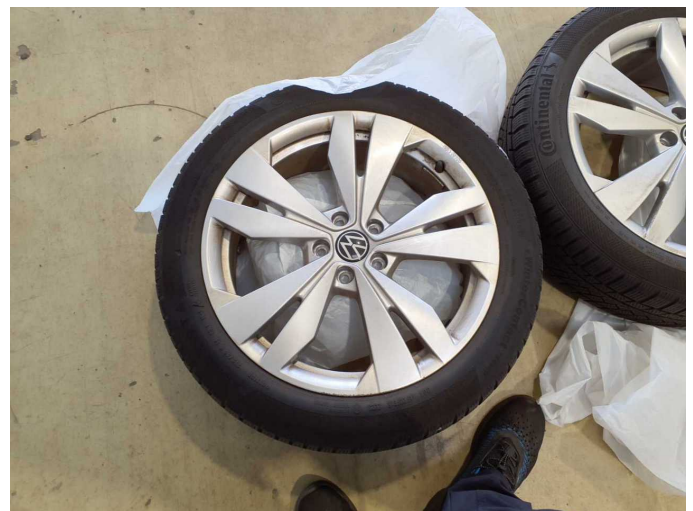
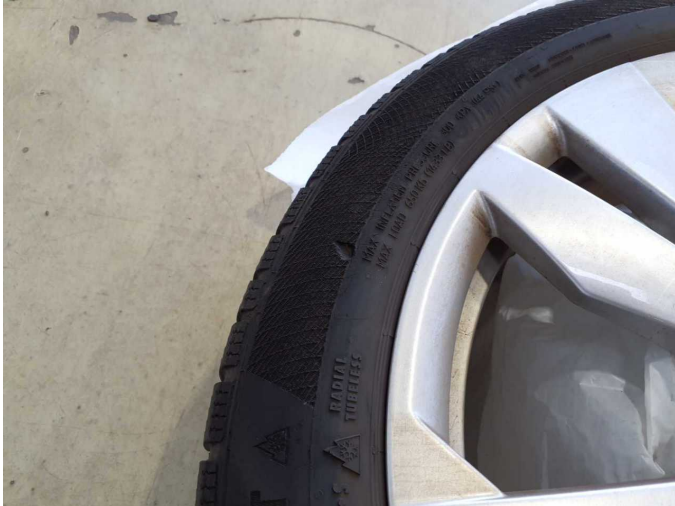
| No. | Component group | Description |
|---|---|---|
| 1 | 2nd wheel set | 1 tyre - Broken / torn - No deduction |

**Wear and tear 1:** 2nd wheel set: 1 tyre - Broken / torn - No deduction

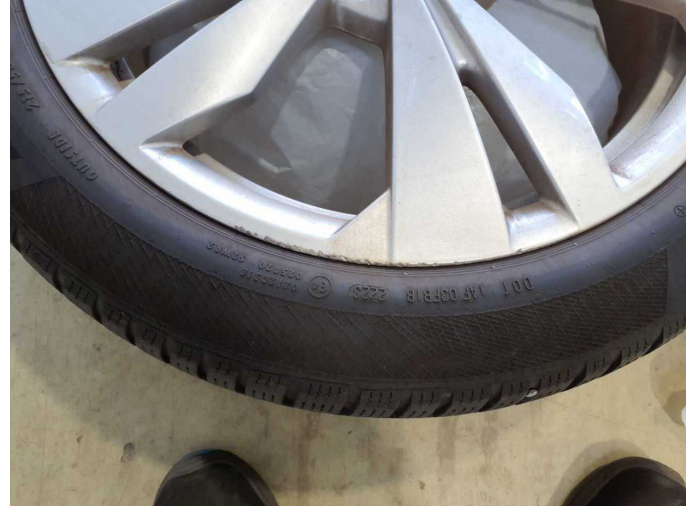
| No. | Component group | Description |
|---|---|---|
| 2 | 2nd wheel set | 1 alloy rim - Scratch(es) - No deduction |

**Wear and tear 2:** 2nd wheel set: 1 alloy rim - Scratch(es) - No deduction

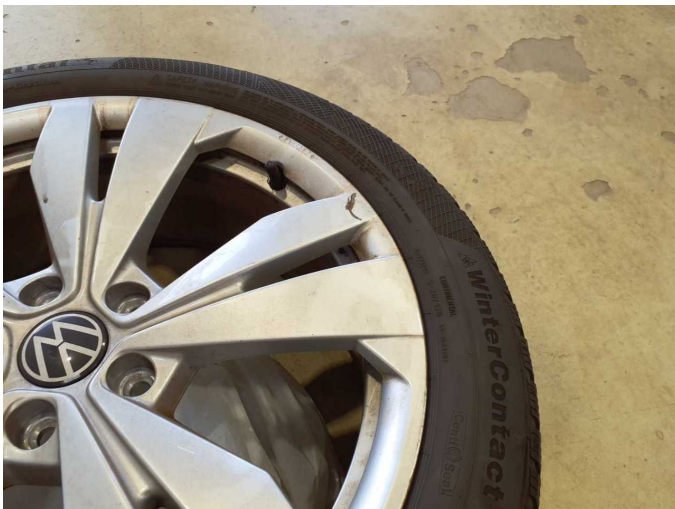
| No. | Component group | Description |
|---|---|---|
| 3 | 2nd wheel set | 1 alloy rim - Scratch(es) - No deduction |

**Wear and tear 3:** 2nd wheel set: 1 alloy rim - Scratch(es) - No deduction

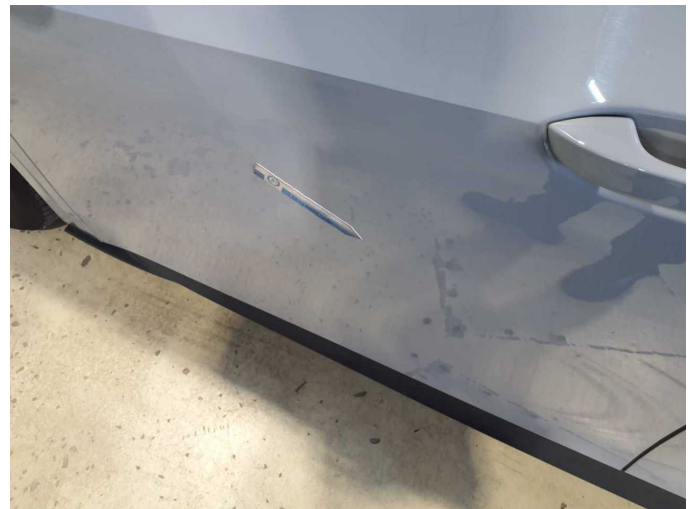
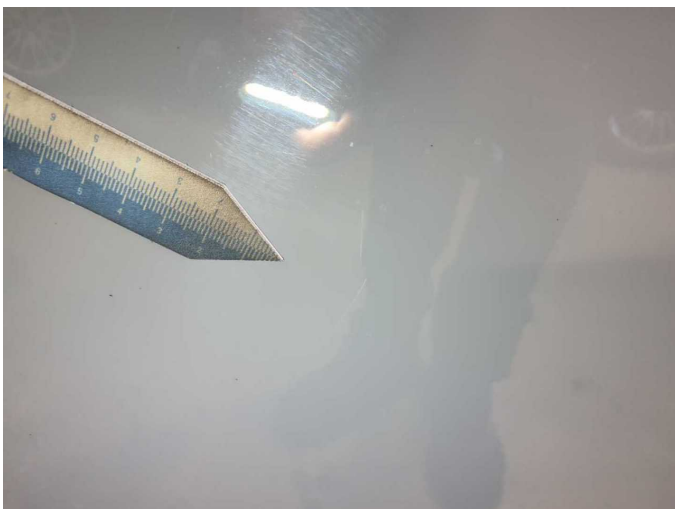
| No. | Component group | Description |
|---|---|---|
| 5 | Door - front left side | Door - Scratch(es) - No deduction |

**Wear and tear 5:** Door - front left side: Door - Scratch(es) - No deduction

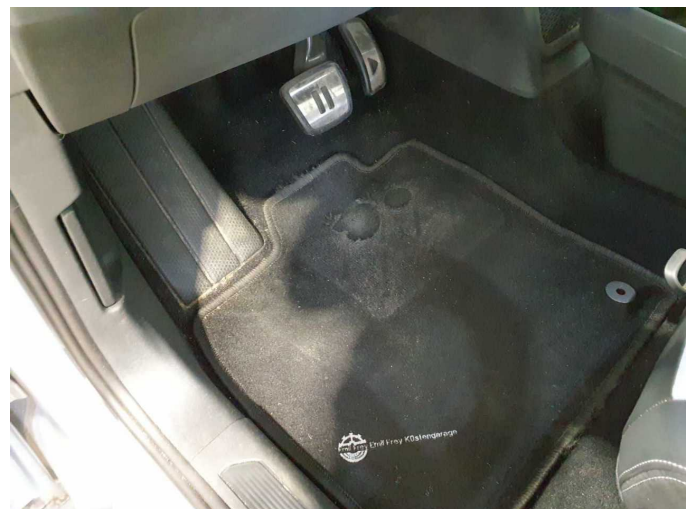
| No. | Component group | Description |
|---|---|---|
| 6 | Trim / covers | Floor mats - Broken / torn - No deduction |

**Wear and tear 6:** Trim / covers: Floor mats - Broken / torn - No deduction
