Expertise

Protocol number: 46825015  
Order No. / Reference: 26671254  
Inspection date: 28 Jul 2026

Manufacturer: Mazda

Model: 2 SKYACTIV G 90 M HYBRID Homura

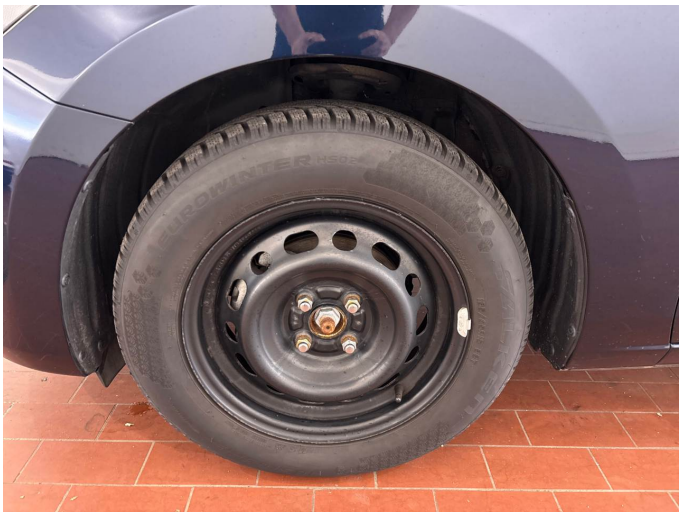
Figure 12: Mounted tyres

| # | Tyre size | Type of tyre | Manufacturer | Tread depth |
|---|---|---|---|---|
| 1) | 185/65 R15 88T | Winter tyres on Steel | Falken | 6mm / 6mm |
| 2) | 185/65 R15 88T | Winter tyres on Steel | Falken | 7mm / 7mm |

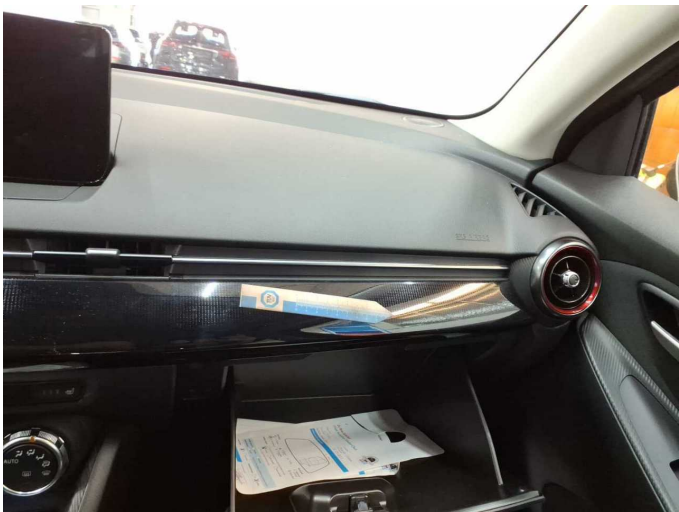
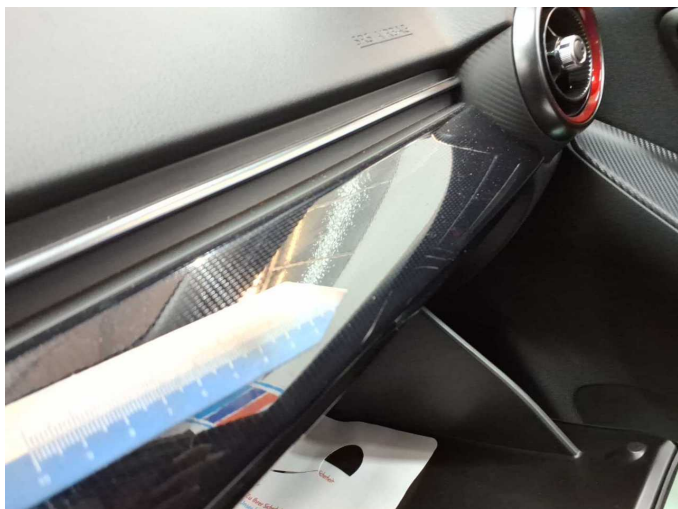
| No. | Component group | Description |
|---|---|---|
| 1 | Instrument panel | Cover - Scratched - Smart repair |

Damage 1: Instrument panel: Cover - Scratched - Smart repair

**Damage 1:** Instrument panel: Cover - Scratched - Smart repair

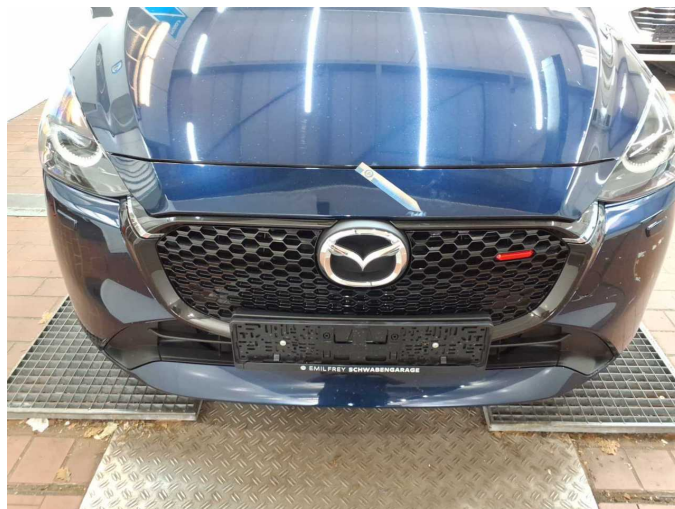
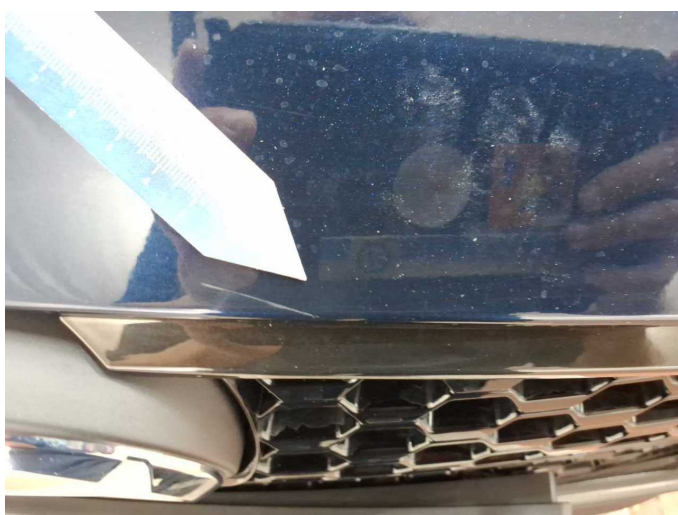
| No. | Component group | Description |
|---|---|---|
| 2 | Front bumper | Front bumper - Scratched - Cover / polish |

**Damage 2:** Front bumper: Front bumper - Scratched - Cover / polish

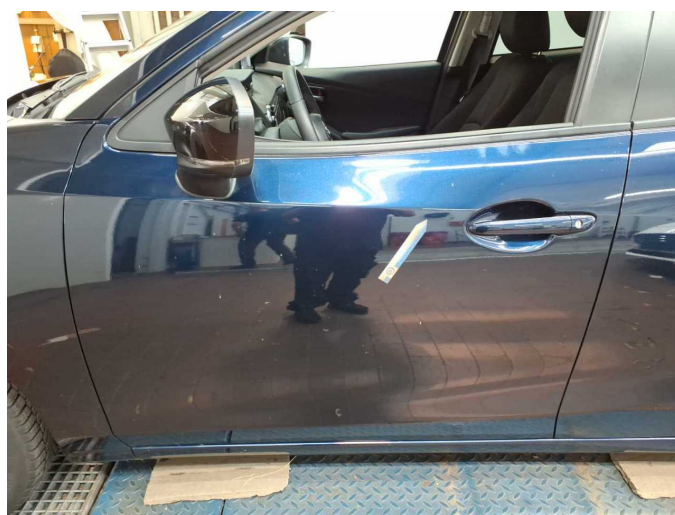
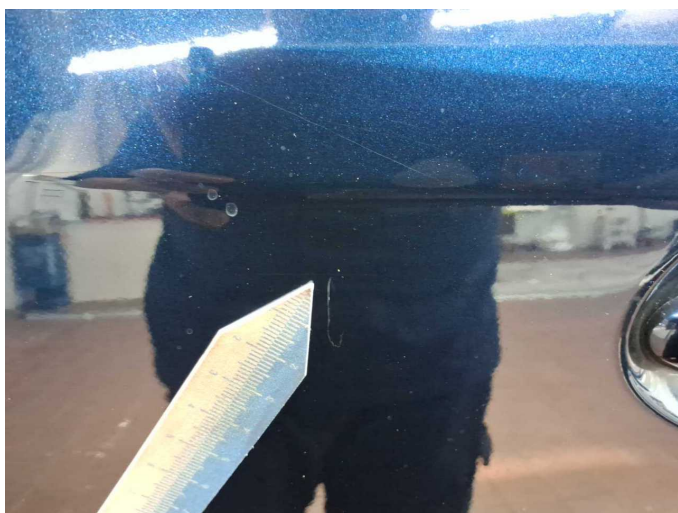
| No. | Component group | Description |
|---|---|---|
| 3 | Door - front left side | Door - Scratched - Cover / polish |

**Damage 3:** Door - front left side: Door - Scratched - Cover / polish

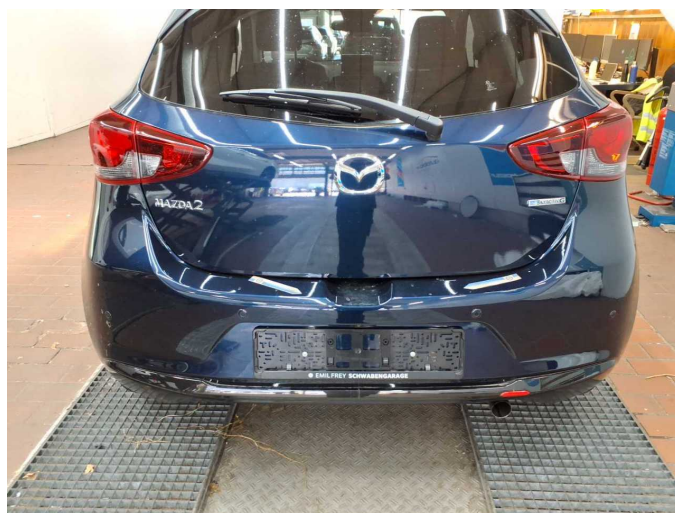
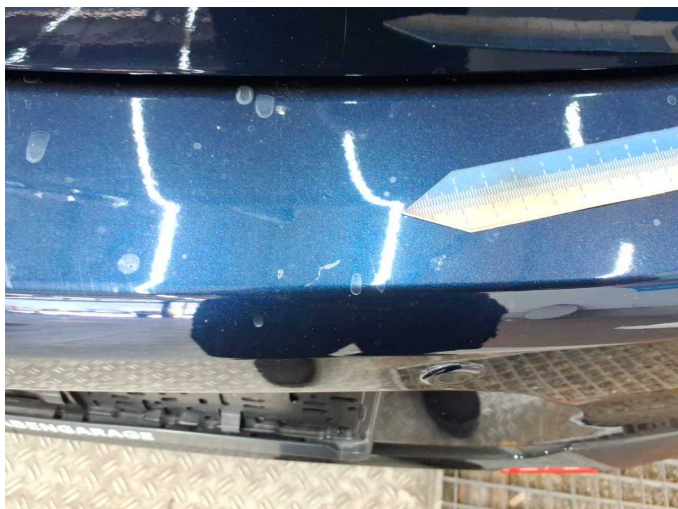
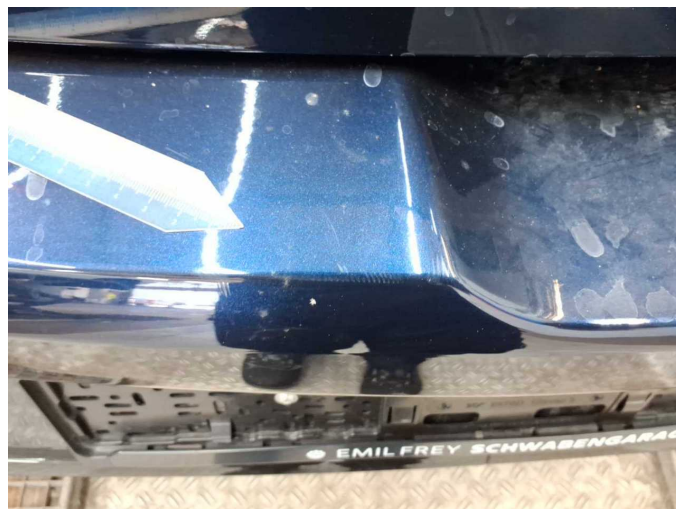
| No. | Component group | Description |
|---|---|---|
| 4 | Rear bumper | Rear bumper - Scratch(es) - Paint |

**Damage 4:** Rear bumper: Rear bumper - Scratch(es) - Paint

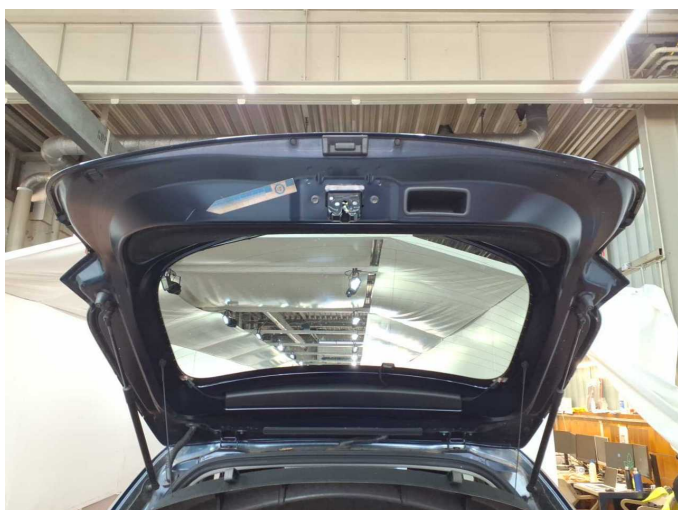
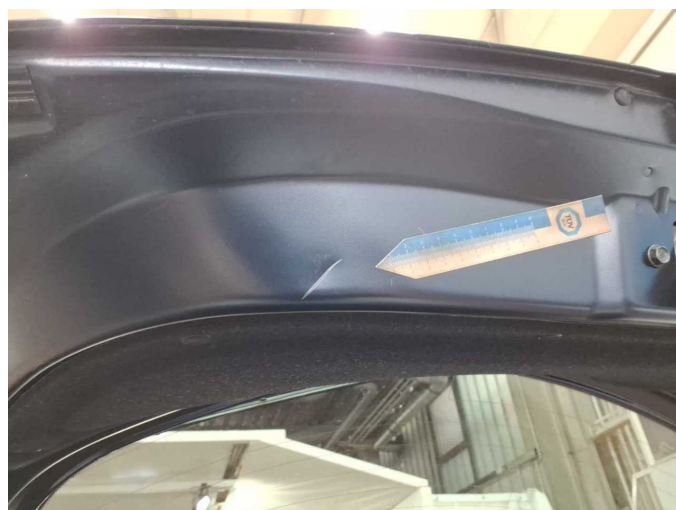
| No. | Component group | Description |
|---|---|---|
| 5 | Boot lid / rear door | Boot lid - Dent / paintcoat damage - Repair and paint |

**Damage 5:** Boot lid / rear door: Boot lid - Dent / paintcoat damage - Repair and paint
