Expertise

Protocol number: 46549761  
Order No. / Reference: 26510948  
Inspection date: 15 Jul 2026

Manufacturer: Mercedes-Benz

Model: E 220 d T 9G-TRONIC Avantgarde

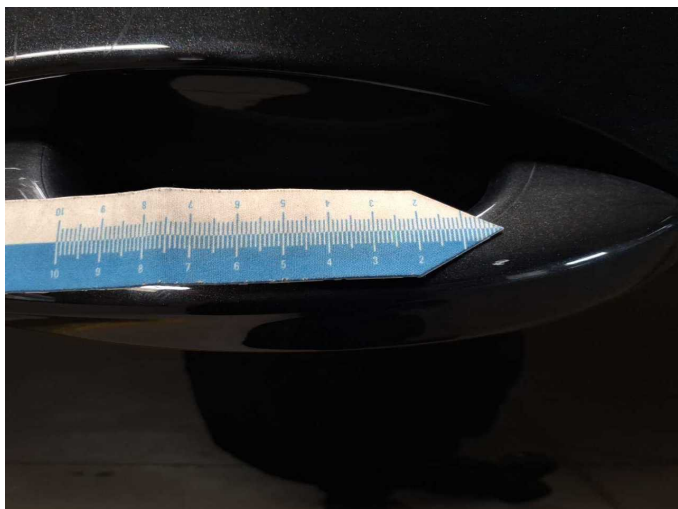
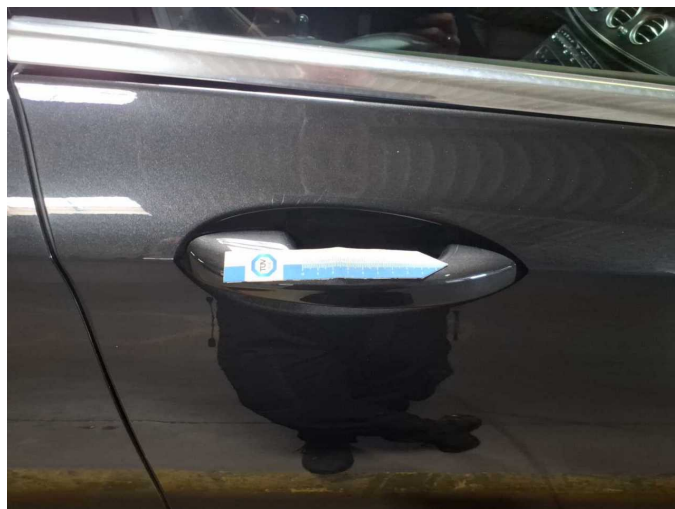
| No. | Component group | Description |
|---|---|---|
| 2 | Door - front right side | Door handle - outside - Scratch(es) - Smart repair |

**Damage 2:** Door - front right side: Door handle - outside - Scratch(es) - Smart repair

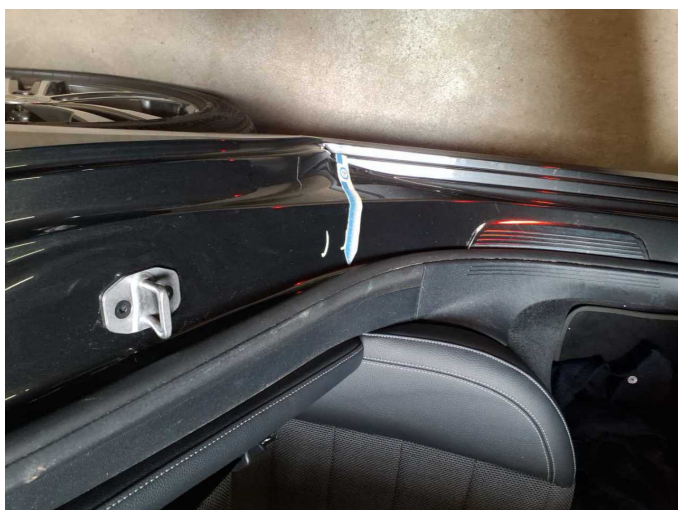
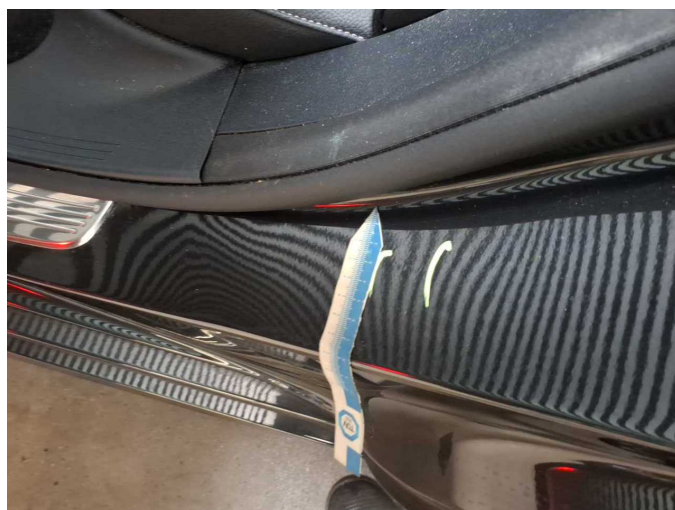
| No. | Component group | Description |
|---|---|---|
| 3 | Side panel - rear left side | Sill - dent(s) - Smooth repair work |

**Damage 3:** Side panel - rear left side: Sill - dent(s) - Smooth repair work

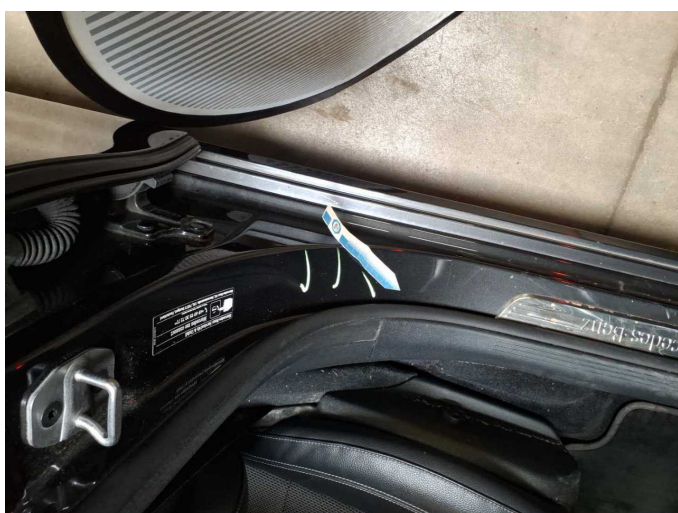
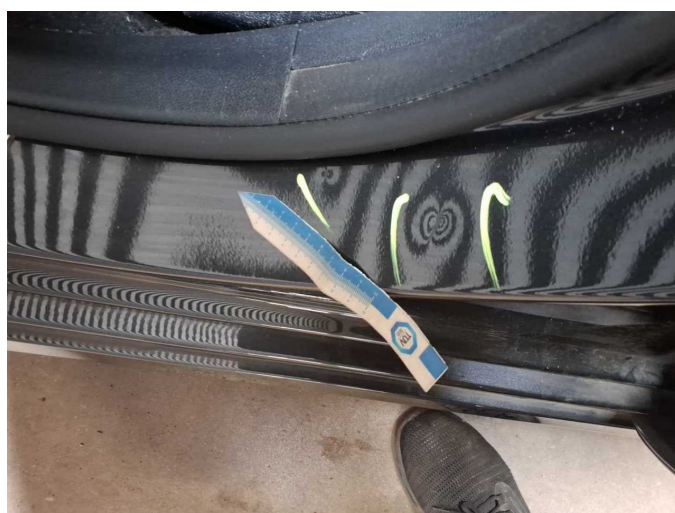
| No. | Component group | Description |
|---|---|---|
| 4 | Sill - left side | Sill - dent(s) - Smooth repair work |

**Damage 4:** Sill - left side: Sill - dent(s) - Smooth repair work

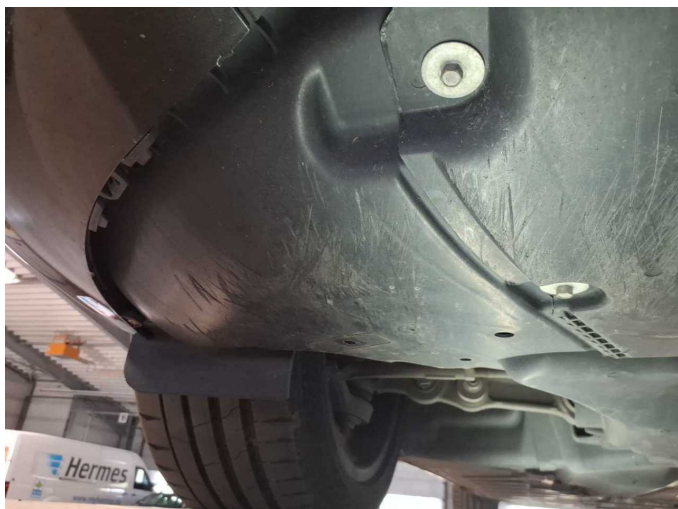
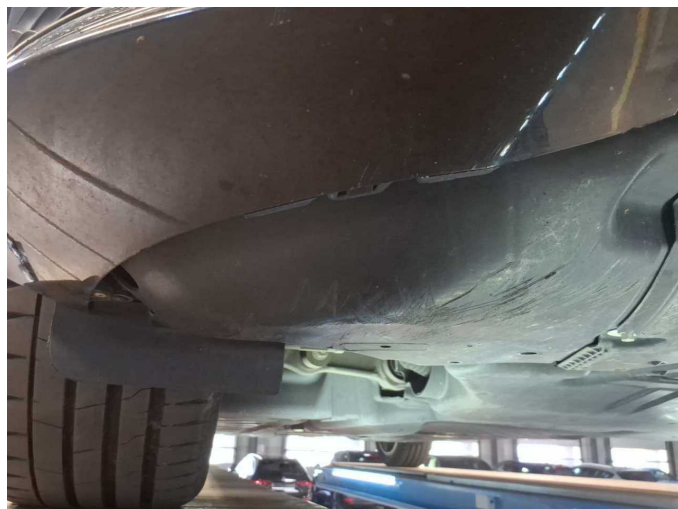
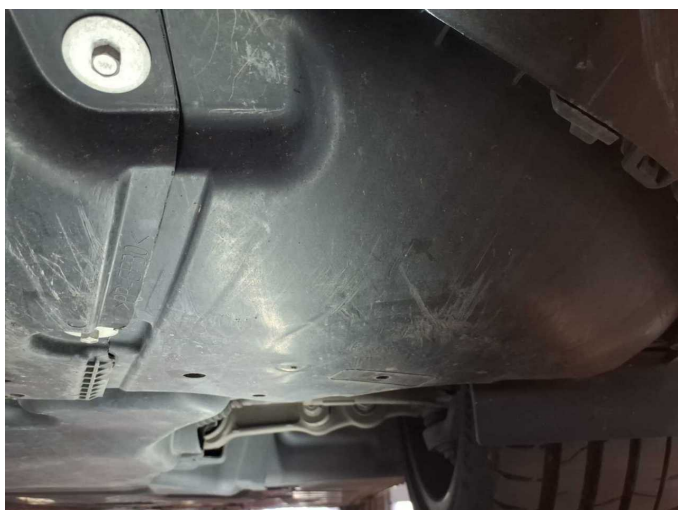
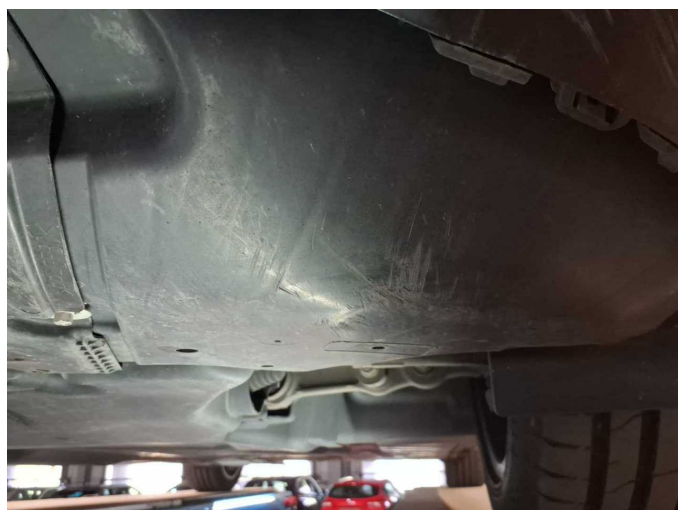
| No. | Component group | Description |
|---|---|---|
| 5 | Body | Underbody panelling - Scratch(es) - Replace |

**Damage 5:** Body: Underbody panelling - Scratch(es) - Replace

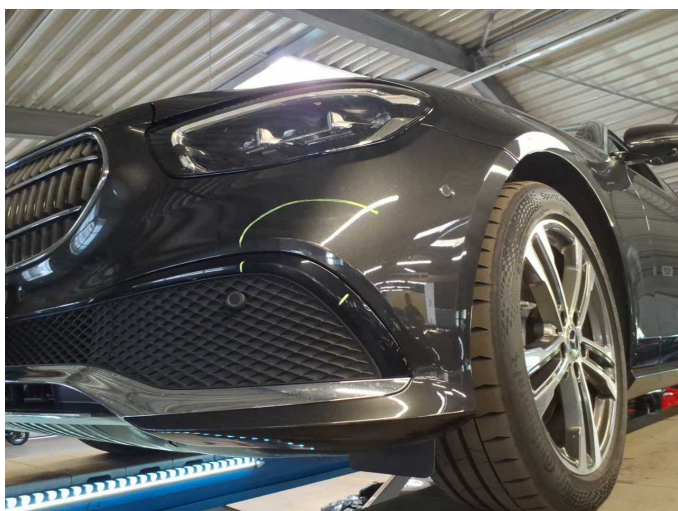
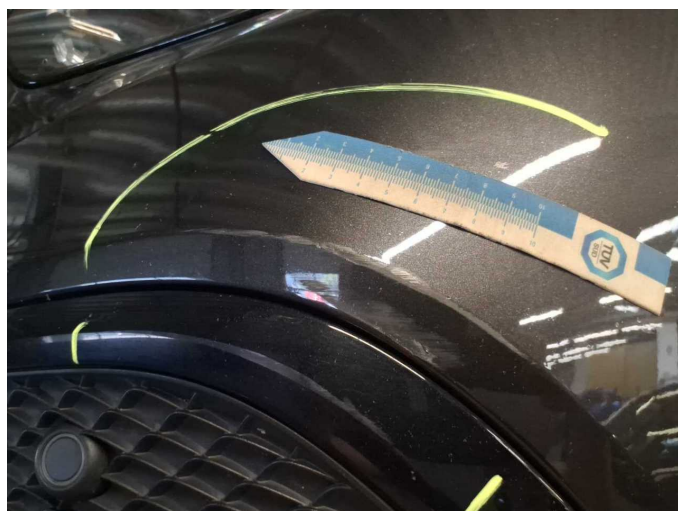
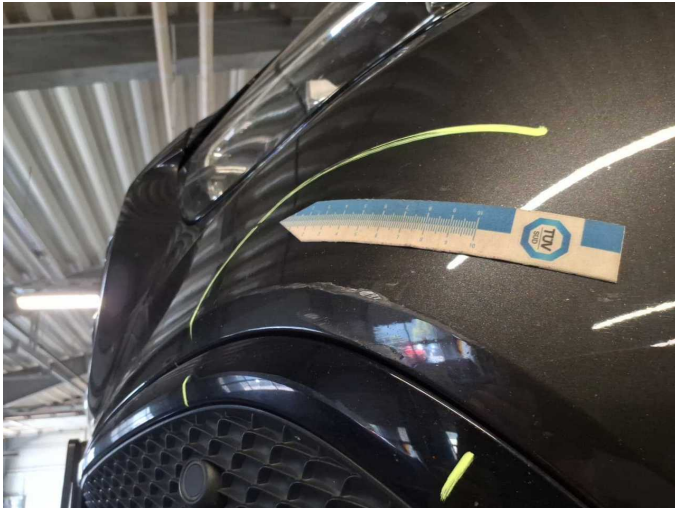
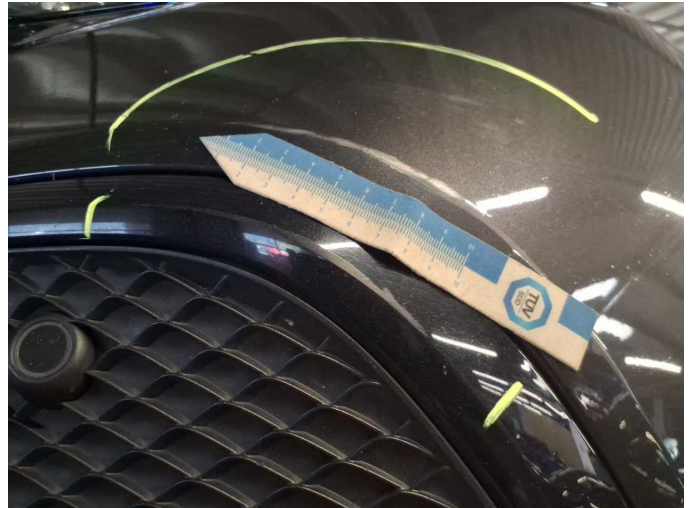
| No. | Component group | Description |
|---|---|---|
| 6 | Front bumper | Front bumper (+ Blende) - Scratched - Paint |

**Damage 6:** Front bumper: Front bumper (+ Blende) - Scratched - Paint

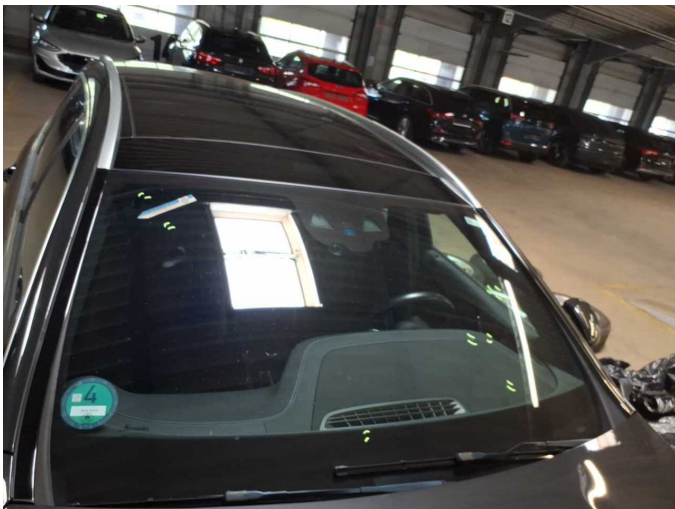
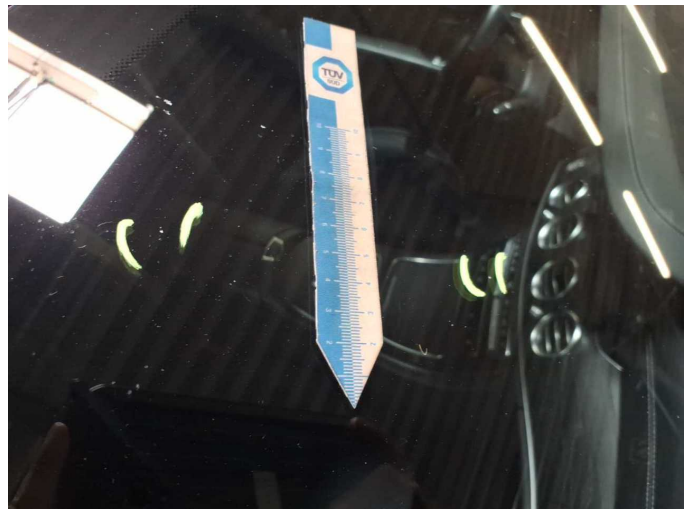
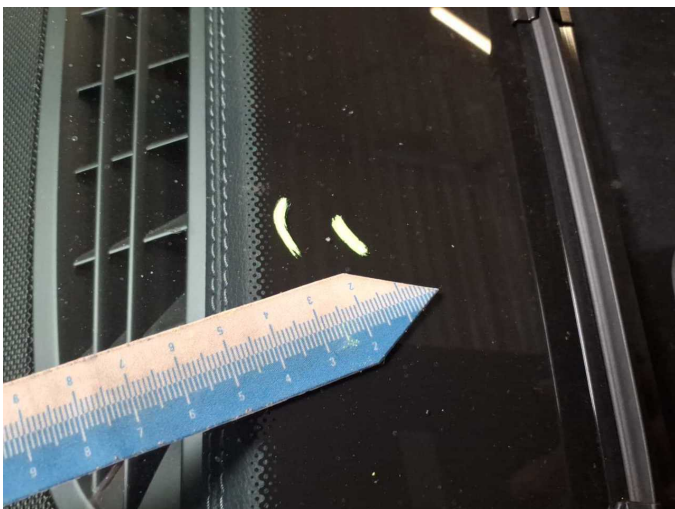
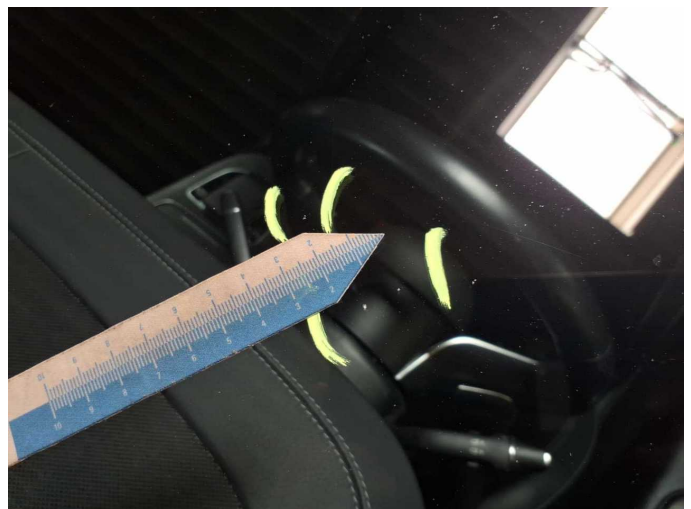
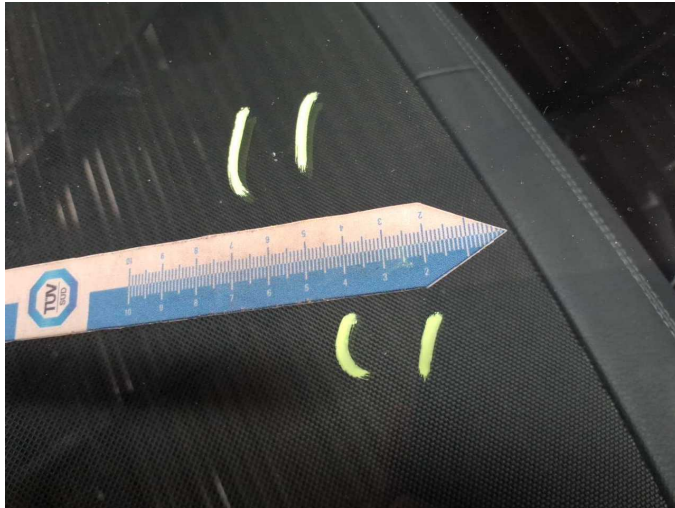
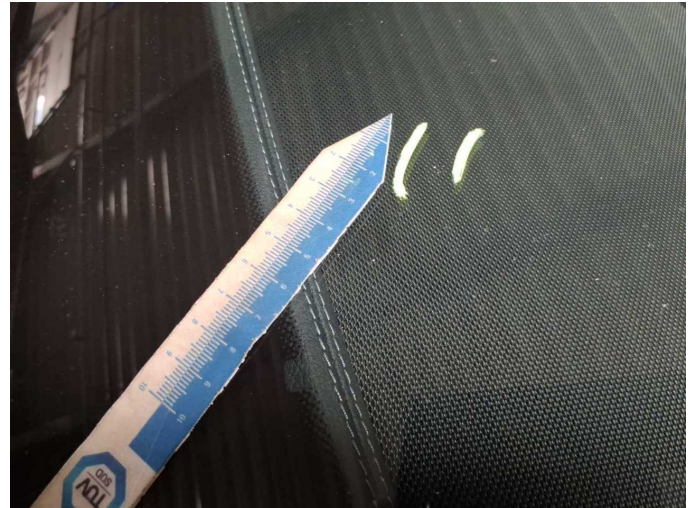
| No. | Component group | Description |
|---|---|---|
| 2 | Vehicle glazing | Windscreen - Stone chips |

**Wear and tear 2:** Vehicle glazing: Windscreen - Stone chips

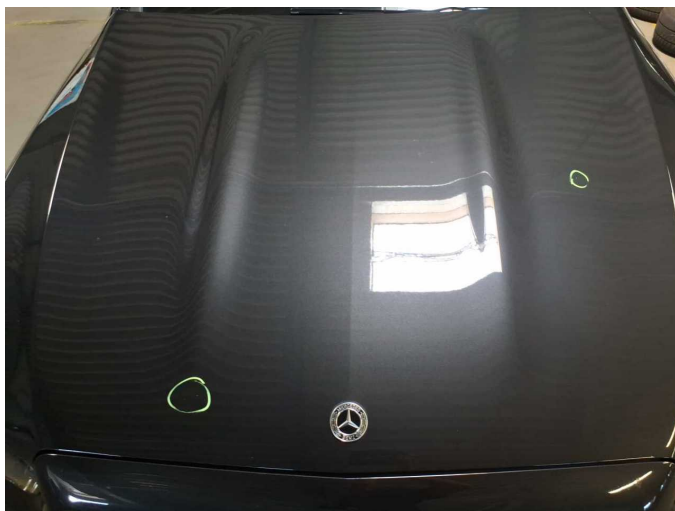
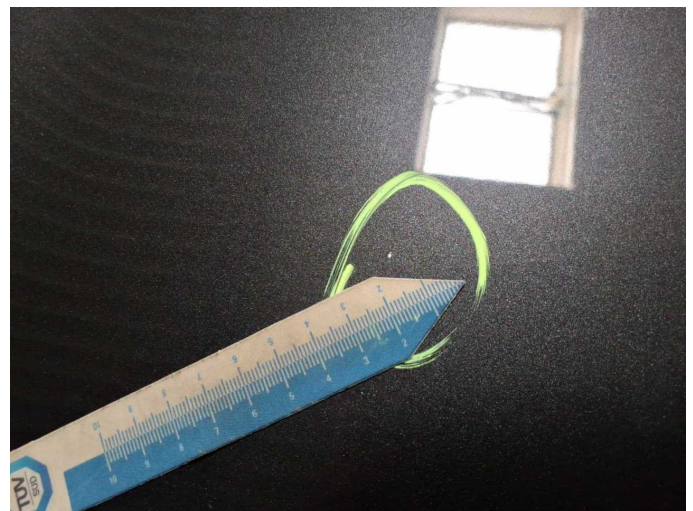
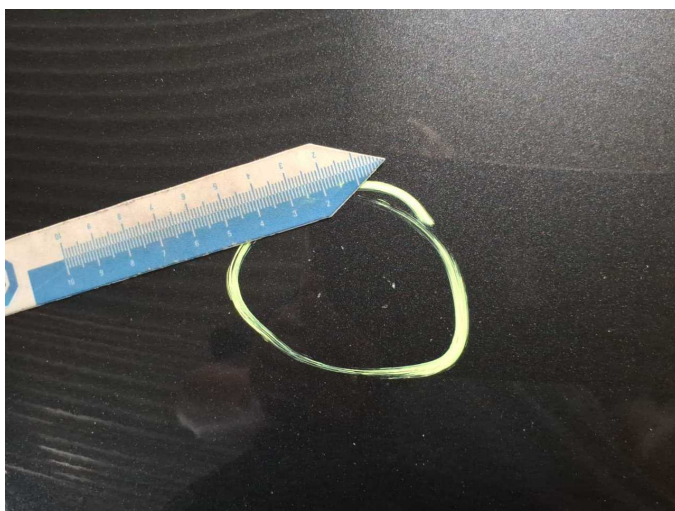
| No. | Component group | Description |
|---|---|---|
| 3 | Bonnet | Bonnet - Stone chips |

**Wear and tear 3:** Bonnet: Bonnet - Stone chips

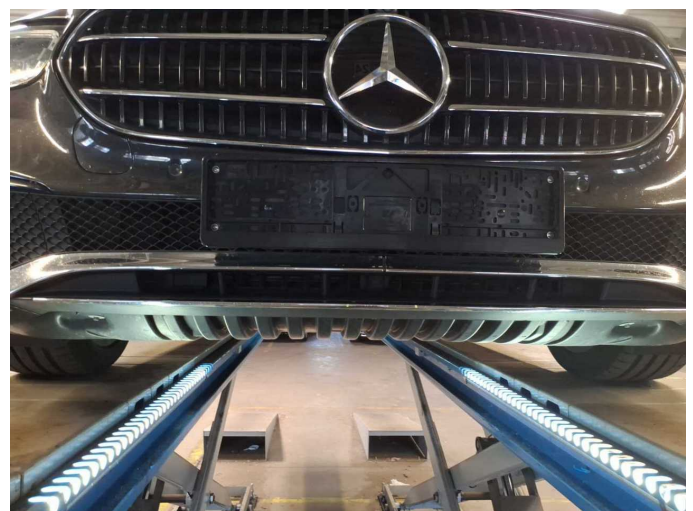
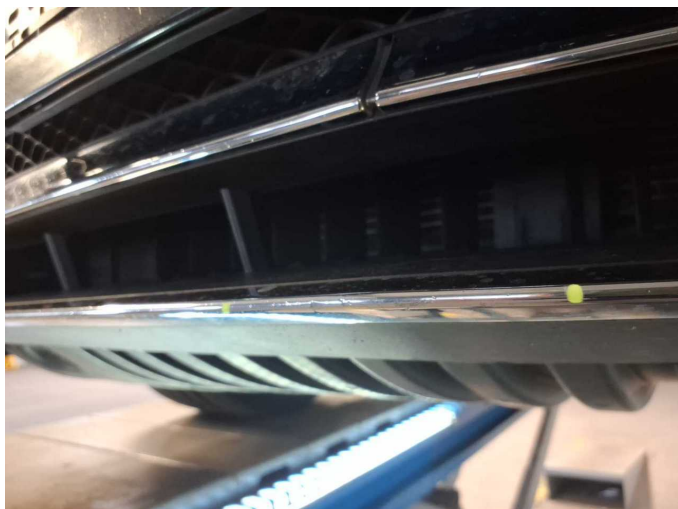
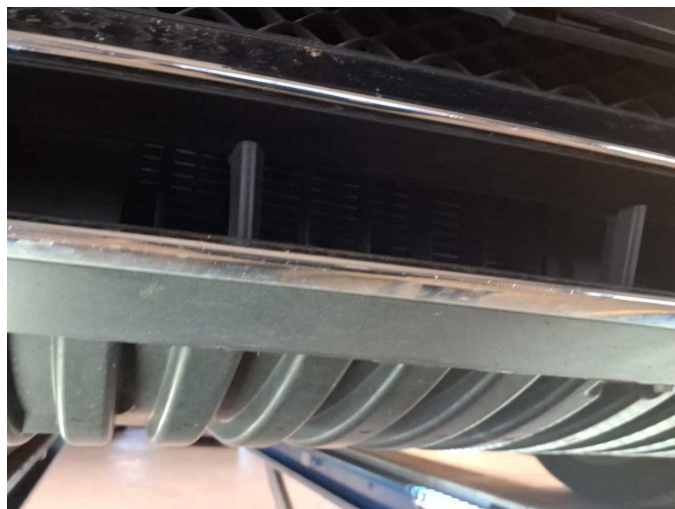
| No. | Component group | Description |
|---|---|---|
| 4 | Front bumper | Spoiler (Zierleiste) - Stone chips |

**Wear and tear 4:** Front bumper: Spoiler (Zierleiste) - Stone chips

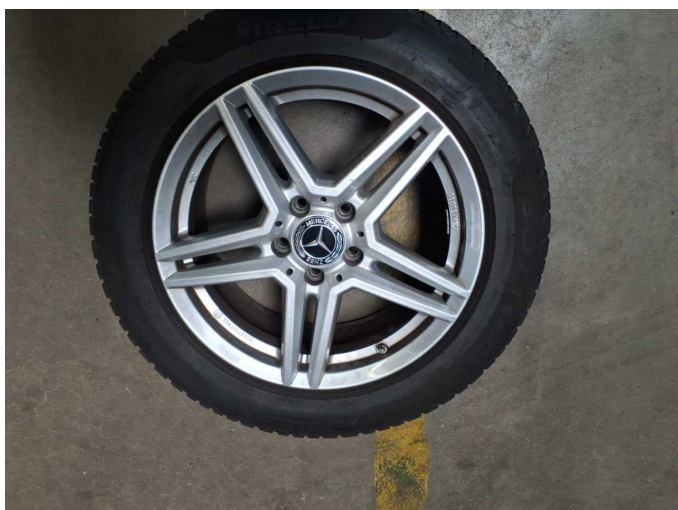
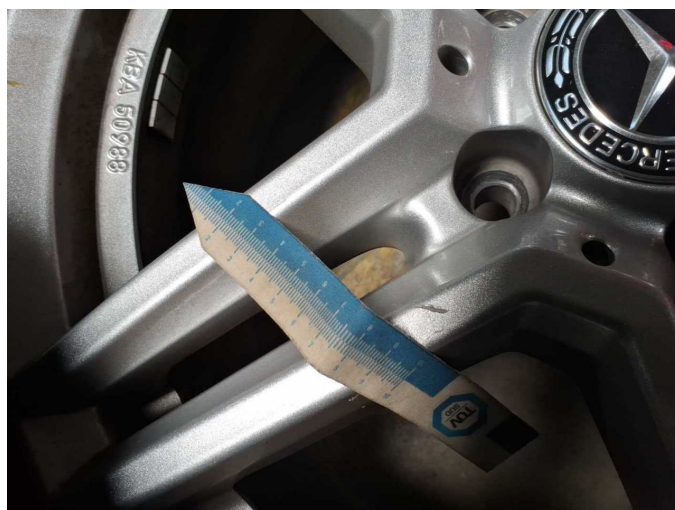
| No. | Component group | Description |
|---|---|---|
| 5 | 2nd wheel set | 1 alloy rim - Scratch(es) - No deduction |

**Wear and tear 5:** 2nd wheel set: 1 alloy rim - Scratch(es) - No deduction
