Expertise

Protocol number: 46527606  
Order No. / Reference: 26505329  
Inspection date: 8 Jul 2026

Manufacturer: Volkswagen

Model: ID.3 Pro S (4-Sitzer)

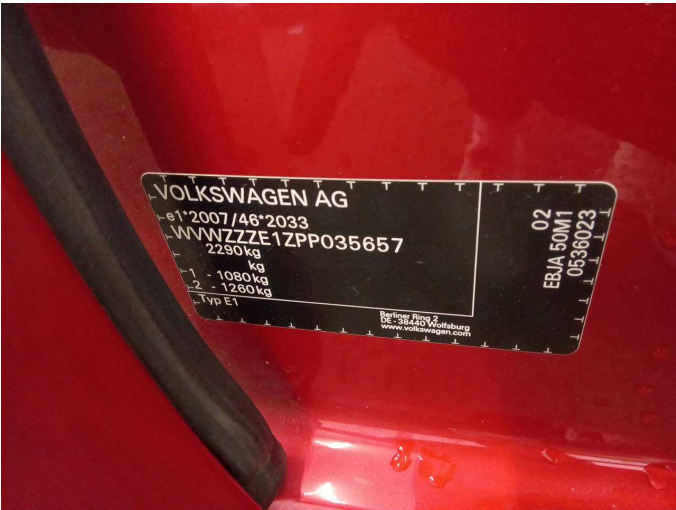
Figure 11: VIN

| VIN comparison | The vehicle identification number (VIN) was read from the vehicle and its conformity with the submitted documents was confirmed by the undersigned during the inspection. |

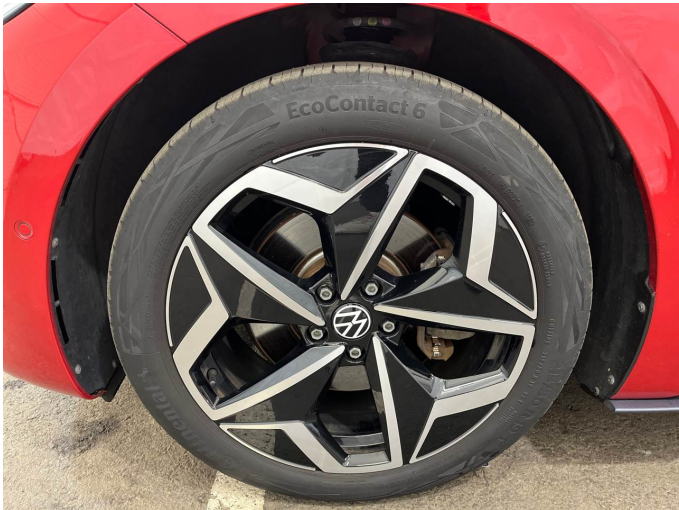
Figure 12: Mounted tyres

| # | Tyre size | Type of tyre | Manufacturer | Tread depth |
|---|---|---|---|---|
| 1) | 215/50 R19 93T | Summer tires (with run-flat tires) on Light alloy | Continental | 5mm / 5mm |
| 2) | 215/50 R19 93T | Summer tires (with run-flat tires) on Light alloy | Continental | 4mm / 4mm |

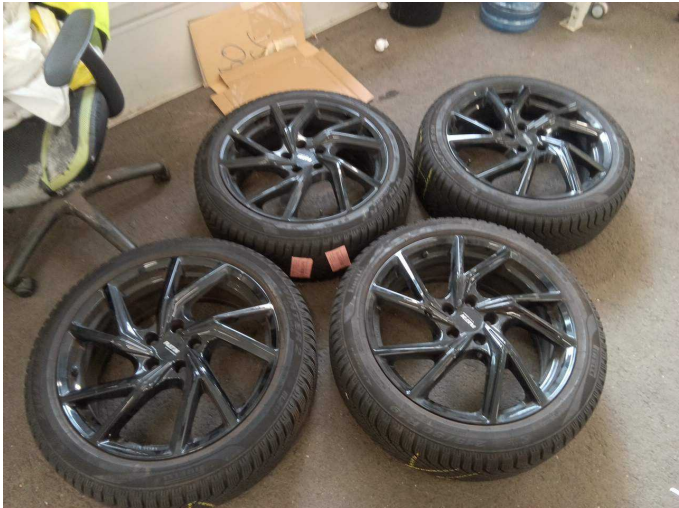
Figure 16: Additional tyres

| # | Tyre size | Type of tyre | Manufacturer | Tread depth |
|---|---|---|---|---|
| 1) | 215/50 R19 93T | Winter tires (with run-flat tires) on Light alloy | Pirelli | 5mm / 5mm |
| 2) | 215/50 R19 93T | Winter tires (with run-flat tires) on Light alloy | Pirelli | 7mm / 7mm |

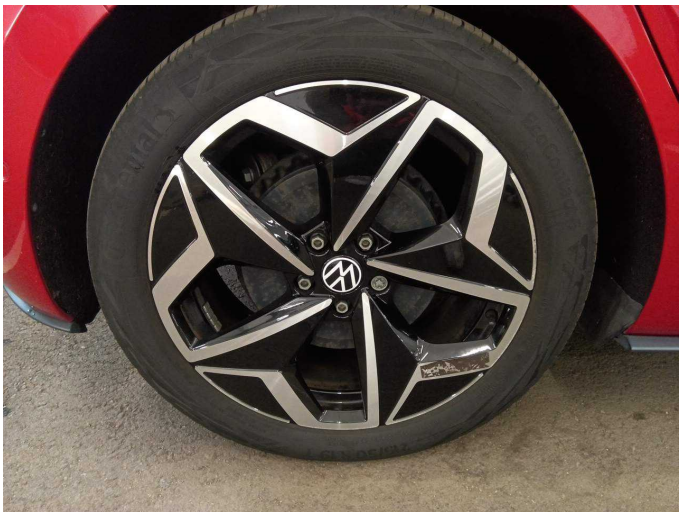
Damage 2: 1

| No. | Component group | Description |
|---|---|---|
| 2 | Wheel / tyres | Alloy rim - rear right side - Scratch(es) - Loss in value |

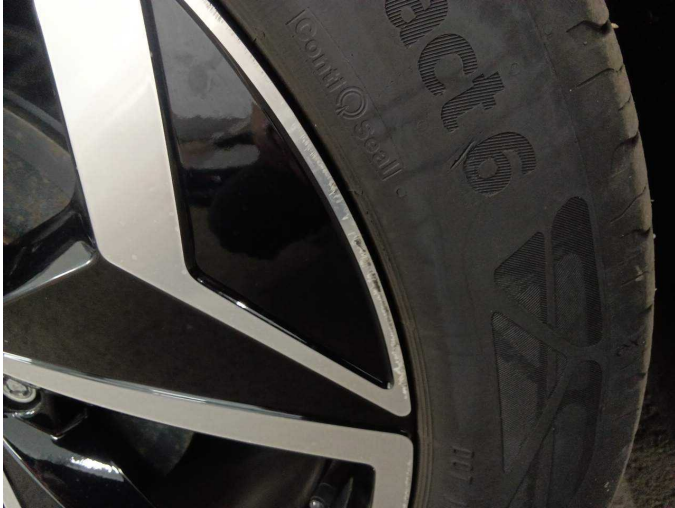
**Damage 2:** Wheel / tyres: Alloy rim - rear right side - Scratch(es) - Loss in value

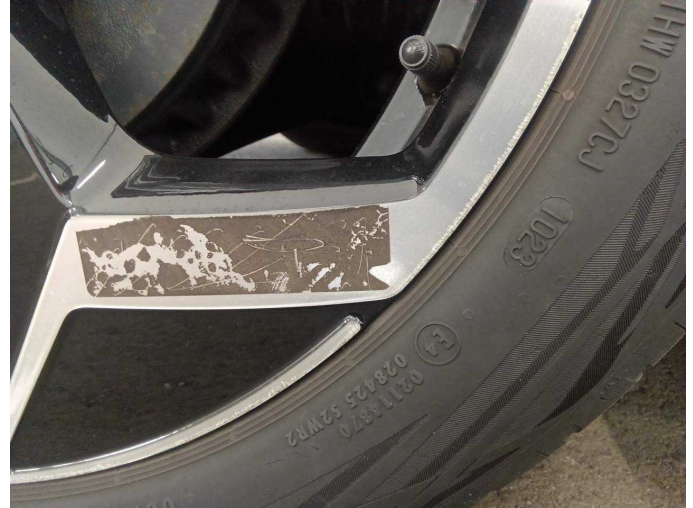
**Damage 2:** Wheel / tyres: Alloy rim - rear right side - Scratch(es) - Loss in value

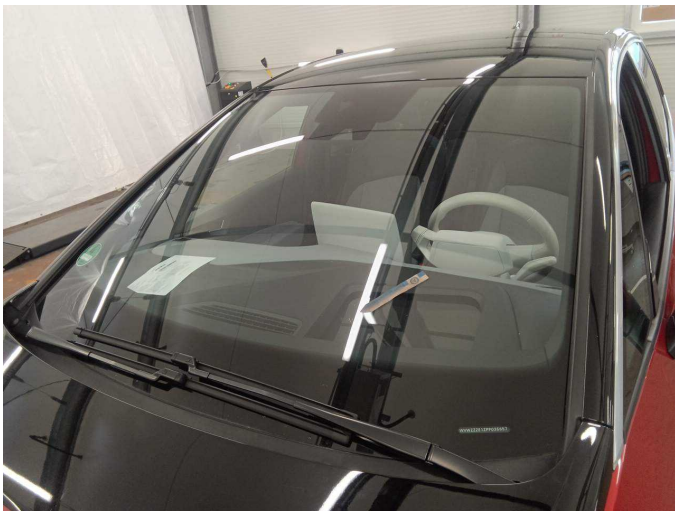
| No. | Component group | Description |
|---|---|---|
| 1 | Vehicle glazing | Windscreen - Stone chips - No deduction |

**Wear and tear 1:** Vehicle glazing: Windscreen - Stone chips - No deduction

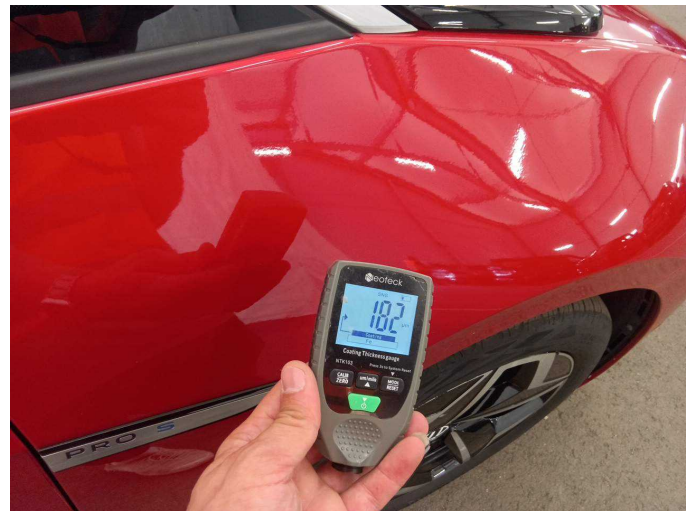
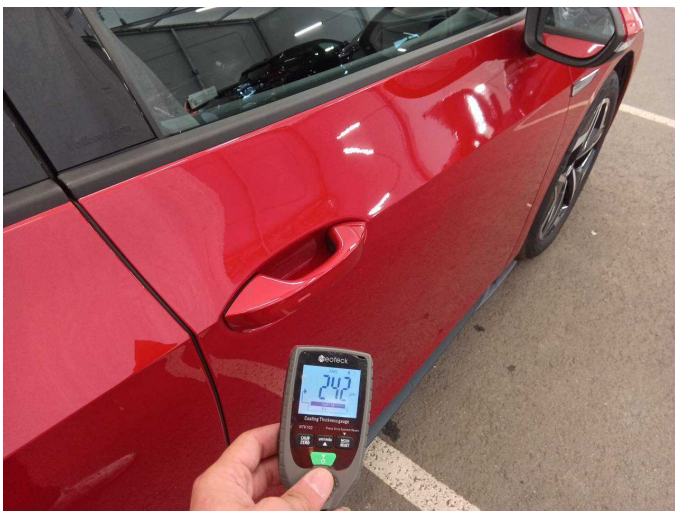
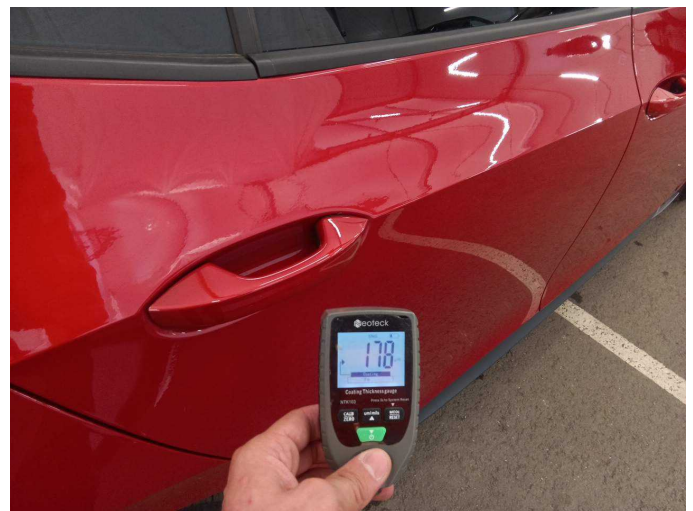
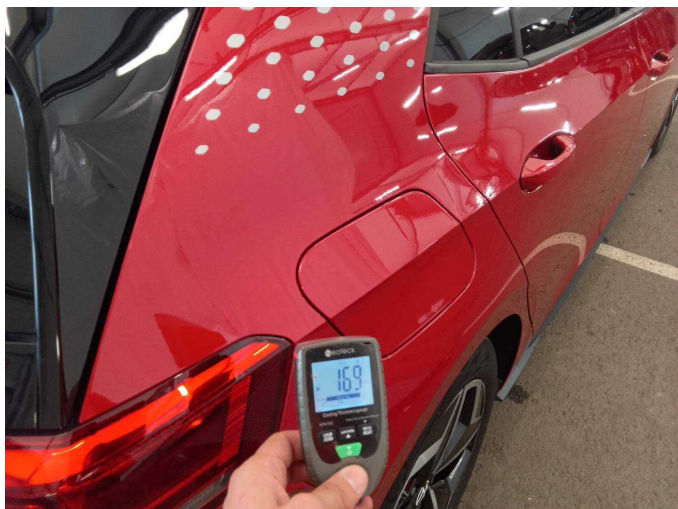
1 Mudguard - right side, Side panel - rear right side, Door - rear right side, Door - front right side

| Mudguard - right side | 182 µm | Side panel - rear right side | 168 µm |
| Door - rear right side | 168 µm | Door - front right side | 207 µm |

**Repainting 1:** Mudguard - right side, Side panel - rear right side, Door - rear right side, Door - front right side
