Expertise

Protocol number: 46909030  
Order No. / Reference: 26854184  
Inspection date: 5 Aug 2026

Manufacturer: Opel

Model: Astra Sports Tourer 1.5 D Automatik Elegance

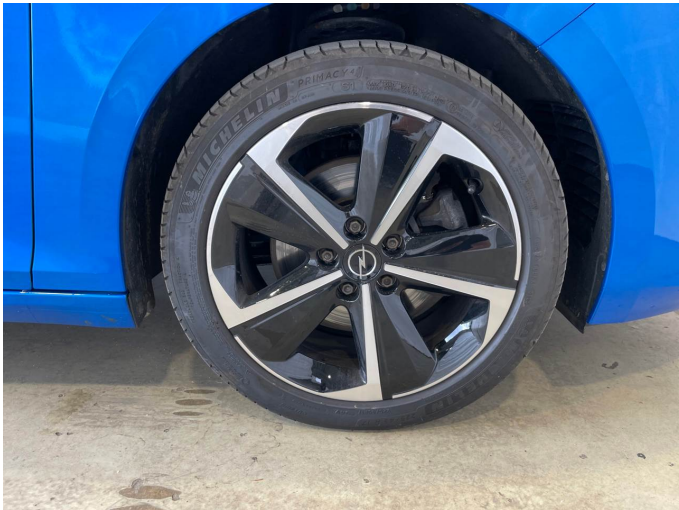
Figure 12: Mounted tyres

| Tyres | | | | |
|---|---|---|---|---|
| 1) | 225/45 R17 94V | Summer tyres on Light alloy | Michelin | 5mm / 5mm |
| 2) | 225/45 R17 94V | Summer tyres on Light alloy | Michelin | 5mm / 5mm |

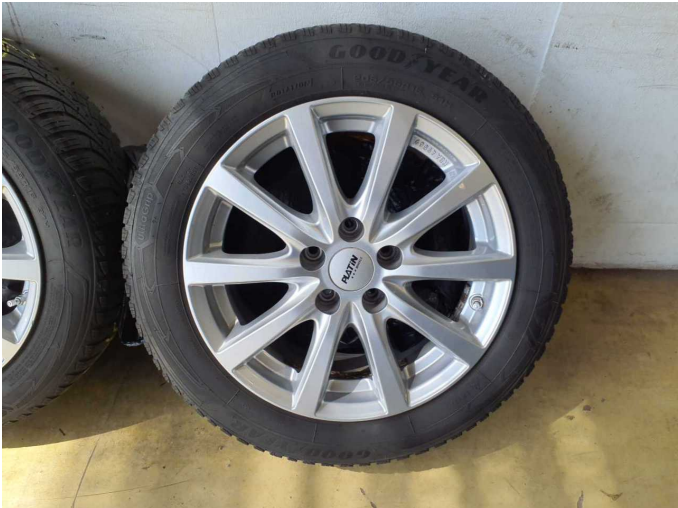
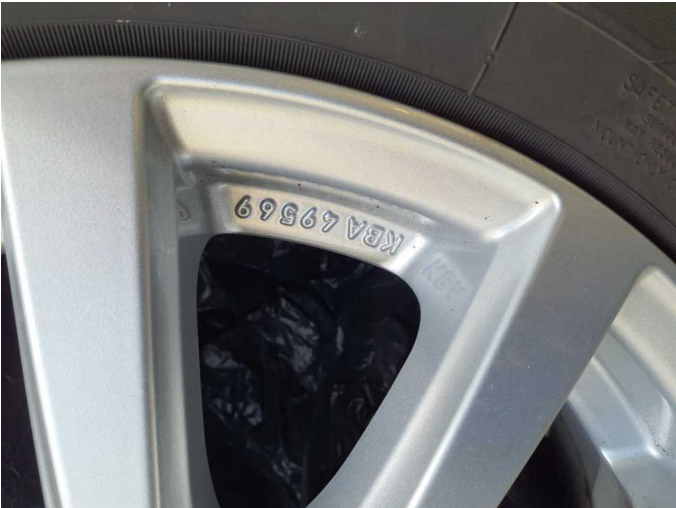
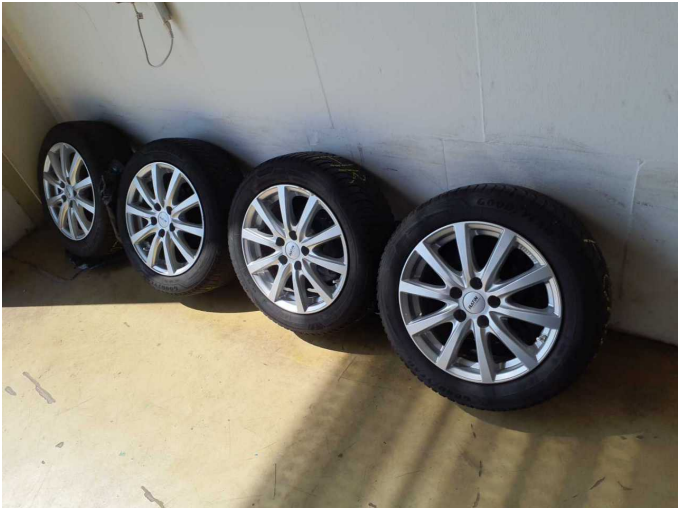
Figure 14: Additional tyres

| Tyres | | | | |
|---|---|---|---|---|
| 1) | 205/55 R16 91H | Winter tyres on Light alloy | Goodyear | 3mm / 3mm |
| 2) | 205/55 R16 91H | Winter tyres on Light alloy | Goodyear | 3mm / 3mm |

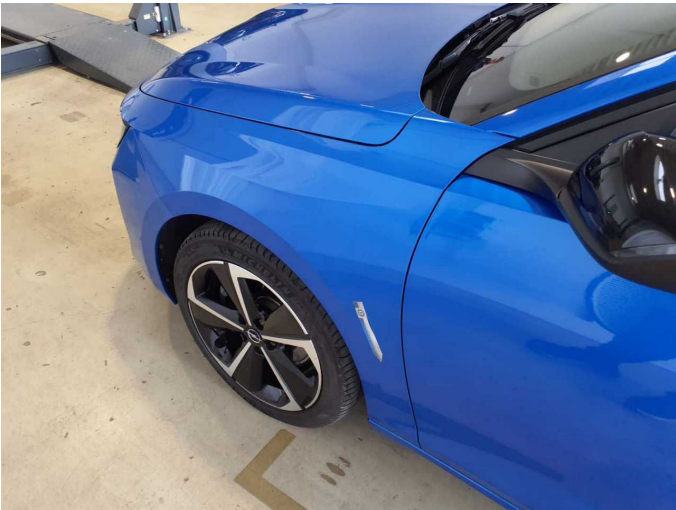
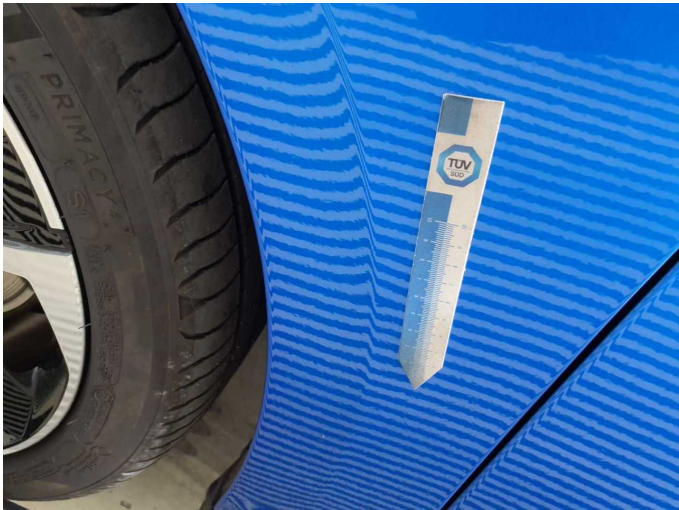
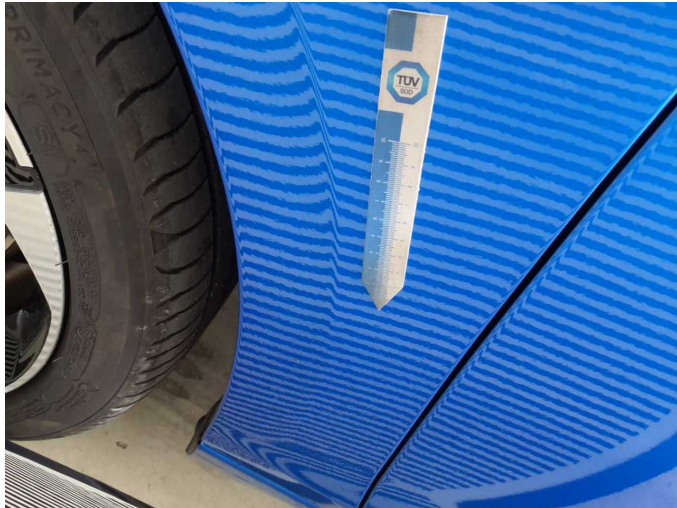
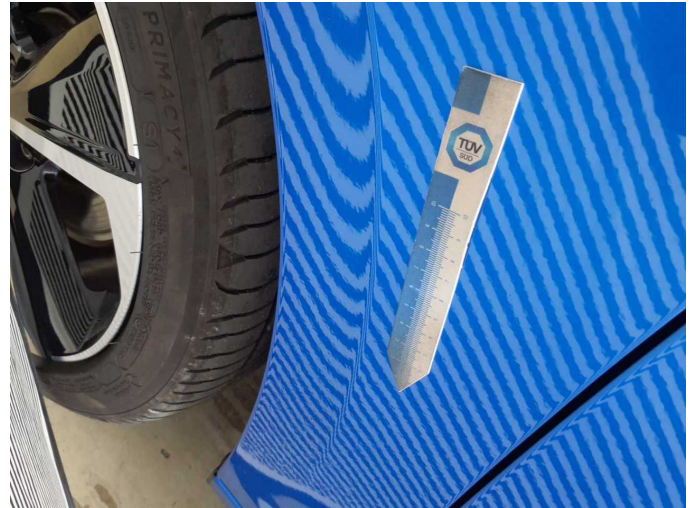
| No. | Component group | Description |
|---|---|---|
| 1 | Mudguard - left side | Mudguard - left side - dent(s) - Smart repair |

Damage 1: Mudguard - left side: Mudguard - left side - dent(s) - Smart repair

**Damage 1:** Mudguard - left side: Mudguard - left side - dent(s) - Smart repair

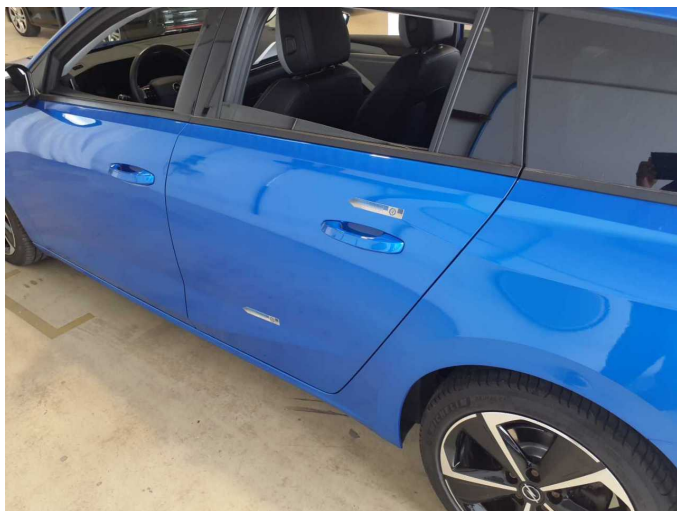
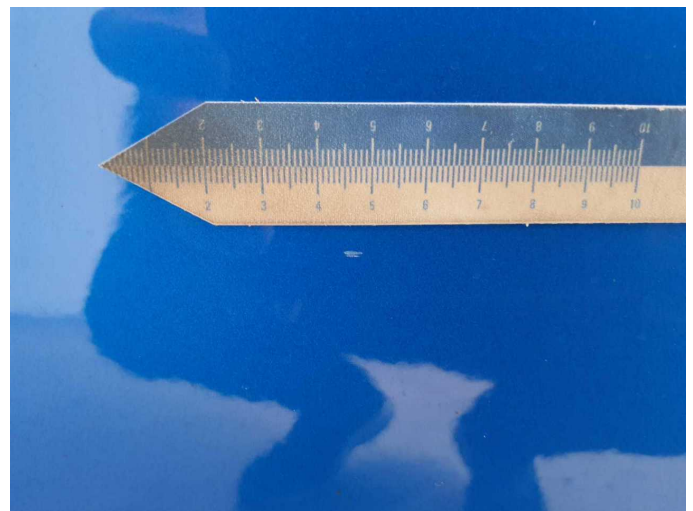
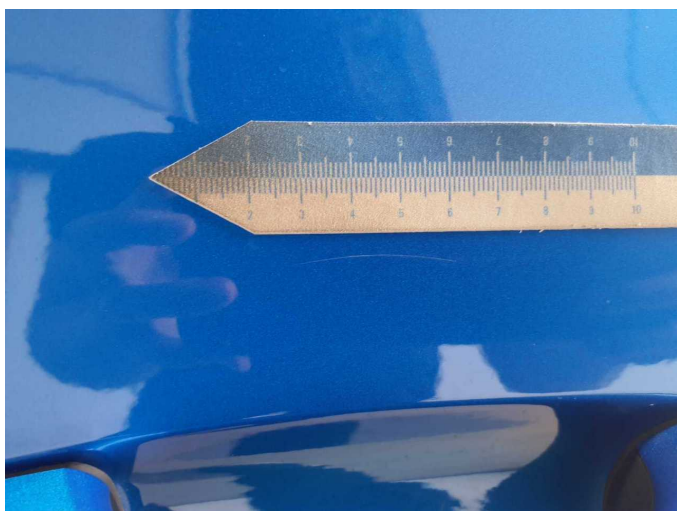
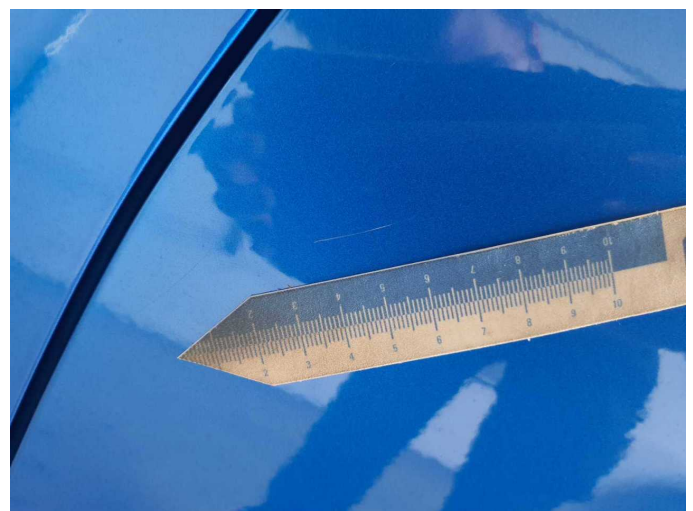
| No. | Component group | Description |
|---|---|---|
| 2 | Door - rear left side | Door - Scratch(es) - Paint |

**Damage 2:** Door - rear left side: Door - Scratch(es) - Paint

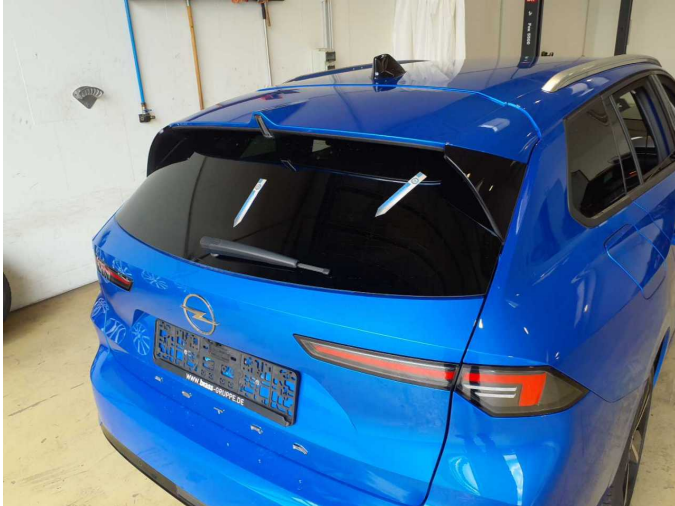
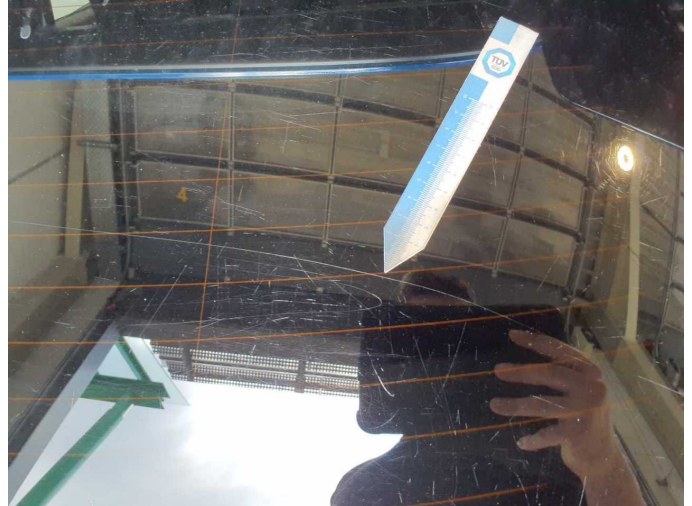
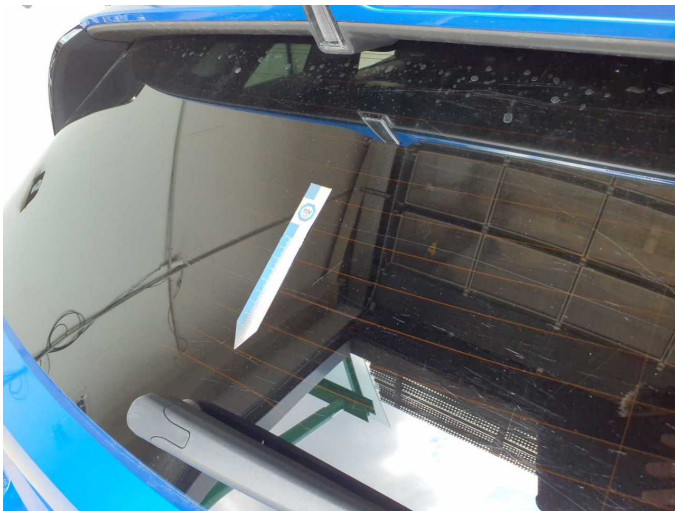
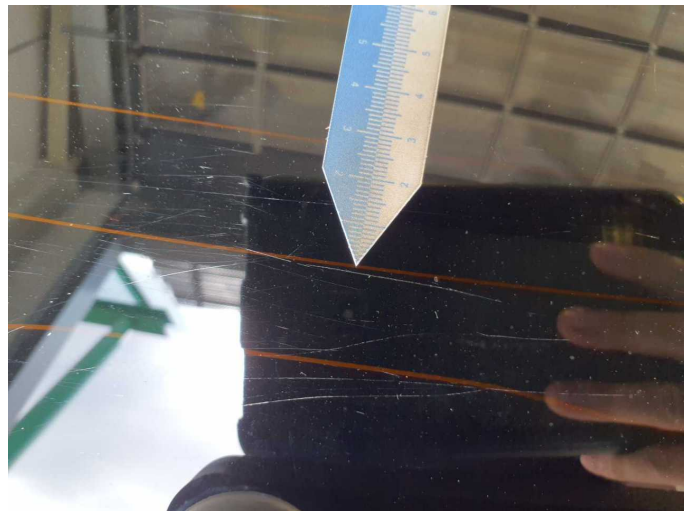
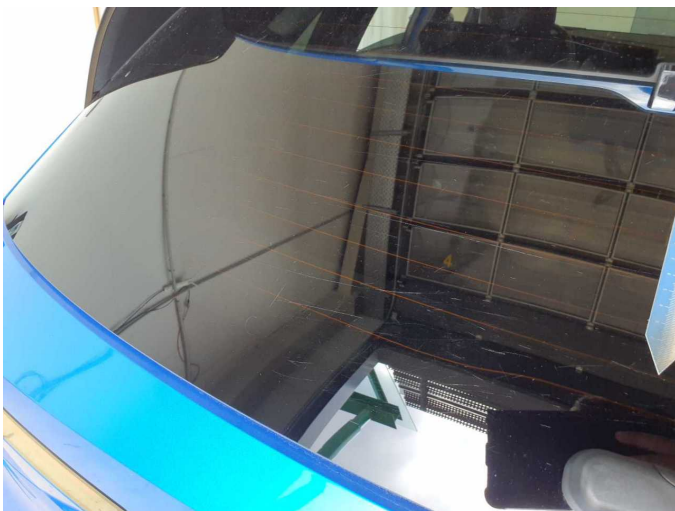
| No. | Component group | Description |
|---|---|---|
| 3 | Vehicle glazing | Rear window - Scratch(es) - Replace |

**Damage 3:** Vehicle glazing: Rear window - Scratch(es) - Replace
