Expertise

Protocol number: 46318788
Order No. / Reference: 26349719
Inspection date: 3 Jul 2026

Model: S-Max 2.0 EcoBlue Aut. Titanium

An order was placed to prepare a sales report for the described vehicle. This report includes the following:

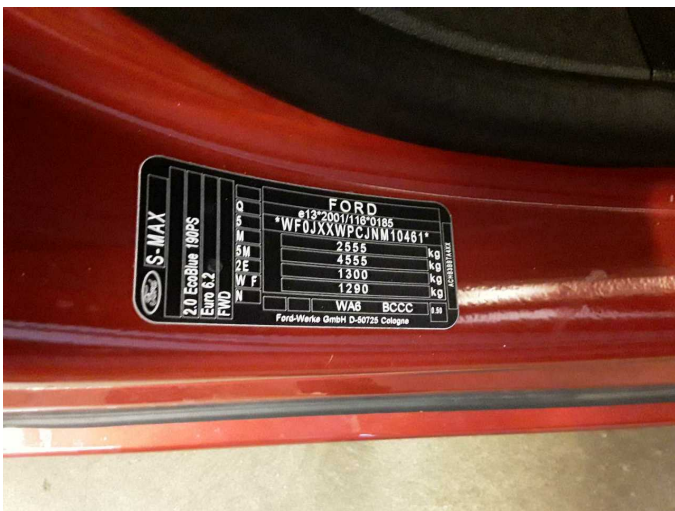
Figure 11: VIN

Documents submitted	At the time of the inspection, the vehicle registration certificate Part 2 (title) was available, but the vehicle registration certificate Part 1 (document) was not. (Copy)
VIN comparison	The vehicle identification number (VIN) was read from the vehicle and its conformity with the submitted documents was confirmed by the undersigned during the inspection.
Inspection	The inspection conditions were sufficient for the assessment of the vehicle. Lifting equipment and/or a pit were available for examining the vehicle.
Test drive	No test drive/shunting maneuver was carried out during the inspection of the vehicle.
Engine function test	An engine test run was performed.

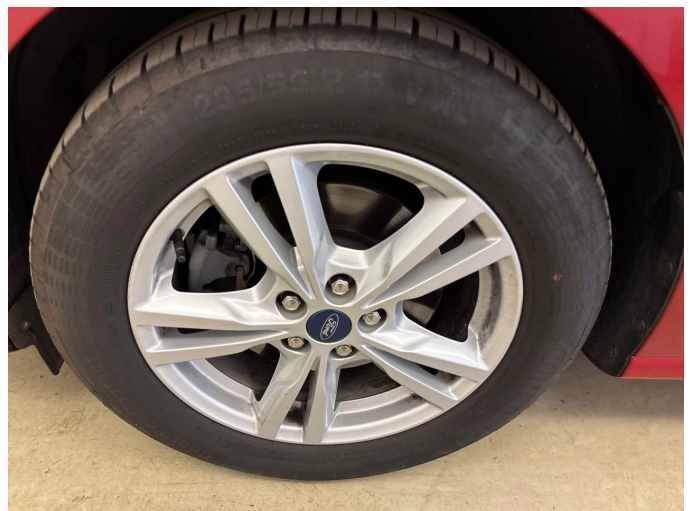
Figure 12: Mounted tyres

#	Tyre size	Type of tyre	Manufacturer	Tread depth
1)	235/55 R17 103V	Summer tyres on Light alloy	Continental	4mm / 4mm
2)	235/55 R17 103V	Summer tyres on Light alloy	Continental	4mm / 4mm

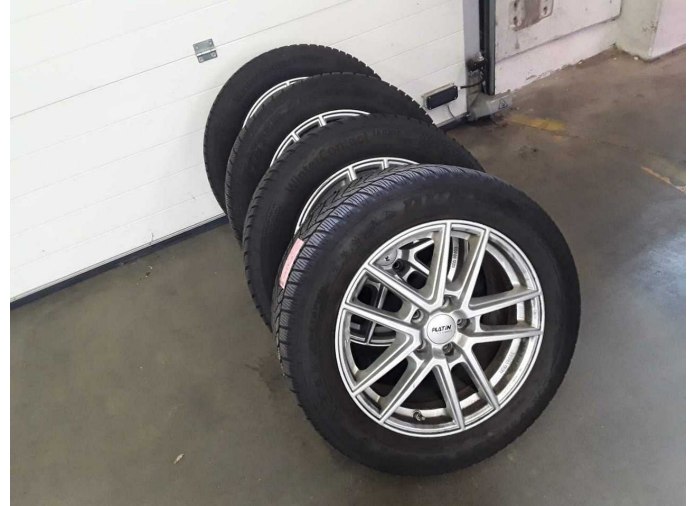
Figure 14: Additional tyres

#	Tyre size	Type of tyre	Manufacturer	Tread depth
1)	235/55 R17 103V	Winter tyres on Light alloy	Dunlop	5mm / 5mm
2)	235/55 R17 103V	Winter tyres on Light alloy	Dunlop	5mm / 5mm

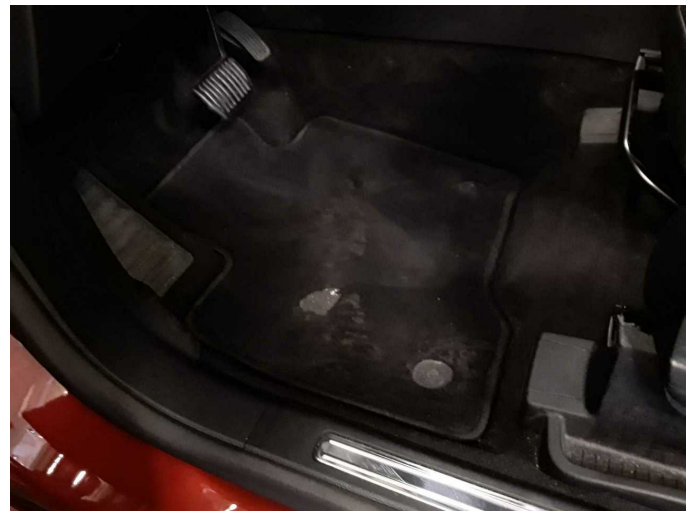
Damage 1: Trim / covers: Floor mats - Damaged - Replace

No.	Component group	Description
1	Trim / covers	Floor mats - Damaged - Replace
2	Door - front left side	Door - Scratch(es) - Paint
3	Front bumper	Front bumper - Deformed - Paint
4	Boot lid / rear door	Boot lid - Scratch(es) - Paint

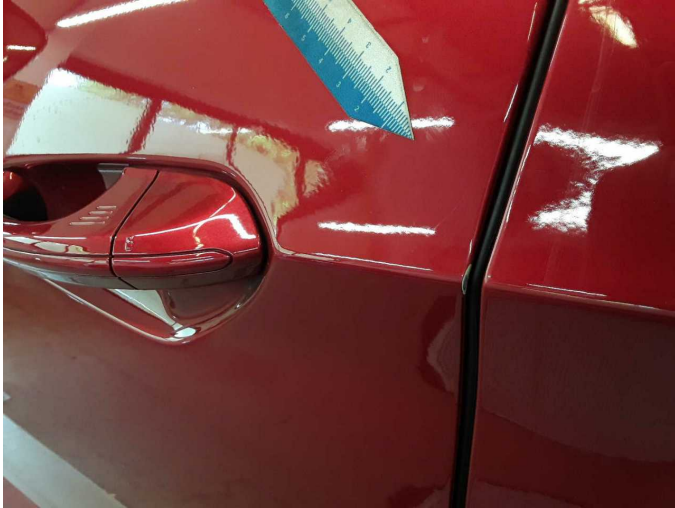
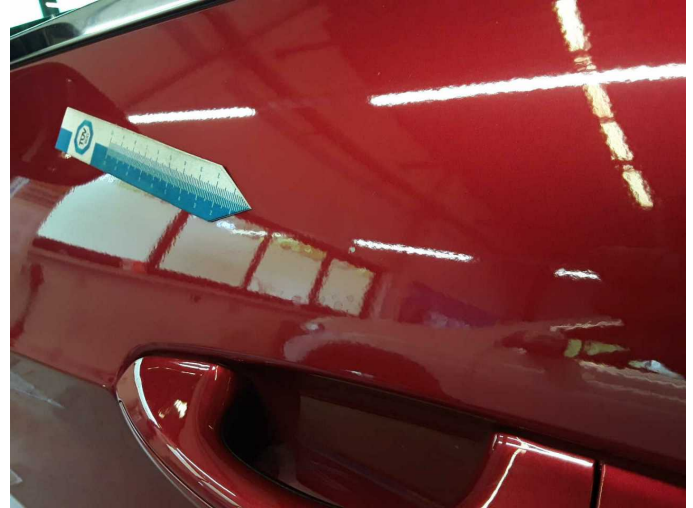
Damage 2: Door - front left side: Door - Scratch(es) - Paint

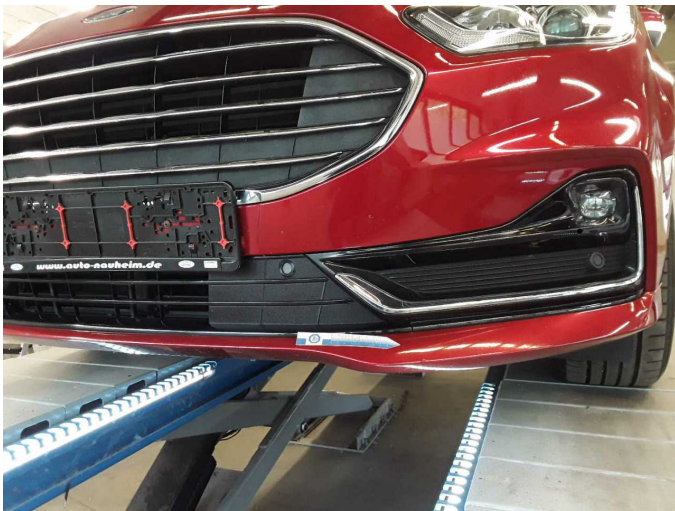
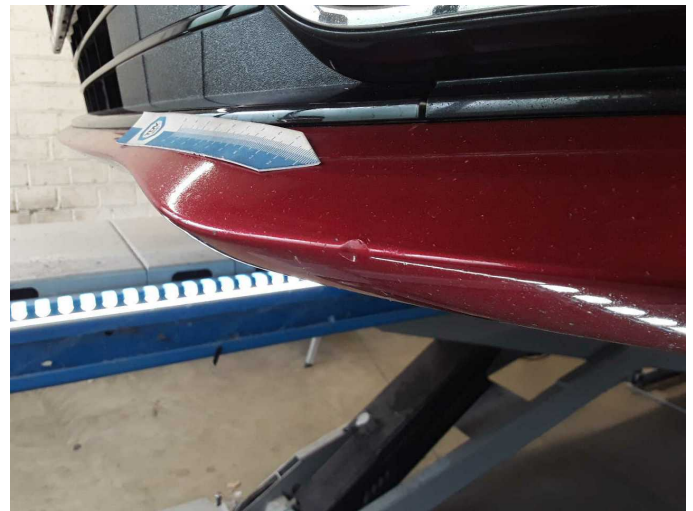
Damage 3: Front bumper: Front bumper - Deformed - Paint
