Expertise

Protocol number: 46848760  
Order No. / Reference: 26728128  
Inspection date: 3 Aug 2026

Manufacturer: Ford

Model: Focus Turnier 1.5 EcoBlue Start-Stopp-System Aut. TITANIUM X

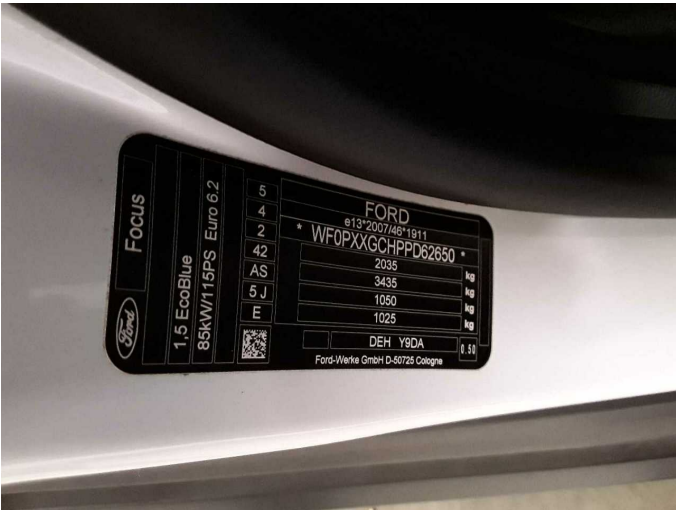
Figure 11: VIN

| VIN comparison | The vehicle identification number (VIN) was read from the vehicle and its conformity with the submitted documents was confirmed by the undersigned during the inspection. |

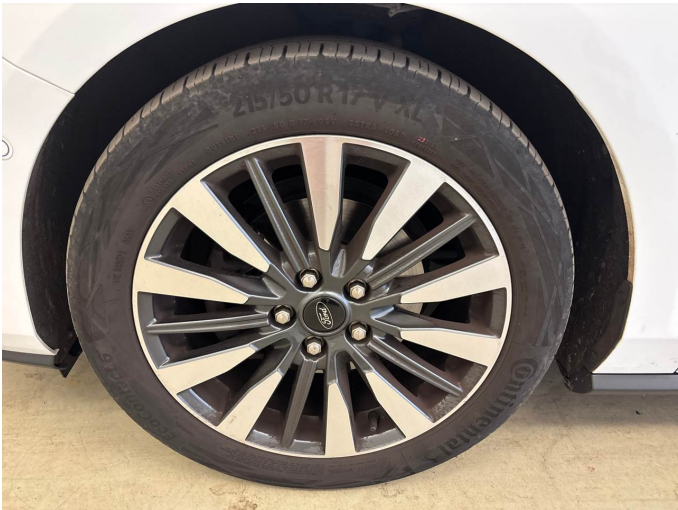
Figure 12: Mounted tyres

| # | Tyre size | Type of tyre | Manufacturer | Tread depth |
|---|---|---|---|---|
| 1) | 215/50 R17 95V | Summer tyres on Light alloy | Continental | 5mm / 5mm |
| 2) | 215/50 R17 95V | Summer tyres on Light alloy | Continental | 6mm / 6mm |

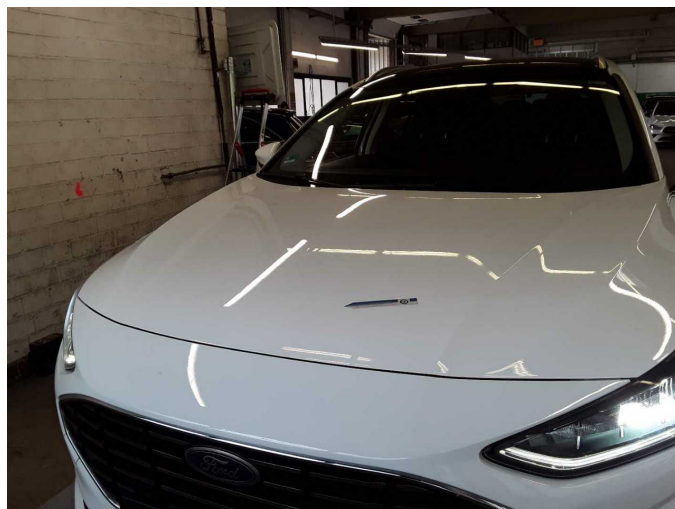
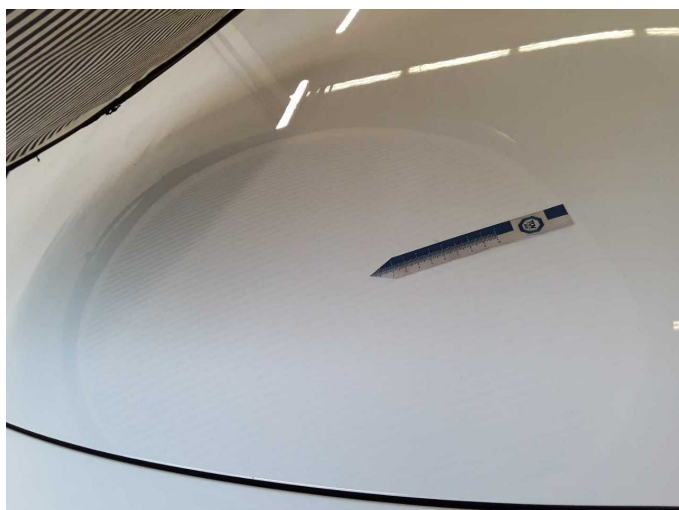
| No. | Component group | Description |
|---|---|---|
| 1 | Bonnet | Bonnet - dent(s) - Smooth repair work |

**Damage 1:** Bonnet: Bonnet - dent(s) - Smooth repair work

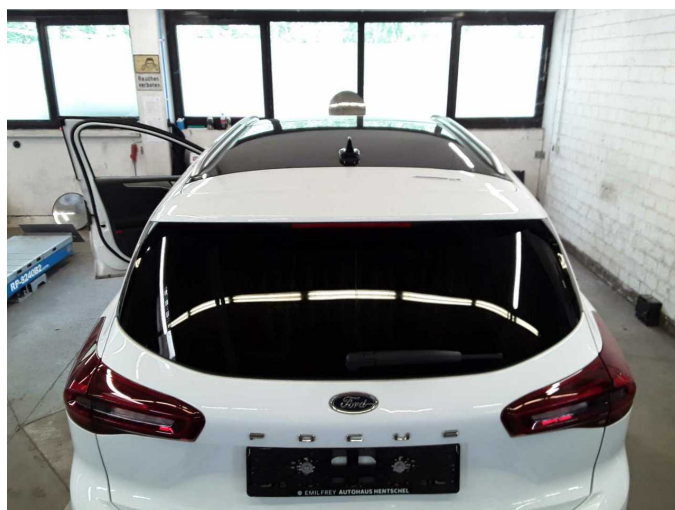
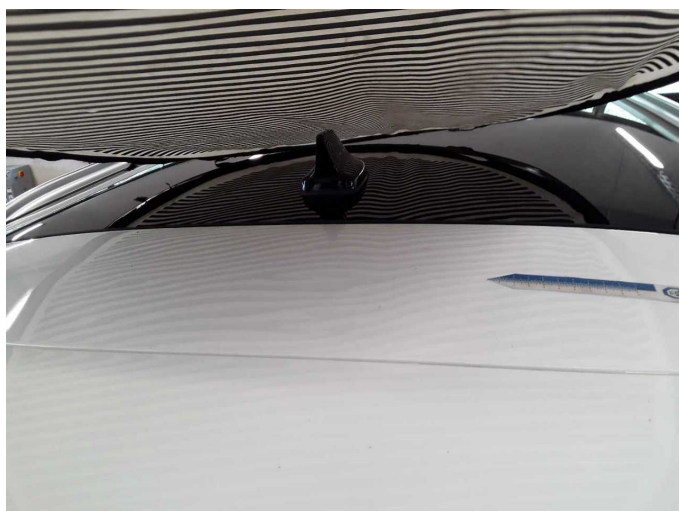
| No. | Component group | Description |
|---|---|---|
| 2 | Boot lid / rear door | Boot lid - dent(s) - Smooth repair work |

**Damage 2:** Boot lid / rear door: Boot lid - dent(s) - Smooth repair work

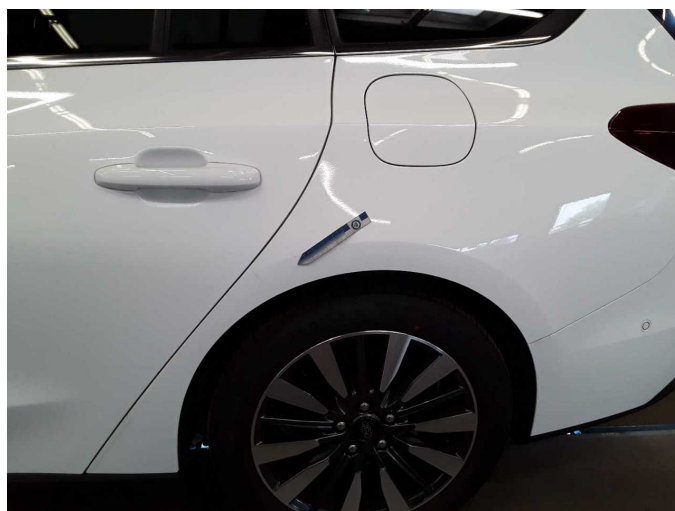
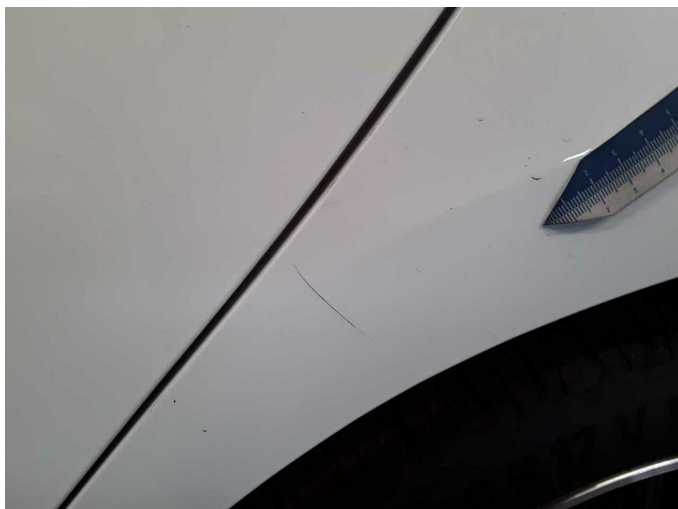
| No. | Component group | Description |
|---|---|---|
| 3 | Side panel - rear left side | Side panel - Scratch(es) - Smart repair |

**Damage 3:** Side panel - rear left side: Side panel - Scratch(es) - Smart repair

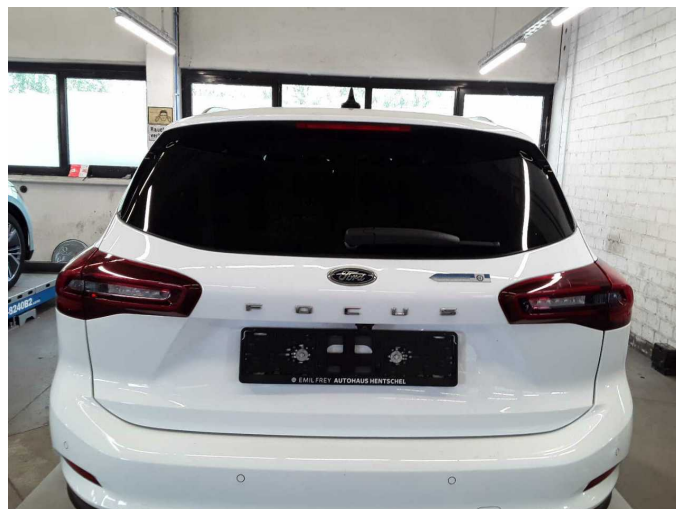
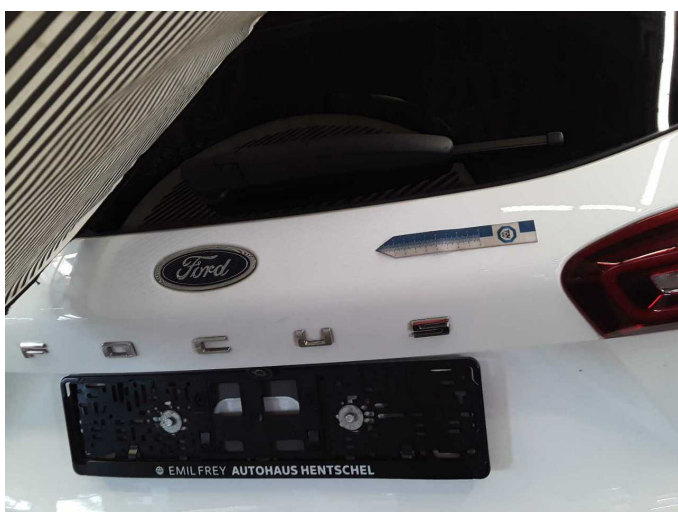
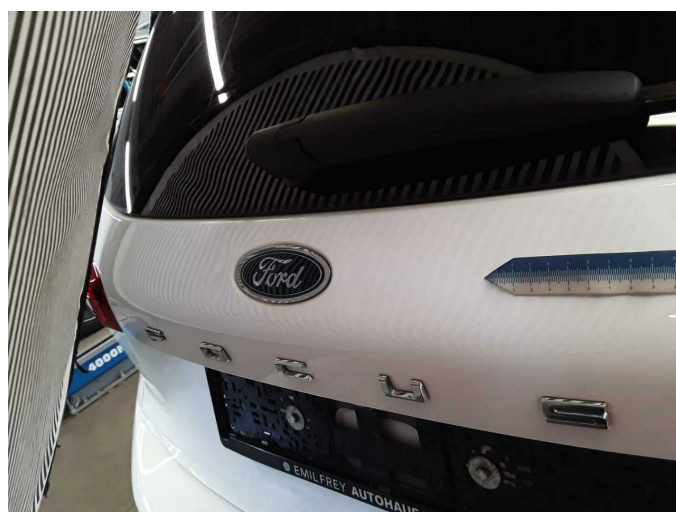
| No. | Component group | Description |
|---|---|---|
| 5 | Boot lid / rear door | Boot lid - dent(s) - Smooth repair work |

**Damage 5:** Boot lid / rear door: Boot lid - dent(s) - Smooth repair work

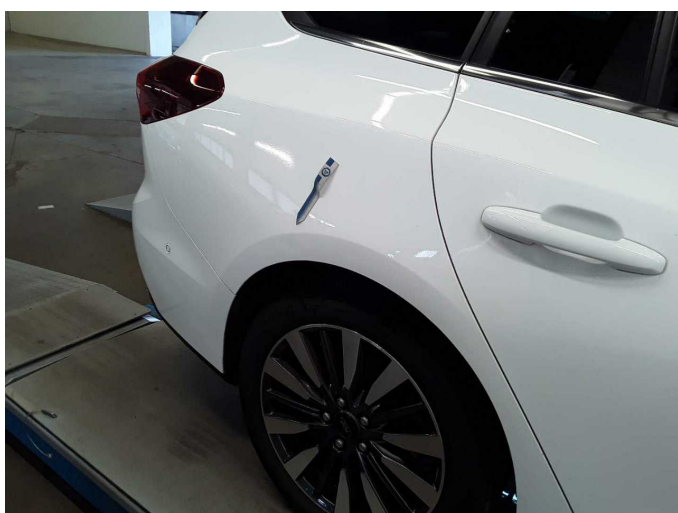
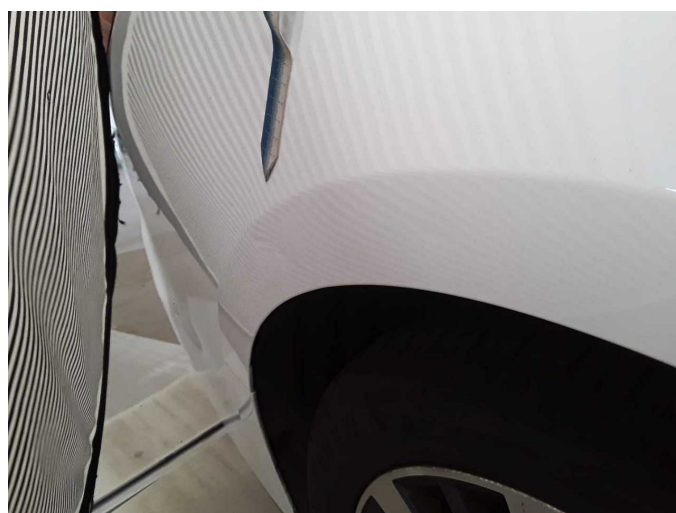
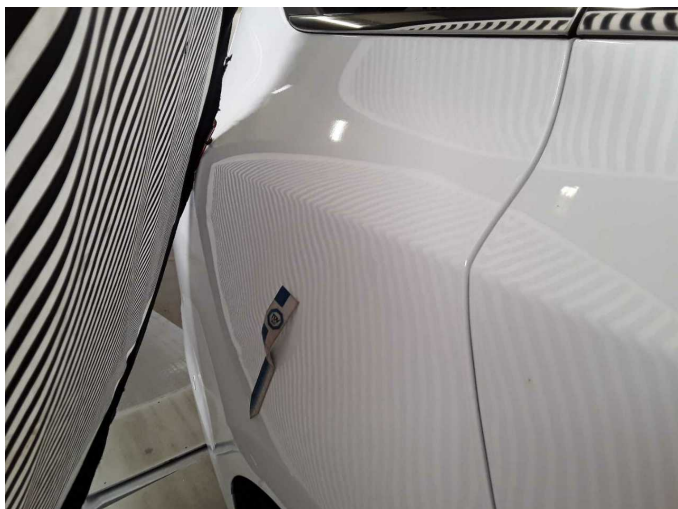
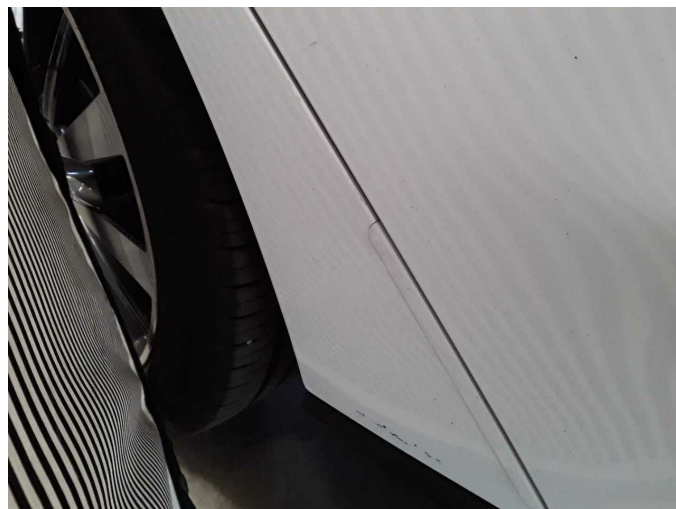
| No. | Component group | Description |
|---|---|---|
| 6 | Side panel - rear right side | Side panel - dent(s) - Smooth repair work |

**Damage 6:** Side panel - rear right side: Side panel - dent(s) - Smooth repair work

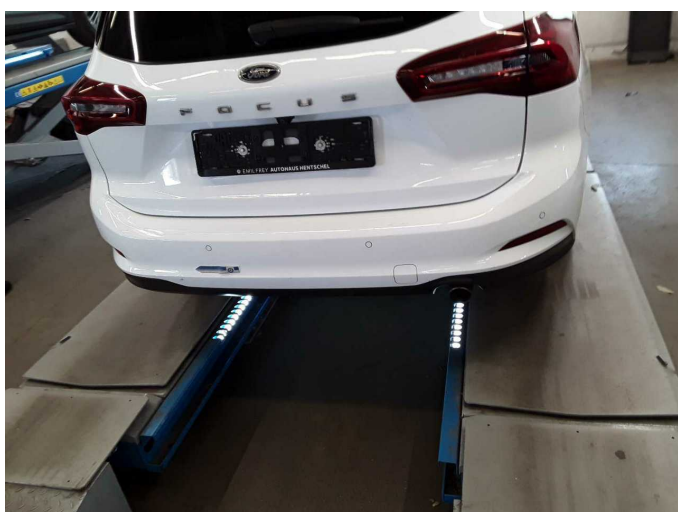
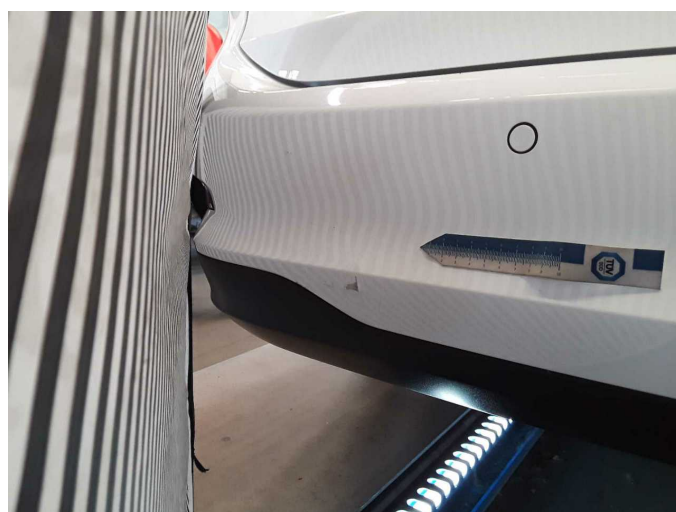
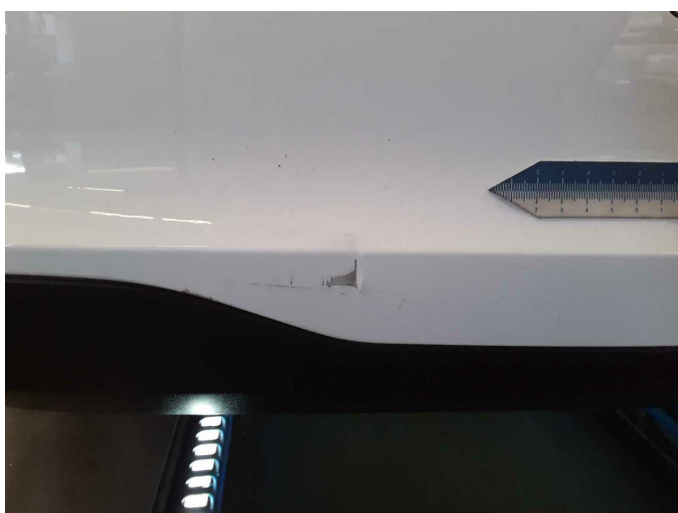
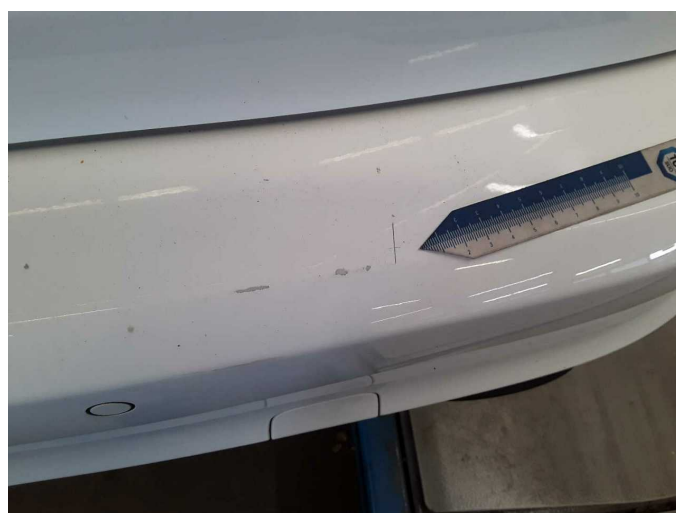
| No. | Component group | Description |
|---|---|---|
| 7 | Rear bumper | Rear bumper - Dent / paintcoat damage - Repair and paint |

**Damage 7:** Rear bumper: Rear bumper - Dent / paintcoat damage - Repair and paint

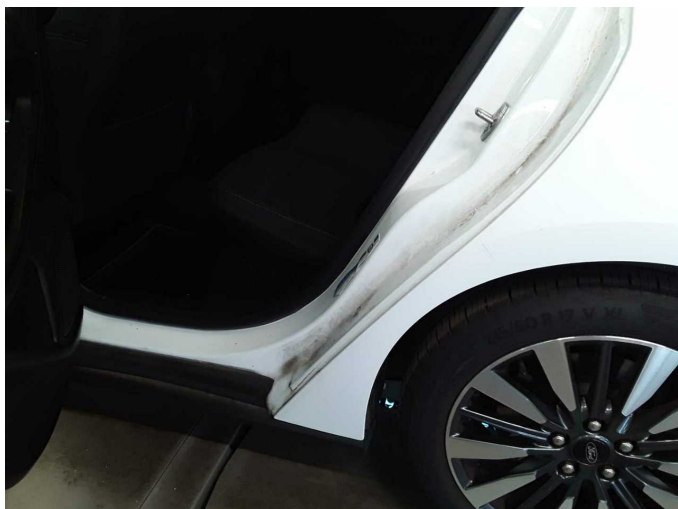
| No. | Component group | Description |
|---|---|---|
| 1 | Side panel - rear left side | Sill - dent(s) - No deduction |

**Wear and tear 1:** Side panel - rear left side: Sill - dent(s) - No deduction
