Expertise

Protocol number: 45529429
Order No. / Reference: 26337667
Inspection date: 19 May 2026

Model: GLE 300 d 4Matic 9G-TRONIC

VIN: W1N1671091A639318

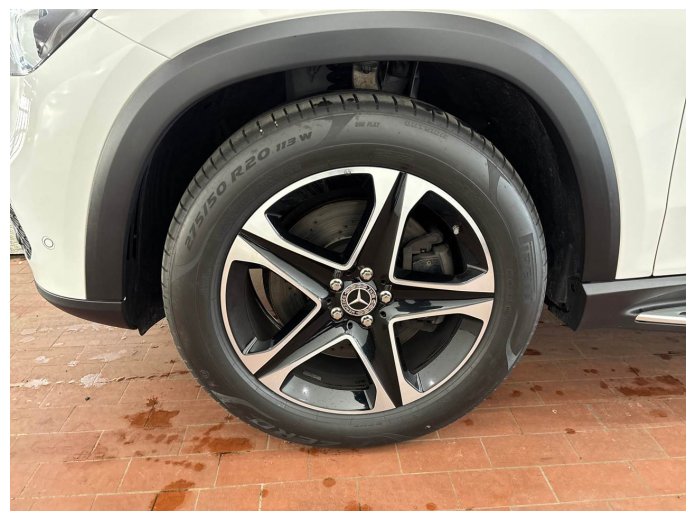
#	Tyre size	Type of tyre	Manufacturer	Tread depth
1)	275/50 R20 113W	Summer tyres on Light alloy	Pirelli	6mm / 6mm
2)	275/50 R20 113W	Summer tyres on Light alloy	Pirelli	5mm / 5mm

Figure 12: Mounted tyres

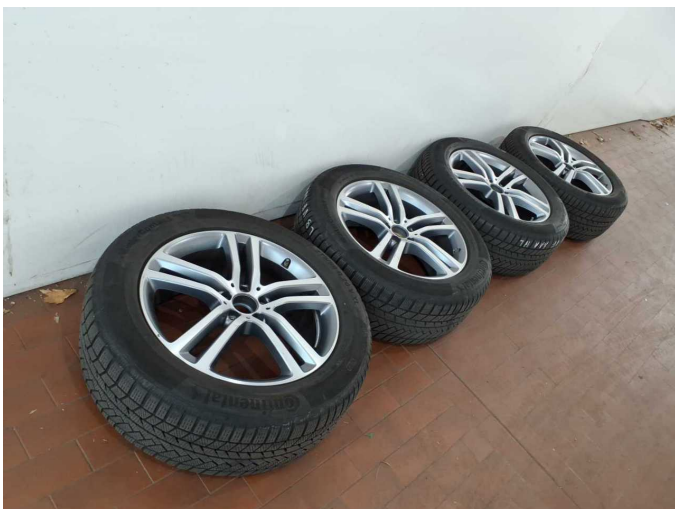
#	Tyre size	Type of tyre	Manufacturer	Tread depth
1)	275/50 R20 113V	Winter tyres on Light alloy	Continental	5mm / 5mm
2)	275/50 R20 113V	Winter tyres on Light alloy	Continental	5mm / 5mm

Figure 17: Additional tyres

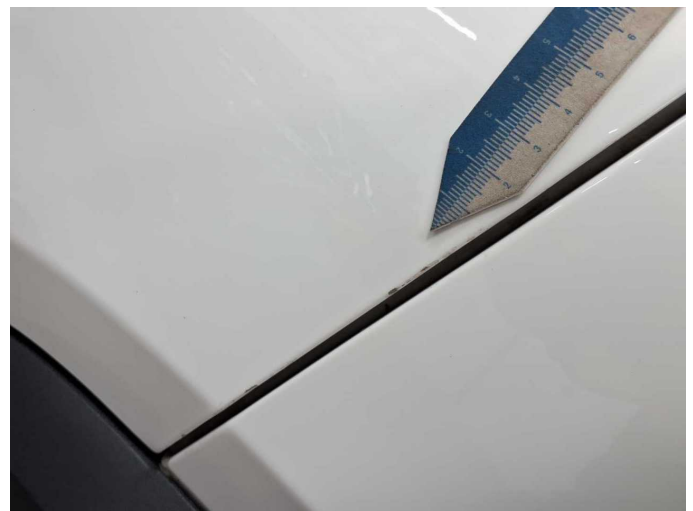
No.	Component group	Description
1	Door - rear left side	Door - Scratch(es) - Smart repair

Damage 1: Door - rear left side: Door - Scratch(es) - Smart repair

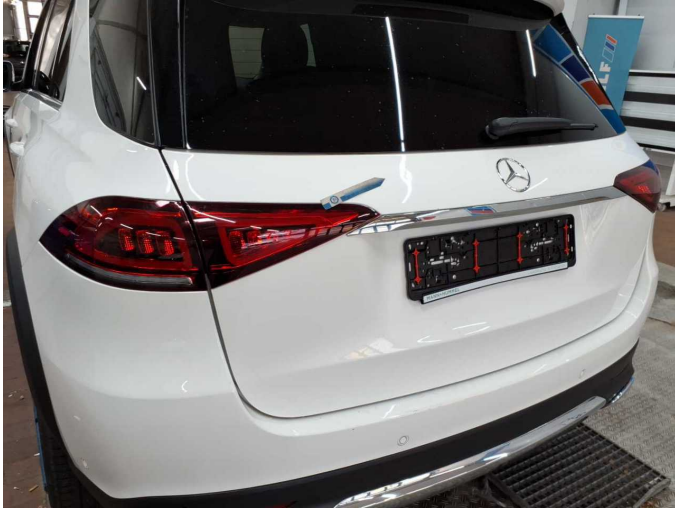
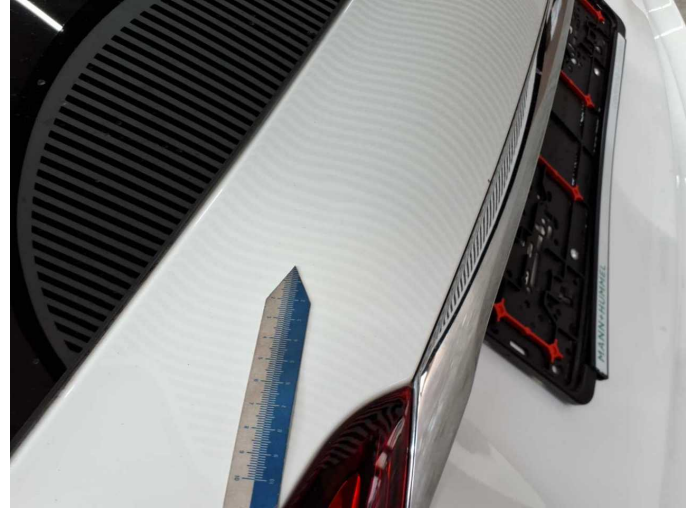
No.	Component group	Description
1	Vehicle glazing	Windscreen - Stone chips - No deduction
2	Boot lid / rear door	Boot lid - dent(s) - No deduction
3	Door - front right side	Door - dent(s) - No deduction

Wear and tear 2: Boot lid / rear door: Boot lid - dent(s) - No deduction

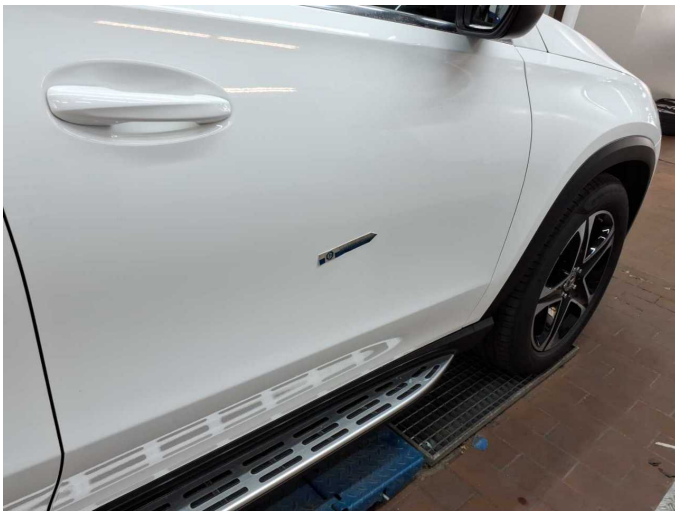
Wear and tear 3: Door - front right side: Door - dent(s) - No deduction

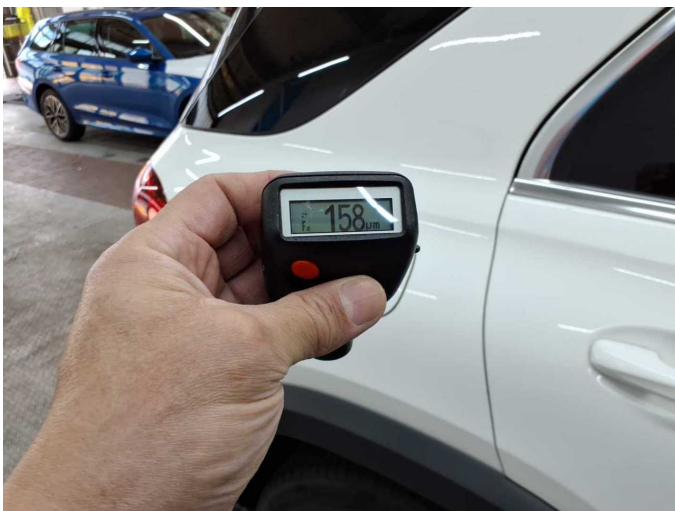
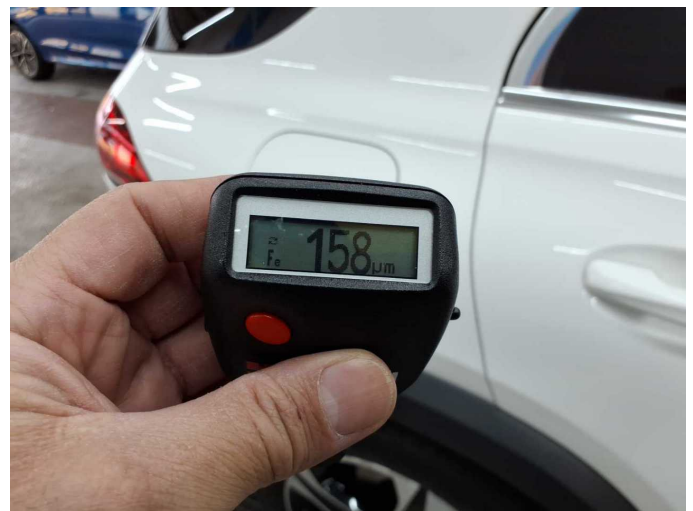
1 Side panel - rear right side, Professionally carried out, Invoice of repair done Non-existent

Side panel - rear right side 158 µm |

Repainting 1: Side panel - rear right side
