Expertise

Protocol number: 46110485  
Order No. / Reference: 26483945  
Inspection date: 23 Jun 2026

Model: Tiguan Allspace 2.0 TDI SCR 4Motion DSG R-Line

VIN: WVGZZZ5N8PM066266

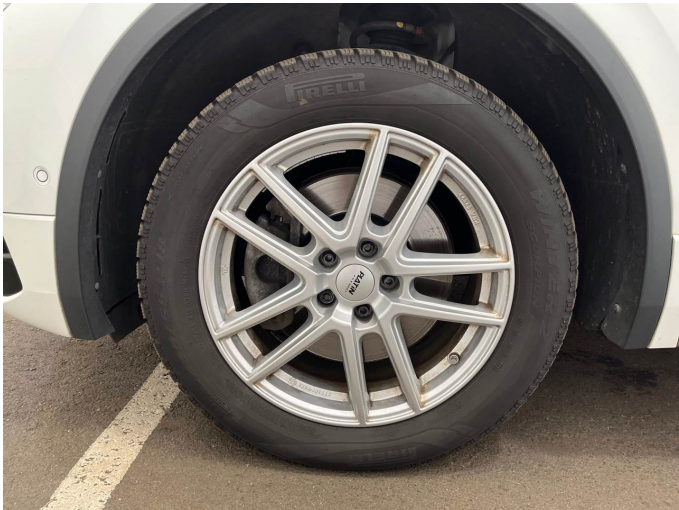
Figure 12: Mounted tyres

| Tyres | | | | |
|---|---|---|---|---|
| 1) | 235/55 R18 104H | Winter tires (with run-flat tires) on Light alloy | Pirelli | 5mm / 5mm |
| 2) | 235/55 R18 104H | Winter tires (with run-flat tires) on Light alloy | Pirelli | 7mm / 7mm |

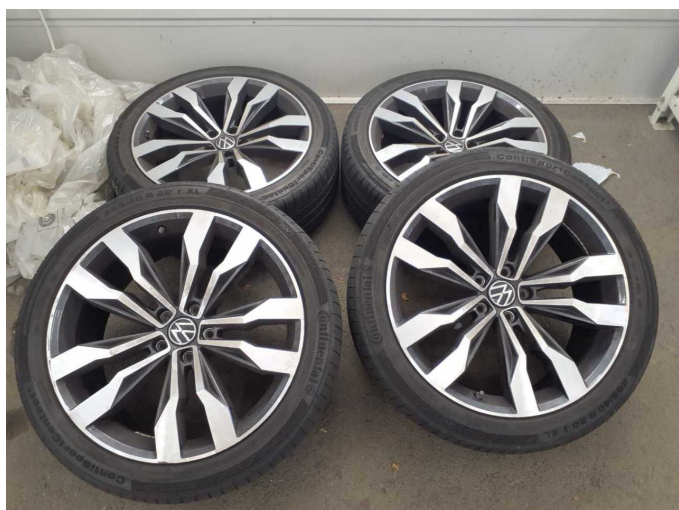
Figure 15: Additional tyres

| Tyres | | | | |
|---|---|---|---|---|
| 1) | 255/40 R20 101V | Summer tires (with run-flat tires) on Light alloy | Continental | 4mm / 4mm |
| 2) | 255/40 R20 101V | Summer tires (with run-flat tires) on Light alloy | Continental | 4mm / 4mm |

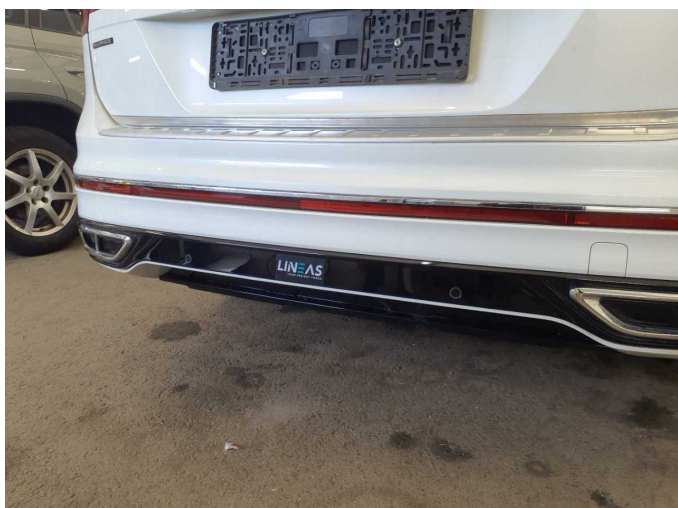
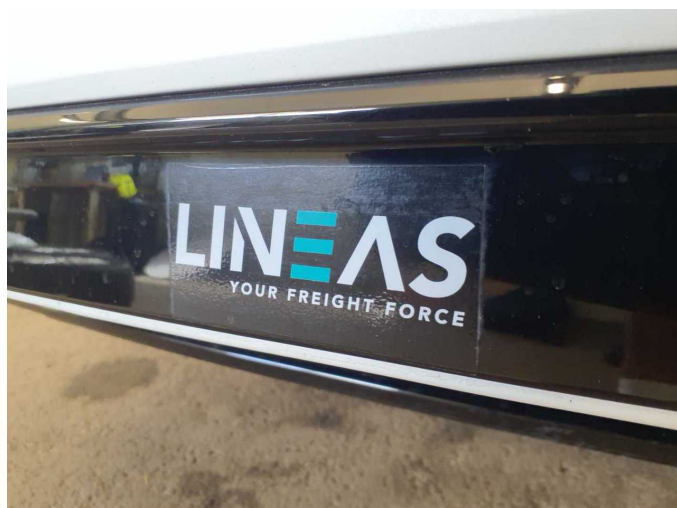
**Damage 1:** Rear bumper: Spoiler - Glued / labelled - De-glue / neutralise

| No. | Component group | Description |
|---|---|---|
| 1 | Rear bumper | Spoiler - Glued / labelled - De-glue / neutralise |

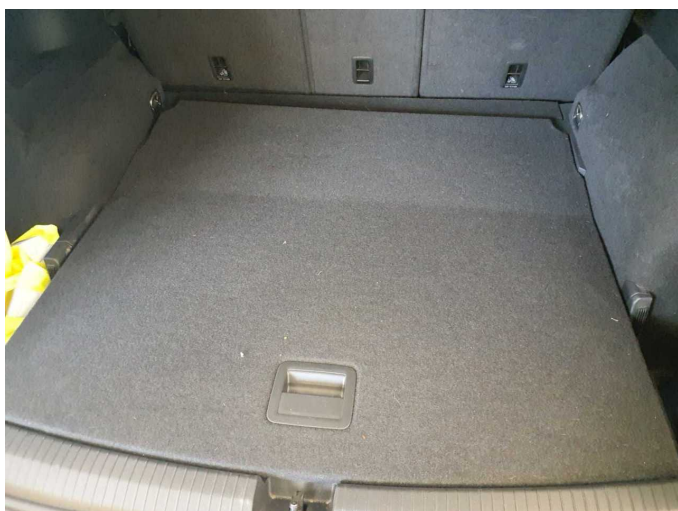
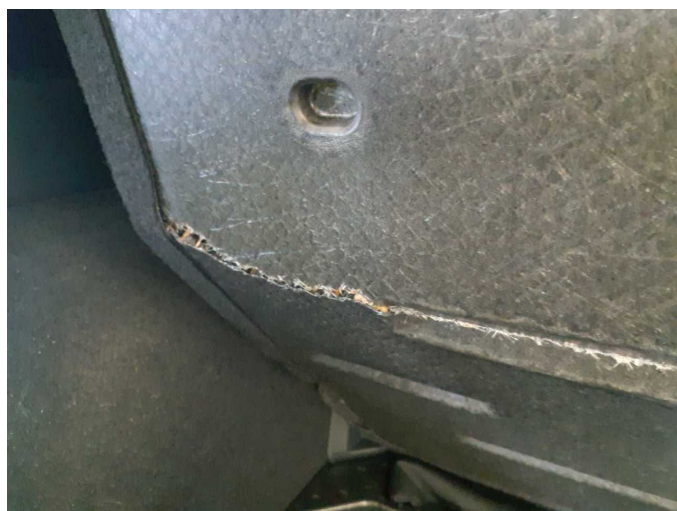
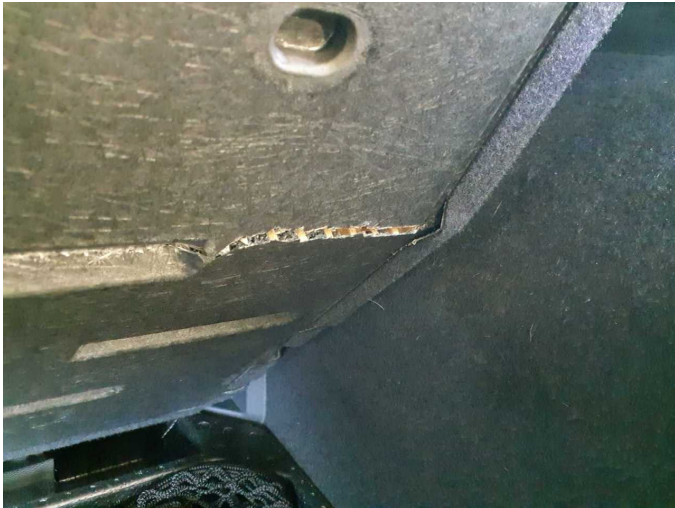
**Damage 2:** Interior: Cargo area floor - Broken / torn - Replace

| No. | Component group | Description |
|---|---|---|
| 2 | Interior | Cargo area floor - Broken / torn - Replace |

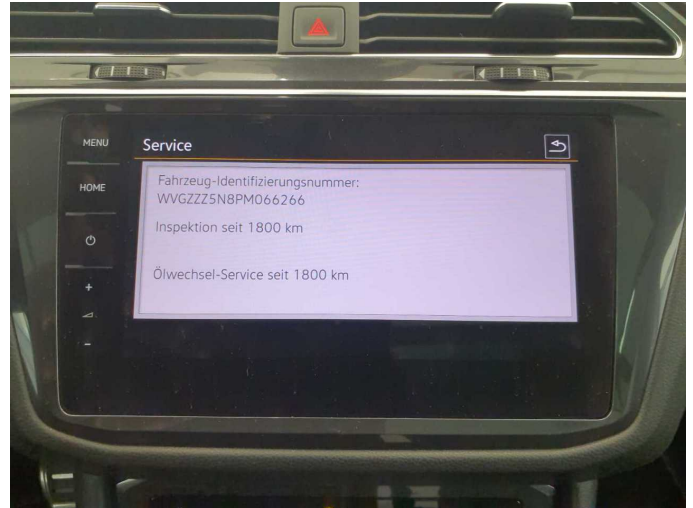
**Damage 3:** Misc.: Inspection / maintenance - Due - Perform

| No. | Component group | Description |
|---|---|---|
| 3 | Misc. | Inspection / maintenance - Due - Perform |

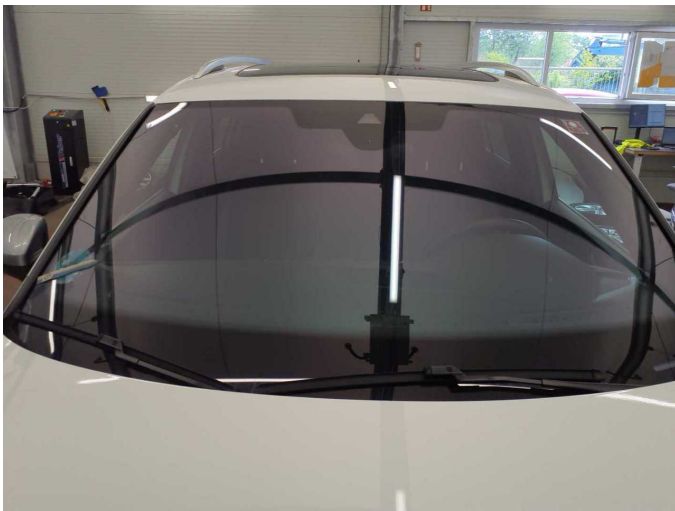
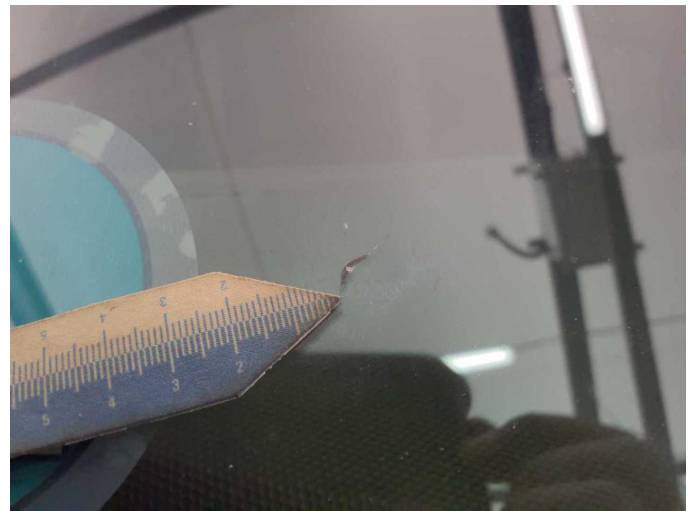
**Damage 4:** Vehicle glazing: Windscreen with lane departure assistant - Broken / torn - Replace

| No. | Component group | Description |
|---|---|---|
| 4 | Vehicle glazing | Windscreen with lane departure assistant - Broken / torn - Replace |
