Expertise

Protocol number: 46850179  
Order No. / Reference: 26734120  
Inspection date: 3 Aug 2026

Manufacturer: Ford

Model: Mondeo Turnier 2.0 EcoBlue Aut. Titanium

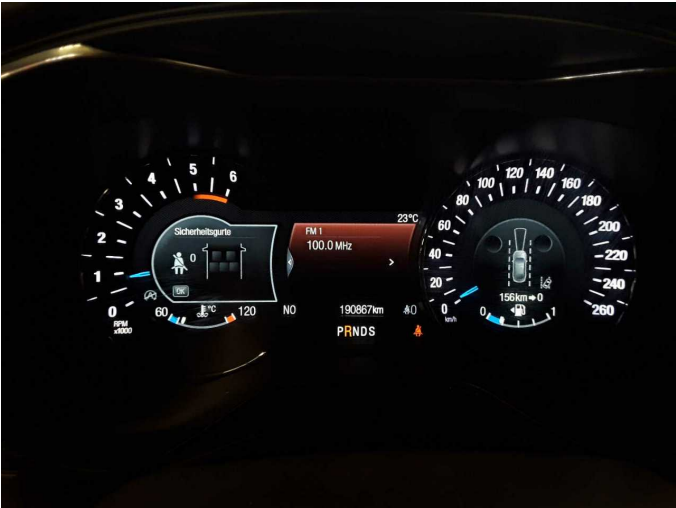
| Vehicle details | |
|---|---|
| Mileage (Read) | 190,867 km |

Figure 7: Instrument cluster

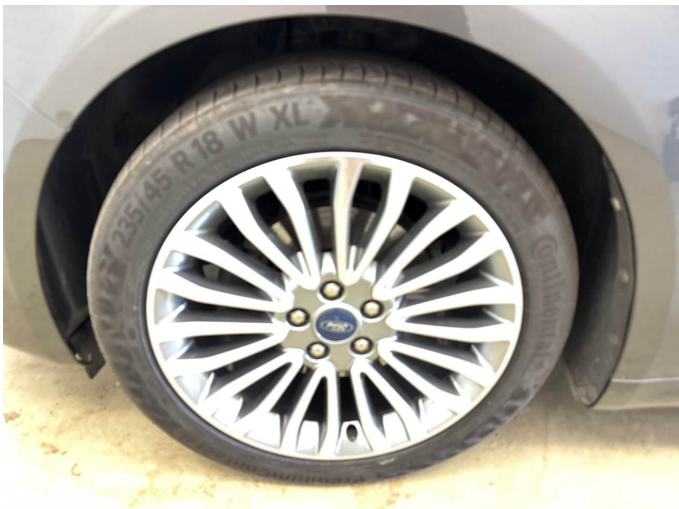
| Mounted tyres | | | | |
|---|---|---|---|---|
| 1) | 235/45 R18 98W | Summer tyres on Light alloy | Continental | 5mm / 5mm |
| 2) | 235/45 R18 98W | Summer tyres on Light alloy | Continental | 6mm / 6mm |

Figure 12: Mounted tyres

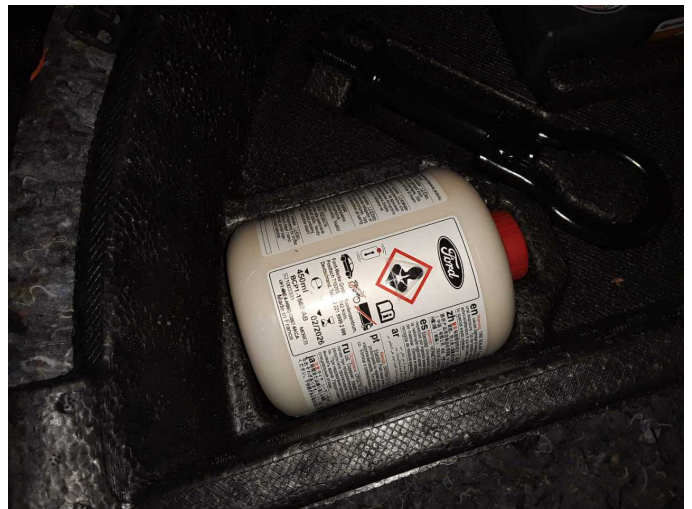
| No. | Component group | Description |
|---|---|---|
| 1 | Equipment | Tirefit filler - Expired - Replace |

Damage 1: Equipment: Tirefit filler - Expired - Replace

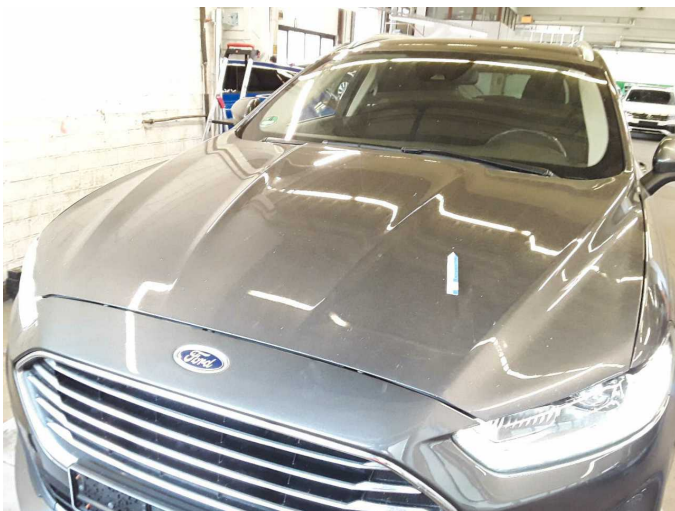
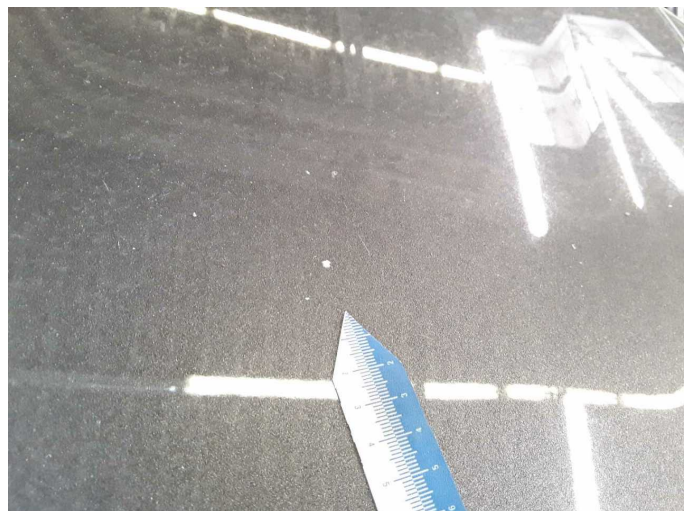
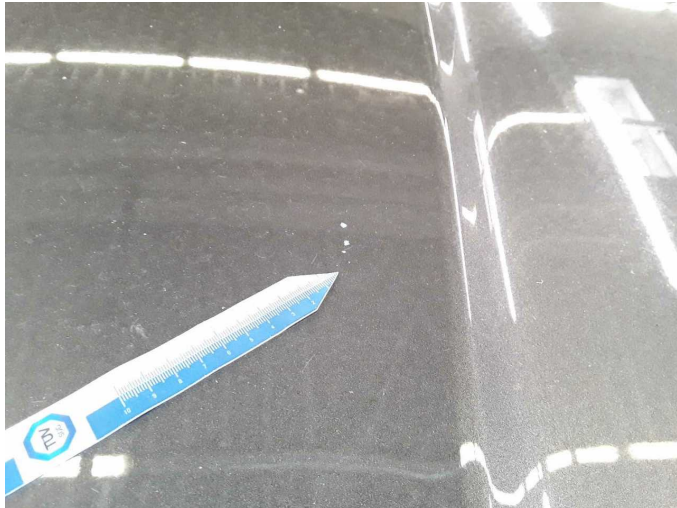
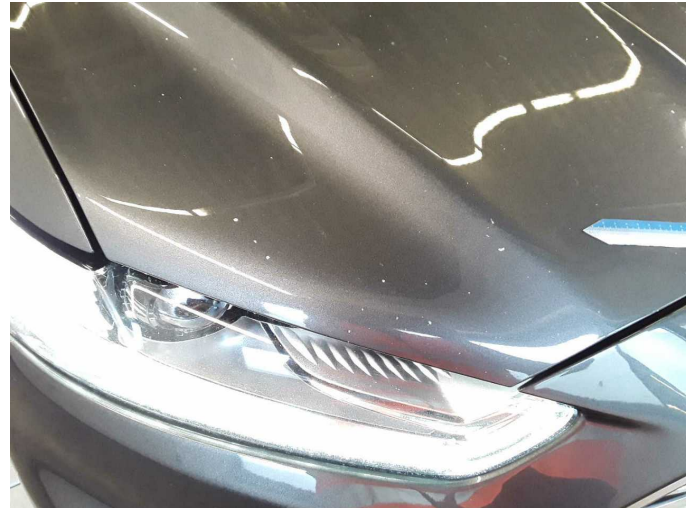
| No. | Component group | Description |
|---|---|---|
| 2 | Bonnet | Bonnet - Stone chips - Paint |

Damage 2: Bonnet: Bonnet - Stone chips - Paint

**Damage 2:** Bonnet: Bonnet - Stone chips - Paint

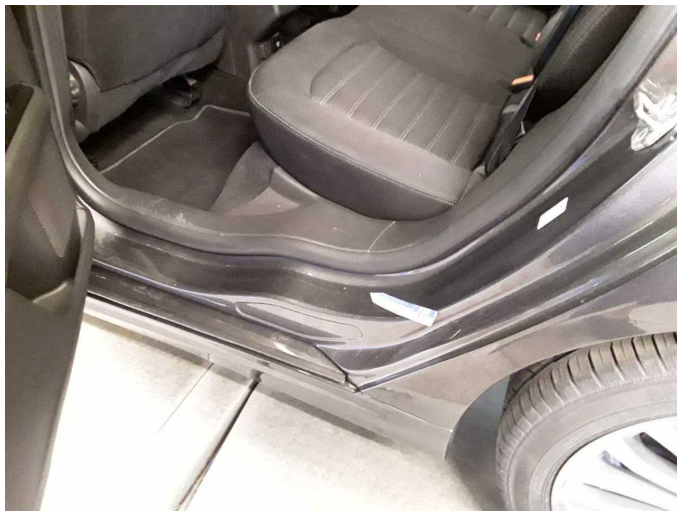
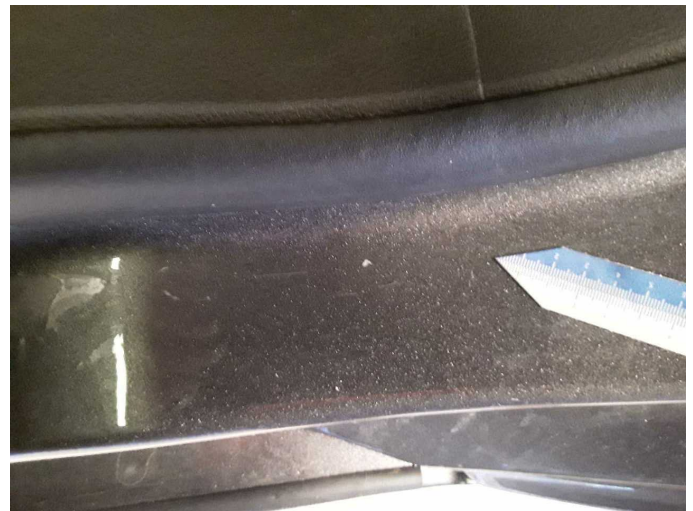
| No. | Component group | Description |
|---|---|---|
| 1 | Side panel - rear left side | Sill - Scratched - No deduction |

**Wear and tear 1:** Side panel - rear left side: Sill - Scratched - No deduction

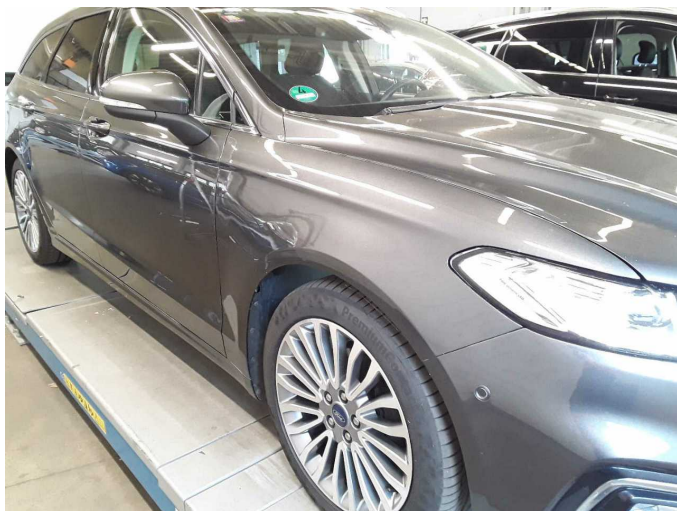
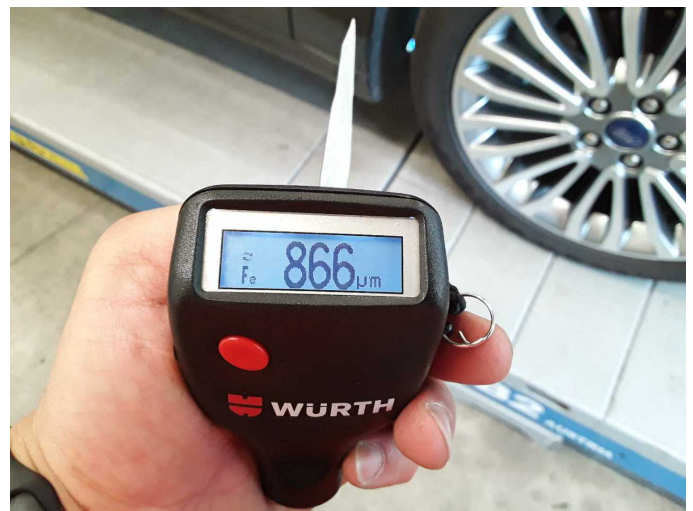
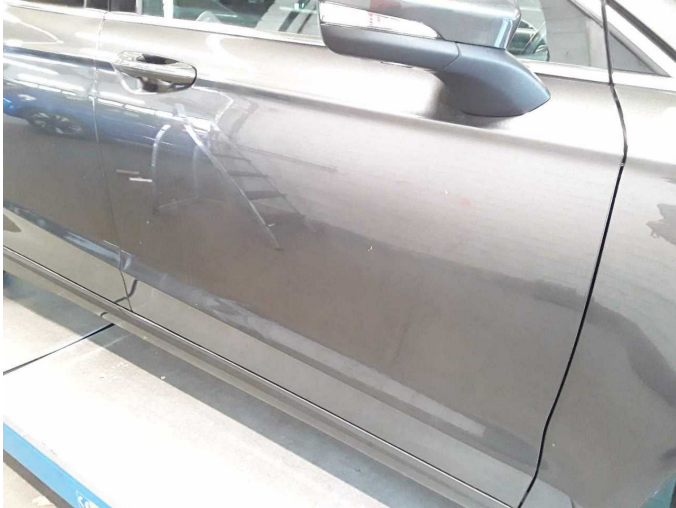
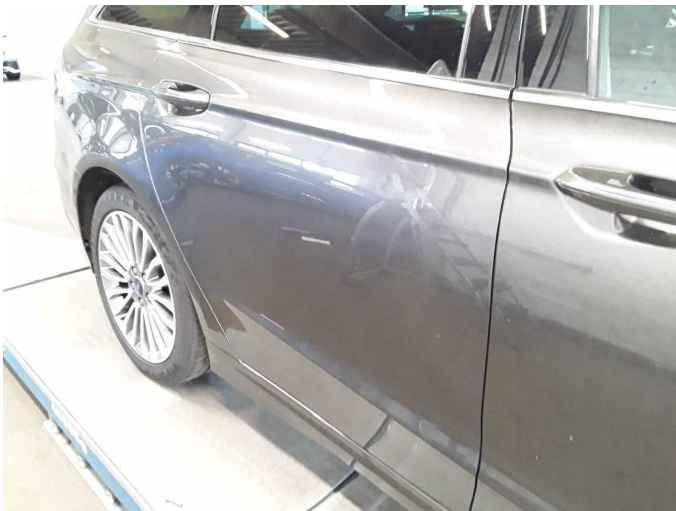
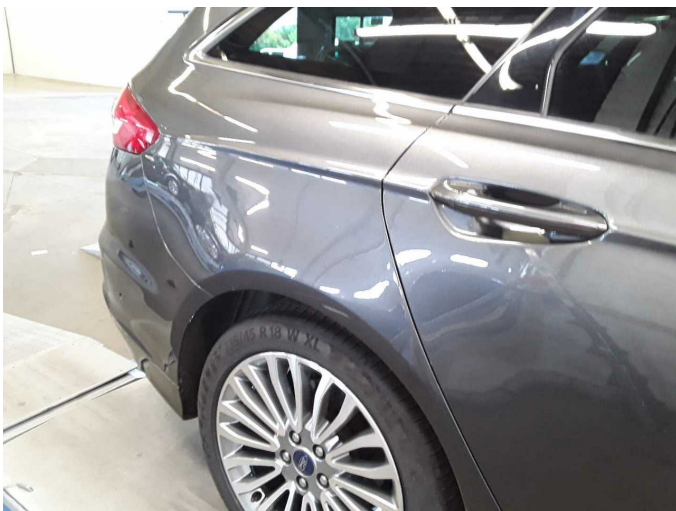
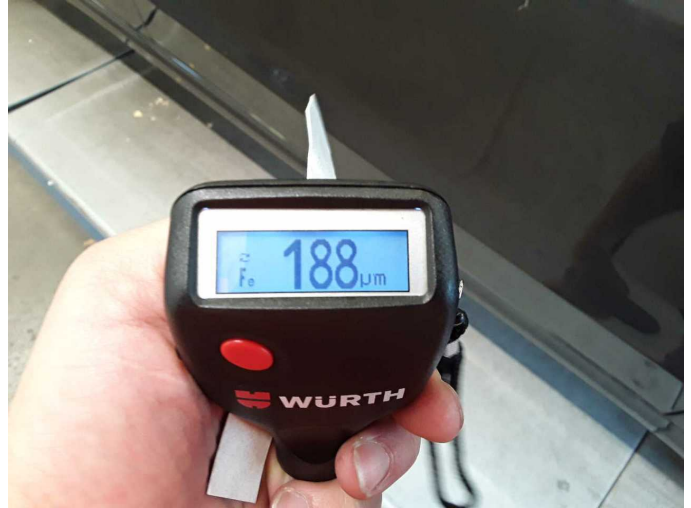
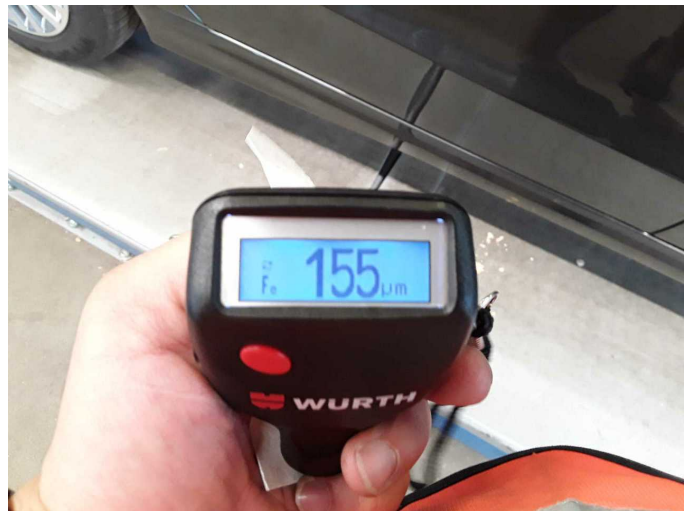
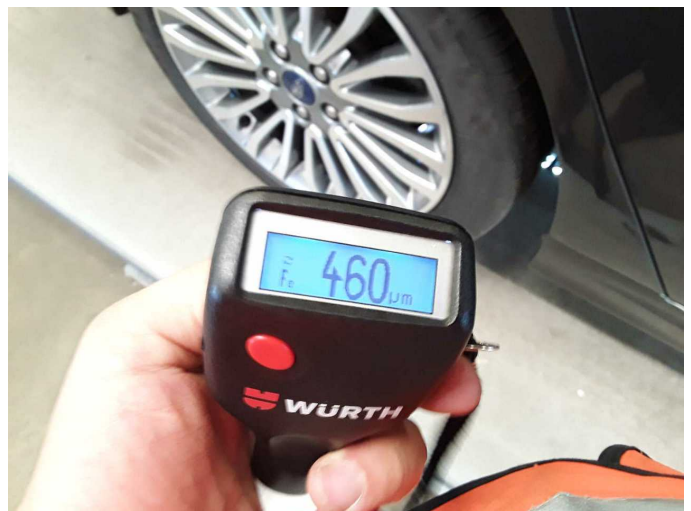
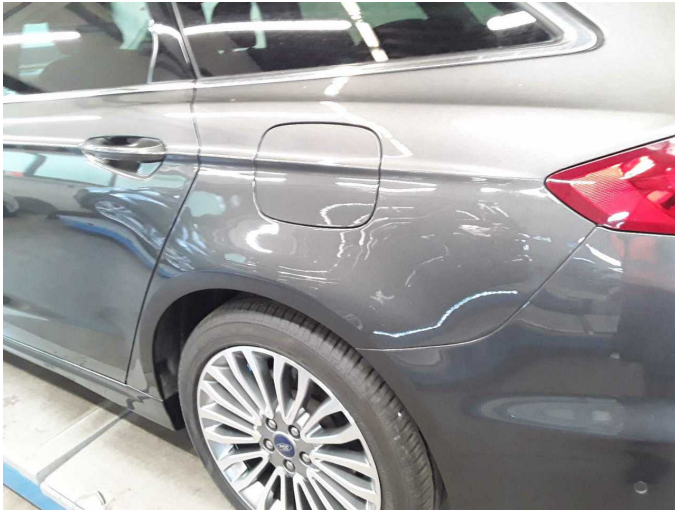
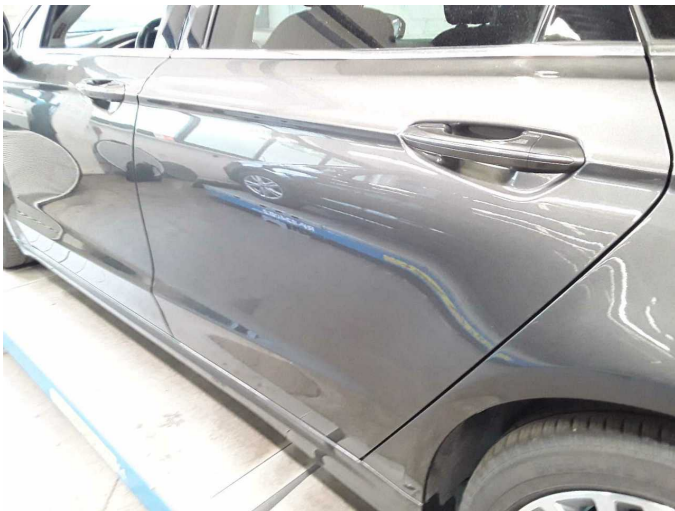
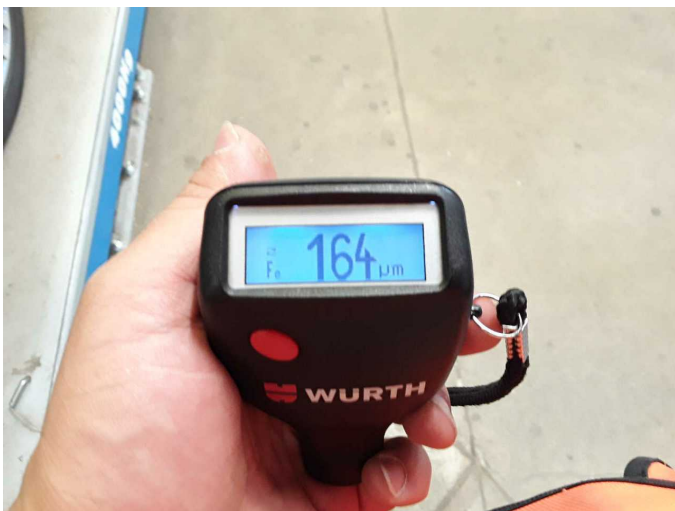
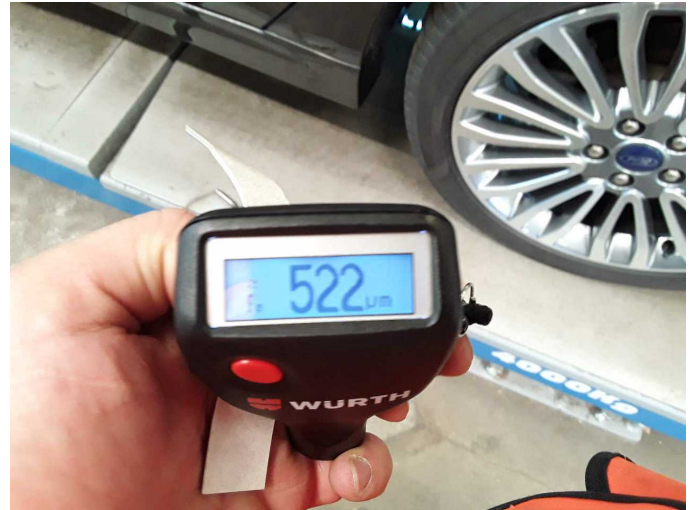
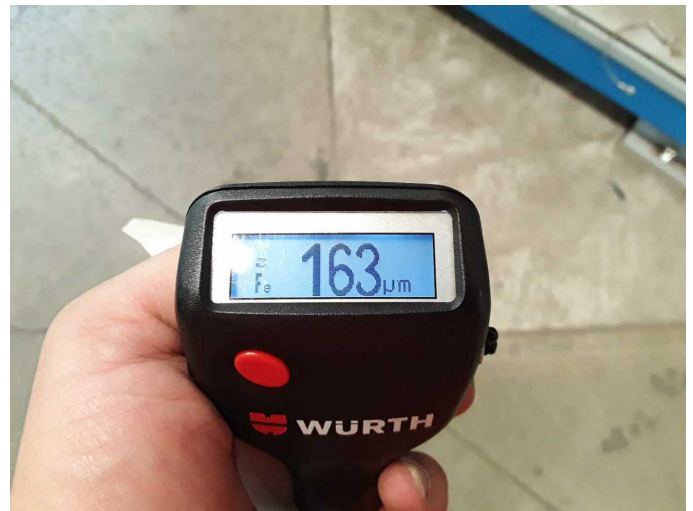
| No. | Repainting |
|---|---|
| 1 | Mudguard - right side, Side panel - rear left side, Side panel - rear right side, Door - rear left side, Door - rear right side, Door - front left side, Door - front right side |

| Mudguard - right side | 881 µm | Side panel - rear left side | 528 µm |
| Side panel - rear right side | 350 µm | Door - rear left side | 157 µm |
| Door - rear right side | 149 µm | Door - front left side | 161 µm |
| Door - front right side | 168 µm | | |

**Repainting 1:** Mudguard - right side, Side panel - rear left side, Side panel - rear right side, Door - rear left side, Door - rear right side, Door - front left side, Door - front right side
