Expertise

Protocol number: 46287599  
Order No. / Reference: 26521319  
Inspection date: 1 Jul 2026

Manufacturer: Volvo

Model: XC40 Recharge 69 kWh Single Motor Ultimate

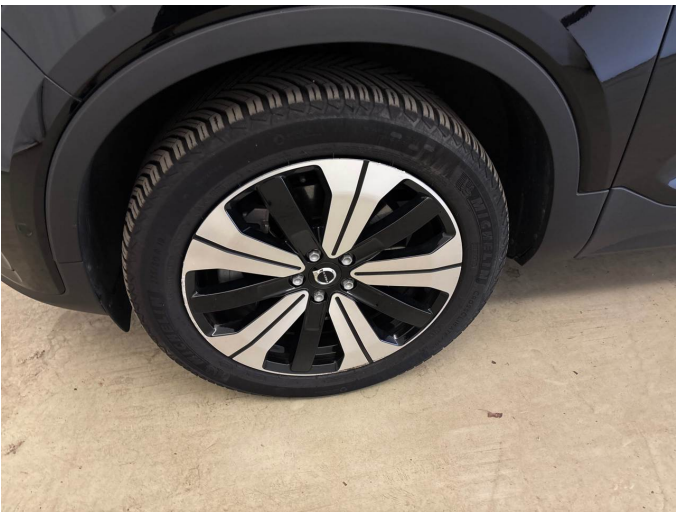
Figure 11: Mounted tyres

| # | Tyre size | Type of tyre | Manufacturer | Tread depth |
|---|---|---|---|---|
| 1) | 235/50 R19 103H | All-season tyres on Light alloy | Michelin | 5mm / 5mm |
| 2) | 235/50 R19 103H | All-season tyres on Light alloy | Michelin | 5mm / 5mm |

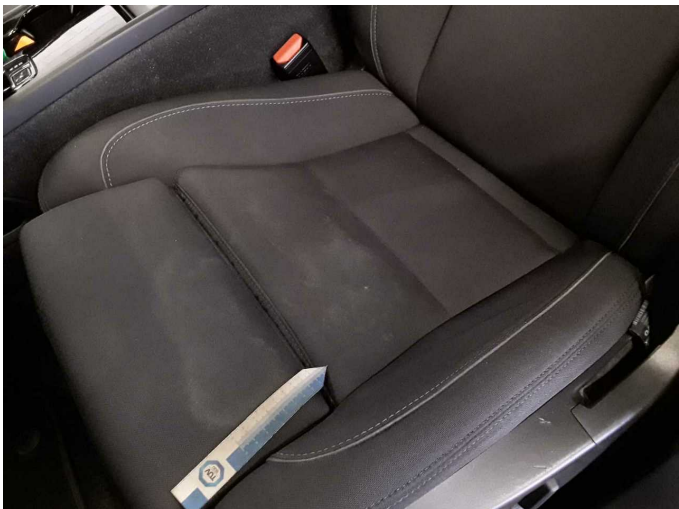
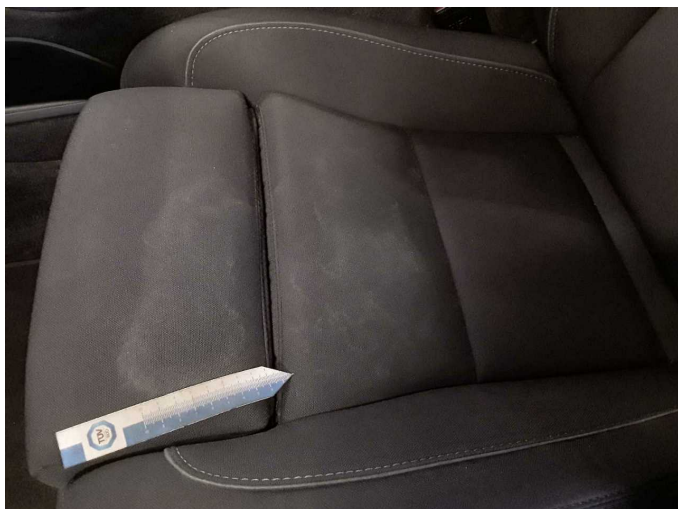
| No. | Component group | Description |
|---|---|---|
| 1 | Seat - front | Seat cover - left side - Soiled - Clean |

Damage 1: Seat - front: Seat cover - left side - Soiled - Clean

**Damage 1:** Seat - front: Seat cover - left side - Soiled - Clean

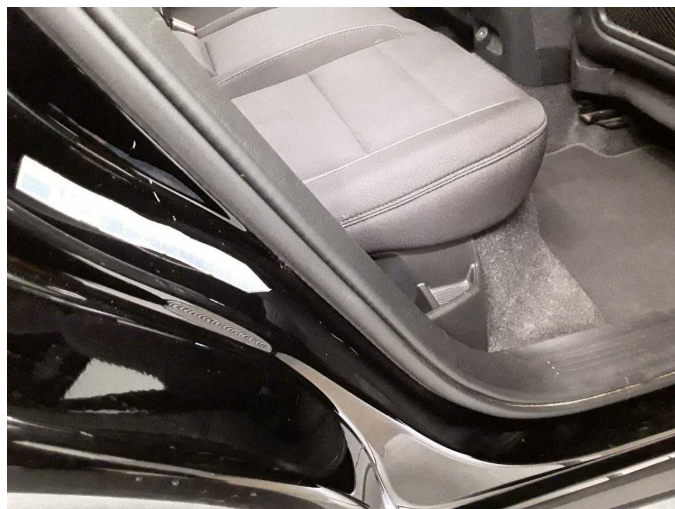
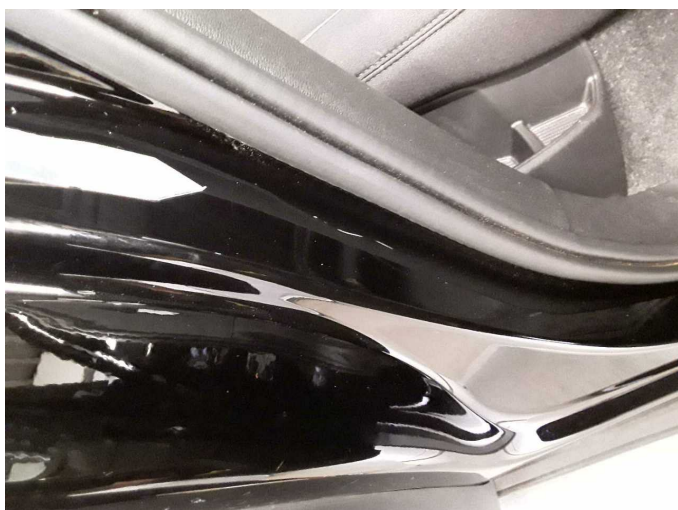
| No. | Component group | Description |
|---|---|---|
| 2 | Side panel - rear right side | Sill - Scratch(es) - Smart repair |

**Damage 2:** Side panel - rear right side: Sill - Scratch(es) - Smart repair

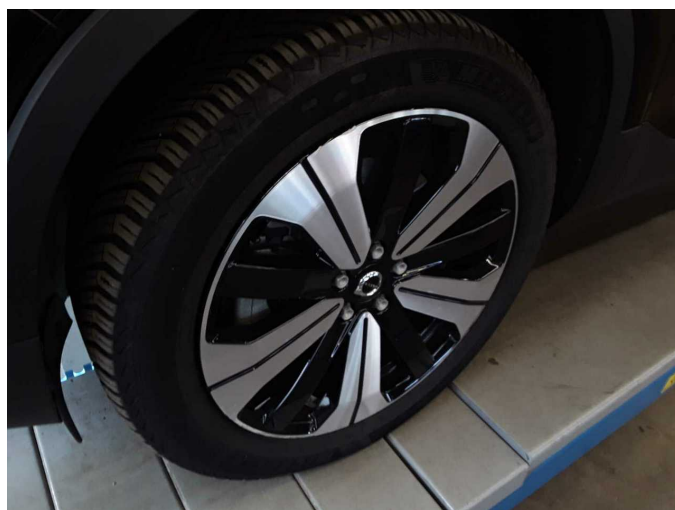
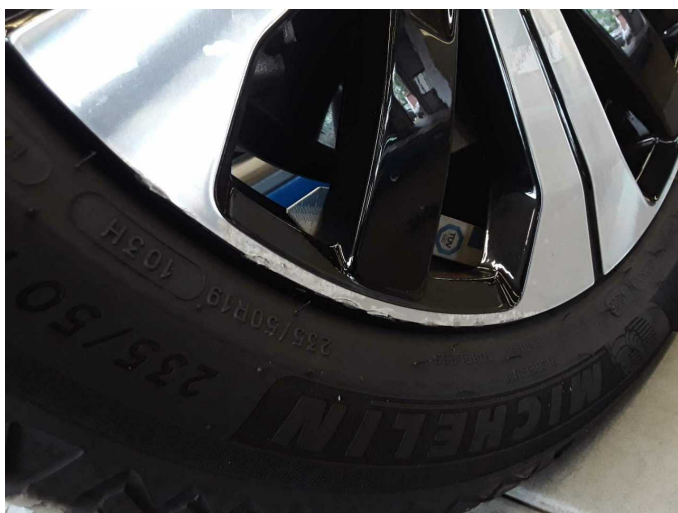
| No. | Component group | Description |
|---|---|---|
| 3 | Wheel / tyres | Alloy rim - front left side - Scratched - Loss in value |

**Damage 3:** Wheel / tyres: Alloy rim - front left side - Scratched - Loss in value

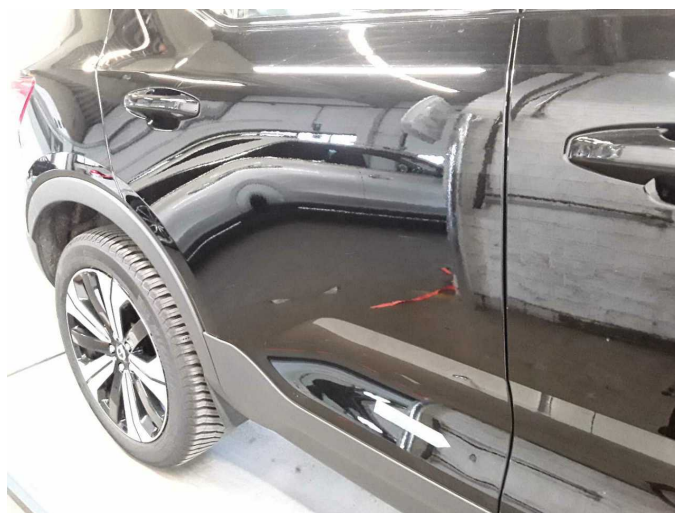
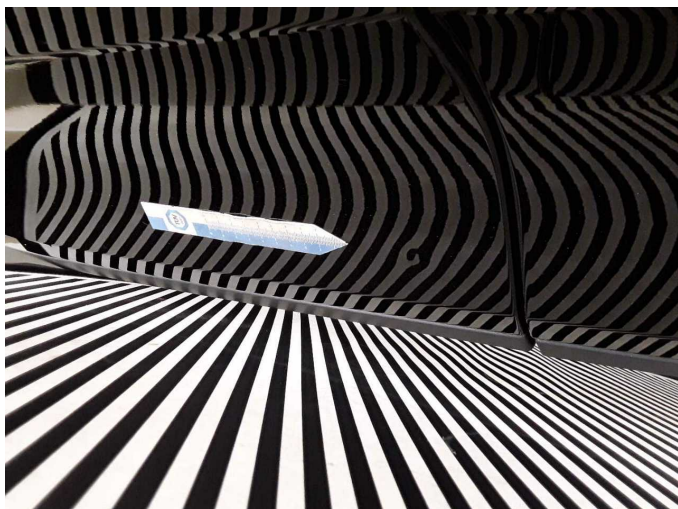
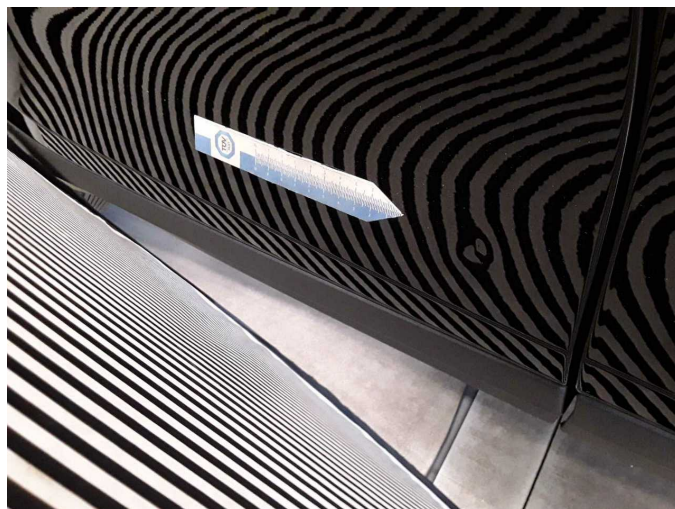
| No. | Component group | Description |
|---|---|---|
| 4 | Door - rear right side | Door - Deformed - Repair and paint |

**Damage 4:** Door - rear right side: Door - Deformed - Repair and paint

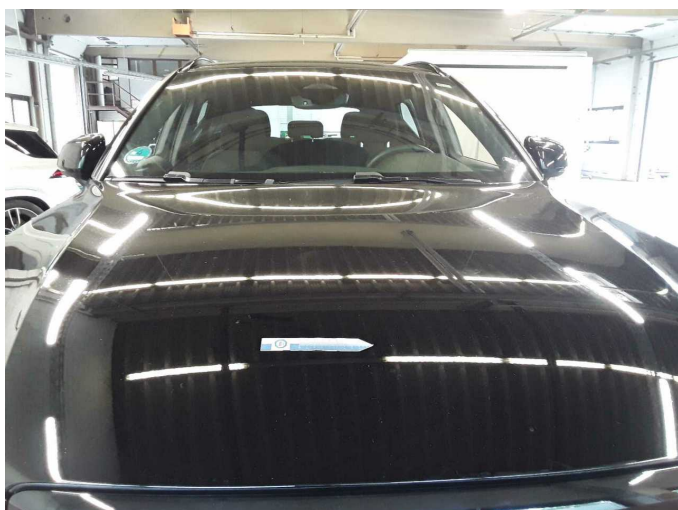
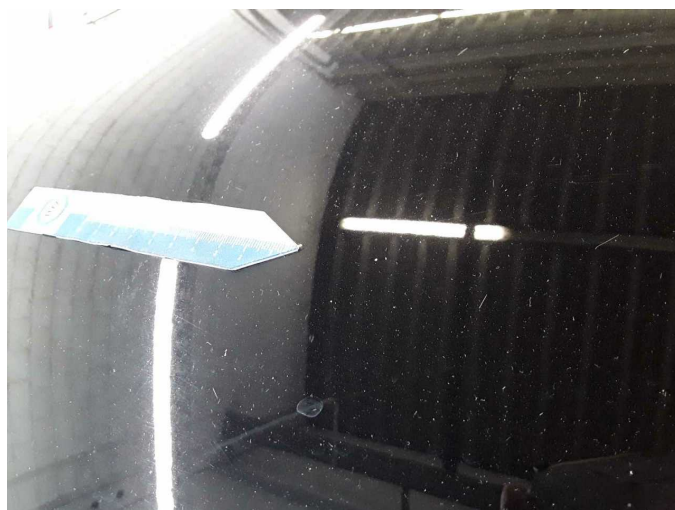
| No. | Component group | Description |
|---|---|---|
| 1 | Bonnet | Bonnet - Stone chips - No deduction |

**Wear and tear 1:** Bonnet: Bonnet - Stone chips - No deduction

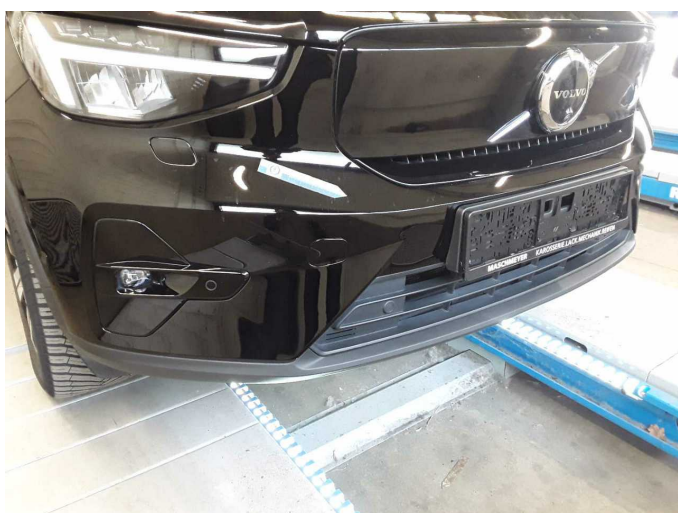
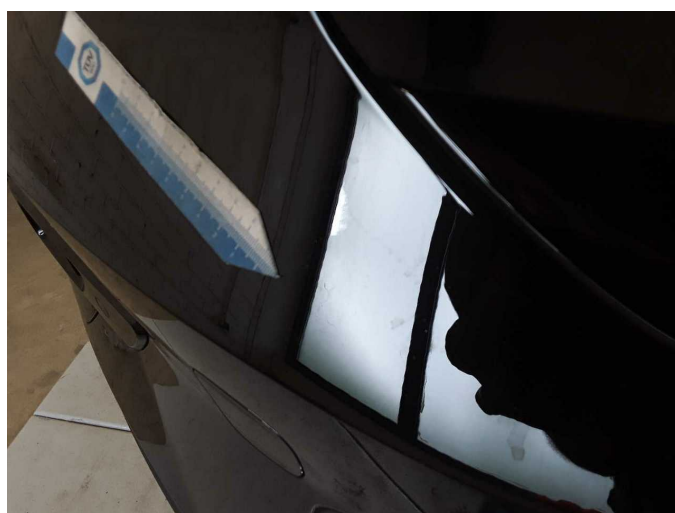
| No. | Component group | Description |
|---|---|---|
| 2 | Front bumper | Front bumper - Stone chips - No deduction |

**Wear and tear 2:** Front bumper: Front bumper - Stone chips - No deduction

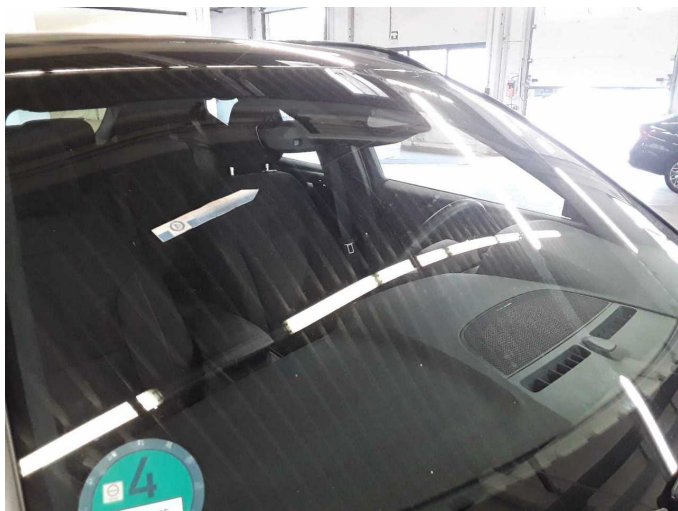
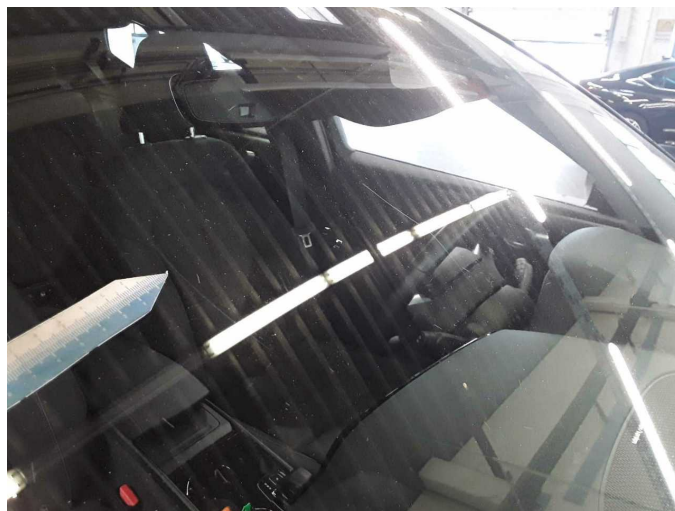
| No. | Component group | Description |
|---|---|---|
| 3 | Vehicle glazing | Windscreen - Stone chips - No deduction |

**Wear and tear 3:** Vehicle glazing: Windscreen - Stone chips - No deduction

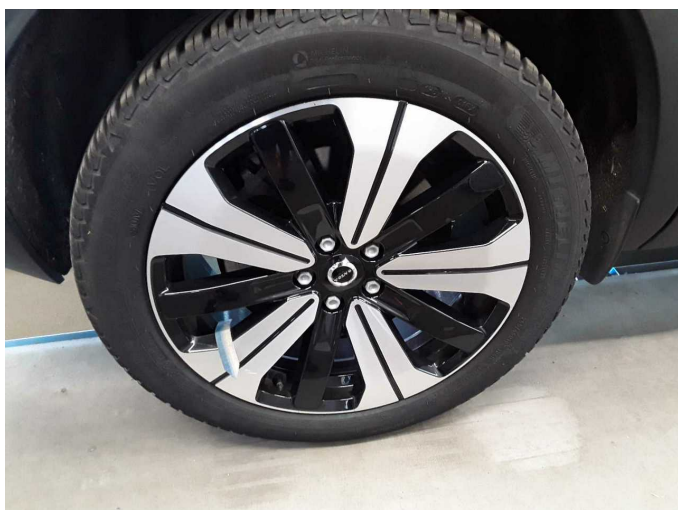
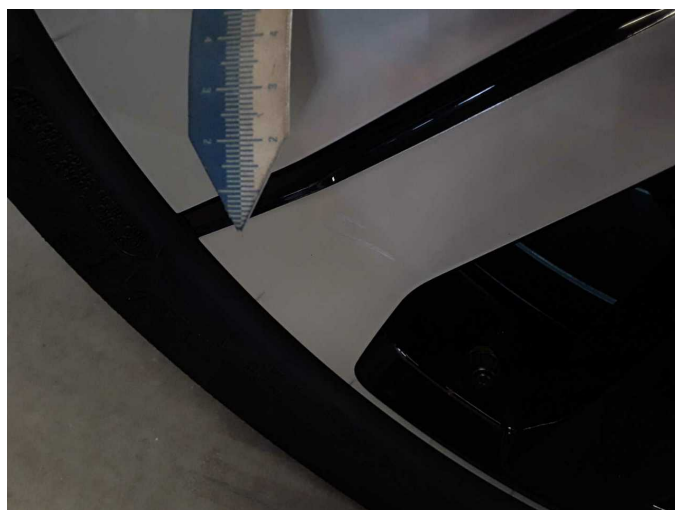
| No. | Component group | Description |
|---|---|---|
| 4 | Wheel / tyres | Alloy rim - rear right side - Scratch(es) - No deduction |

**Wear and tear 4:** Wheel / tyres: Alloy rim - rear right side - Scratch(es) - No deduction

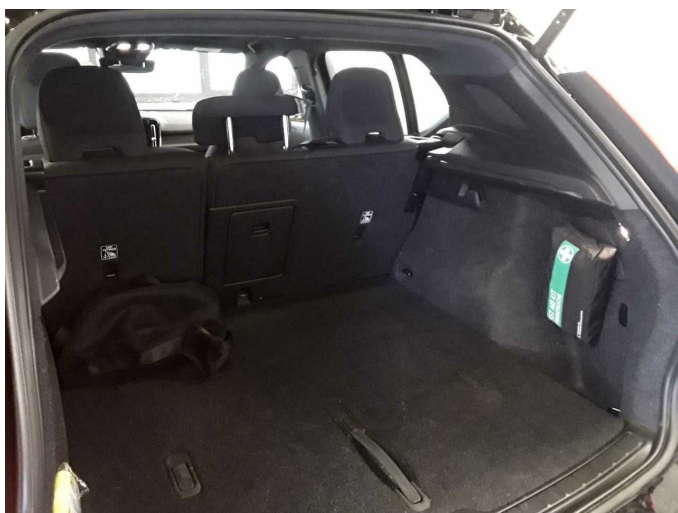
Interior - Rear shelf

**Missing part 1:** Interior: Rear shelf - Missing - Replace
