Expertise

Protocol number: 45902325  
Order No. / Reference: 26325627  
Inspection date: 11 Jun 2026

Manufacturer: Mercedes-Benz  
VIN: W1KAH0EB1RF153722

Model: C 220 d T 9G-TRONIC Avantgarde Advanced

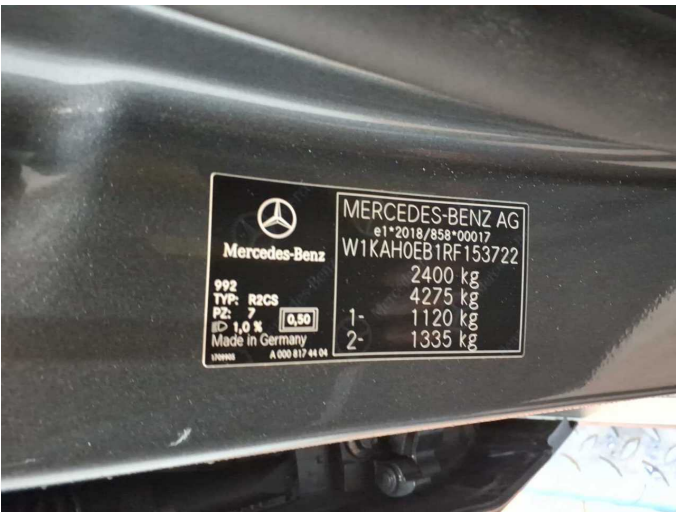
Figure 11: VIN

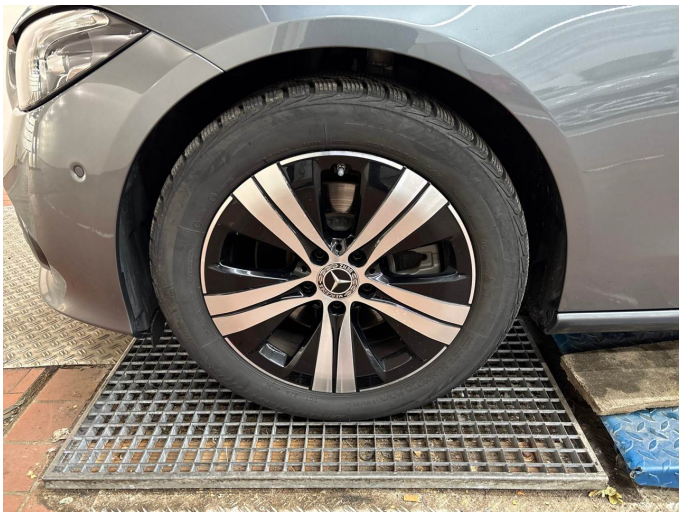
Figure 12: Mounted tyres

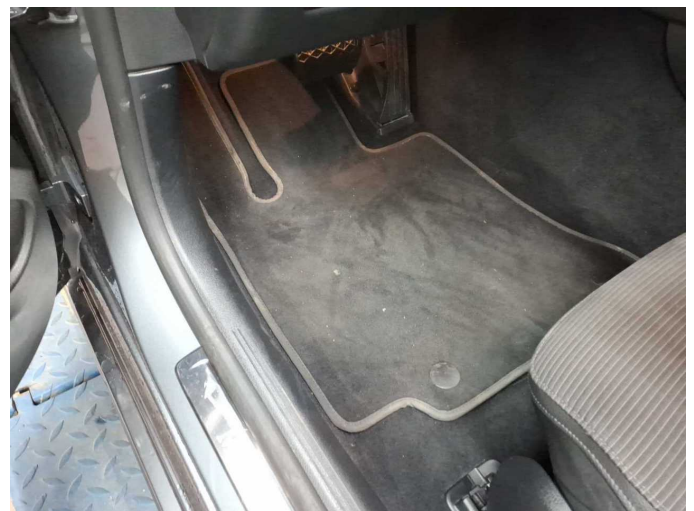
**Damage 1:** Trim / covers: Floor mats - Burn hole (cigarettes) - Replace

| No. | Component group | Description |
|---|---|---|
| 1 | Trim / covers | Floor mats - Burn hole (cigarettes) - Replace |

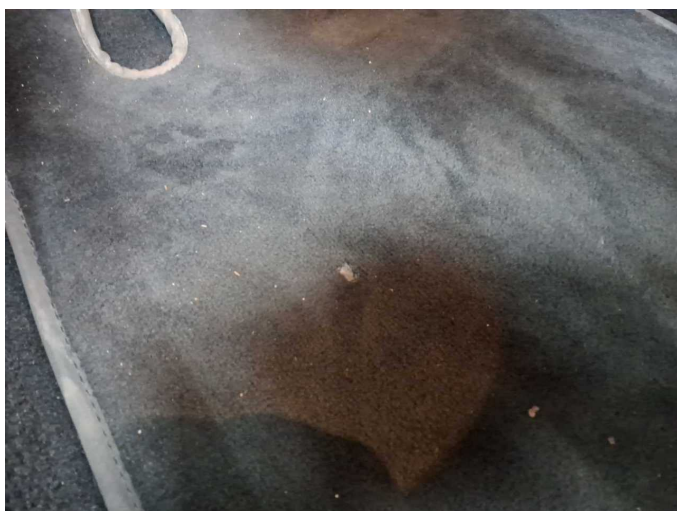
**Damage 1:** Trim / covers: Floor mats - Burn hole (cigarettes) - Replace

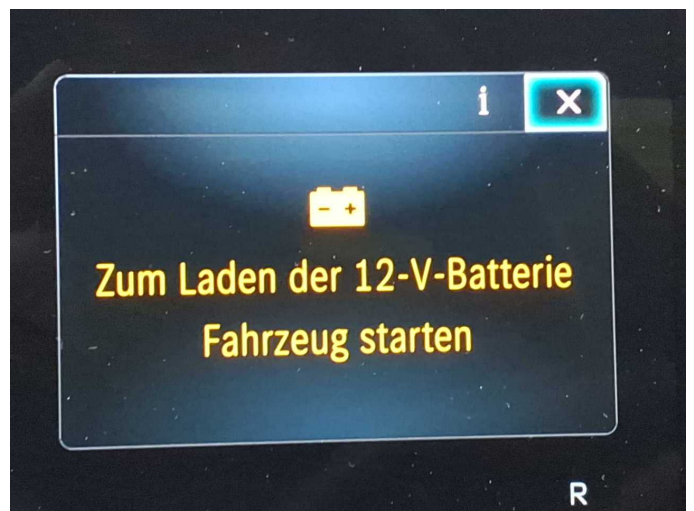
**Damage 2:** Electrical system: Battery - Empty - Perform diagnosis

| No. | Component group | Description |
|---|---|---|
| 2 | Electrical system | Battery - Empty - Perform diagnosis |

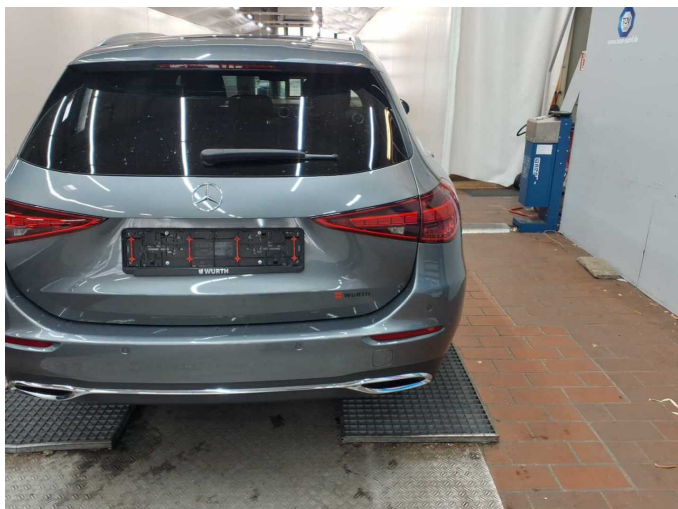
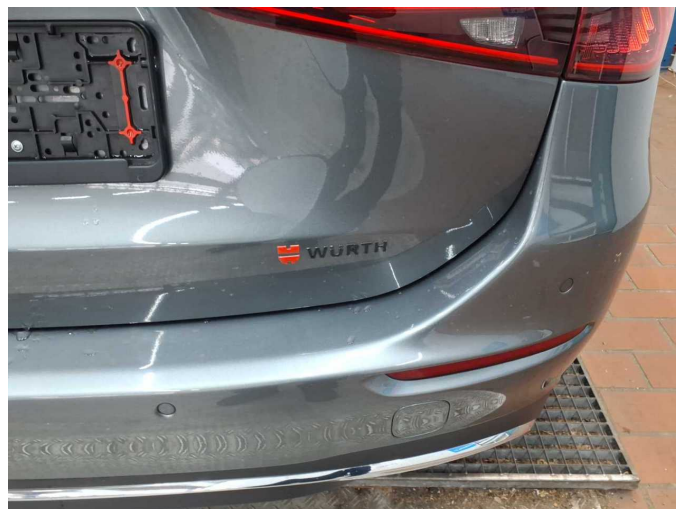
**Damage 4:** Boot lid / rear door: Boot lid - Glued / labelled - De-glue / neutralise

| No. | Component group | Description |
|---|---|---|
| 4 | Boot lid / rear door | Boot lid - Glued / labelled - De-glue / neutralise |

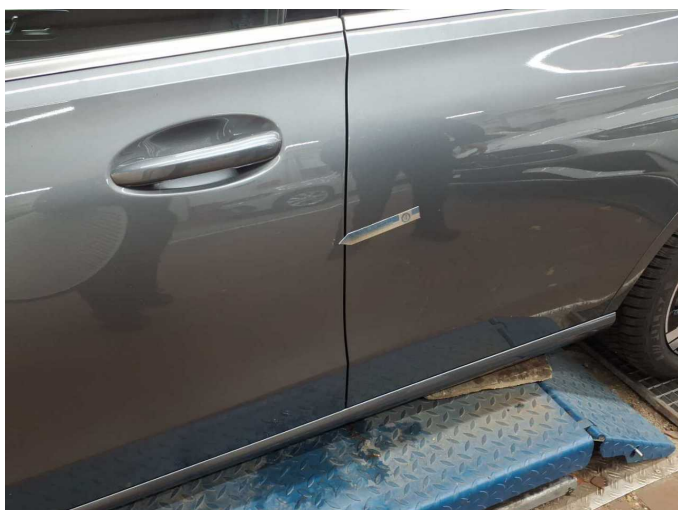
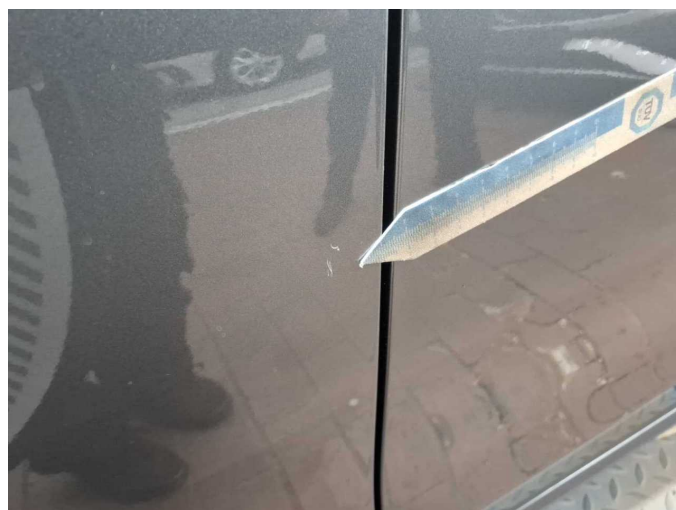
**Damage 5:** Door - front left side: Door - Scratch(es) - Smart repair

| No. | Component group | Description |
|---|---|---|
| 5 | Door - front left side | Door - Scratch(es) - Smart repair |

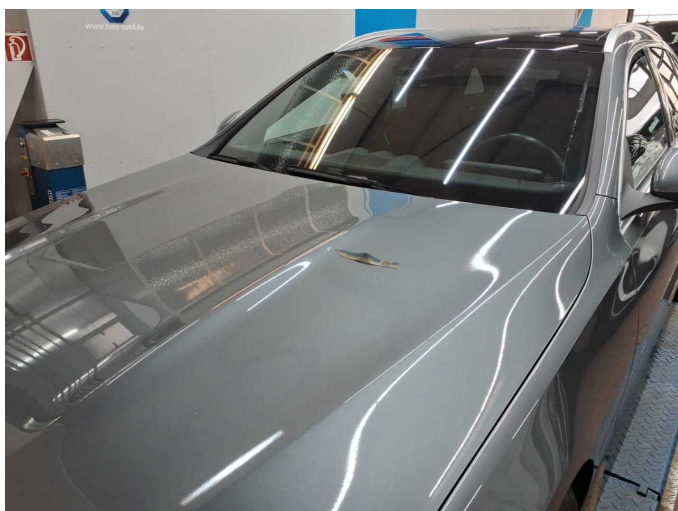
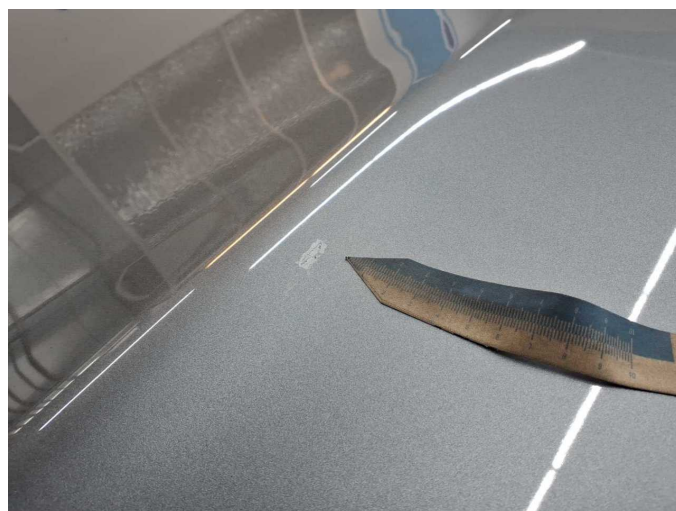
**Damage 6:** Bonnet: Bonnet - Scratch(es) - Paint

| No. | Component group | Description |
|---|---|---|
| 6 | Bonnet | Bonnet - Scratch(es) - Paint |

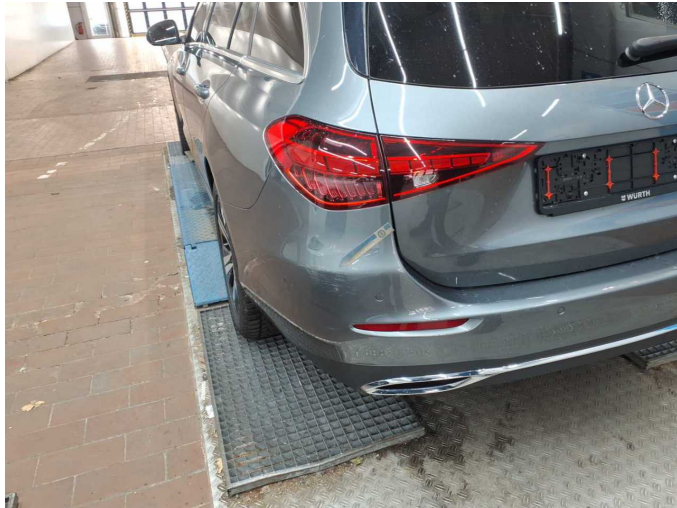
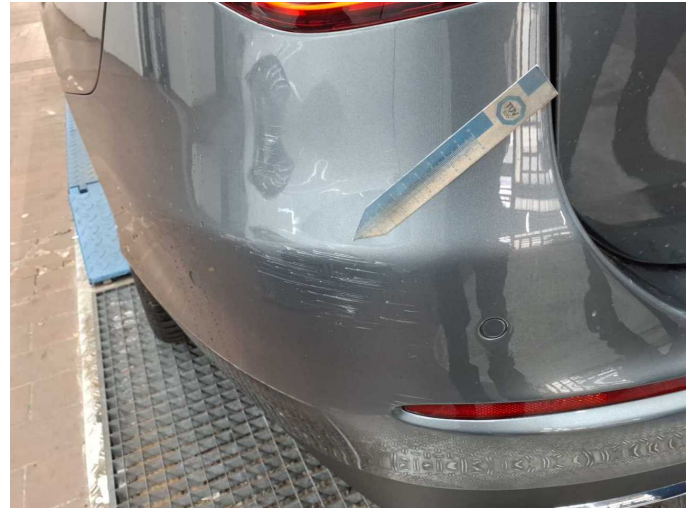
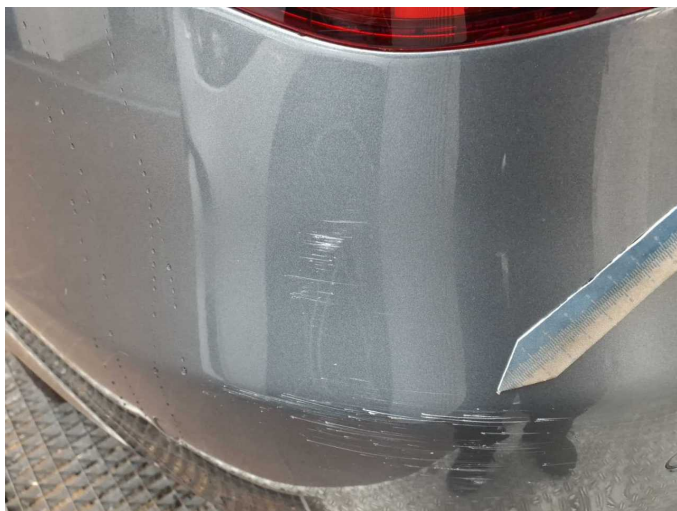
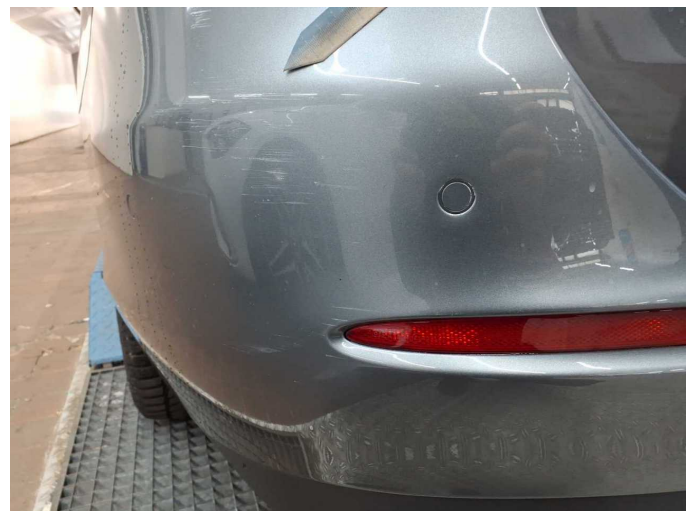
**Damage 7:** Rear bumper: Rear bumper - Scratch(es) - Paint

| No. | Component group | Description |
|---|---|---|
| 7 | Rear bumper | Rear bumper - Scratch(es) - Paint |
