Expertise

Protocol number: 47164498  
Order No. / Reference: 26755040  
Inspection date: 20 Aug 2026

Manufacturer: Land Rover

Model: Range Rover Evoque P300e R-Dynamic SE

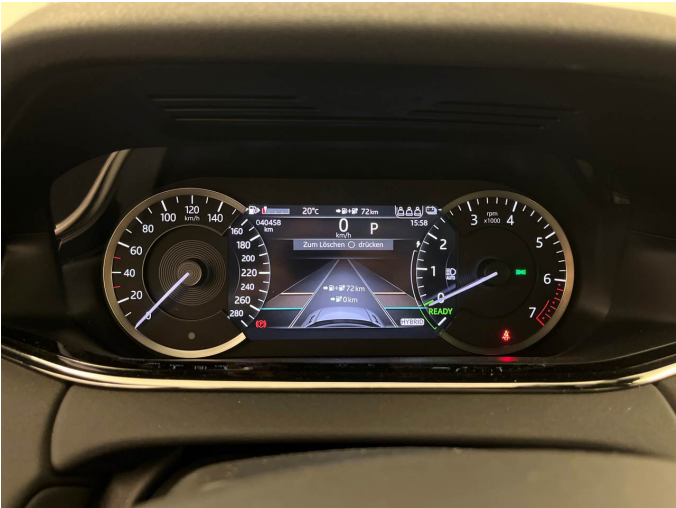
Figure 7: Instrument cluster

| Vehicle details | |
|---|---|
| Mileage (Read) | 40,458 km |

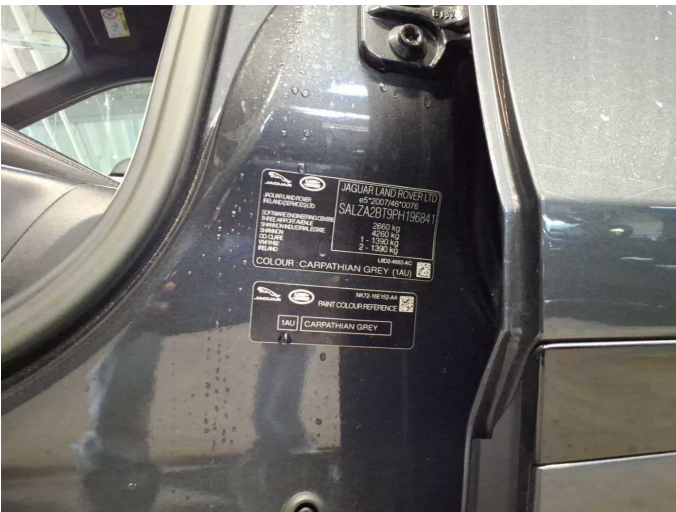
Figure 11: VIN

| VIN comparison | The vehicle identification number (VIN) was read from the vehicle and its conformity with the submitted documents was confirmed by the undersigned during the inspection. |

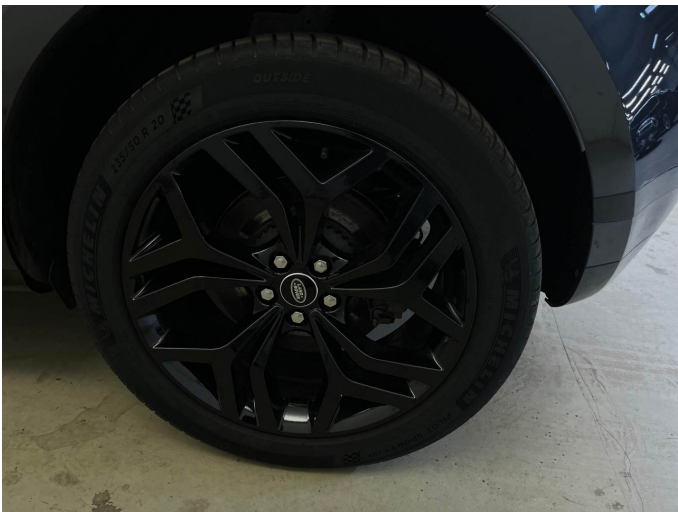
Figure 12: Mounted tyres

| Tyres | | | | |
|---|---|---|---|---|
| 1) | 235/50 R20 104Y | Summer tyres on Light alloy | Michelin | 6mm / 6mm |
| 2) | 235/50 R20 104Y | Summer tyres on Light alloy | Michelin | 6mm / 6mm |

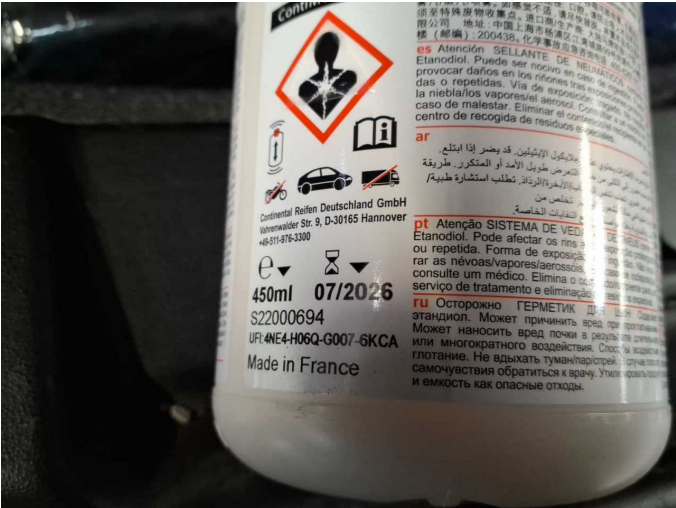
Damage 1: Equipment: Tirefit filler - Expired - Replace

| No. | Component group | Description |
|---|---|---|
| 1 | Equipment | Tirefit filler - Expired - Replace |

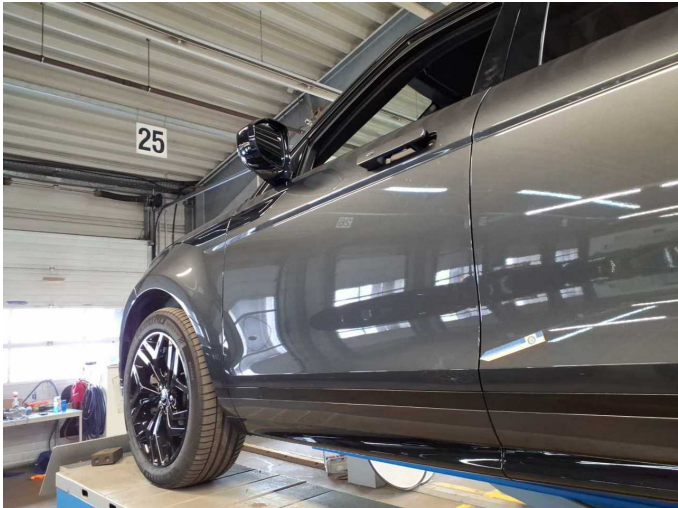
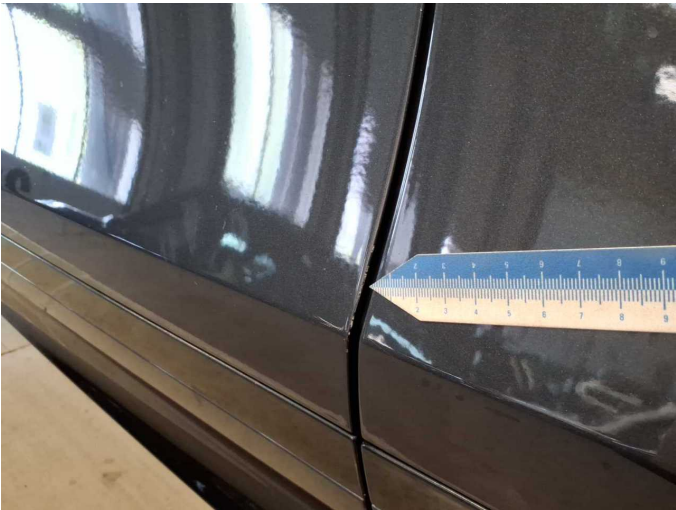
Damage 2: Door - front left side: Door edge - Scratch(es) - Smart repair

| No. | Component group | Description |
|---|---|---|
| 2 | Door - front left side | Door edge - Scratch(es) - Smart repair |

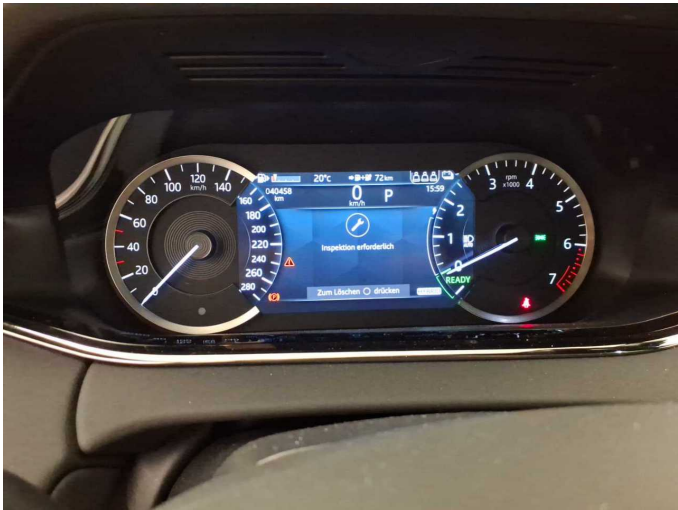
Damage 3: Misc.: Inspection / maintenance - Due - Perform

| No. | Component group | Description |
|---|---|---|
| 3 | Misc. | Inspection / maintenance - Due - Perform |
