Expertise

Protocol number: 45945213
Order No. / Reference: 26479198
Inspection date: 15 Jun 2026

Model: Kodiaq 2.0 TDI DSG Tour

VIN: TMBJJ7NS9P8037841

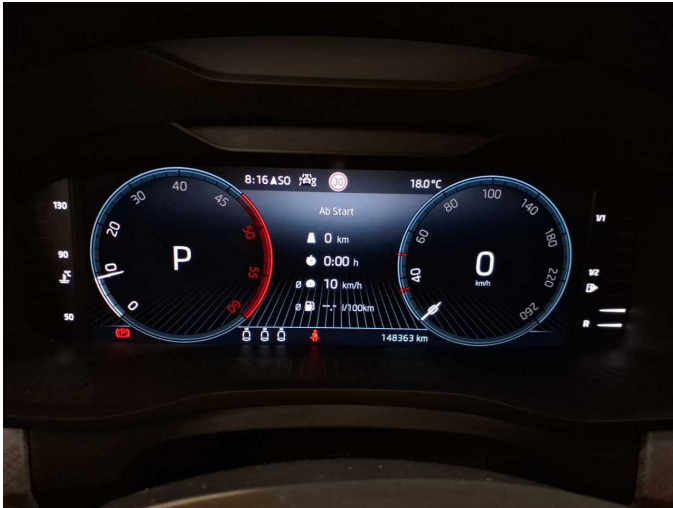
Figure 7: Instrument cluster

Mileage (Read) 148,363 km

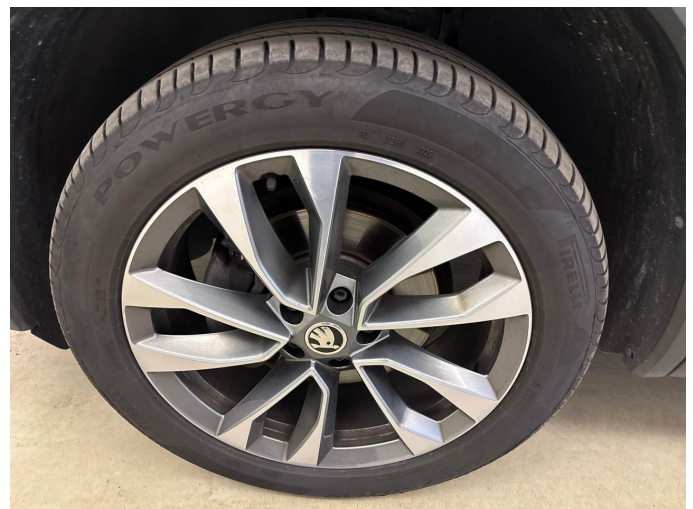
Figure 12: Mounted tyres

#	Tyre size	Type of tyre	Manufacturer	Tread depth
1)	235/50 R19 99V	Summer tyres on Light alloy	Pirelli	5mm / 5mm
2)	235/50 R19 99V	Summer tyres on Light alloy	Pirelli	5mm / 5mm

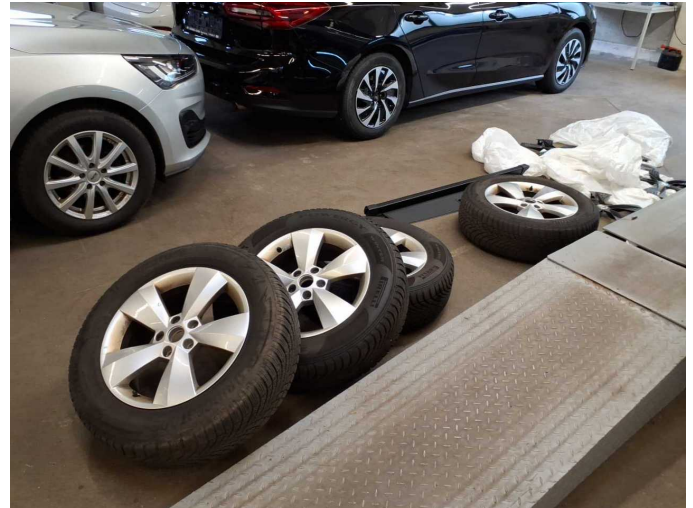
Figure 14: Additional tyres

#	Tyre size	Type of tyre	Manufacturer	Tread depth
1)	215/65 R17 103H	Winter tyres on Light alloy	Bridgestone	5mm / 5mm
2)	215/65 R17 103H	Winter tyres on Light alloy	Pirelli	6mm / 6mm

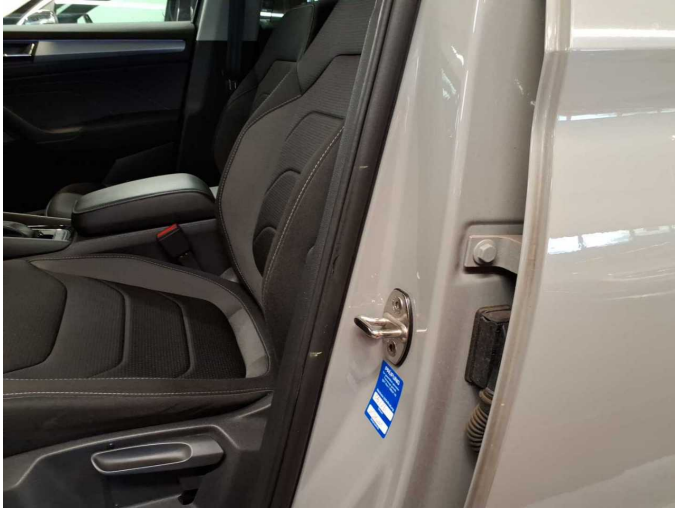
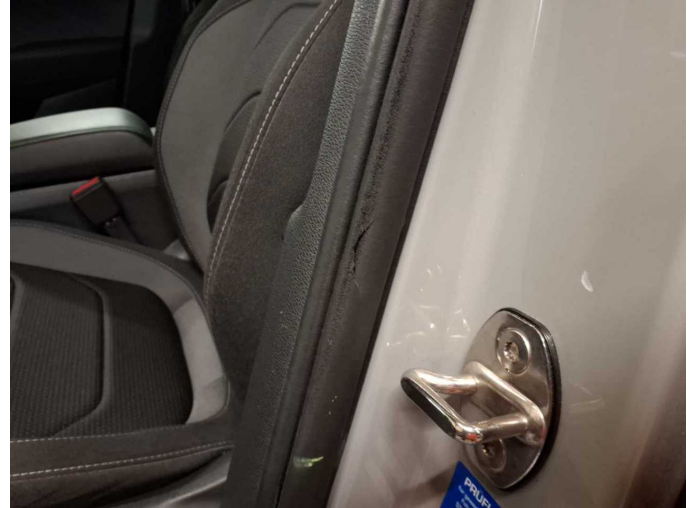
Damage 1: Door - front left side: Door seal - Broken / torn - Replace

No.	Component group	Description
1	Door - front left side	Door seal - Broken / torn - Replace
2	Door - rear right side	Brightware - lower - Scratch(es) - Replace
3	Bonnet	Bonnet - Corrosion - Paint

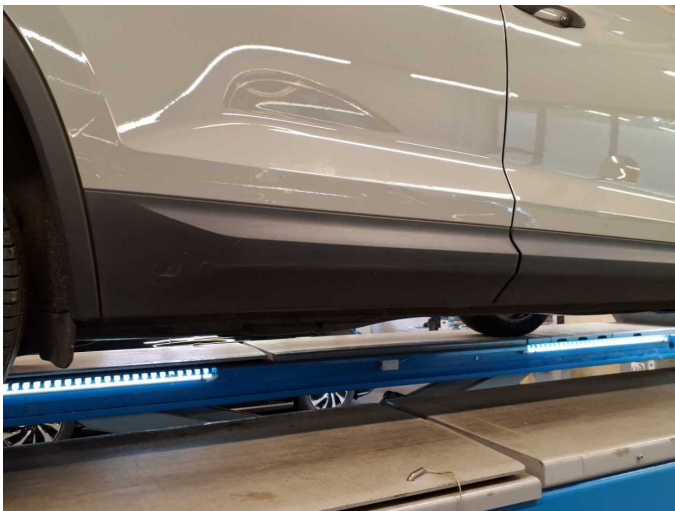
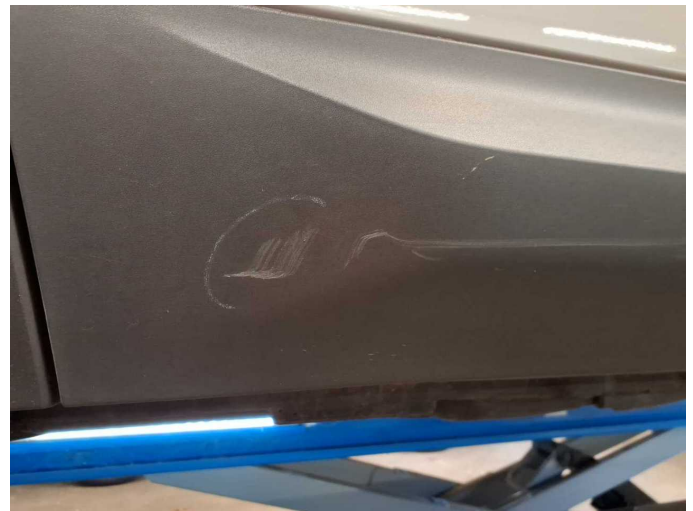
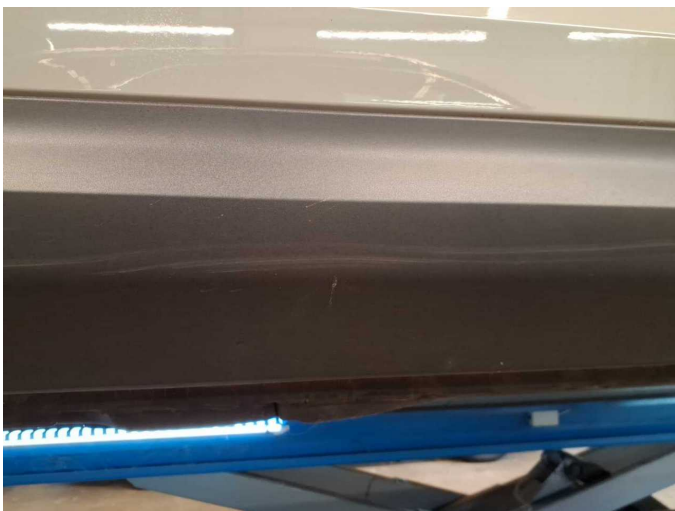
Damage 2: Door - rear right side: Brightware - lower - Scratch(es) - Replace

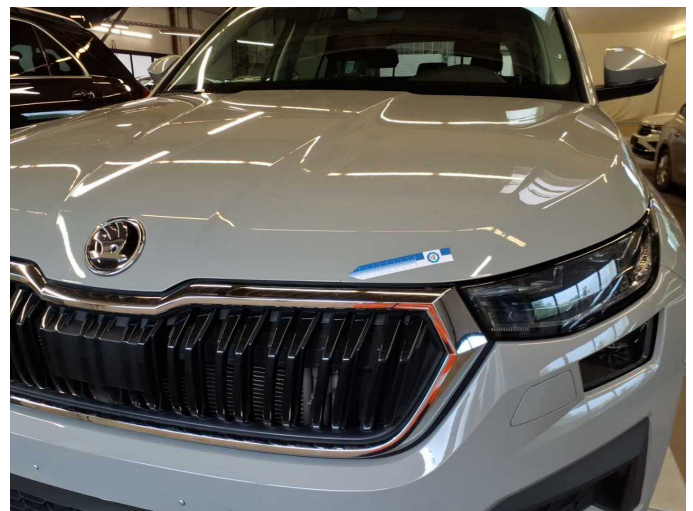
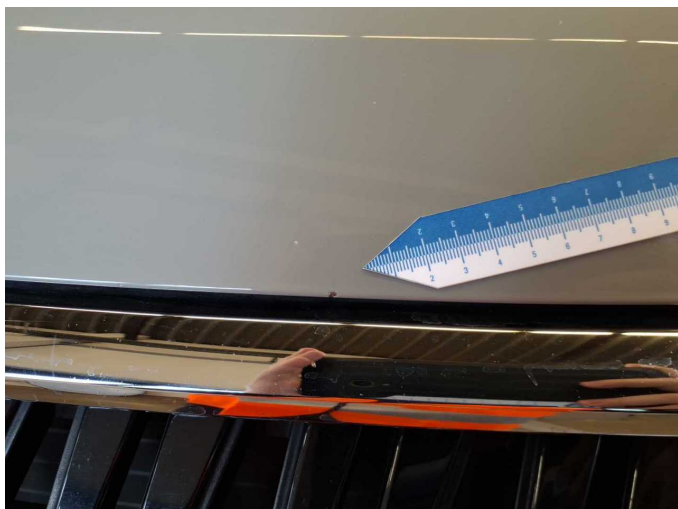
Damage 3: Bonnet: Bonnet - Corrosion - Paint
