Expertise

Protocol number: 46667645  
Order No. / Reference: 26664443  
Inspection date: 23 Jul 2026

Manufacturer: Mercedes-Benz  
VIN: W1NKM0FB0PU021481

Model: GLC 220 d 4Matic 9G-TRONIC Avantgarde Advanced

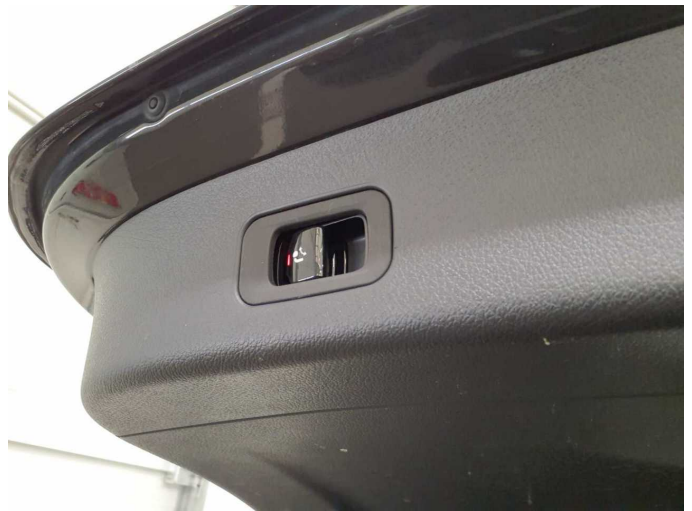
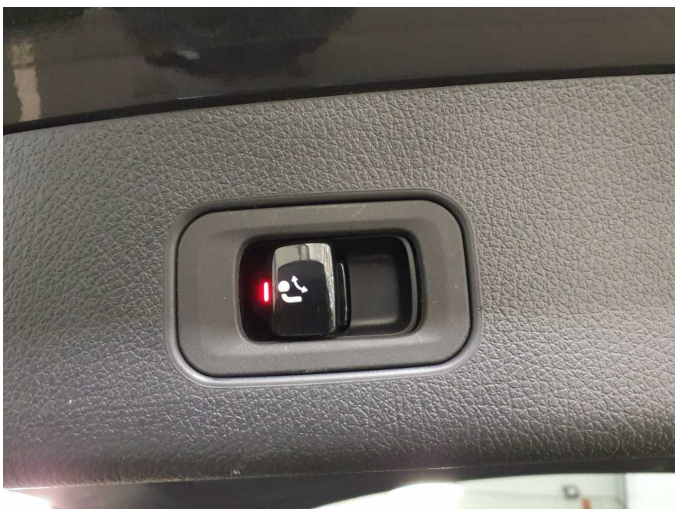
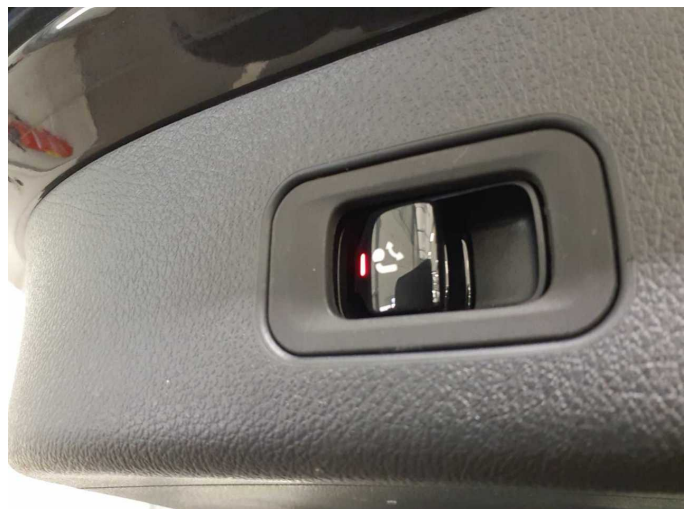
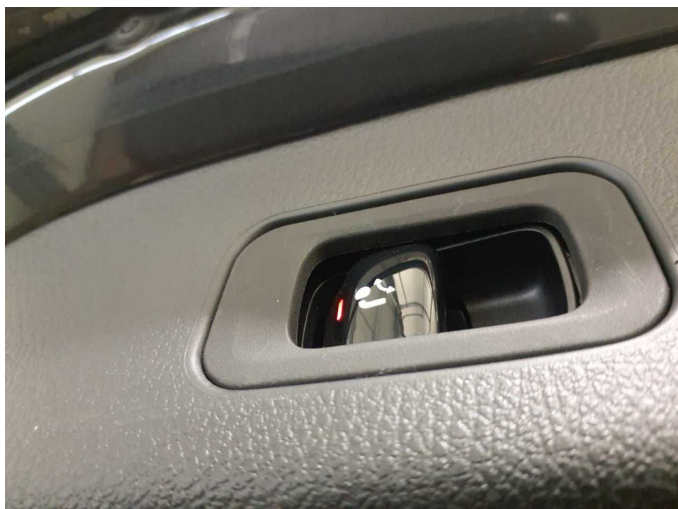
| No. | Component group | Description |
|---|---|---|
| 1 | Trailer hitch | Trailer hitch (Betätigung) - Malposition - Un- / install |

Damage 1: Trailer hitch: Trailer hitch (Betätigung) - Malposition - Un- / install

**Damage 1:** Trailer hitch: Trailer hitch (Betätigung) - Malposition - Un- / install

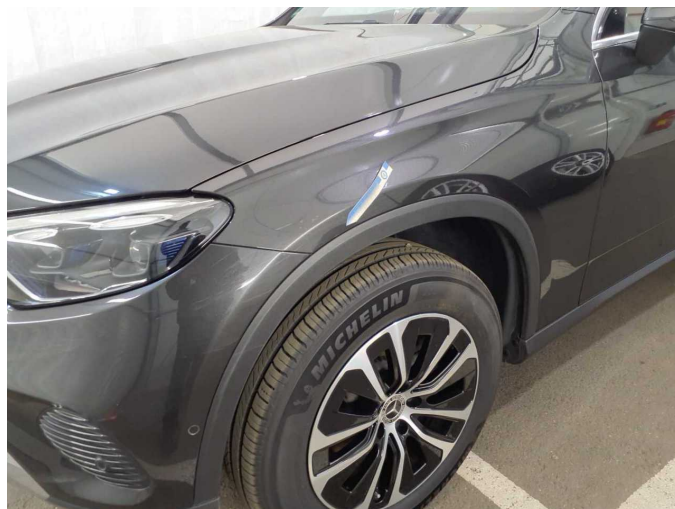
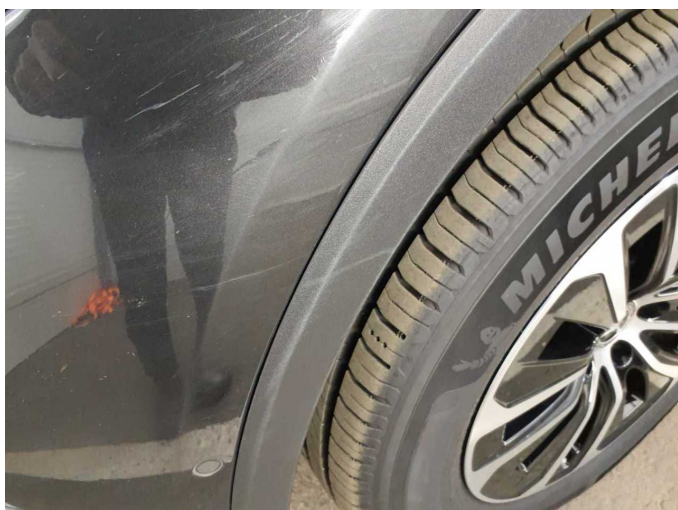
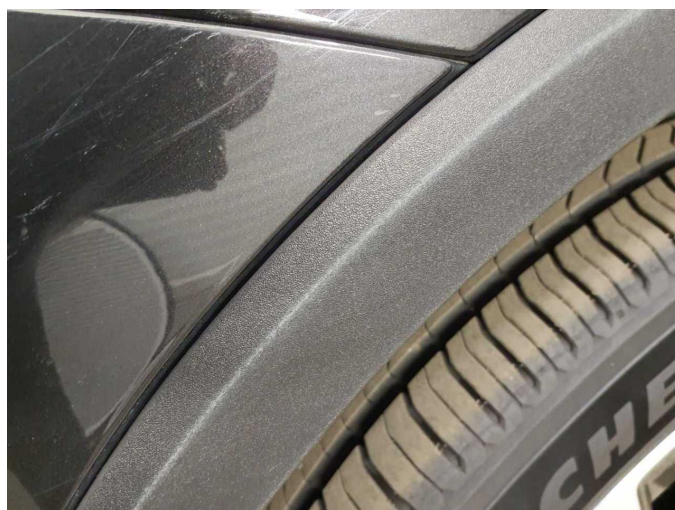
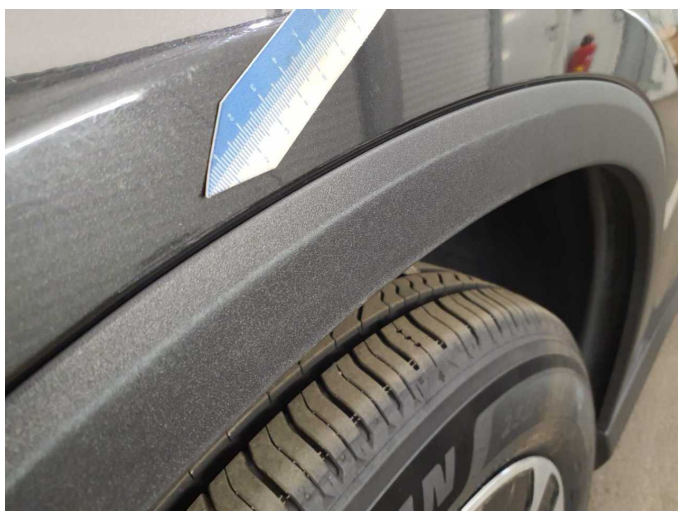
| No. | Component group | Description |
|---|---|---|
| 2 | Mudguard - left side | Wheel well extension - Scratch(es) - Loss in value |

**Damage 2:** Mudguard - left side: Wheel well extension - Scratch(es) - Loss in value

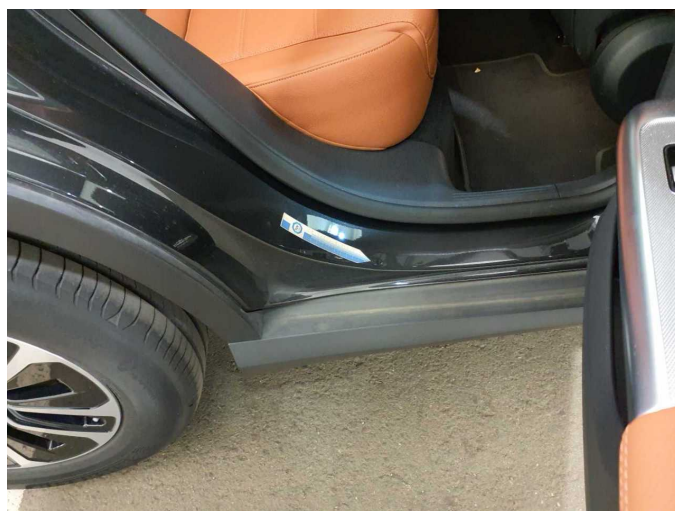
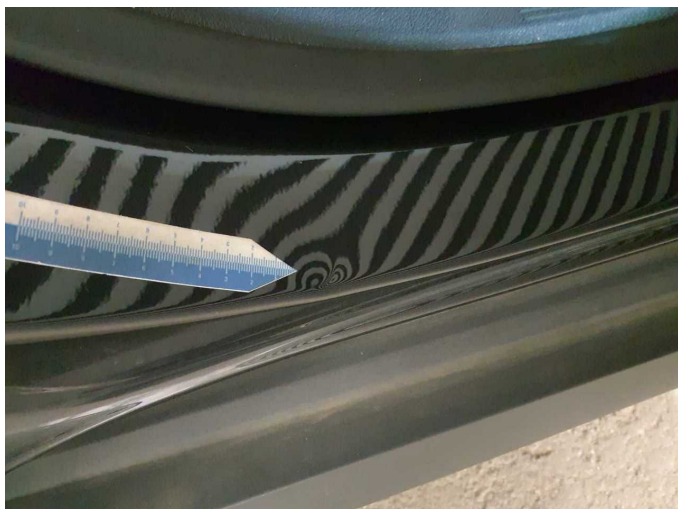
| No. | Component group | Description |
|---|---|---|
| 3 | Side panel - rear right side | Sill - dent(s) - Smart repair |

**Damage 3:** Side panel - rear right side: Sill - dent(s) - Smart repair

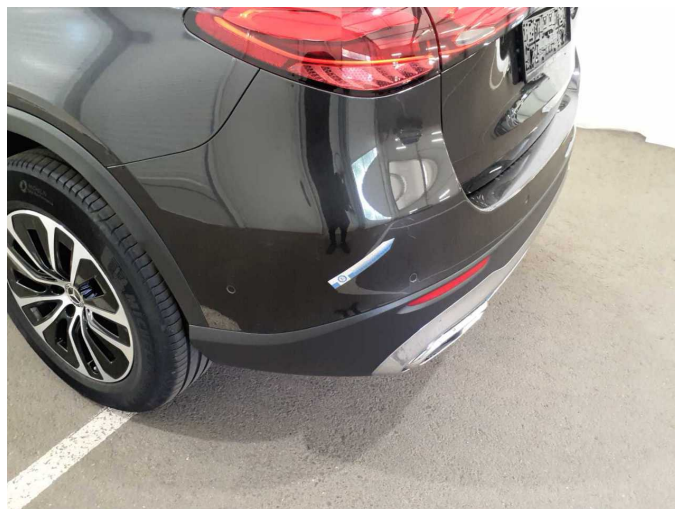
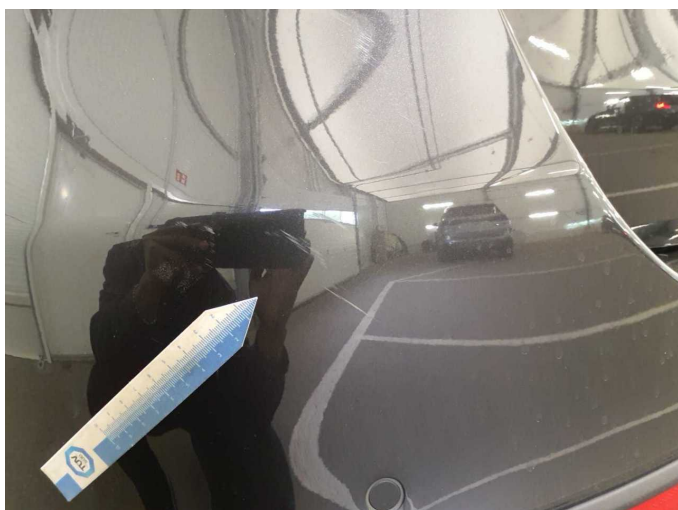
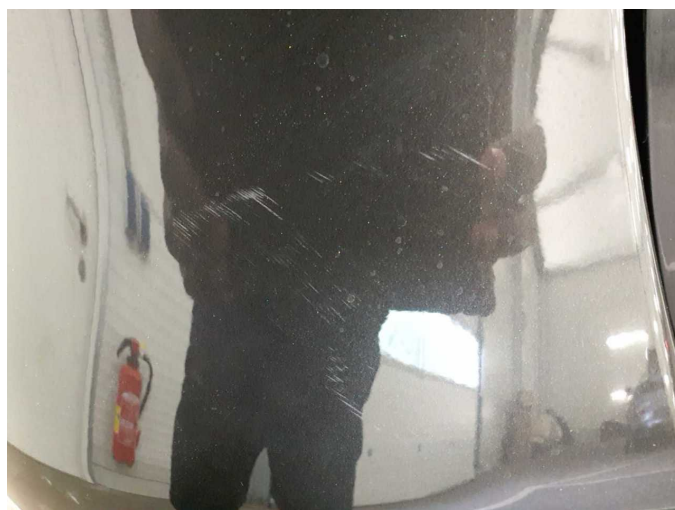
| No. | Component group | Description |
|---|---|---|
| 4 | Rear bumper | Rear bumper - Scratch(es) - Paint |

**Damage 4:** Rear bumper: Rear bumper - Scratch(es) - Paint

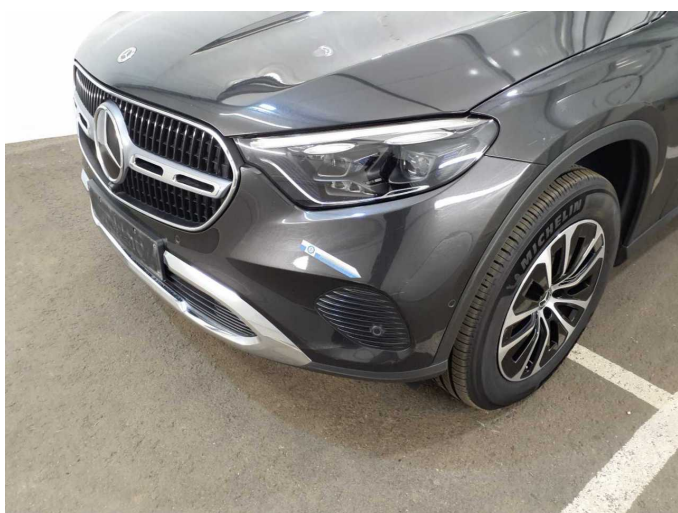
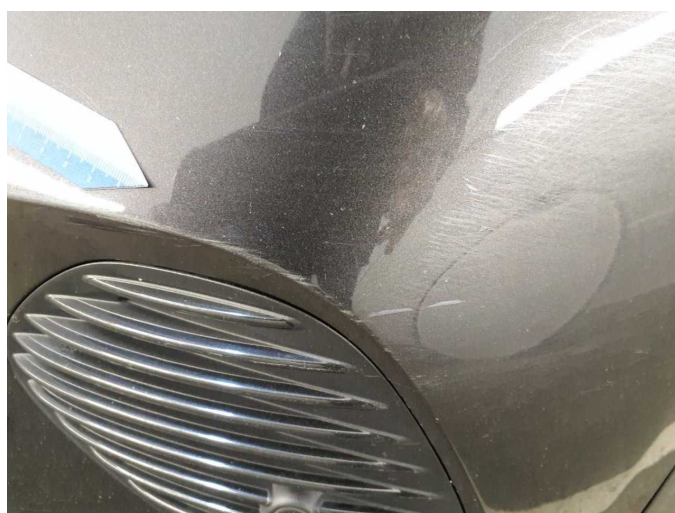
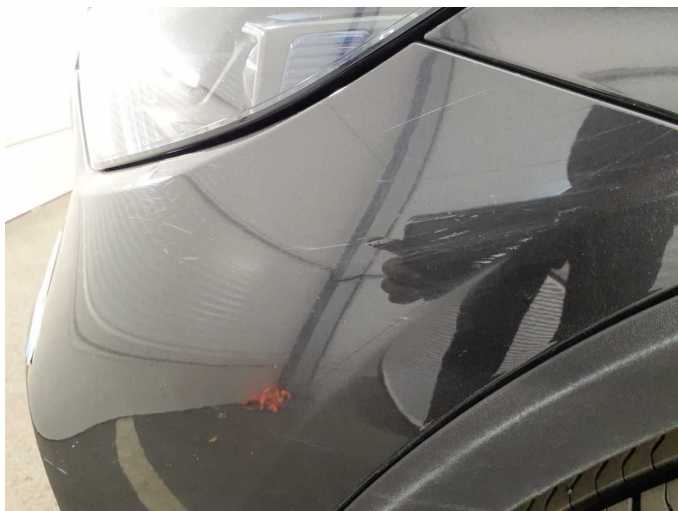
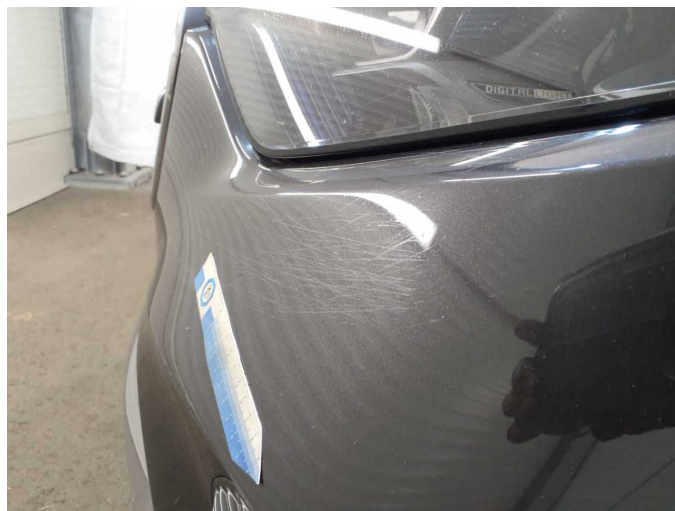
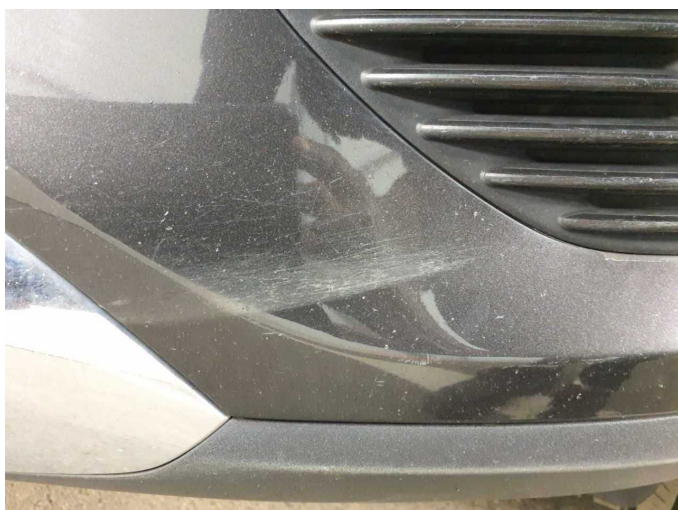
| No. | Component group | Description |
|---|---|---|
| 5 | Front bumper | Front bumper - Scratch(es) - Paint |

**Damage 5:** Front bumper: Front bumper - Scratch(es) - Paint

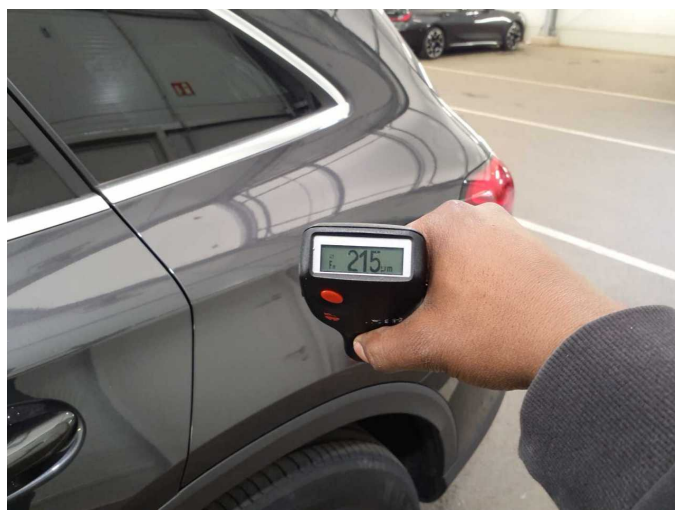
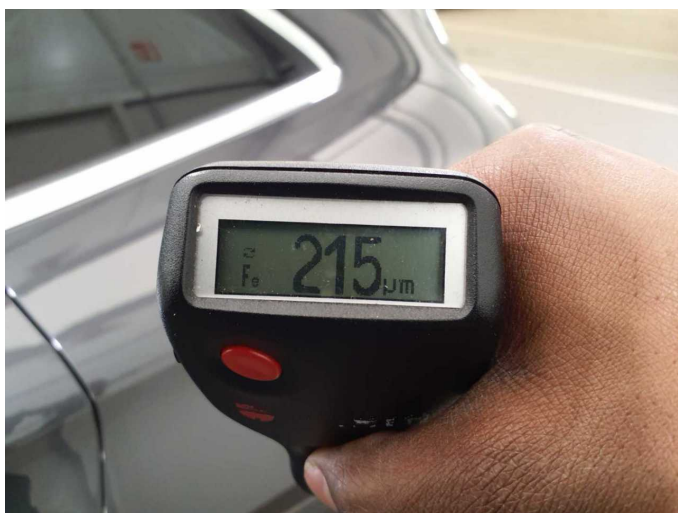
- 1 Side panel - rear left side, Professionally carried out, Invoice of repair done Non-existent
- 2 Door - front left side, Professionally carried out, Invoice of repair done Non-existent

| Side panel - rear left side | 215 µm | Door - front left side | 219 µm |

**Repainting 1:** Side panel - rear left side

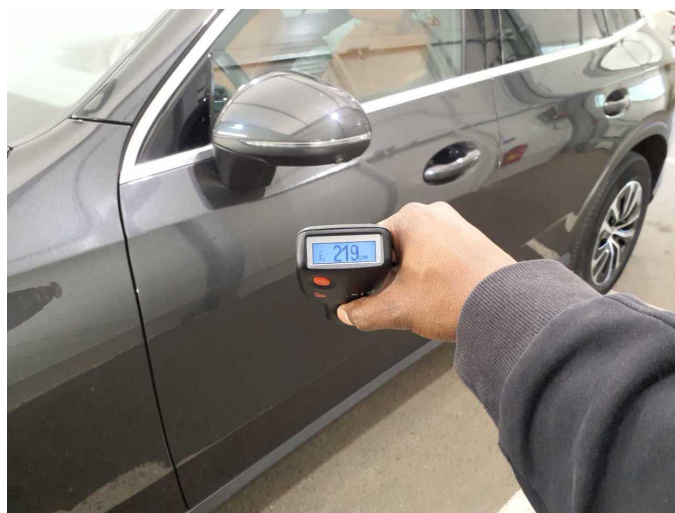
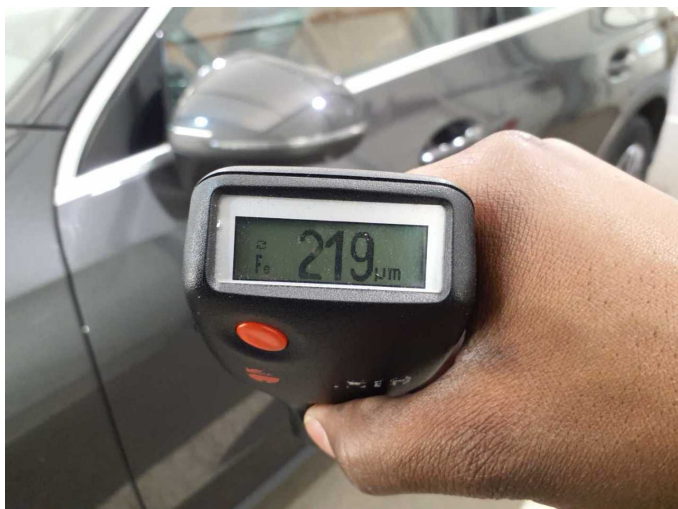
**Repainting 2:** Door - front left side
