Expertise

Protocol number: 46814712  
Order No. / Reference: 26774479  
Inspection date: 31 Jul 2026

Manufacturer: Volkswagen

Model: ID.4 Performance Upgrade Pro

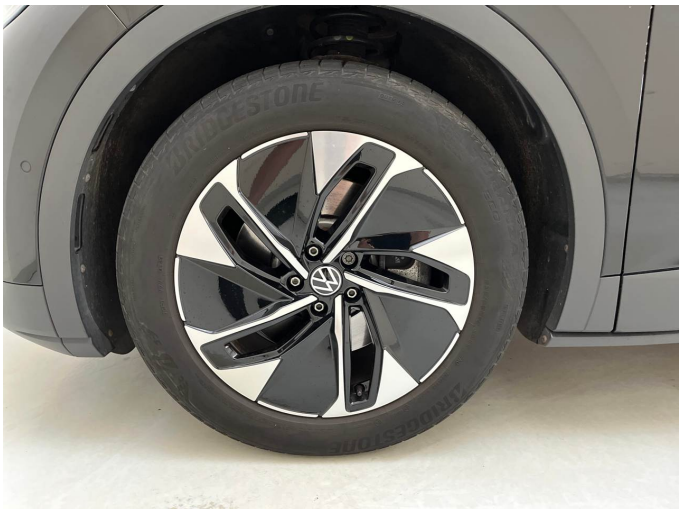
Figure 12: Mounted tyres

| # | Tyre size | Type of tyre | Manufacturer | Tread depth |
|---|---|---|---|---|
| 1) | 235/55 R19 101T | Summer tyres on Light alloy | Bridgestone | 5mm / 5mm |
| 2) | 255/50 R19 103T | Summer tyres on Light alloy | Bridgestone | 4mm / 4mm |

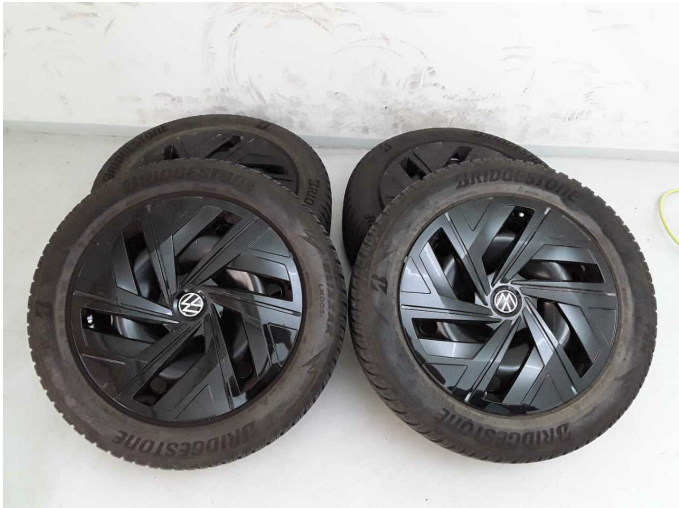
Figure 16: Additional tyres

| # | Tyre size | Type of tyre | Manufacturer | Tread depth |
|---|---|---|---|---|
| 1) | 235/55 R19 101T | Winter tyres on Steel rim with wheel cover | Bridgestone | 7mm / 7mm |
| 2) | 255/50 R19 103T | Winter tyres on Steel rim with wheel cover | Bridgestone | 6mm / 6mm |

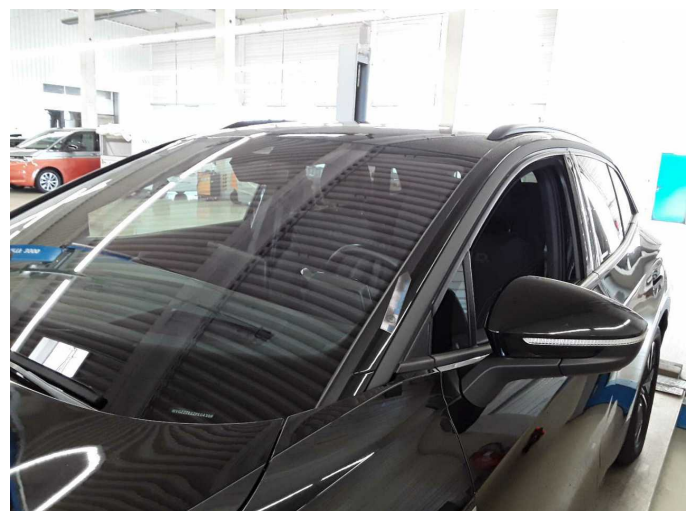
**Damage 1:** Trim / covers: Brightware / decorative strip (Frontscheibe links) - Scratch(es) - Replace

| No. | Component group | Description |
|---|---|---|
| 1 | Trim / covers | Brightware / decorative strip (Frontscheibe links) - Scratch(es) - Replace |

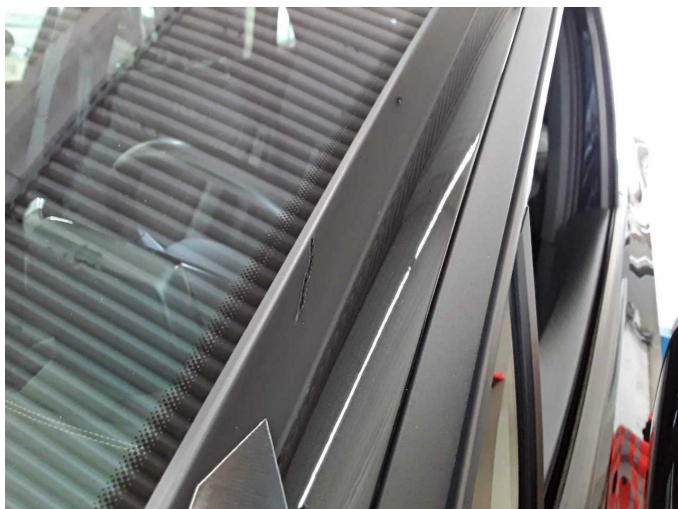
**Damage 1:** Trim / covers: Brightware / decorative strip (Frontscheibe links) - Scratch(es) - Replace

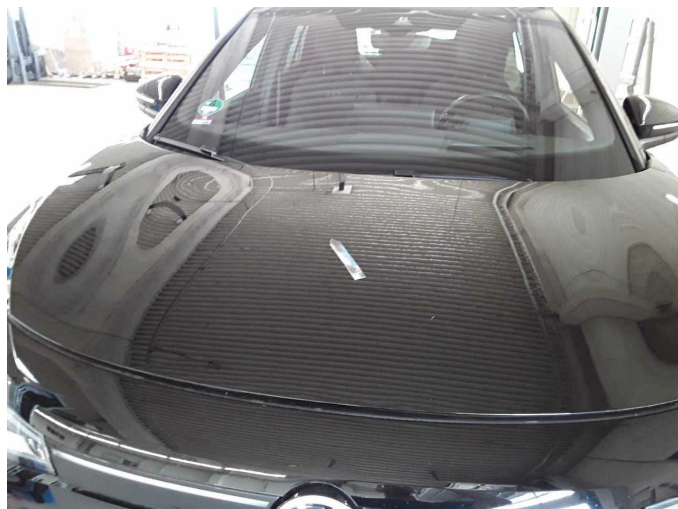
**Damage 2:** Bonnet: Bonnet - dent(s) - Smart repair

| No. | Component group | Description |
|---|---|---|
| 2 | Bonnet | Bonnet - dent(s) - Smart repair |

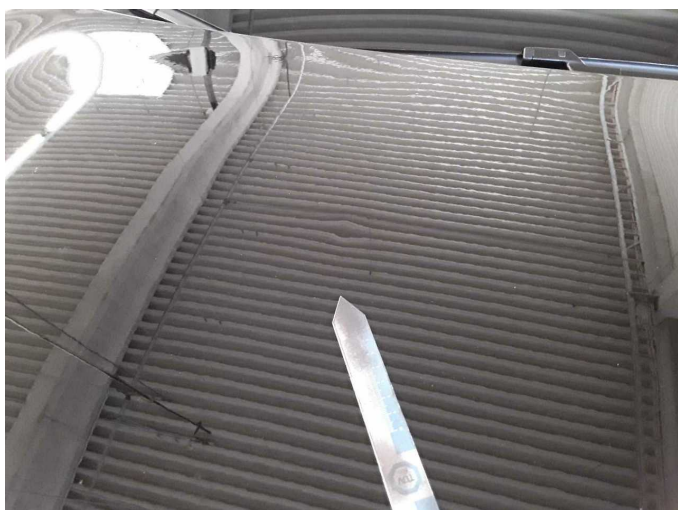
**Damage 2:** Bonnet: Bonnet - dent(s) - Smart repair

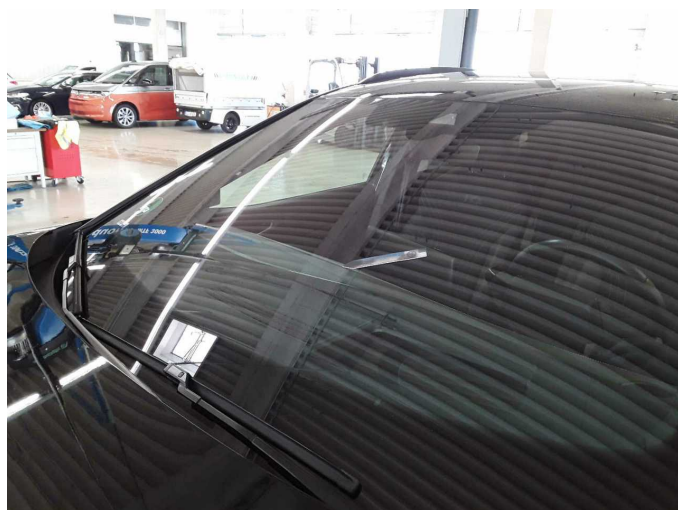
**Damage 3:** Vehicle glazing: Windscreen with lane departure assistant - Stone chips - Replace

| No. | Component group | Description |
|---|---|---|
| 3 | Vehicle glazing | Windscreen with lane departure assistant - Stone chips - Replace |

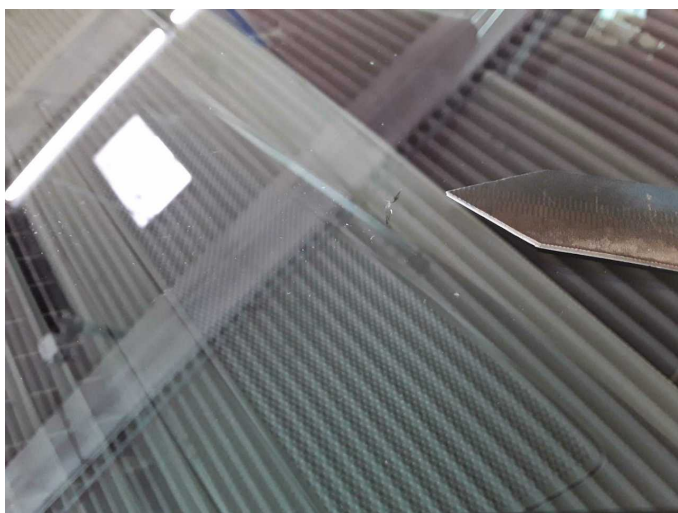
**Damage 3:** Vehicle glazing: Windscreen with lane departure assistant - Stone chips - Replace
