Expertise

Protocol number: 46840719  
Order No. / Reference: 26726164  
Inspection date: 31 Jul 2026

Model: Passat Variant 2.0 TDI SCR DSG Business

VIN: WVGZZZ3CZPE040713

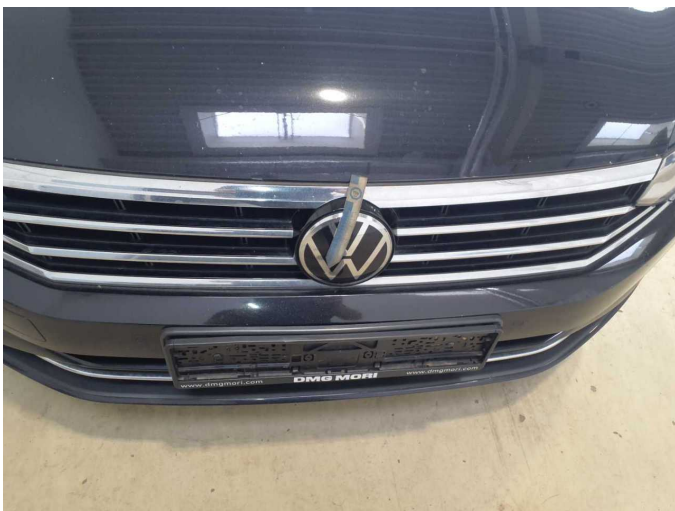
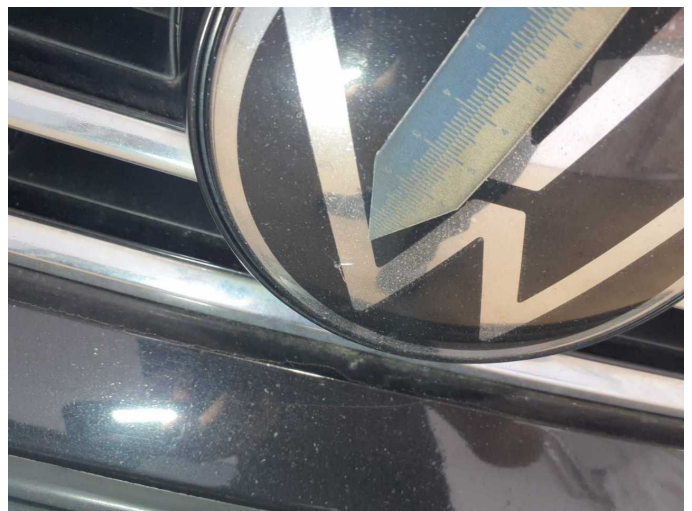
Damage 1: Front structure: Emblem - Stone chips - Loss in value

| No. | Component group | Description |
|---|---|---|
| 1 | Front structure | Emblem - Stone chips - Loss in value |

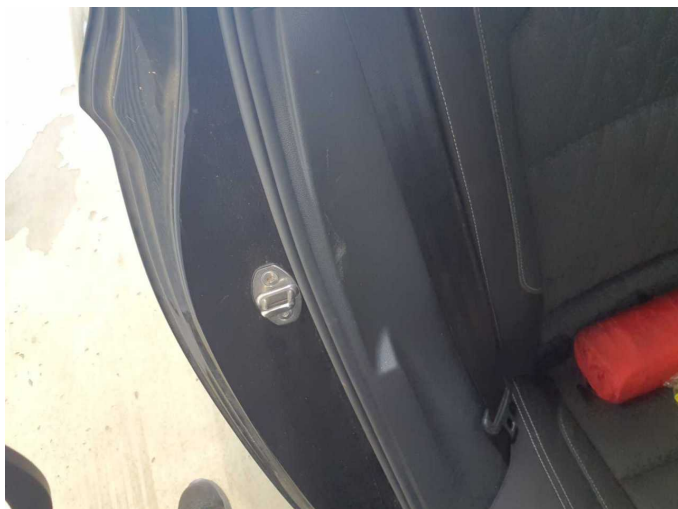
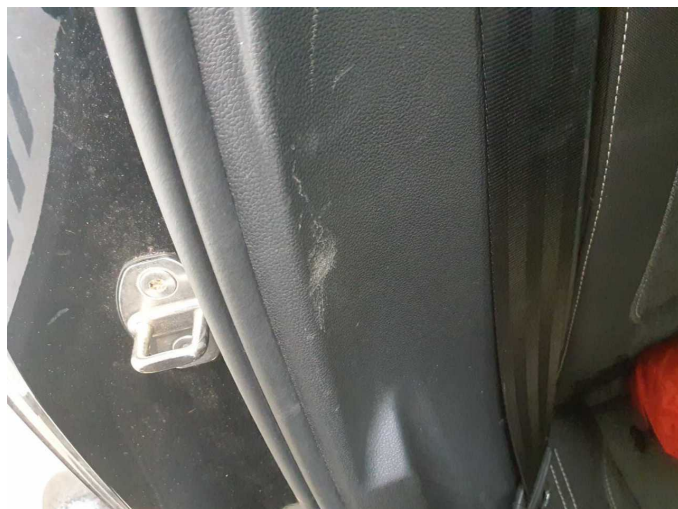
**Damage 2:** Trim / covers: C-pillar - trim - interior, right side - Scratch(es) - Replace

| No. | Component group | Description |
|---|---|---|
| 2 | Trim / covers | C-pillar - trim - interior, right side - Scratch(es) - Replace |

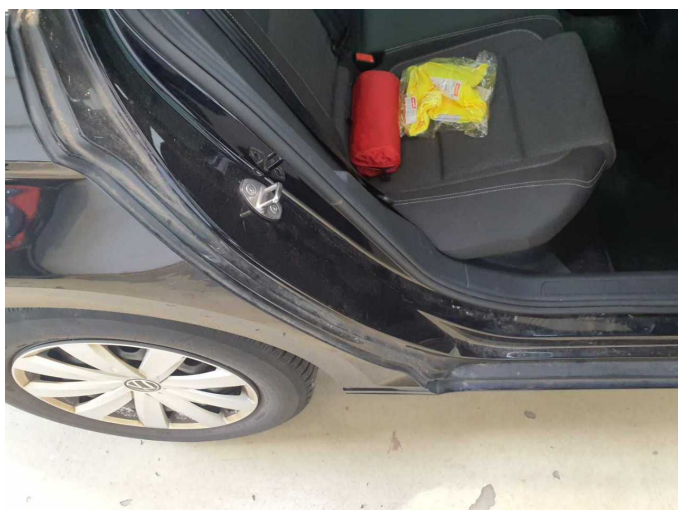
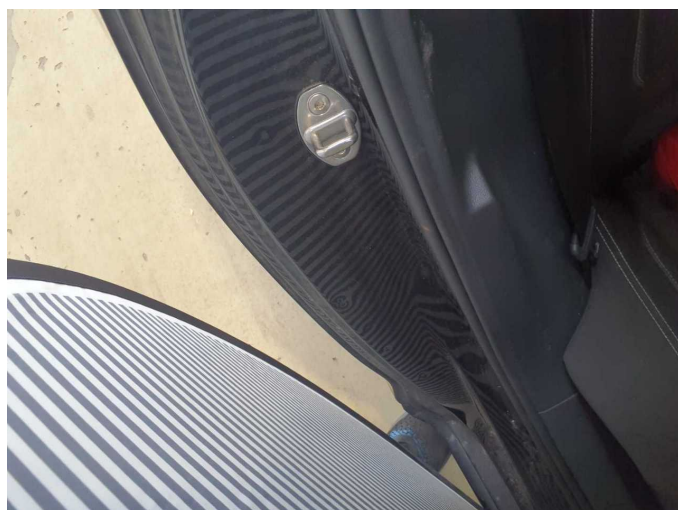
**Damage 3:** Side panel - rear right side: Sill - Dent / paintcoat damage - Smart repair

| No. | Component group | Description |
|---|---|---|
| 3 | Side panel - rear right side | Sill - Dent / paintcoat damage - Smart repair |

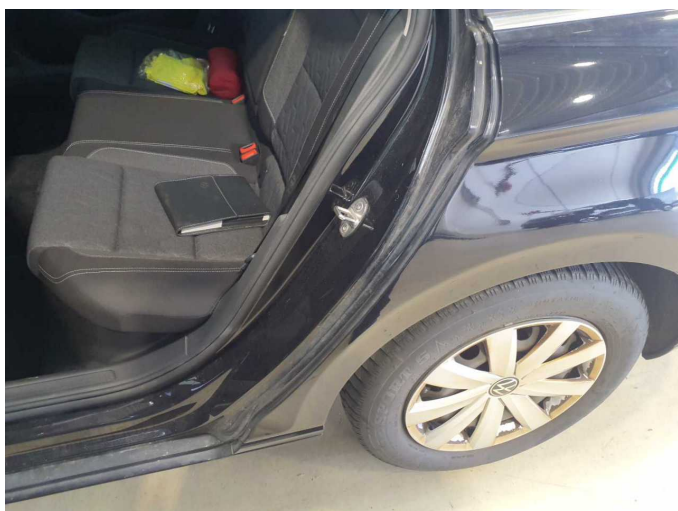
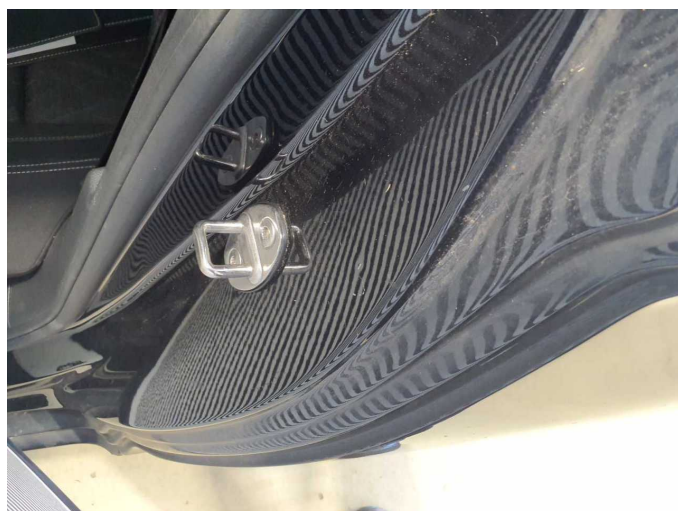
**Damage 4:** Side panel - rear left side: Sill - Dent / paintcoat damage - Smart repair

| No. | Component group | Description |
|---|---|---|
| 4 | Side panel - rear left side | Sill - Dent / paintcoat damage - Smart repair |

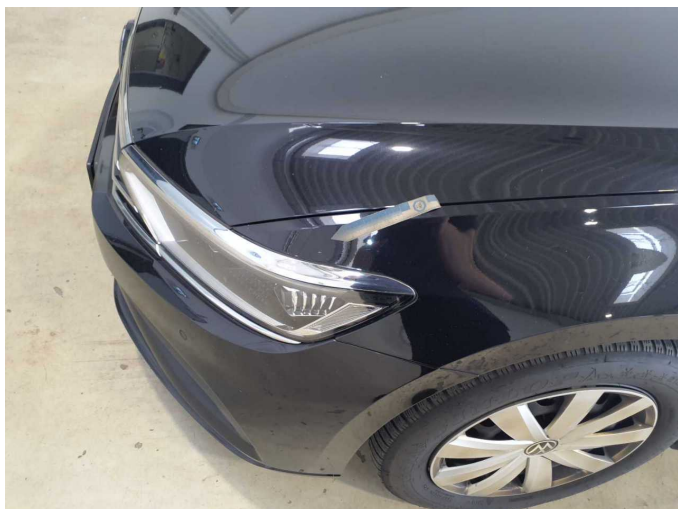
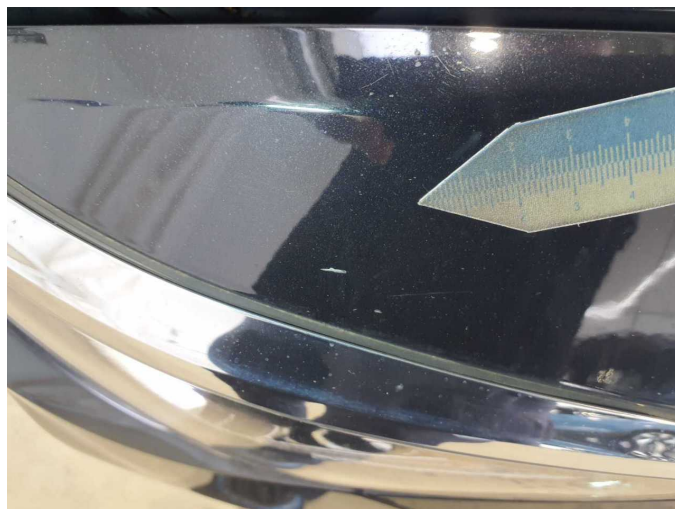
**Damage 5:** Mudguard - left side: Mudguard - left side - Scratch(es) - Smart repair

| No. | Component group | Description |
|---|---|---|
| 5 | Mudguard - left side | Mudguard - left side - Scratch(es) - Smart repair |

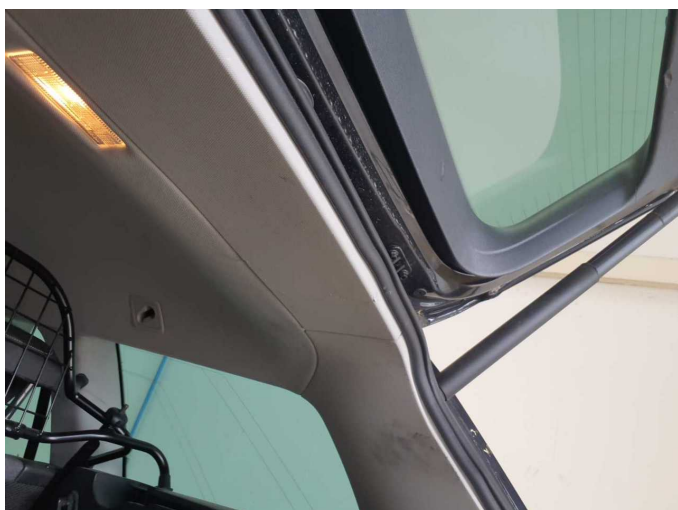
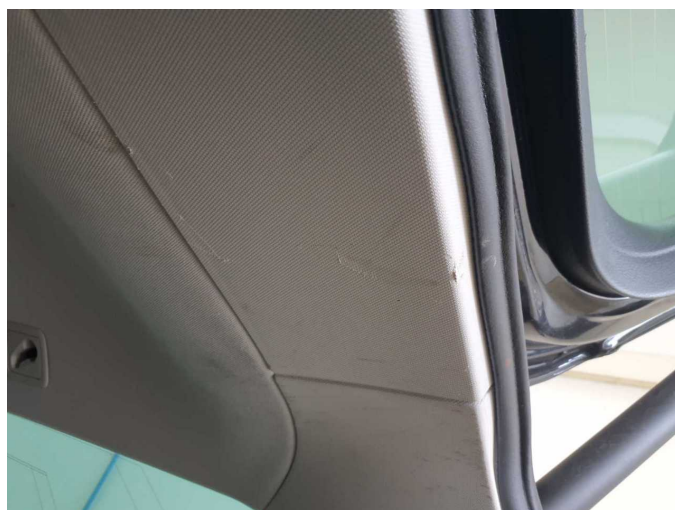
**Damage 6:** Trim / covers: Boot lining - Scratch(es) - Replace

| No. | Component group | Description |
|---|---|---|
| 6 | Trim / covers | Boot lining - Scratch(es) - Replace |

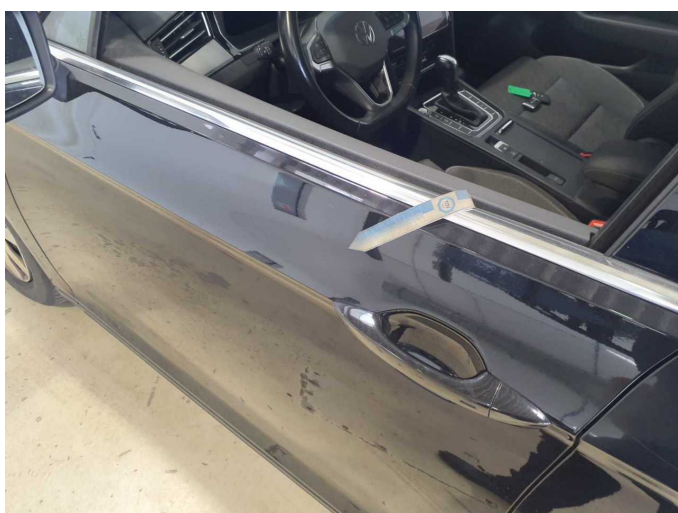
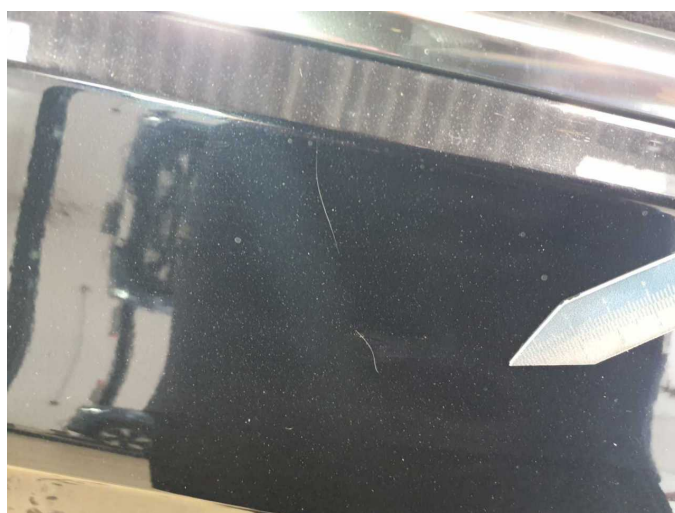
**Damage 7:** Door - front left side: Door - Scratch(es) - Smart repair

| No. | Component group | Description |
|---|---|---|
| 7 | Door - front left side | Door - Scratch(es) - Smart repair |

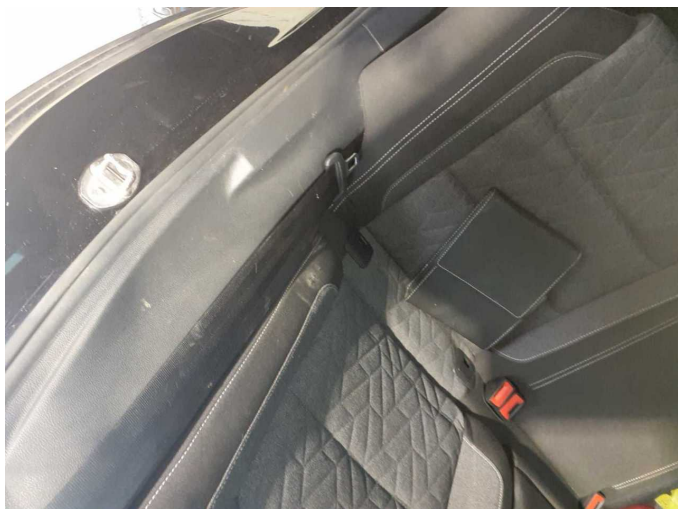
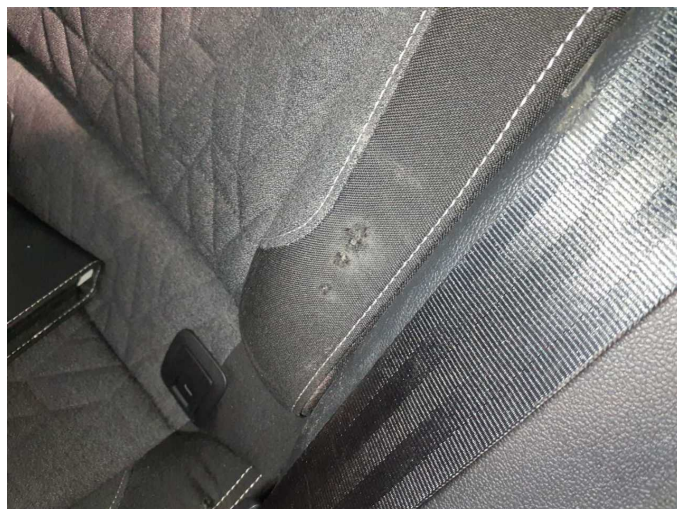
**Damage 8:** Seat - rear: Upholstery - Broken / torn - Loss in value

| No. | Component group | Description |
|---|---|---|
| 8 | Seat - rear | Upholstery - Broken / torn - Loss in value |

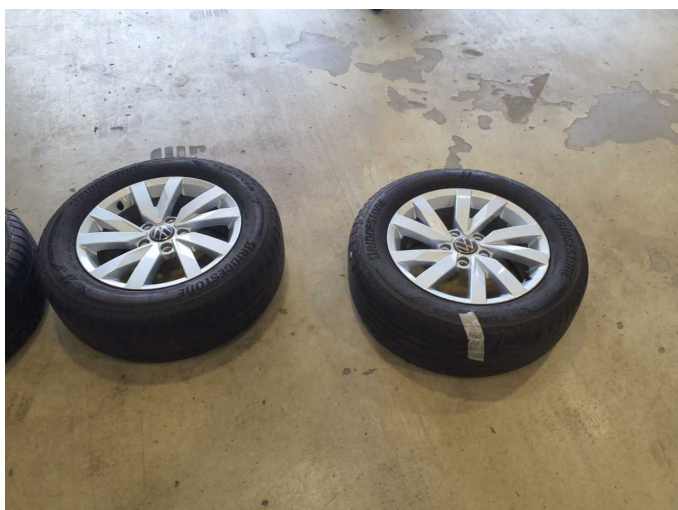
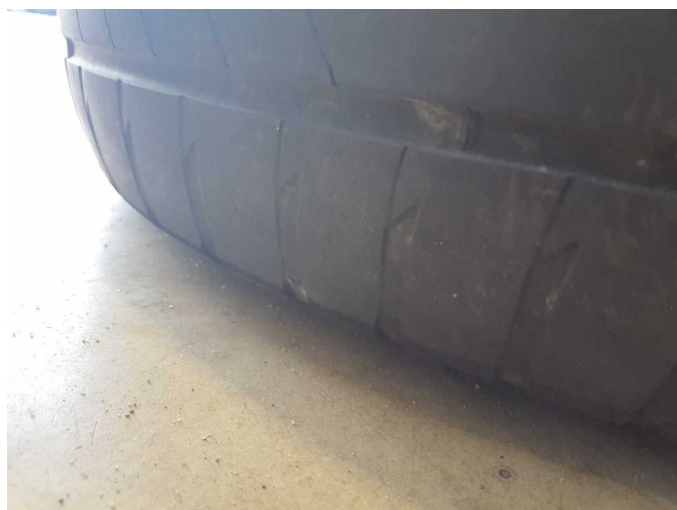
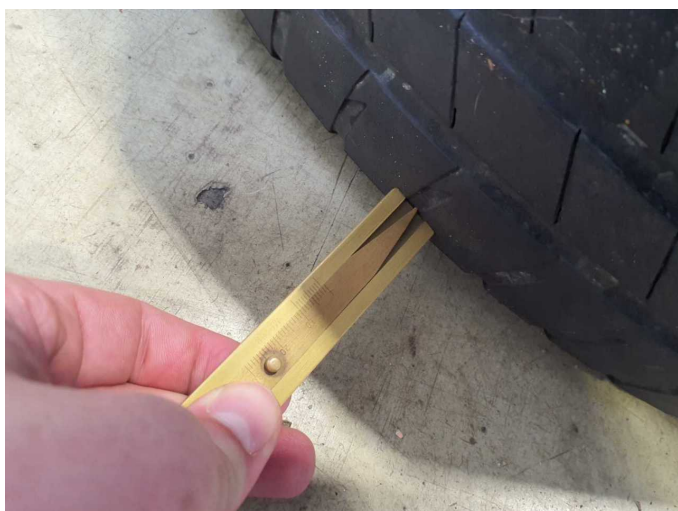
**Damage 9:** 2nd wheel set: 2 tyres - Worn - Replace

| No. | Component group | Description |
|---|---|---|
| 9 | 2nd wheel set | 2 tyres - Worn - Replace |

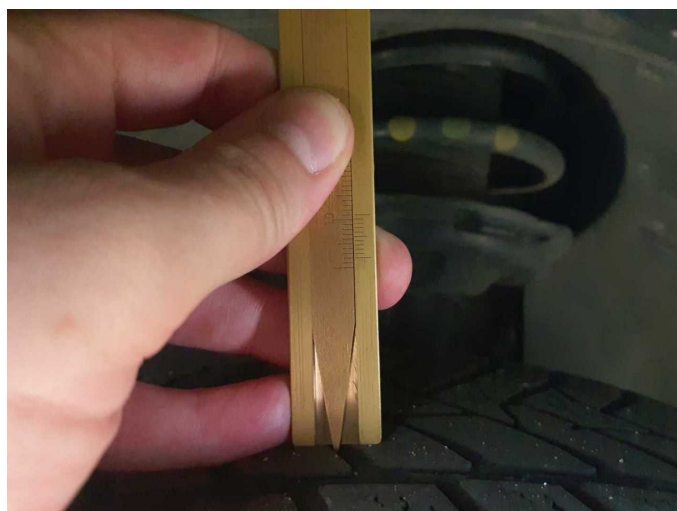
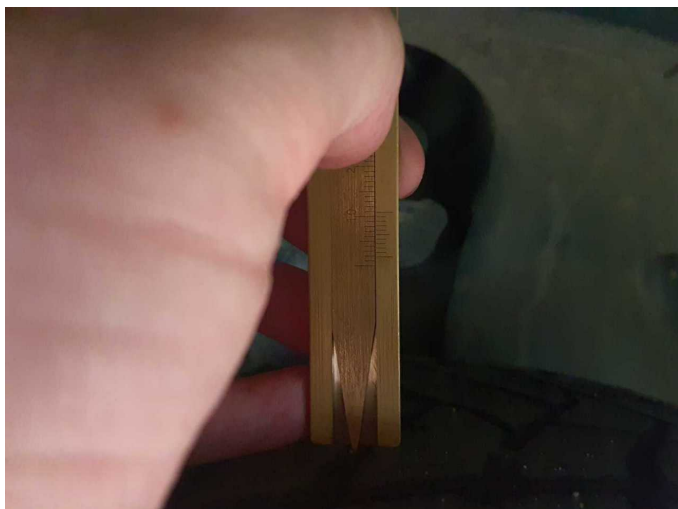
**Damage 10:** Wheel / tyres: Tyre - front - Worn - Replace

| No. | Component group | Description |
|---|---|---|
| 10 | Wheel / tyres | Tyre - front - Worn - Replace |

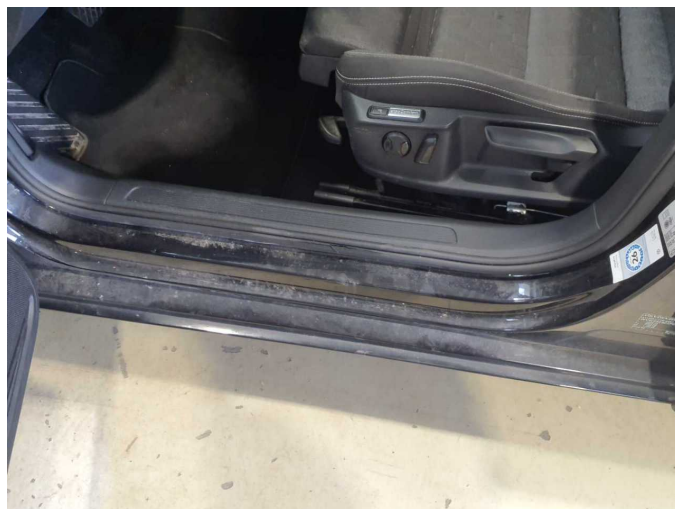
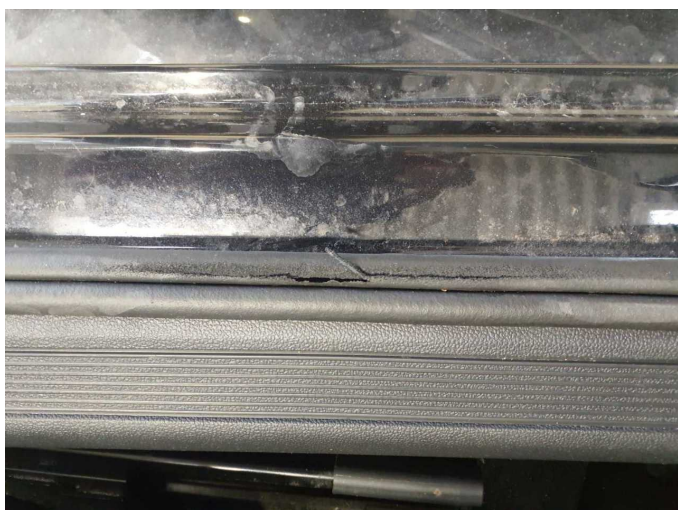
**Damage 11:** Door - front left side: Door seal - Broken / torn - Replace

| No. | Component group | Description |
|---|---|---|
| 11 | Door - front left side | Door seal - Broken / torn - Replace |

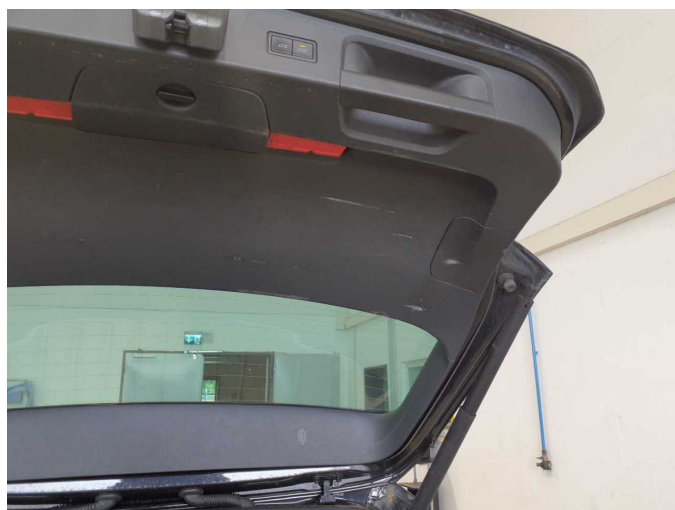
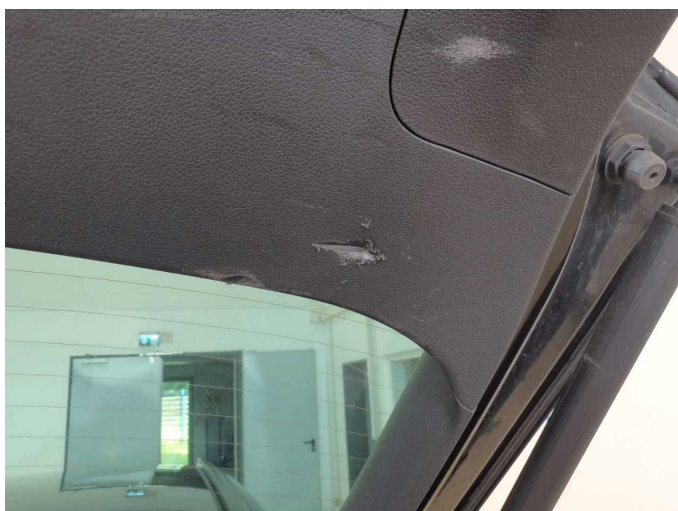
**Damage 12:** Trim / covers: Boot lid - interior trim - Scratch(es) - Replace

| No. | Component group | Description |
|---|---|---|
| 12 | Trim / covers | Boot lid - interior trim - Scratch(es) - Replace |

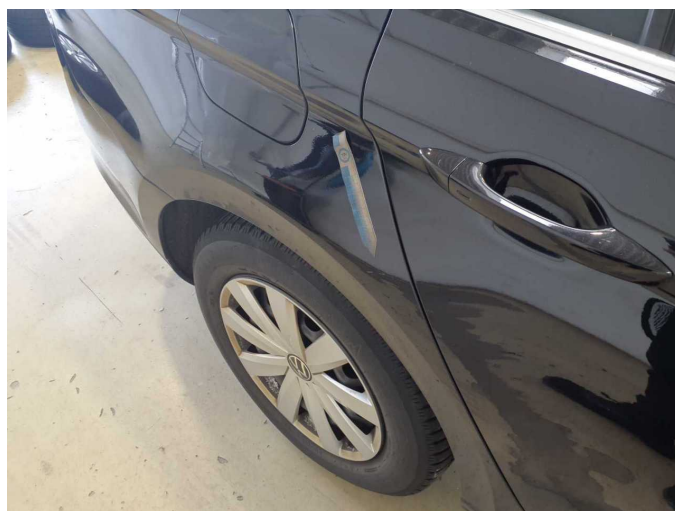
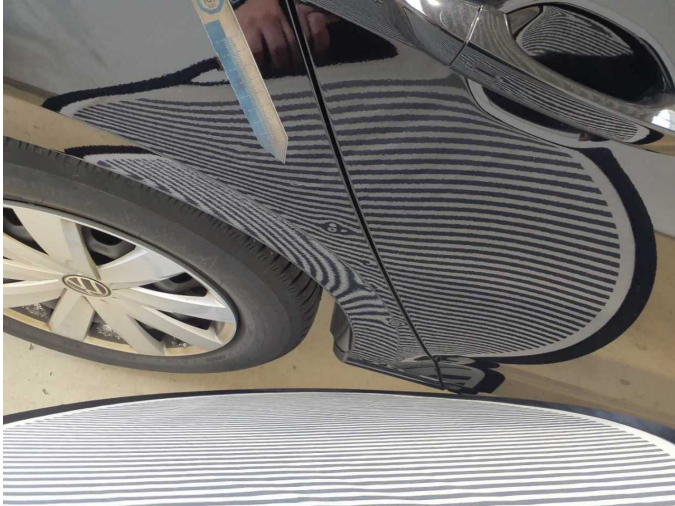
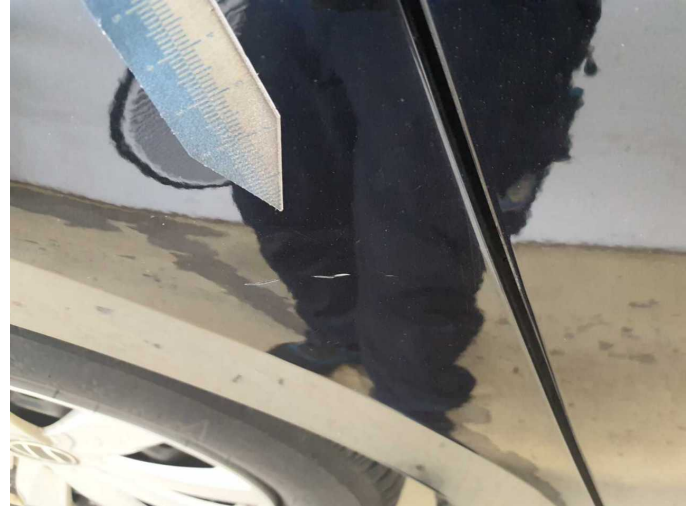
**Damage 13:** Side panel - rear right side: Side panel - Dent / paintcoat damage - Repair and paint

| No. | Component group | Description |
|---|---|---|
| 13 | Side panel - rear right side | Side panel - Dent / paintcoat damage - Repair and paint |

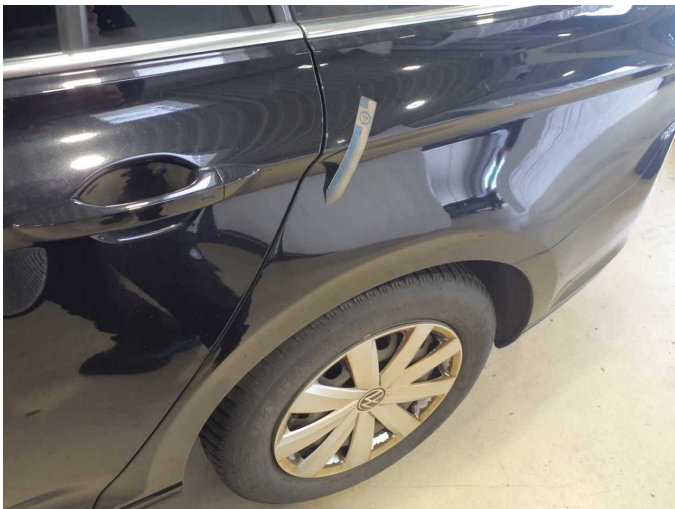
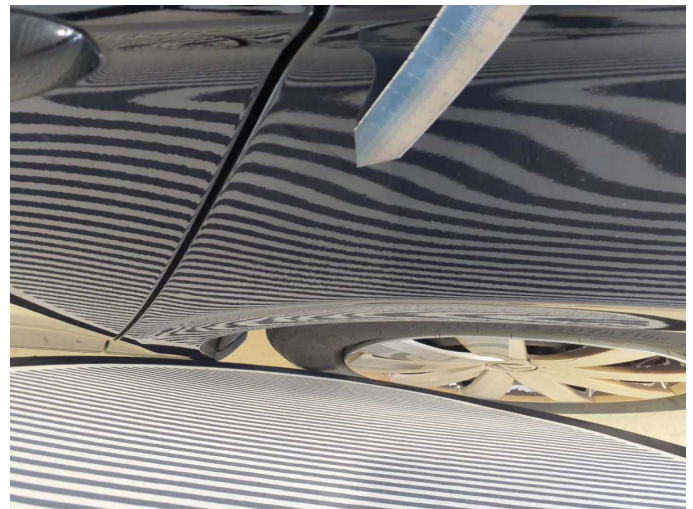
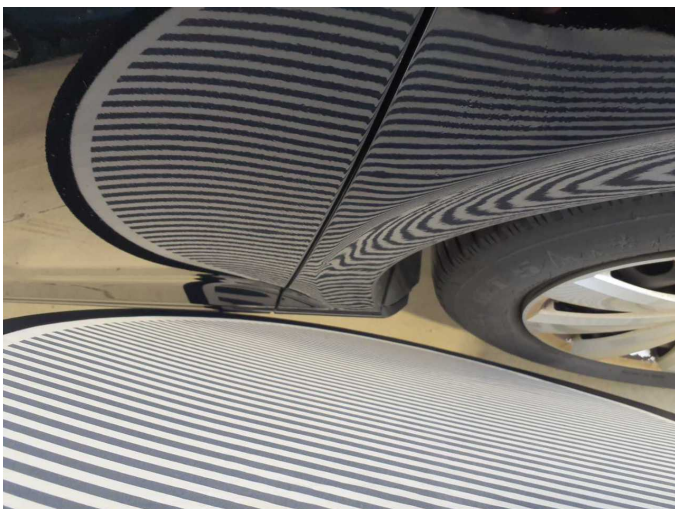
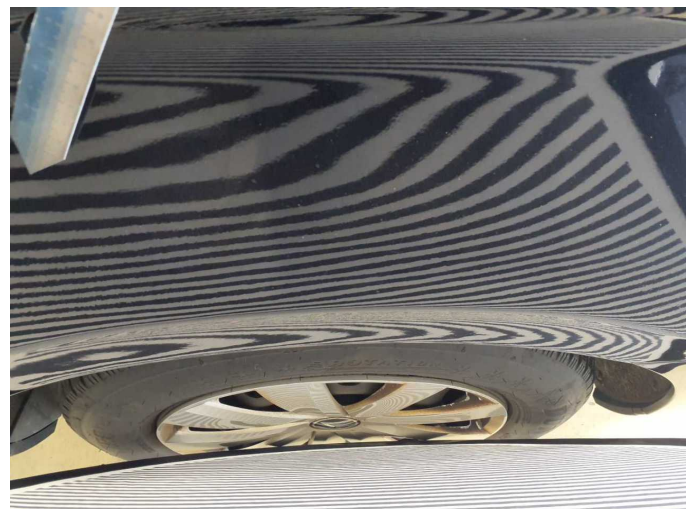
Side panel - rear left side 575 µm |

**Damage 14:** Side panel - rear left side: Side panel (Spachtel eingefallen)  
- Unprofessionally repaired - Repair and paint

| No. | Component group | Description |
|---|---|---|
| 14 | Side panel - rear left side | Side panel (Spachtel eingefallen) - Unprofessionally repaired - Repair and paint |

- 1 Side panel - rear left side, Unprofessionally carried out, Invoice of repair done Non-existent

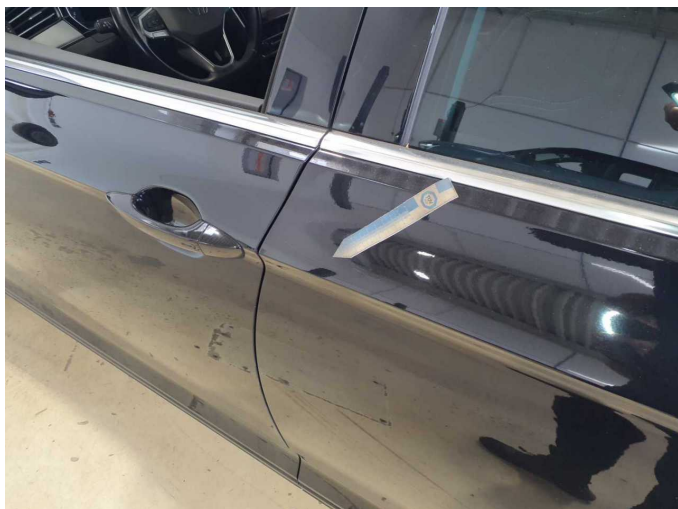
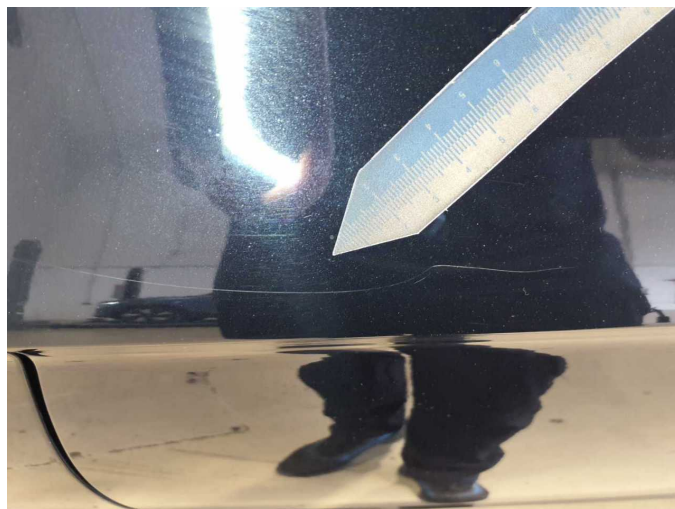
**Damage 15:** Door - rear left side: Door - Scratch(es) - Paint

| No. | Component group | Description |
|---|---|---|
| 15 | Door - rear left side | Door - Scratch(es) - Paint |

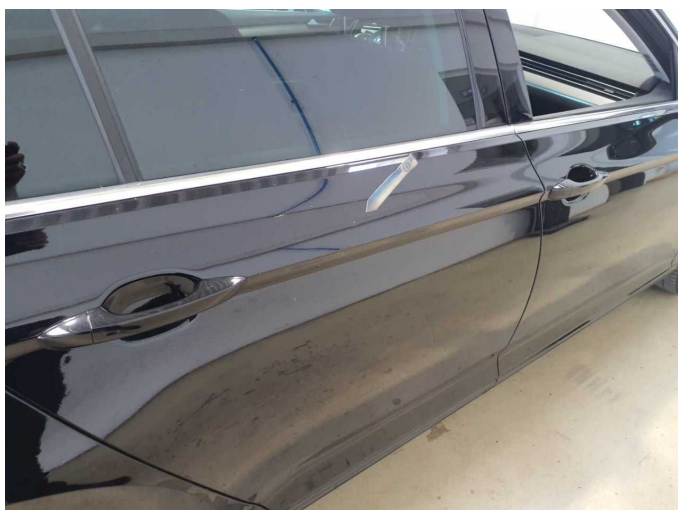
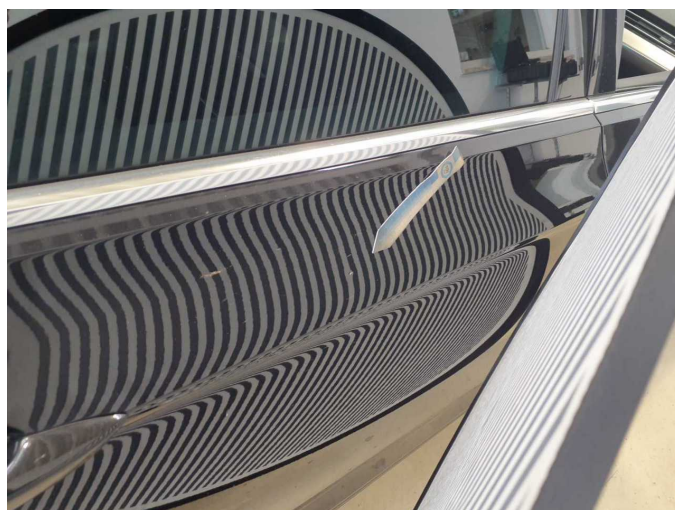
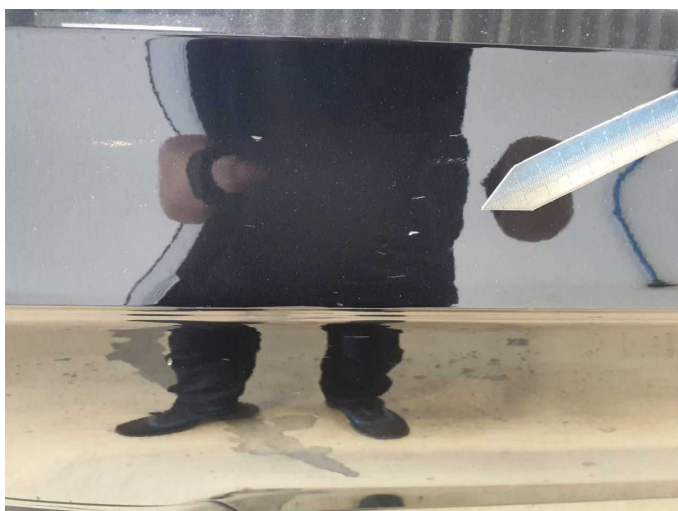
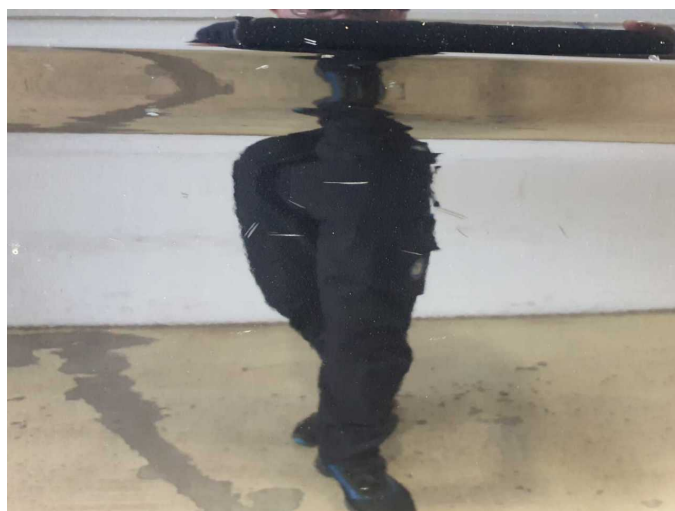
**Damage 16:** Door - rear right side: Door - Dent / paintcoat damage - Repair and paint

| No. | Component group | Description |
|---|---|---|
| 16 | Door - rear right side | Door - Dent / paintcoat damage - Repair and paint |

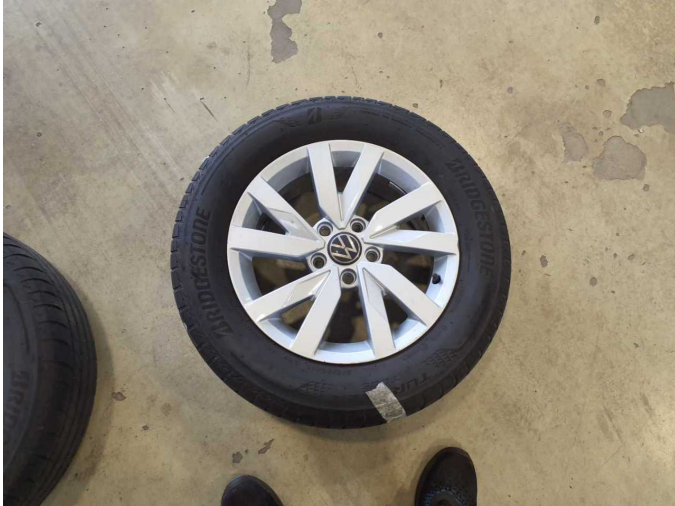
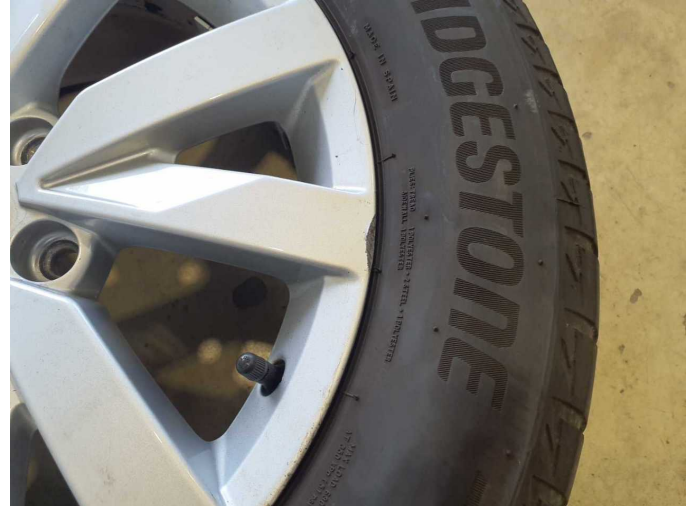
**Damage 17:** 2nd wheel set: 1 alloy rim - Scratch(es) - Replace

| No. | Component group | Description |
|---|---|---|
| 17 | 2nd wheel set | 1 alloy rim - Scratch(es) - Replace |

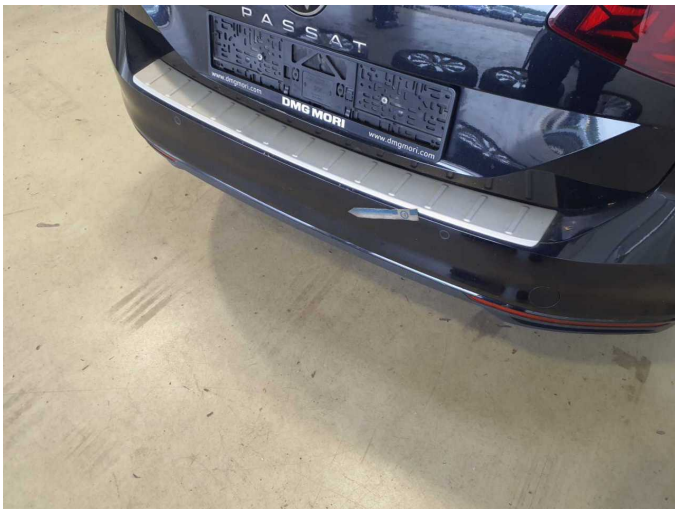
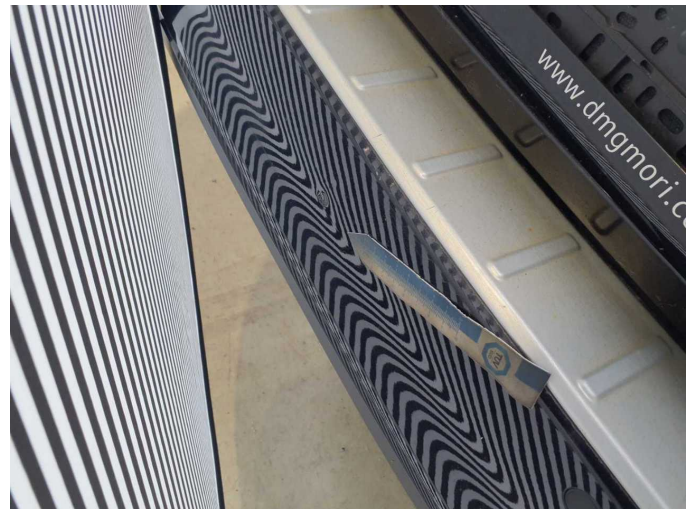
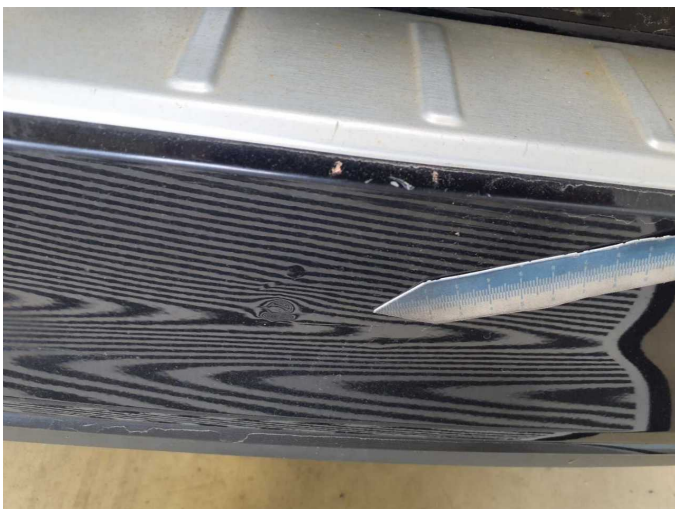
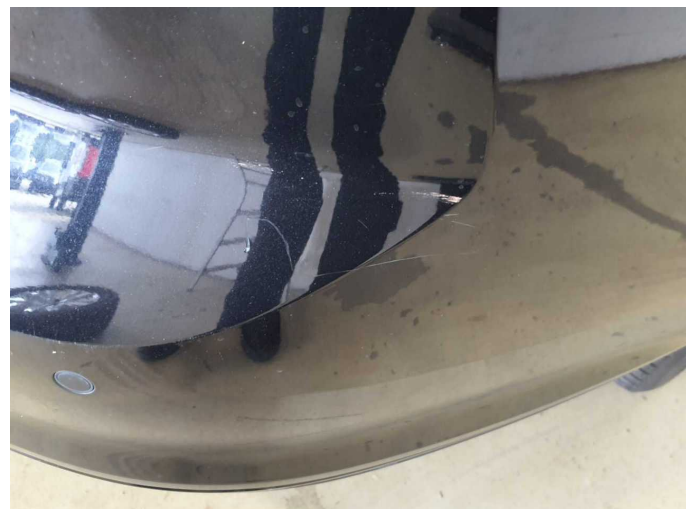
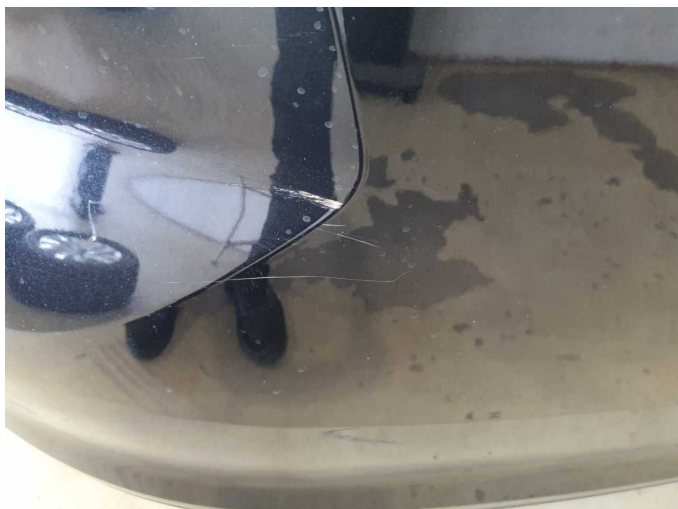
**Damage 18:** Rear bumper: Rear bumper - Dent / paintcoat damage - Repair and paint

| No. | Component group | Description |
|---|---|---|
| 18 | Rear bumper | Rear bumper - Dent / paintcoat damage - Repair and paint |

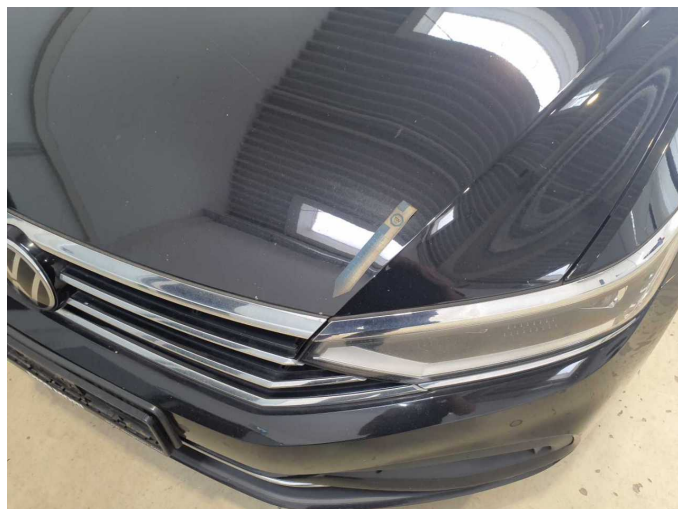
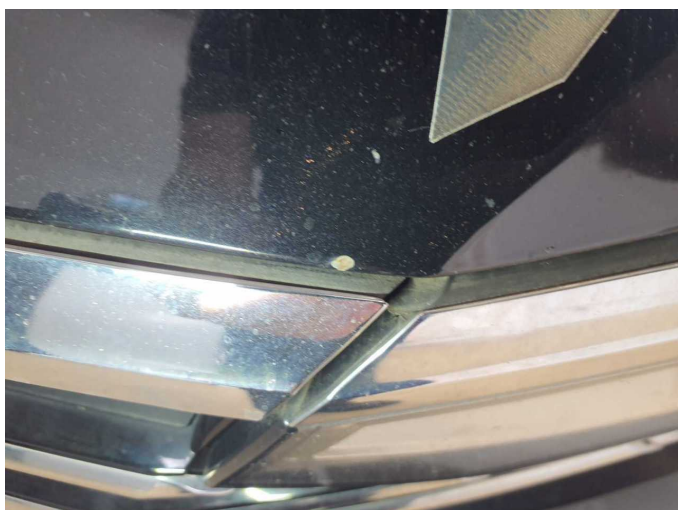
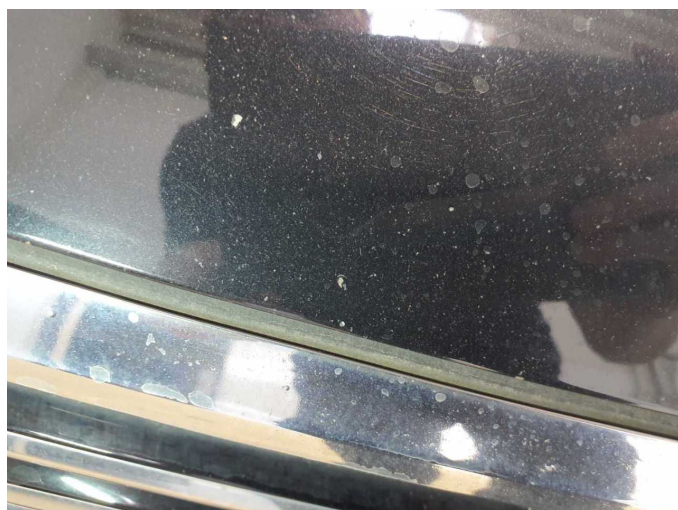
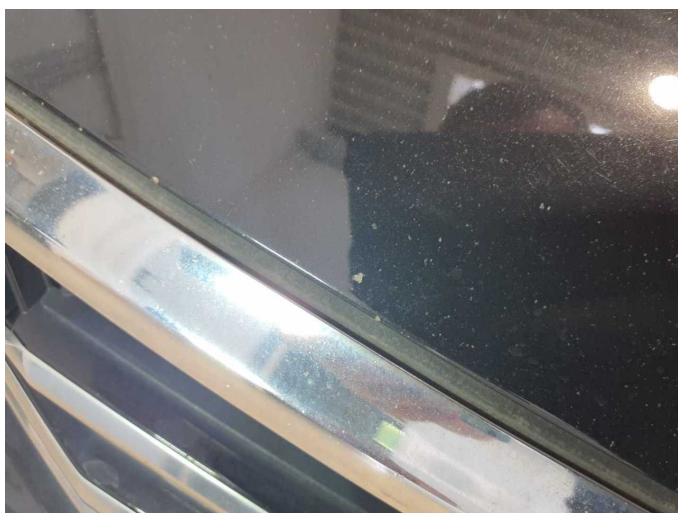
**Damage 19:** Bonnet: Bonnet - Corrosion - Repair and paint

| No. | Component group | Description |
|---|---|---|
| 19 | Bonnet | Bonnet - Corrosion - Repair and paint |

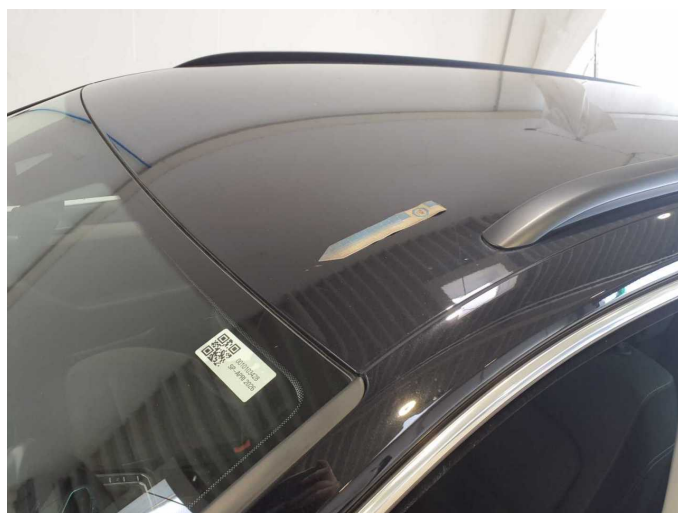
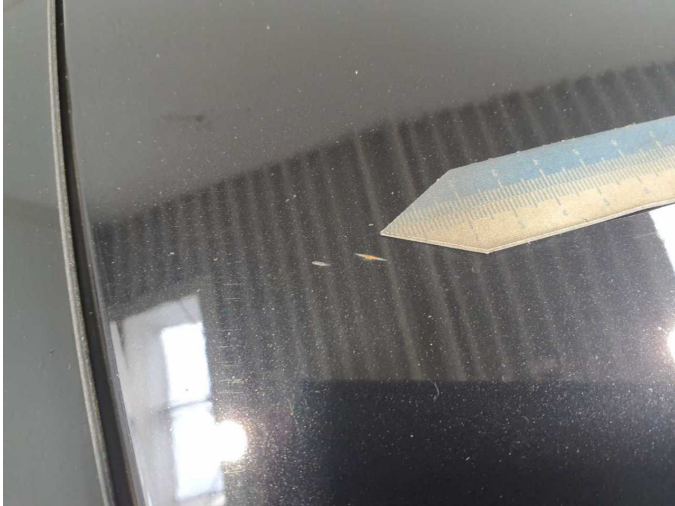
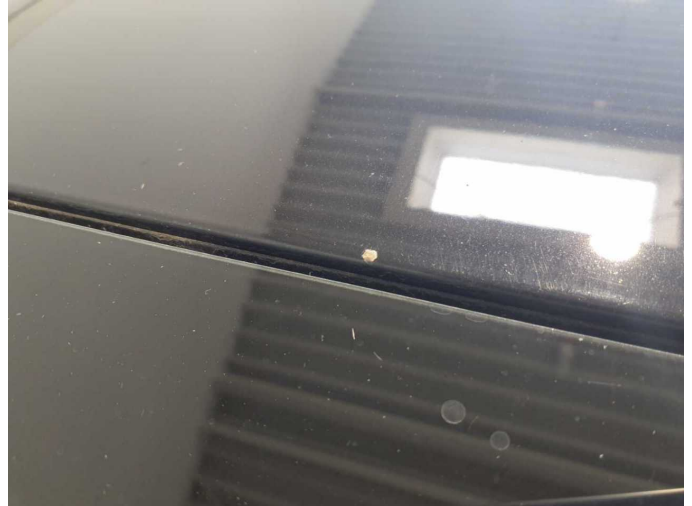
**Damage 20:** Roof: Roof - Corrosion - Repair and paint

| No. | Component group | Description |
|---|---|---|
| 20 | Roof | Roof - Corrosion - Repair and paint |

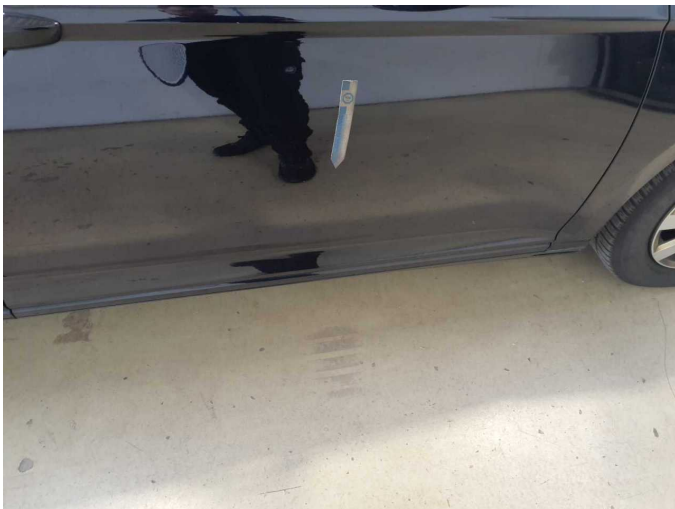
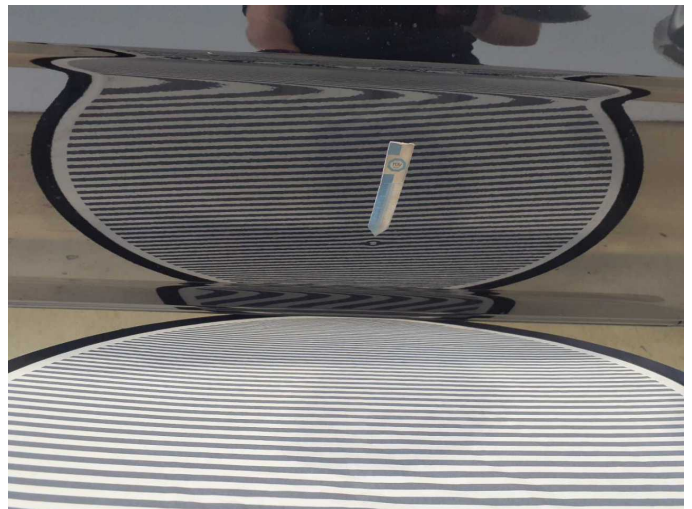
**Wear and tear 4:** Door - front right side: Door - dent(s) - No deduction

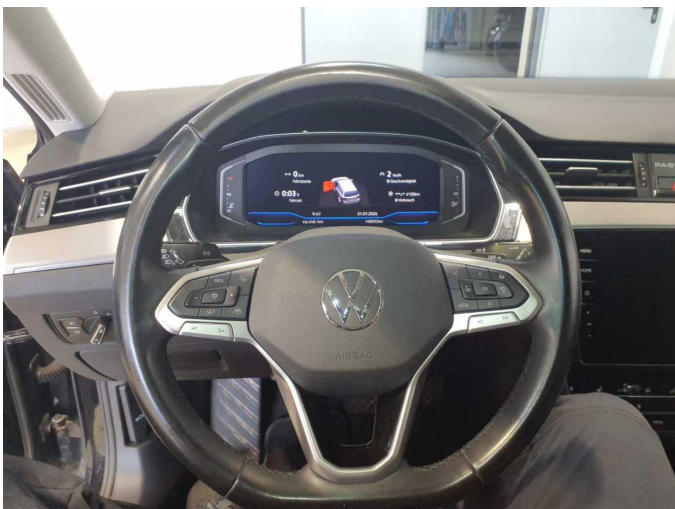
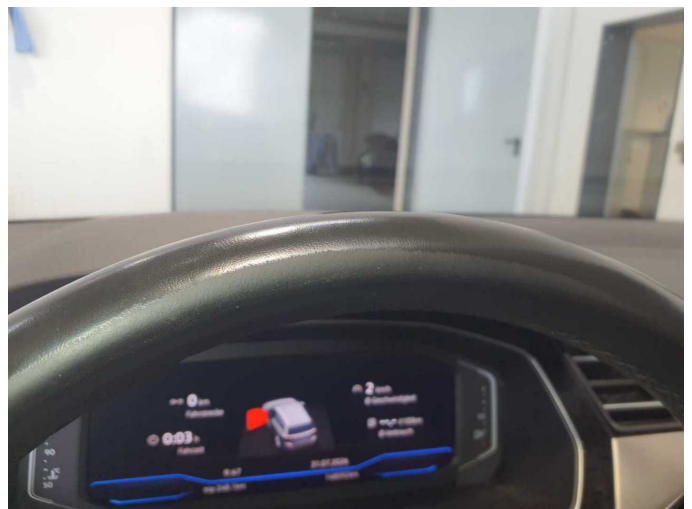
**Wear and tear 5:** Steering system: Steering wheel - Abrasion - No deduction

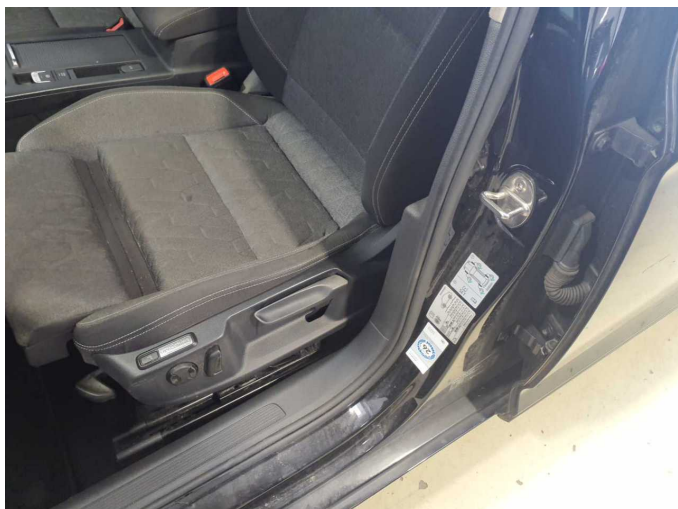
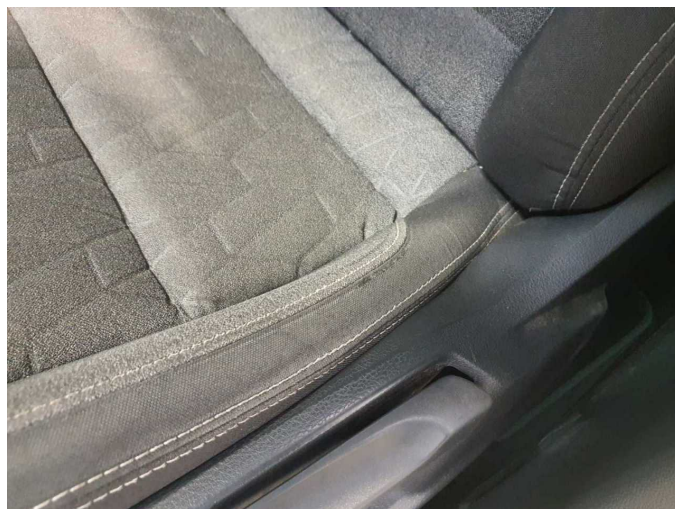
**Wear and tear 6:** Seat - front: Seat cover - left side - Scratch(es) - No deduction

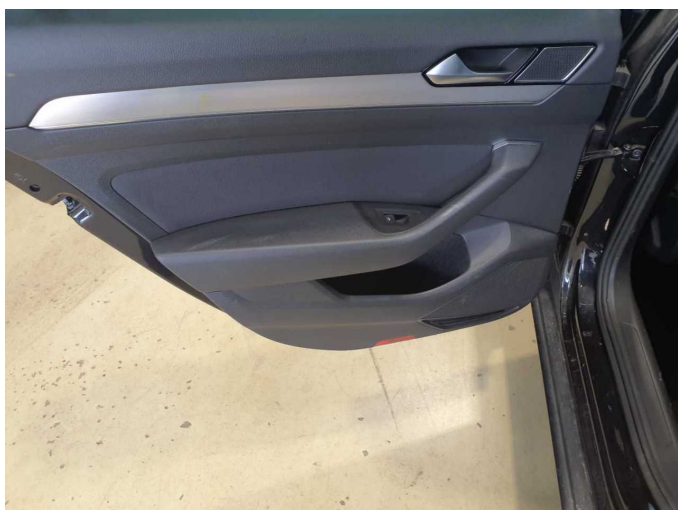
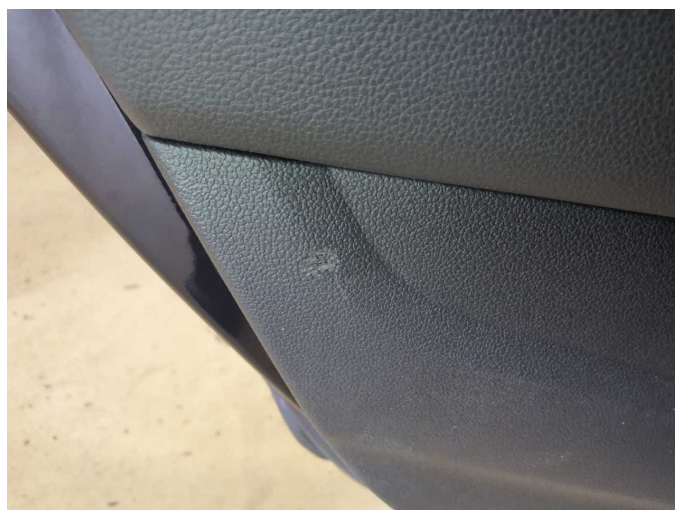
**Wear and tear 7:** Trim / covers: Door trim - rear left side - Scratch(es) - No deduction

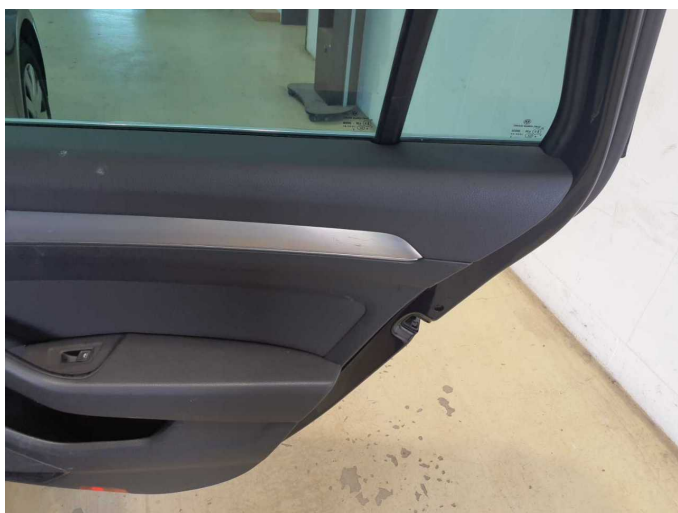
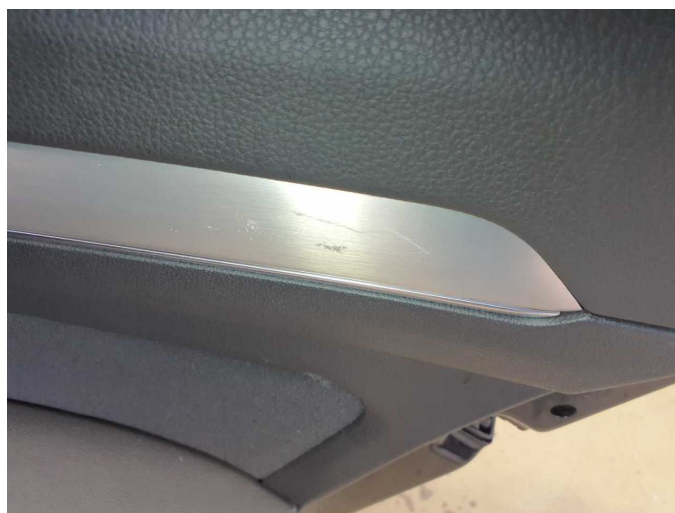
**Wear and tear 8:** Trim / covers: Door trim - rear right side - Scratch(es) - No deduction
