Expertise

Protocol number: 46840719  
Order No. / Reference: 26726164  
Inspection date: 31 Jul 2026

Model: Passat Variant 2.0 TDI SCR DSG Business

VIN: WVGZZZ3CZPE040713

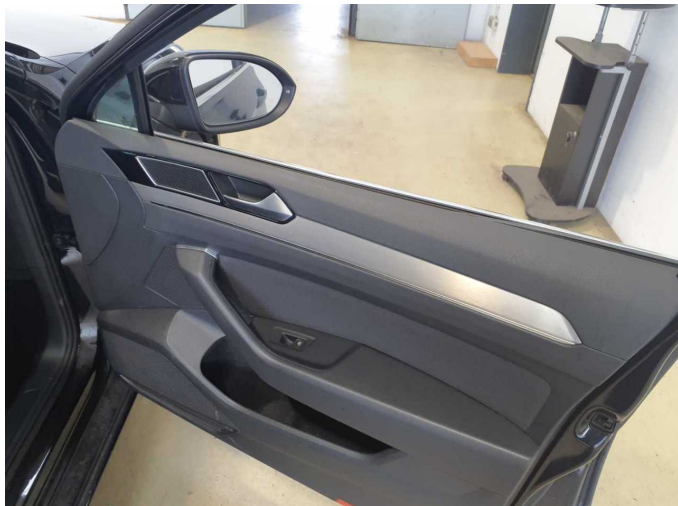
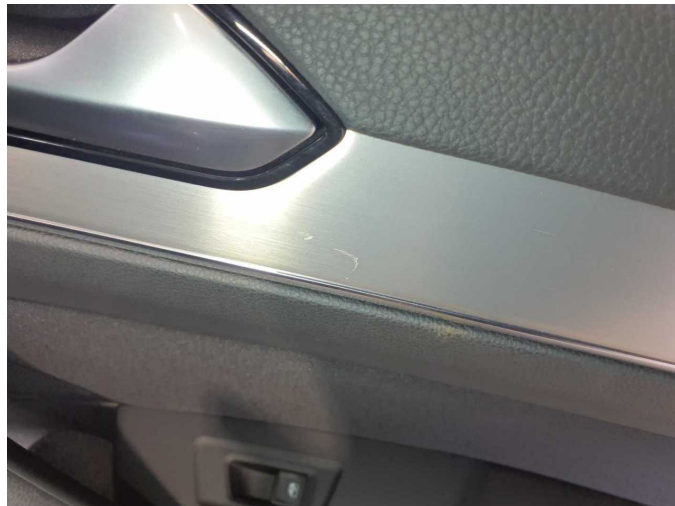
**Wear and tear 9:** Trim / covers: Door trim - front right side - Scratch(es) - No deduction

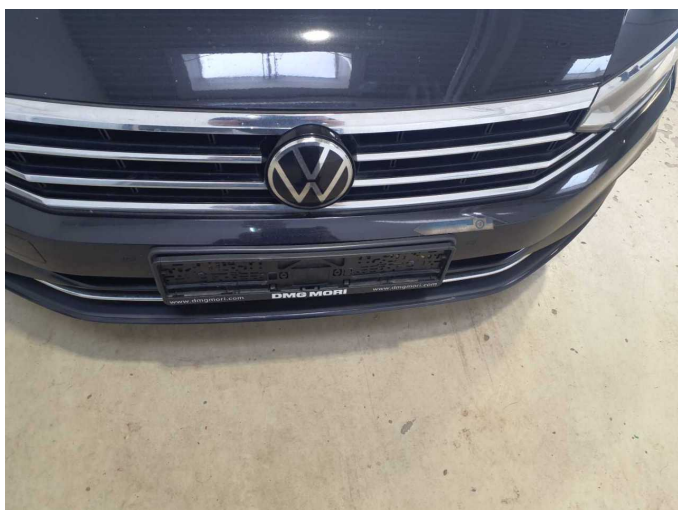
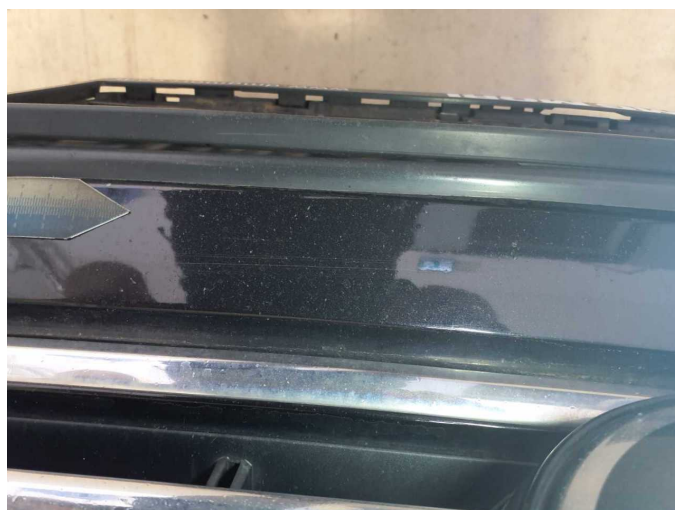
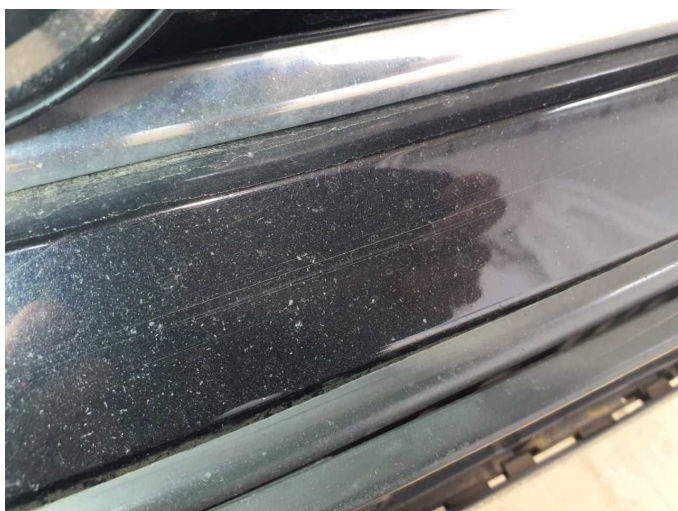
**Wear and tear 10:** Front bumper: Front bumper - Scratch(es) - No deduction

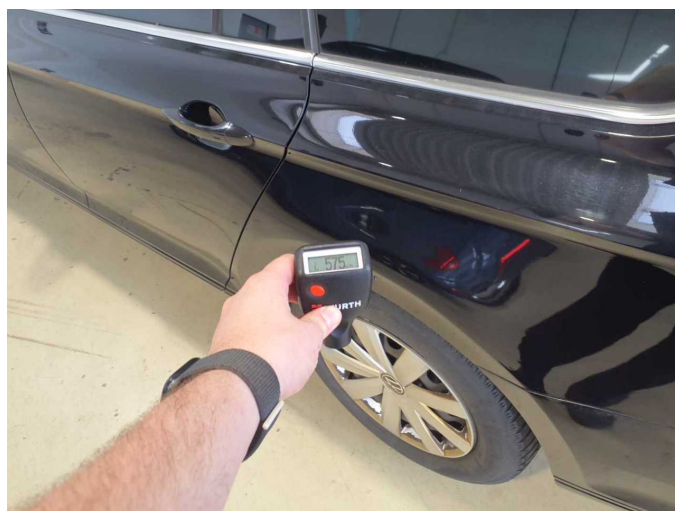
Side panel - rear left side 575 µm |

**Repainting 1:** Side panel - rear left side

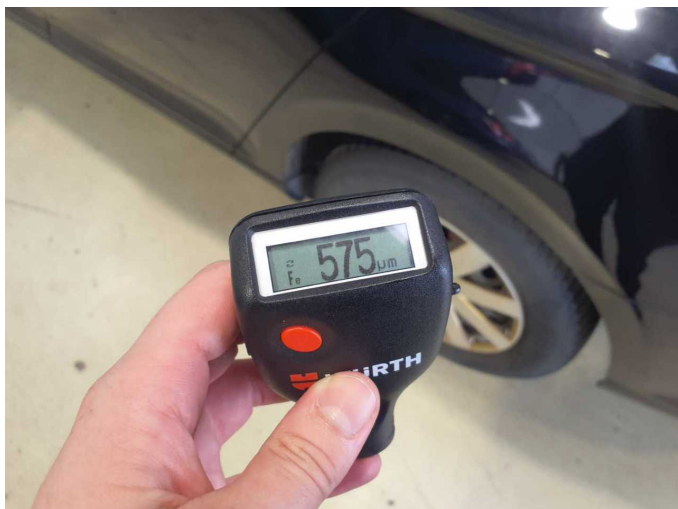
| No. | Component group | Description |
|---|---|---|
| 14 | Side panel - rear left side | Side panel (Spachtel eingefallen) - Unprofessionally repaired - Repair and paint |

- 1 Side panel - rear left side, Unprofessionally carried out, Invoice of repair done Non-existent
