Expertise

Protocol number: 46402139  
Order No. / Reference: 26638780  
Inspection date: 2 Jul 2026

Manufacturer: Opel  
VIN: VXKUHZKWZP4289085

Model: Corsa-e

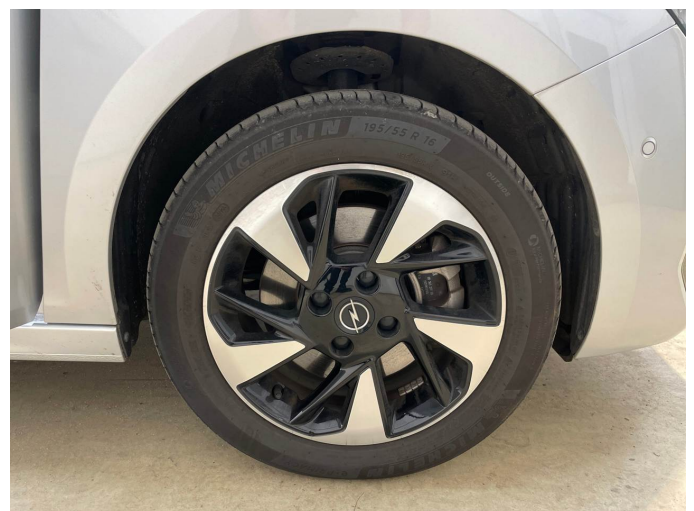
Figure 12: Mounted tyres

| # | Tyre size | Type of tyre | Manufacturer | Tread depth |
|---|---|---|---|---|
| 1) | 195/55 R16 91H | Summer tyres on Light alloy | Michelin | 5mm / 5mm |
| 2) | 195/55 R16 91H | Summer tyres on Light alloy | Michelin | 5mm / 5mm |

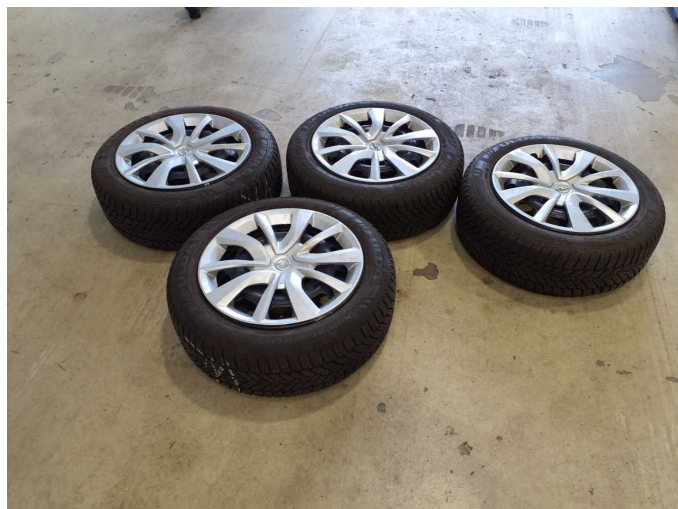
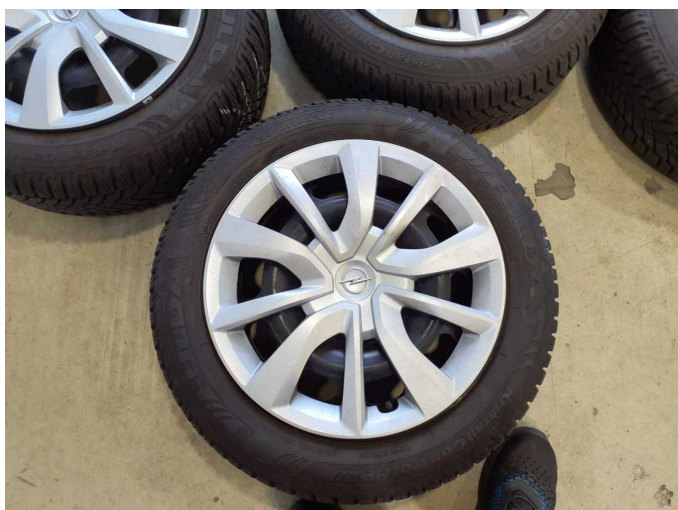
Figure 14: Additional tyres

| # | Tyre size | Type of tyre | Manufacturer | Tread depth |
|---|---|---|---|---|
| 1) | 195/55 R16 87H | Winter tyres on Steel rim with wheel cover | Fulda | 8mm / 8mm |
| 2) | 195/55 R16 87H | Winter tyres on Steel rim with wheel cover | Fulda | 8mm / 8mm |

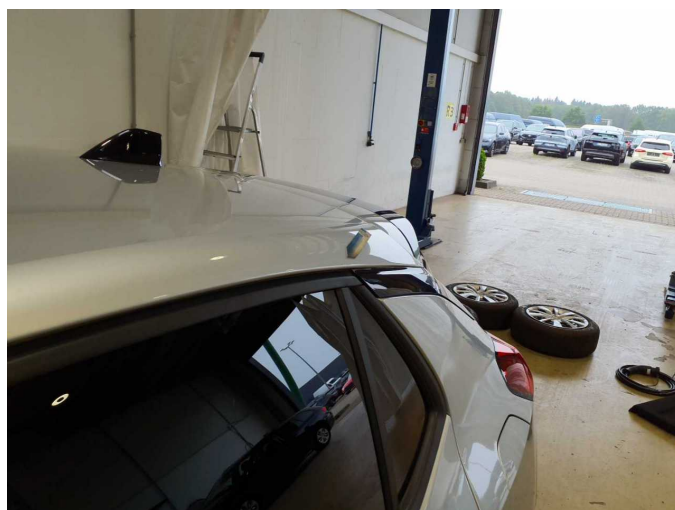
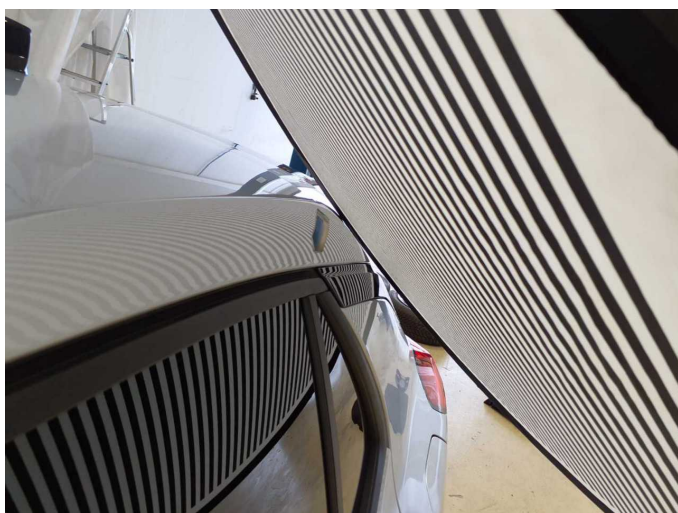
| No. | Component group | Description |
|---|---|---|
| 1 | Roof | Roof rail - left side - dent(s) - Smooth repair work |

Damage 1: Roof: Roof rail - left side - dent(s) - Smooth repair work

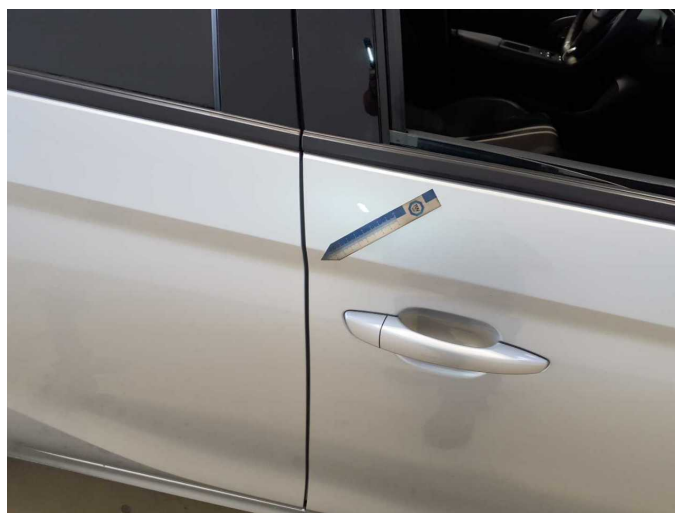
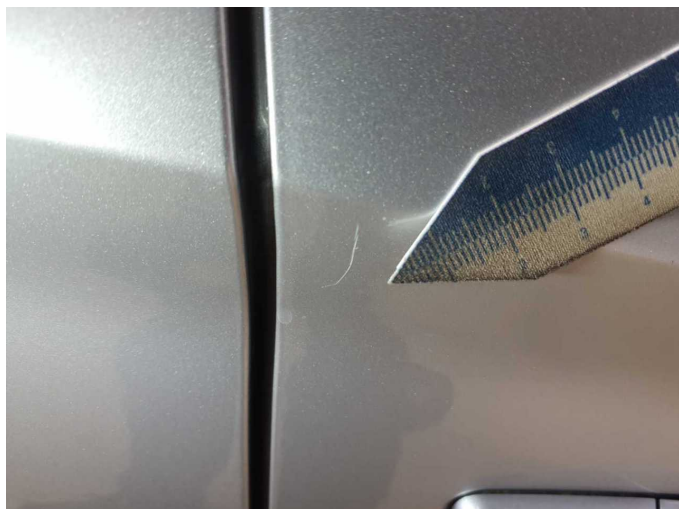
| No. | Component group | Description |
|---|---|---|
| 2 | Door - front right side | Door - Scratch(es) - Smart repair |

Damage 2: Door - front right side: Door - Scratch(es) - Smart repair

**Damage 2:** Door - front right side: Door - Scratch(es) - Smart repair

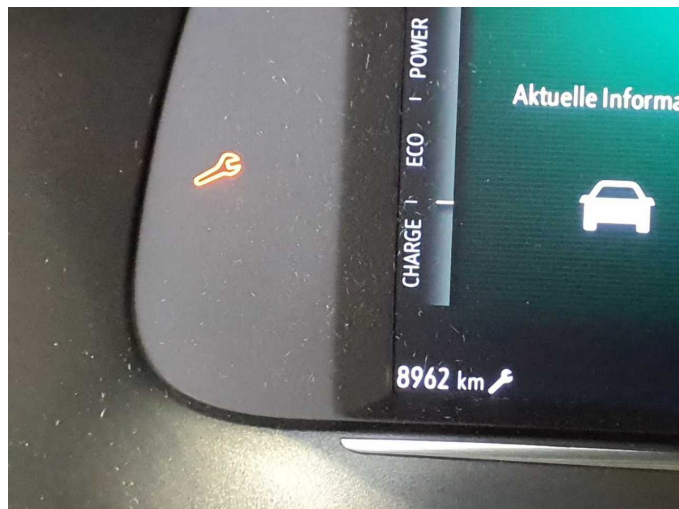
| No. | Component group | Description |
|---|---|---|
| 3 | Misc. | Inspection / maintenance - Due - Perform |

**Damage 3:** Misc.: Inspection / maintenance - Due - Perform

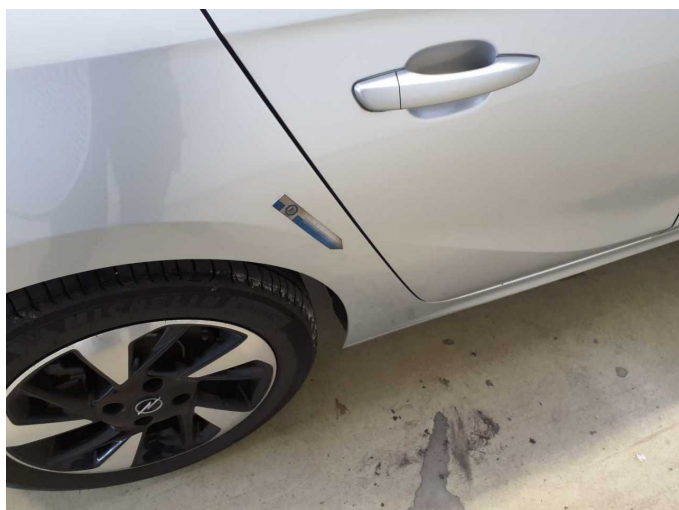
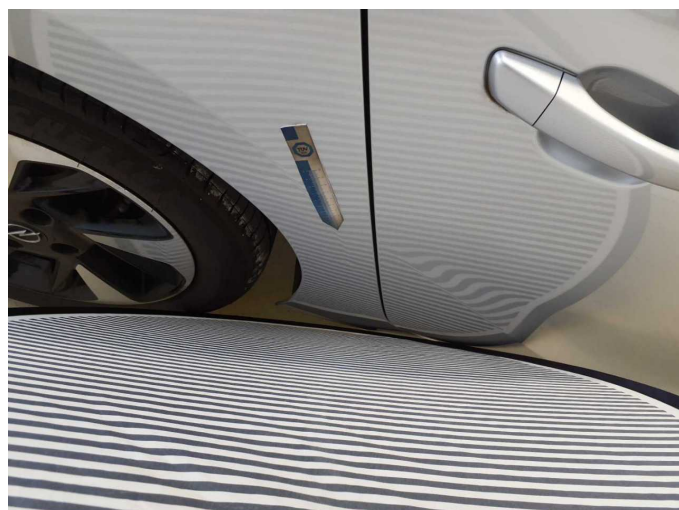
| No. | Component group | Description |
|---|---|---|
| 6 | Side panel - rear right side | Side panel - dent(s) - No deduction |

**Wear and tear 6:** Side panel - rear right side: Side panel - dent(s) - No deduction

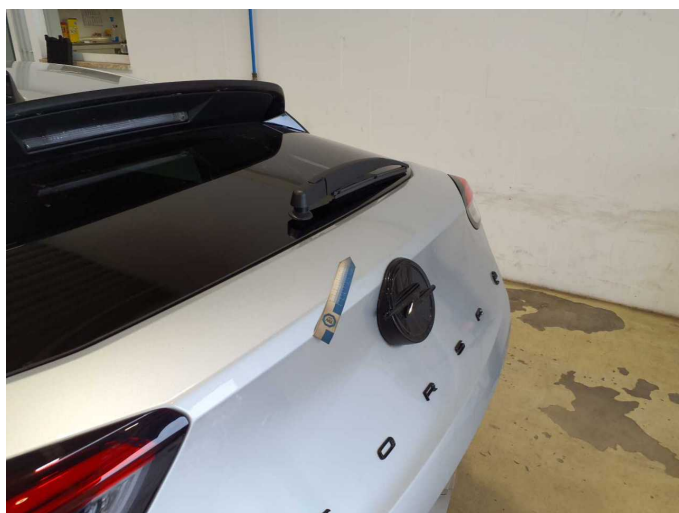
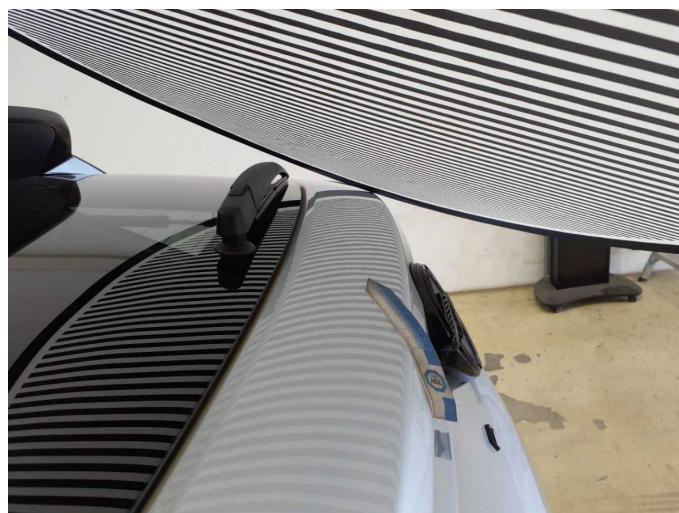
| No. | Component group | Description |
|---|---|---|
| 7 | Boot lid / rear door | Boot lid - dent(s) - No deduction |

**Wear and tear 7:** Boot lid / rear door: Boot lid - dent(s) - No deduction
