Expertise

Protocol number: 46641633  
Order No. / Reference: 26685315  
Inspection date: 22 Jul 2026

Manufacturer: Ford

Model: Mondeo Turnier 2.0 EcoBlue Aut. Titanium

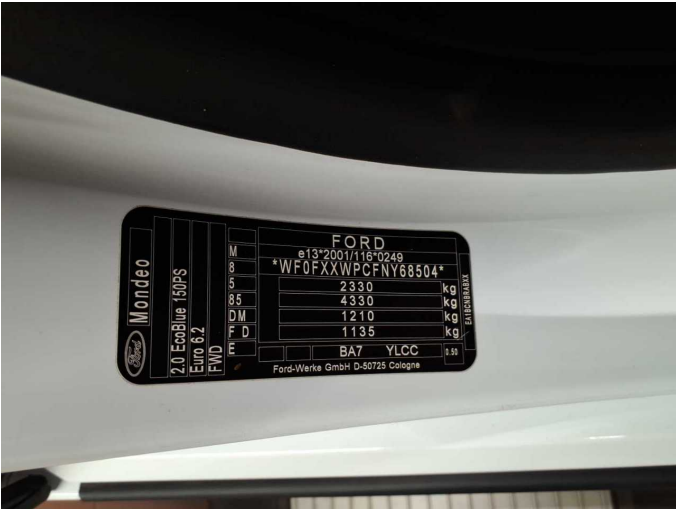
Figure 11: VIN

| VIN comparison | The vehicle identification number (VIN) was read from the vehicle and its conformity with the submitted documents was confirmed by the undersigned during the inspection. |

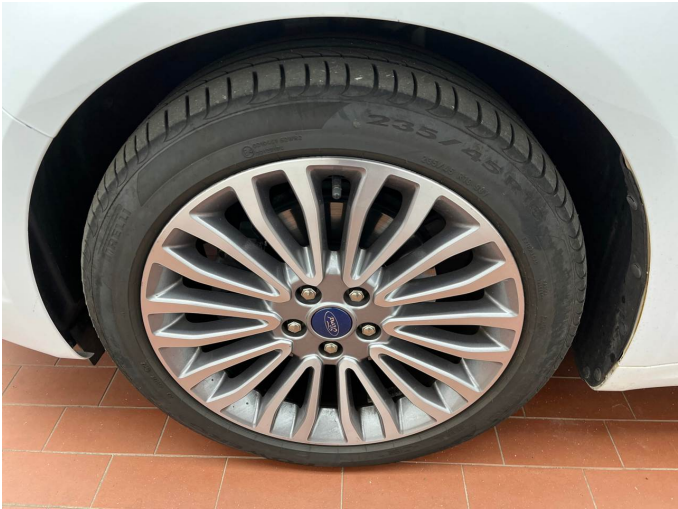
Figure 12: Mounted tyres

| Mounted tyres | | | | |
|---|---|---|---|---|
| 1) | 235/45 R18 98Y | Summer tyres on Light alloy | Pirelli | 5mm / 5mm |
| 2) | 235/45 R18 98Y | Summer tyres on Light alloy | Pirelli | 5mm / 5mm |

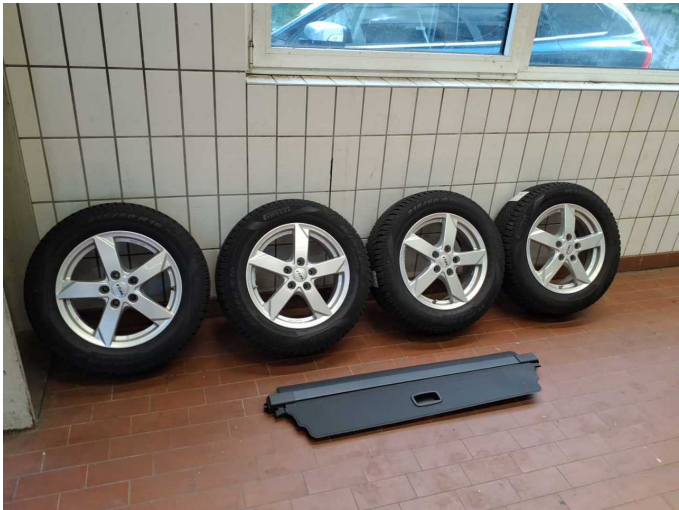
Figure 16: Additional tyres

| Mounted tyres | | | | |
|---|---|---|---|---|
| 1) | 215/60 R16 99H | Winter tyres on Light alloy | Pirelli | 6mm / 6mm |
| 2) | 215/60 R16 99H | Winter tyres on Light alloy | Pirelli | 8mm / 8mm |

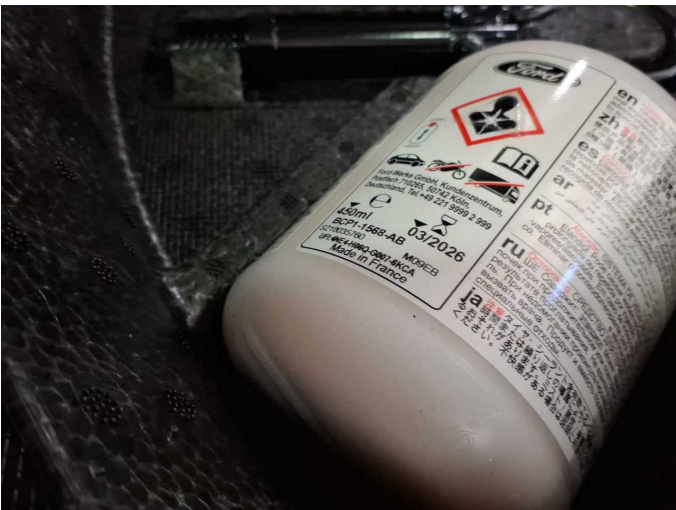
| No. | Component group | Description |
|---|---|---|
| 1 | Equipment | Tirefit filler - Due - Replace |

Damage 1: Equipment: Tirefit filler - Due - Replace

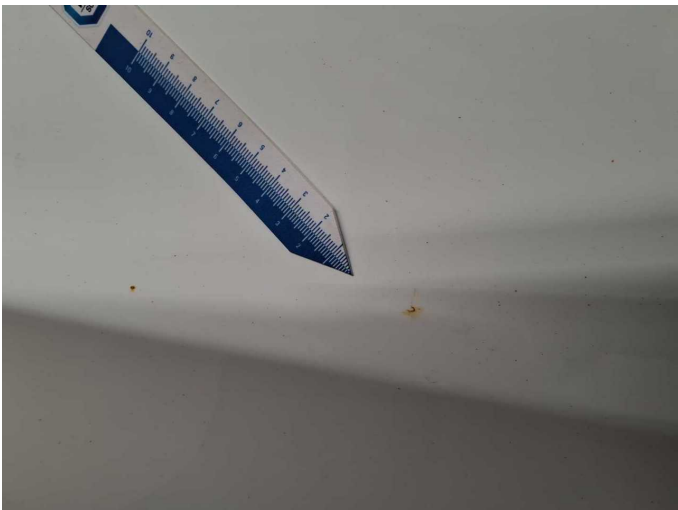
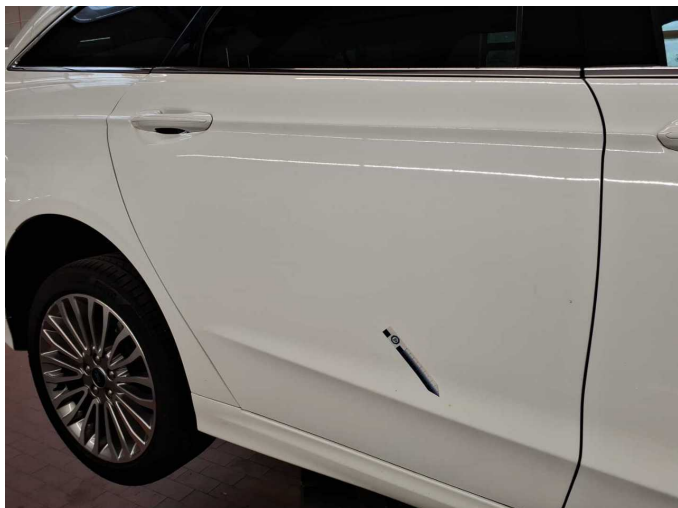
| No. | Component group | Description |
|---|---|---|
| 2 | Door - rear right side | Door (Flugrost - Mehrkosten können entstehen) - Corrosion - Conditioning |

Damage 2: Door - rear right side: Door (Flugrost - Mehrkosten können entstehen) - Corrosion - Conditioning

**Damage 2:** Door - rear right side: Door (Flugrost - Mehrkosten können entstehen) - Corrosion - Conditioning

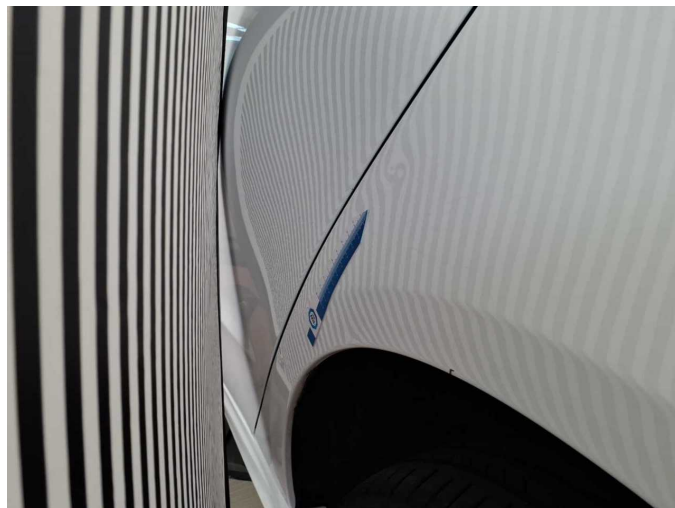
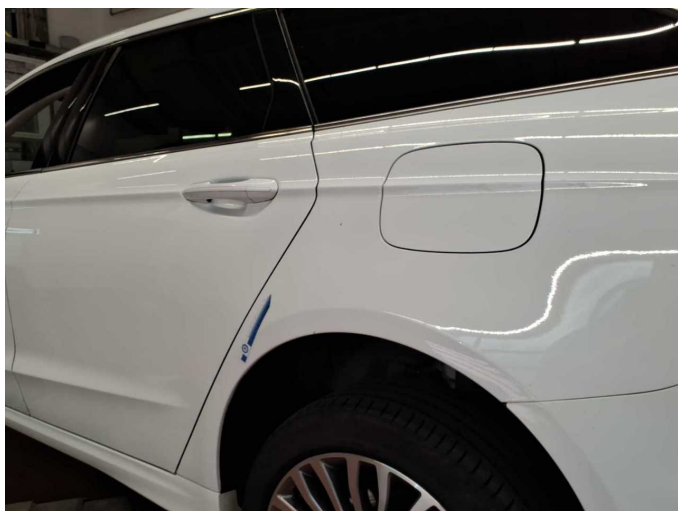
| No. | Component group | Description |
|---|---|---|
| 3 | Side panel - rear left side | Side panel - dent(s) - Smooth repair work |

**Damage 3:** Side panel - rear left side: Side panel - dent(s) - Smooth repair work

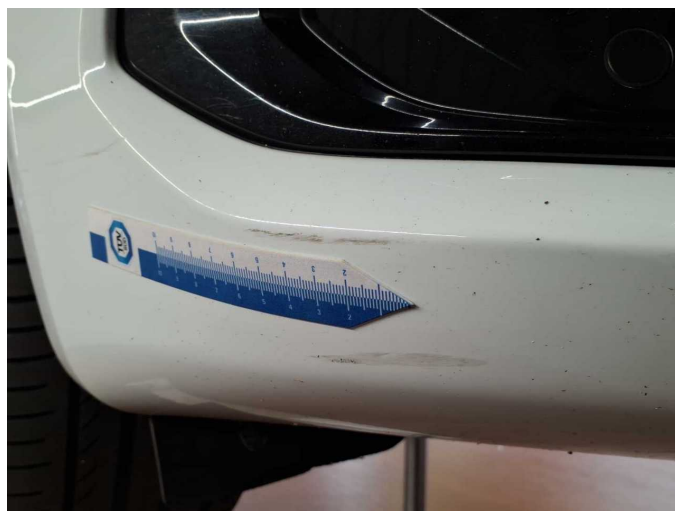
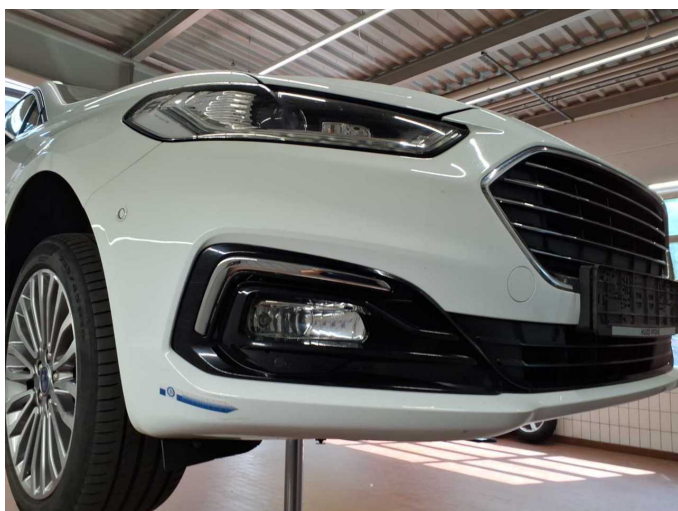
| No. | Component group | Description |
|---|---|---|
| 4 | Front bumper | Front bumper - Scratch(es) - Smart repair |

**Damage 4:** Front bumper: Front bumper - Scratch(es) - Smart repair

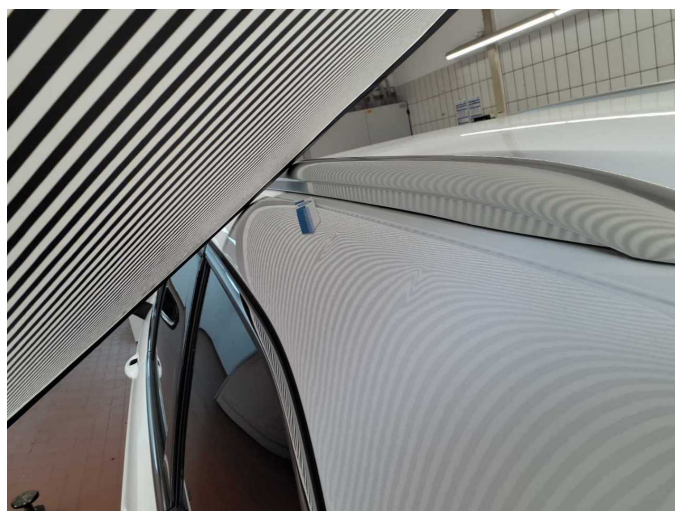
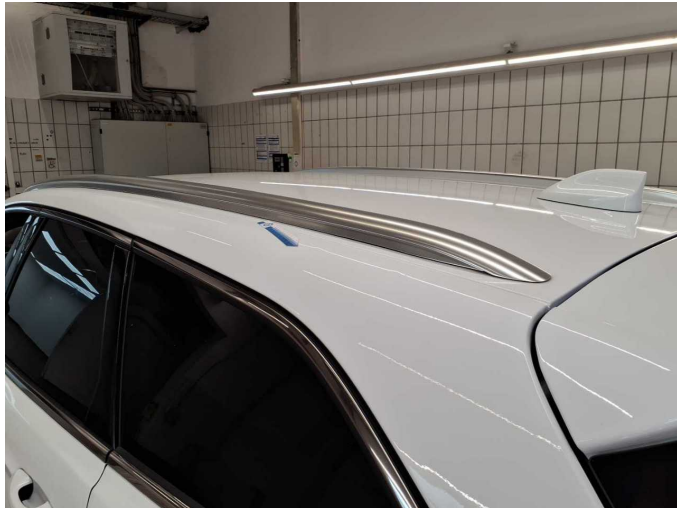
| No. | Component group | Description |
|---|---|---|
| 5 | Roof | Roof rail - left side - dent(s) - Smooth repair work |

**Damage 5:** Roof: Roof rail - left side - dent(s) - Smooth repair work

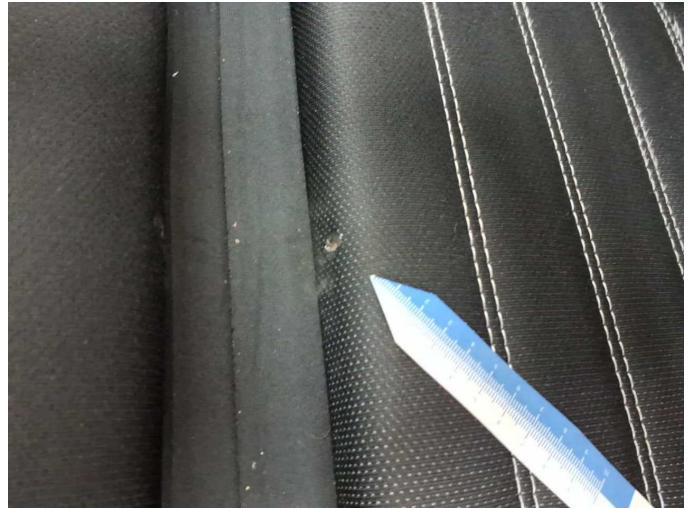
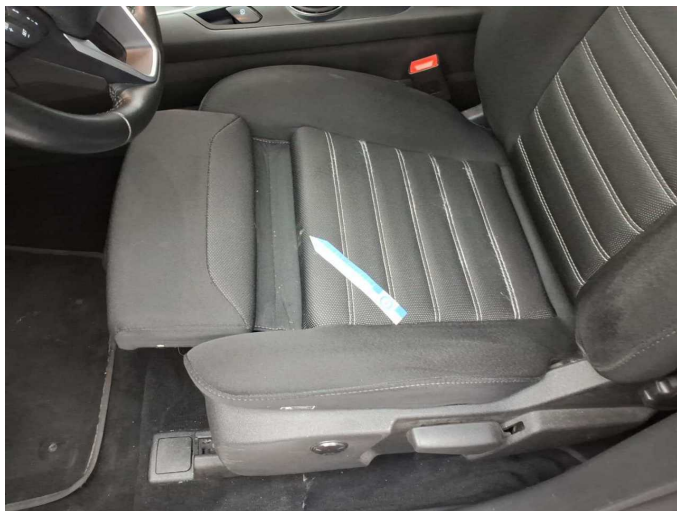
| No. | Component group | Description |
|---|---|---|
| 7 | Seat - front | Seat cover - left side - Burn hole (cigarettes) - Smart repair |

**Damage 7:** Seat - front: Seat cover - left side - Burn hole (cigarettes) - Smart repair

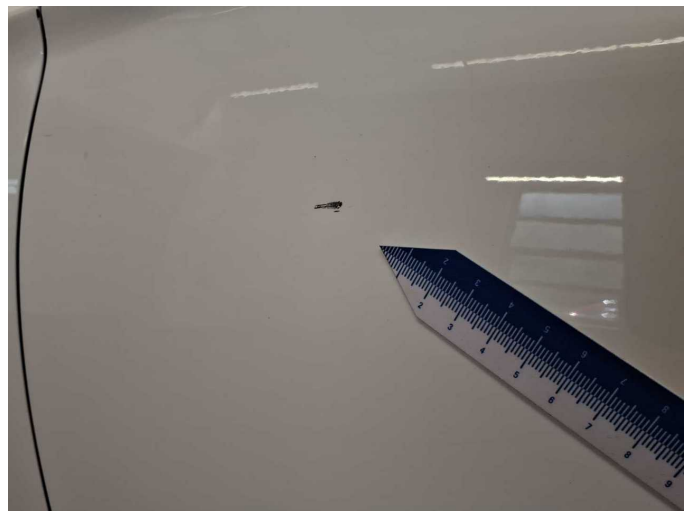
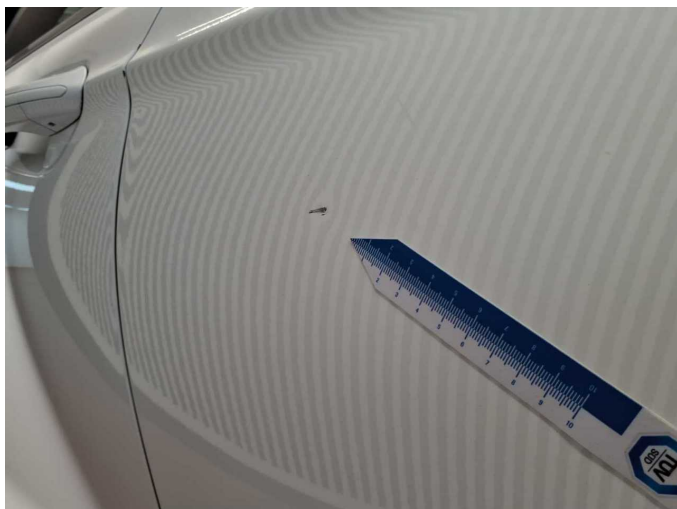
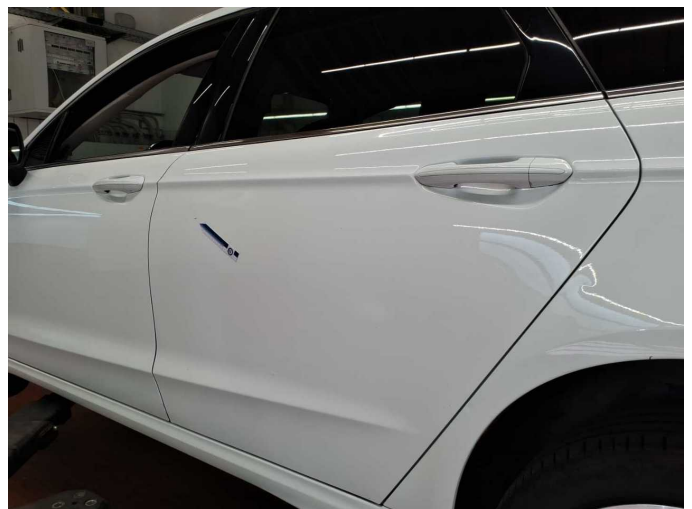
| No. | Component group | Description |
|---|---|---|
| 8 | Door - rear left side | Door - Dent / paintcoat damage - Smart repair |

**Damage 8:** Door - rear left side: Door - Dent / paintcoat damage - Smart repair

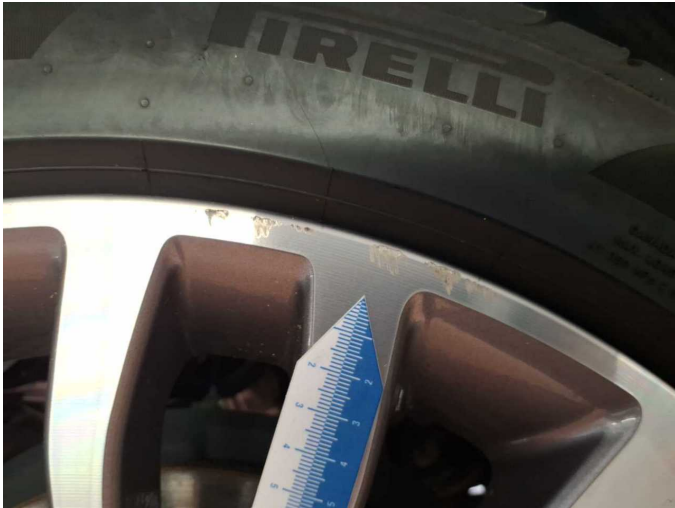
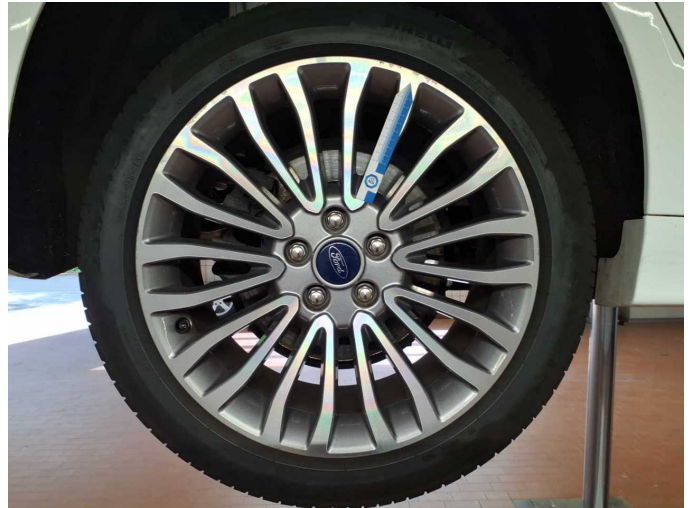
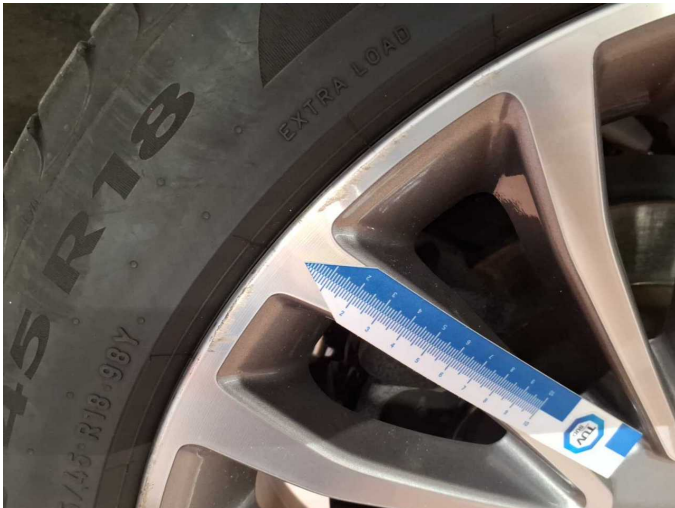
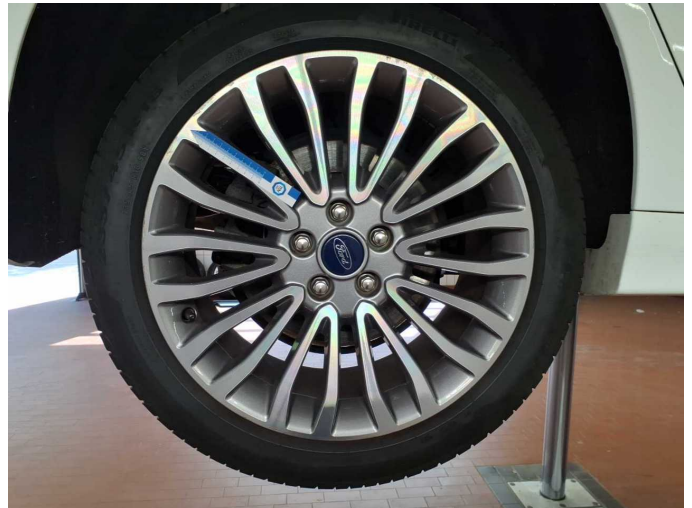
| No. | Component group | Description |
|---|---|---|
| 9 | Wheel / tyres | Alloy rim - rear right side - Scratch(es) - Loss in value |

**Damage 9:** Wheel / tyres: Alloy rim - rear right side - Scratch(es) - Loss in value

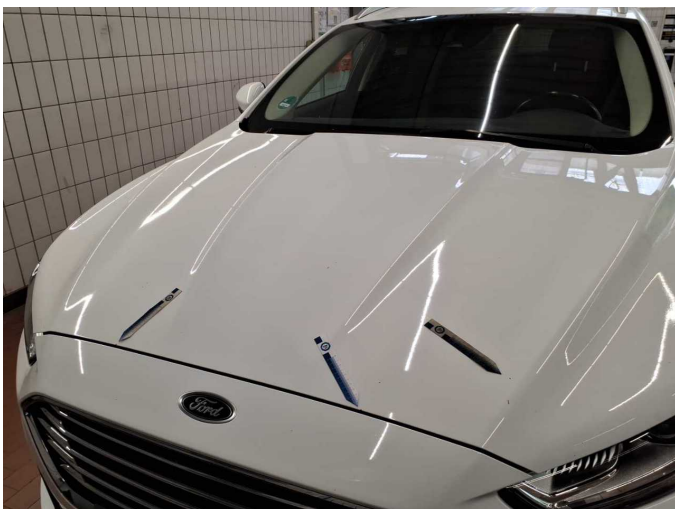
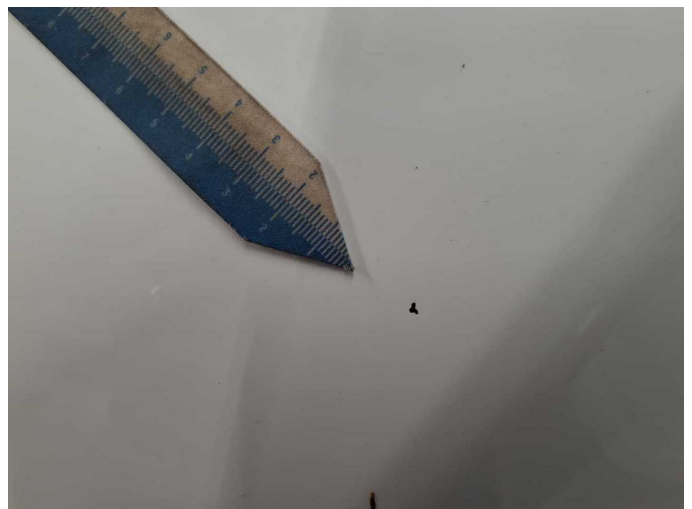
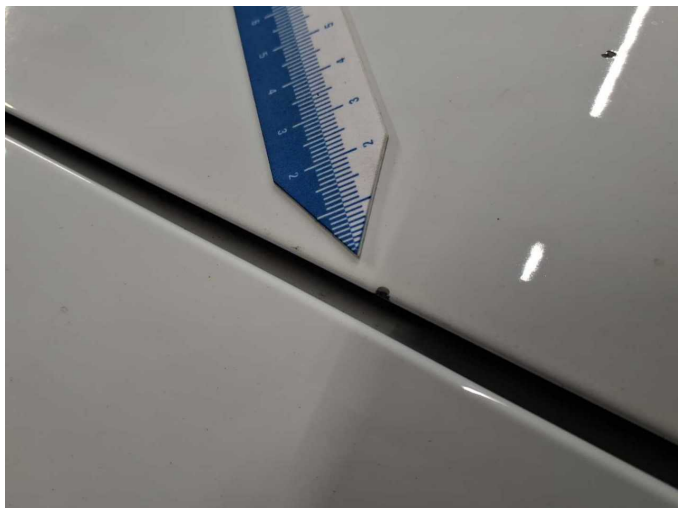
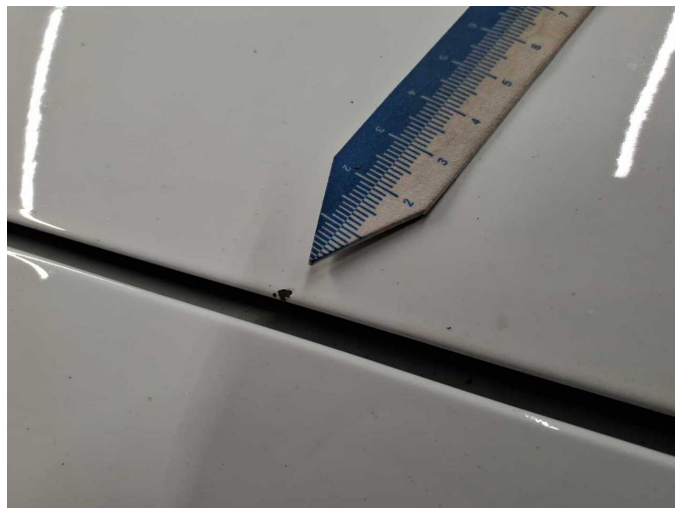
| No. | Component group | Description |
|---|---|---|
| 10 | Bonnet | Bonnet - Stone chips - Paint |

**Damage 10:** Bonnet: Bonnet - Stone chips - Paint

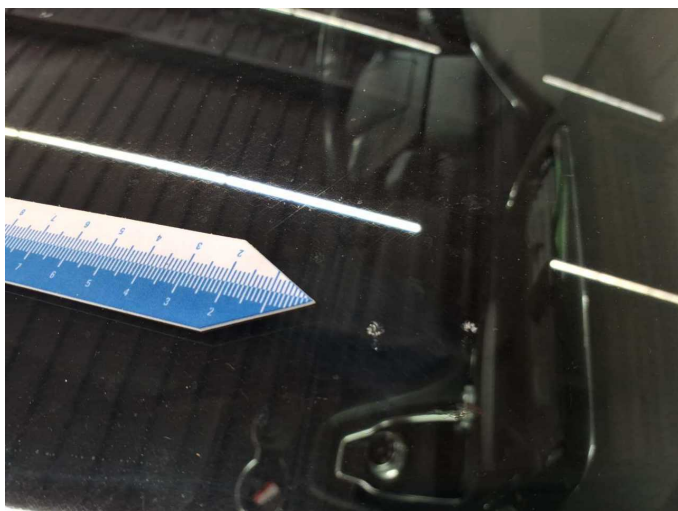
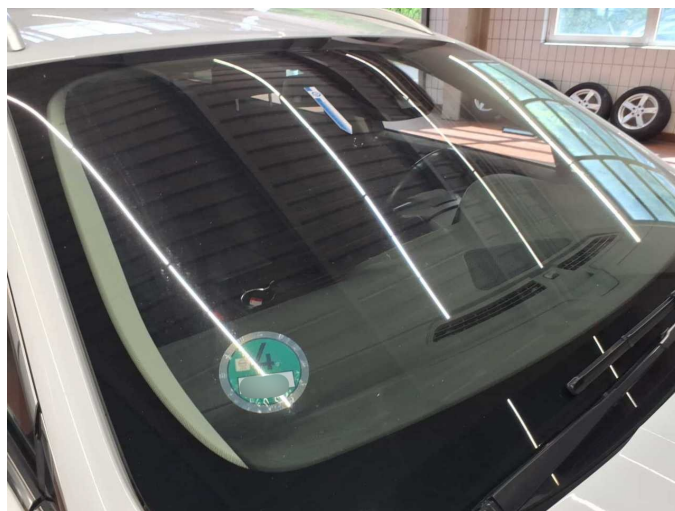
| No. | Component group | Description |
|---|---|---|
| 4 | Vehicle glazing | Windscreen - Stone chips - No deduction |

**Wear and tear 4:** Vehicle glazing: Windscreen - Stone chips - No deduction

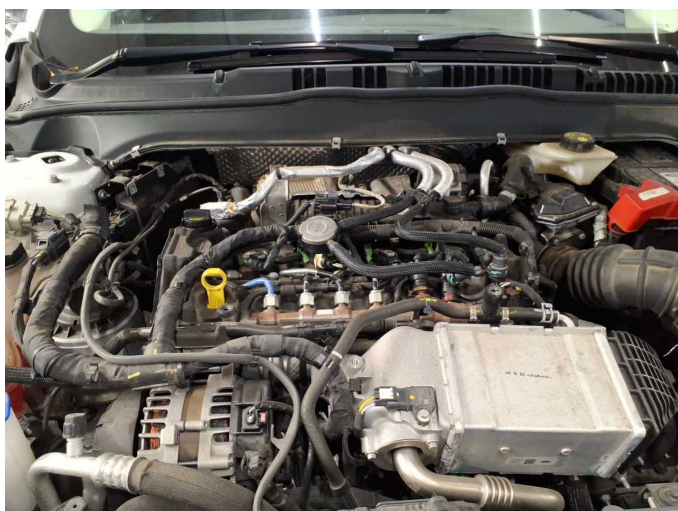
Engine - Engine cover

**Missing part 1:** Engine: Engine cover - Missing - Replace
