Expertise

Protocol number: 46120788  
Order No. / Reference: 26510037  
Inspection date: 23 Jun 2026

Manufacturer: Skoda  
VIN: TMBJJ7NS8P8038611

Model: Kodiaq 2.0 TDI DSG Tour

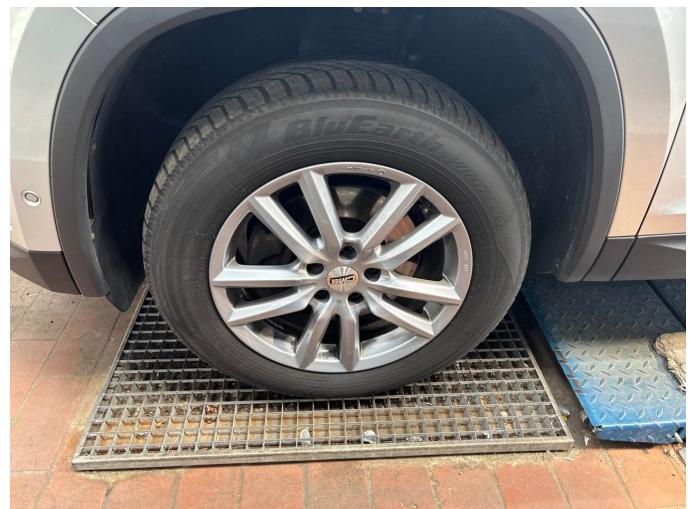
**Figure 12: Mounted tyres**

| # | Tyre size | Type of tyre | Manufacturer | Tread depth |
|---|---|---|---|---|
| 1) | 215/65 R17 99V | Winter tyres on Light alloy | Yokohama | 1mm / 1mm |
| 2) | 215/65 R17 99V | Winter tyres on Light alloy | Yokohama | 6mm / 6mm |

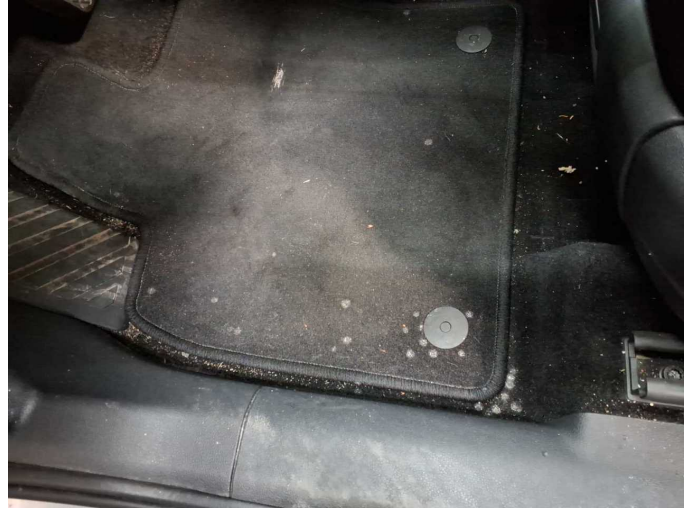
| No. | Component group | Description |
|---|---|---|
| 2 | Trim / covers | Floor mats (Brandlöcher) - Burn hole (cigarettes) - Replace |

**Damage 2:** Trim / covers: Floor mats (Brandlöcher) - Burn hole (cigarettes) - Replace

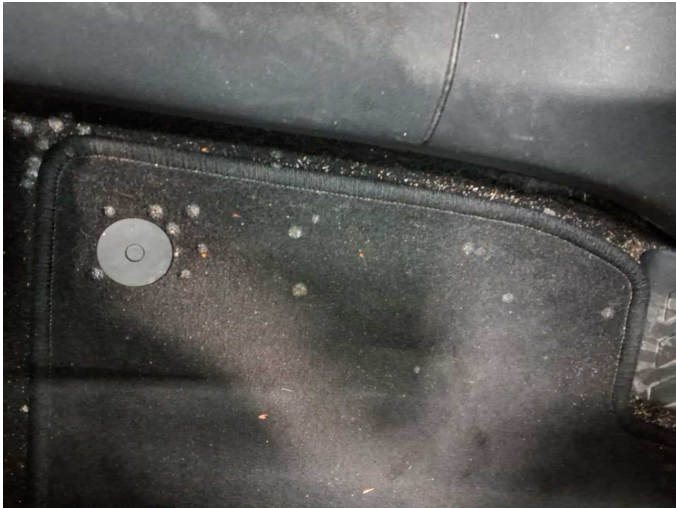
**Damage 2:** Trim / covers: Floor mats (Brandlöcher) - Burn hole (cigarettes) - Replace

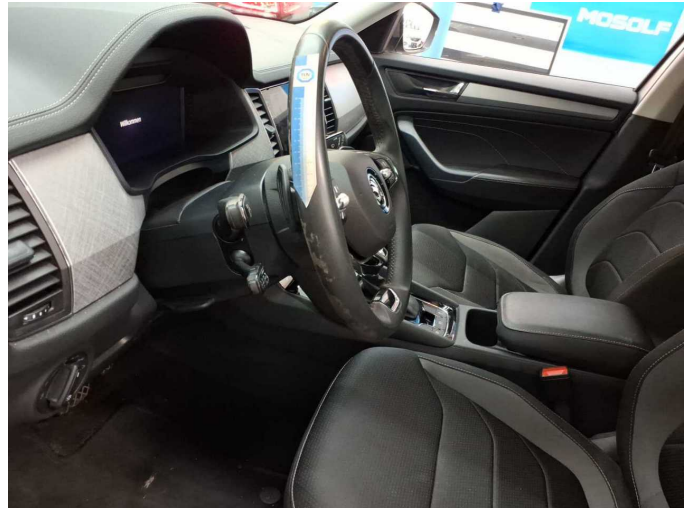
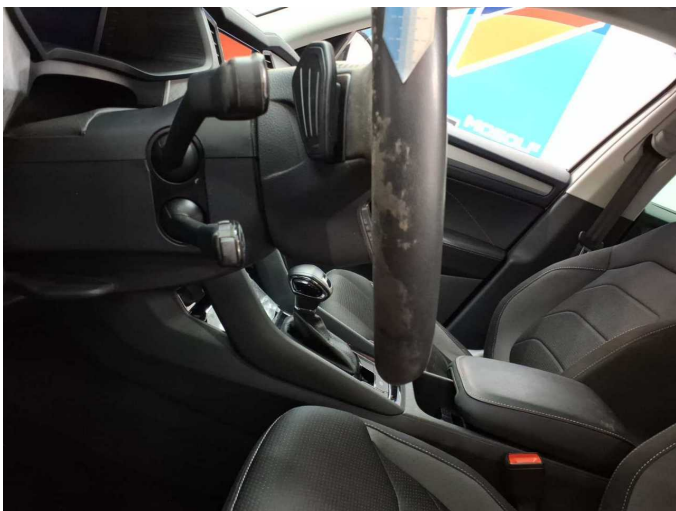
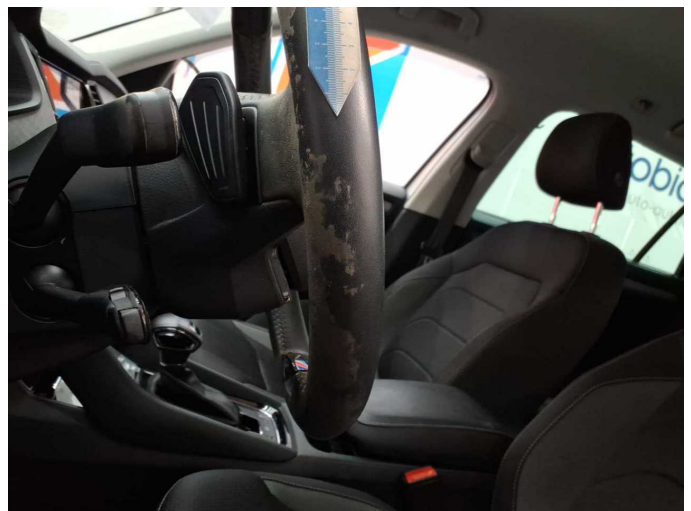
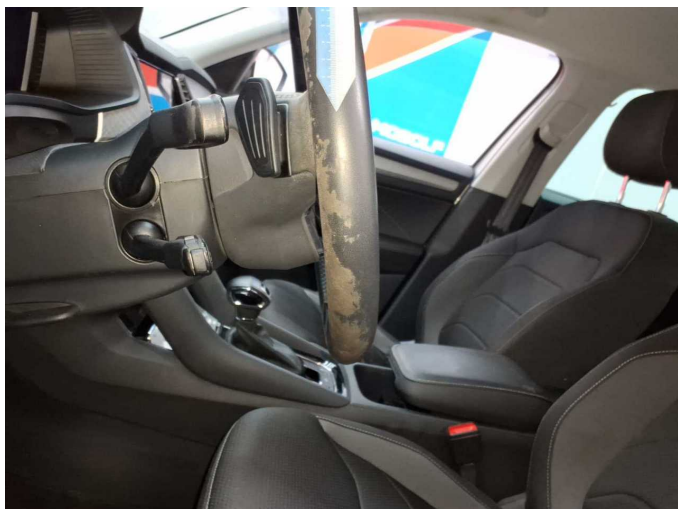
| No. | Component group | Description |
|---|---|---|
| 4 | Steering system | Steering wheel - Abrasion - Smart repair |

**Damage 4:** Steering system: Steering wheel - Abrasion - Smart repair

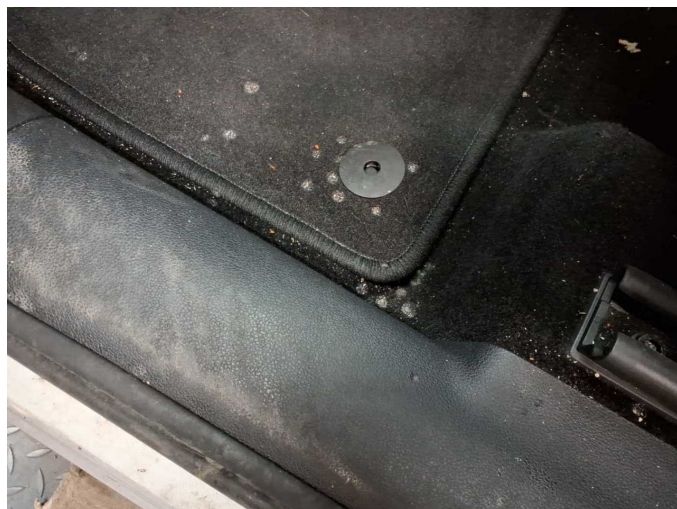
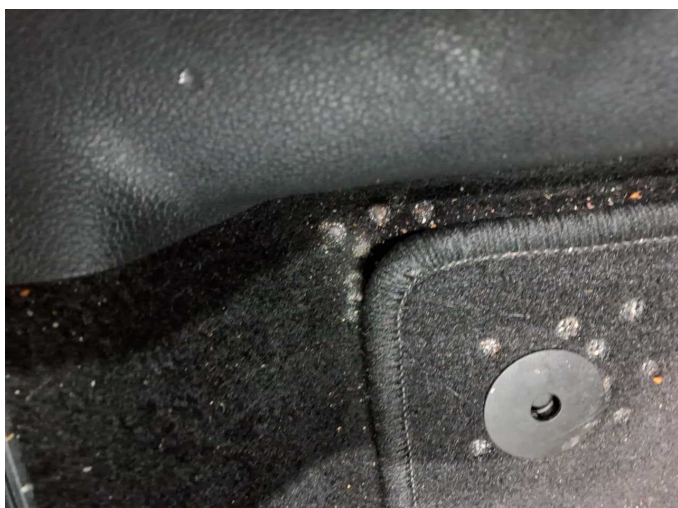
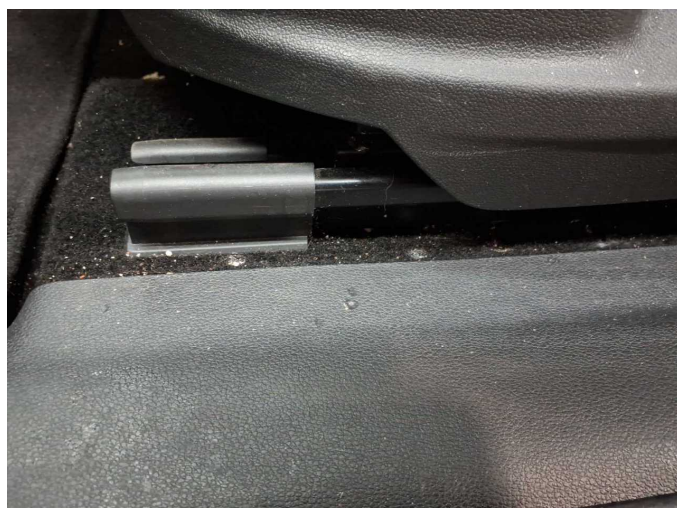
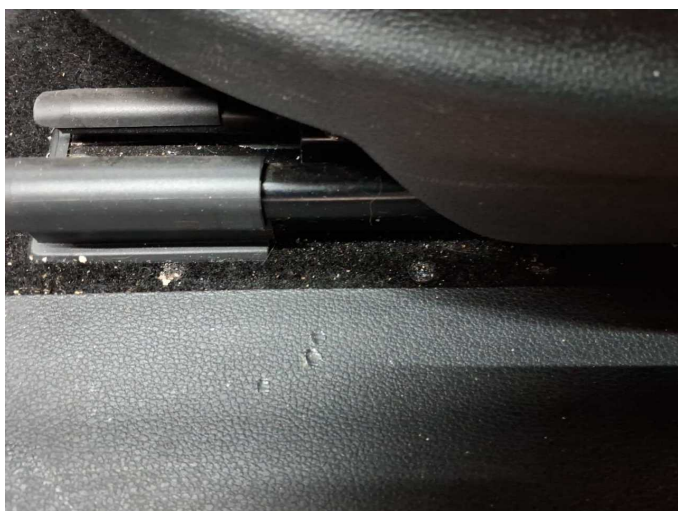
| No. | Component group | Description |
|---|---|---|
| 5 | Trim / covers | Carpet (+ Einstiegsleiste links) - Holes - Smart repair |

**Damage 5:** Trim / covers: Carpet (+ Einstiegsleiste links) - Holes - Smart repair

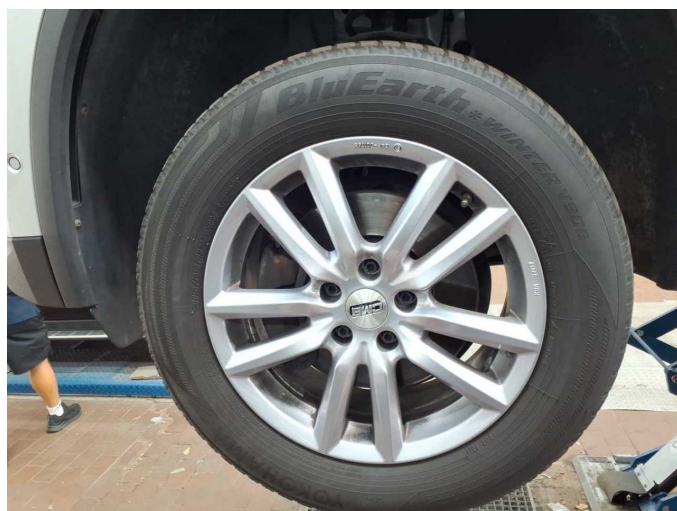
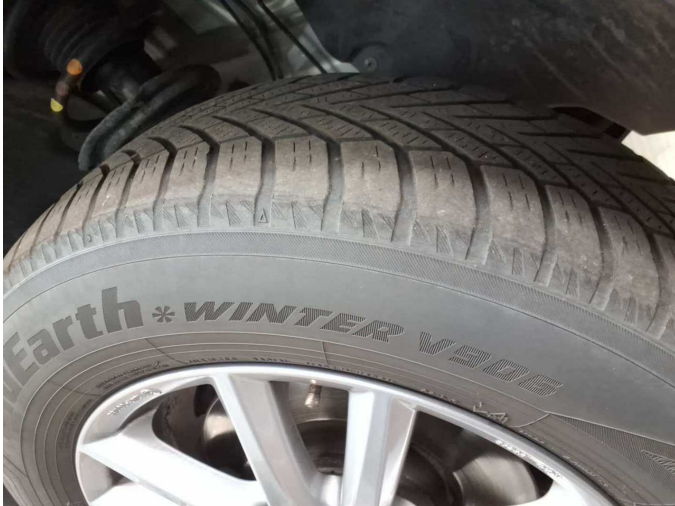
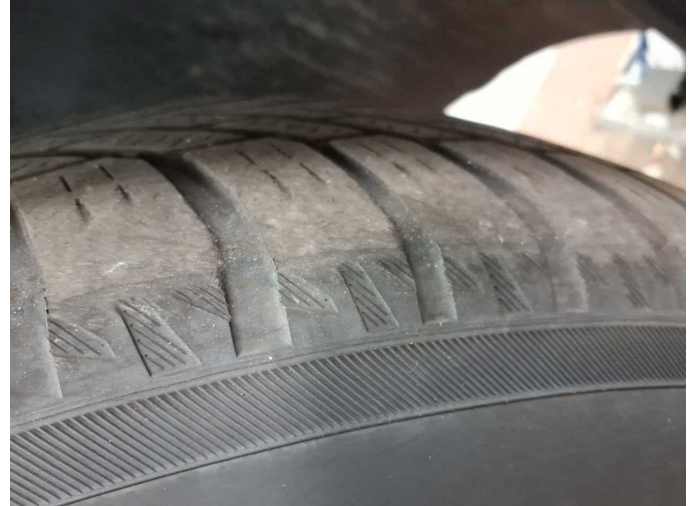
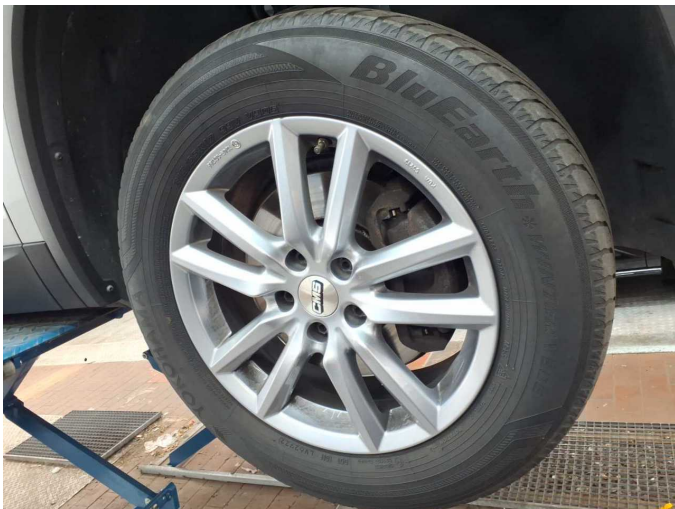
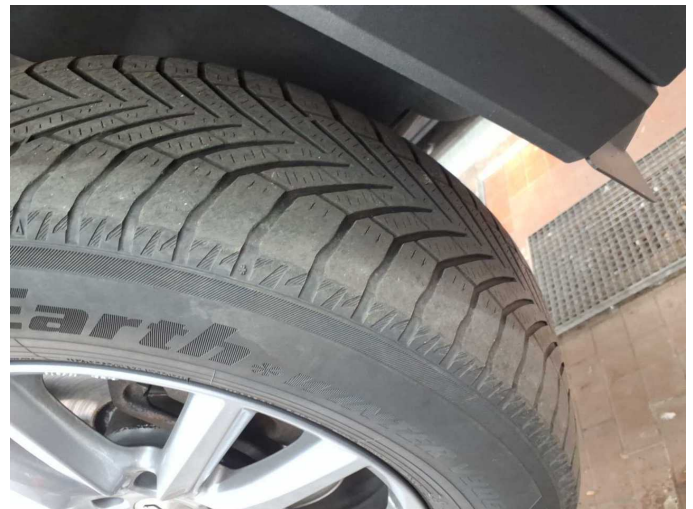
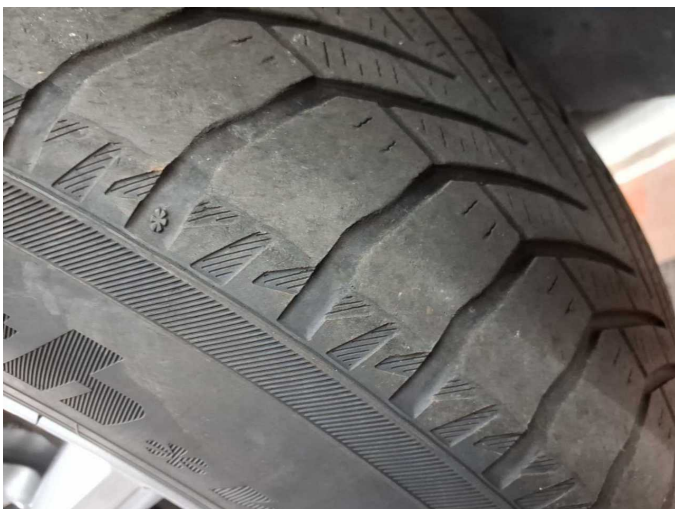
| No. | Component group | Description |
|---|---|---|
| 3 | Wheel / tyres | Tyre - front - Abrasion - No deduction |

**Wear and tear 3:** Wheel / tyres: Tyre - front - Abrasion - No deduction

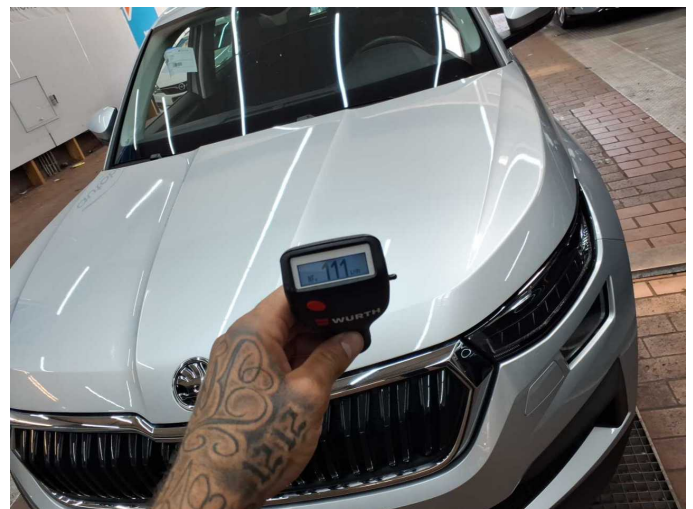
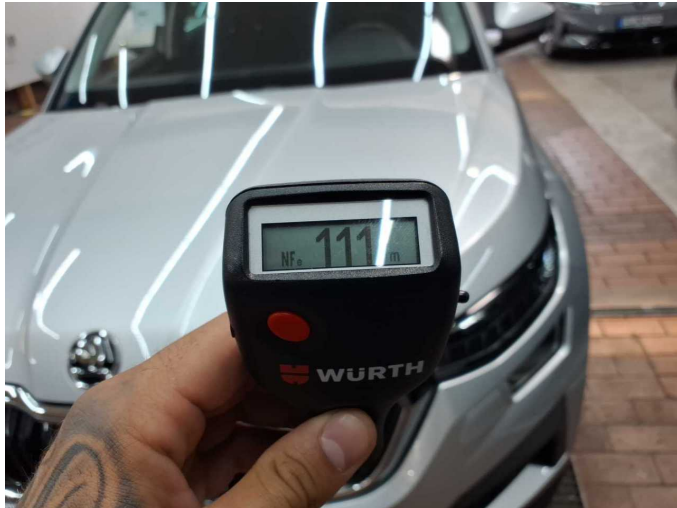
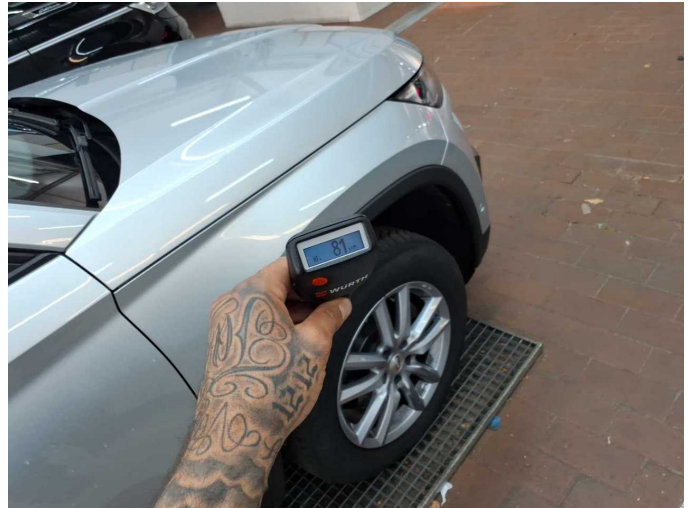
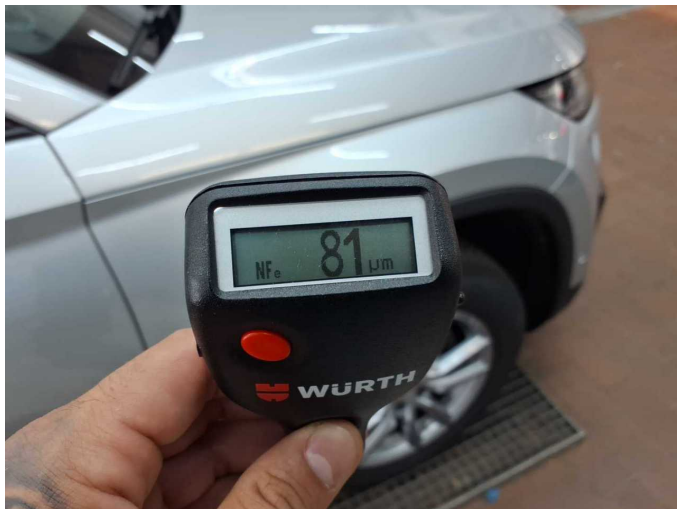
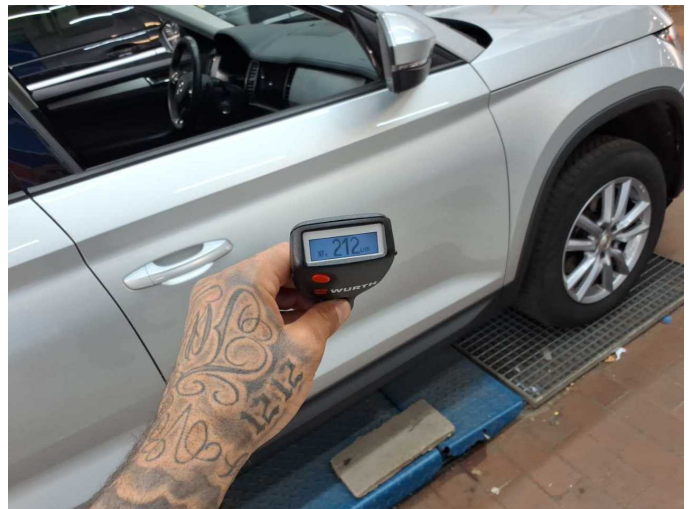
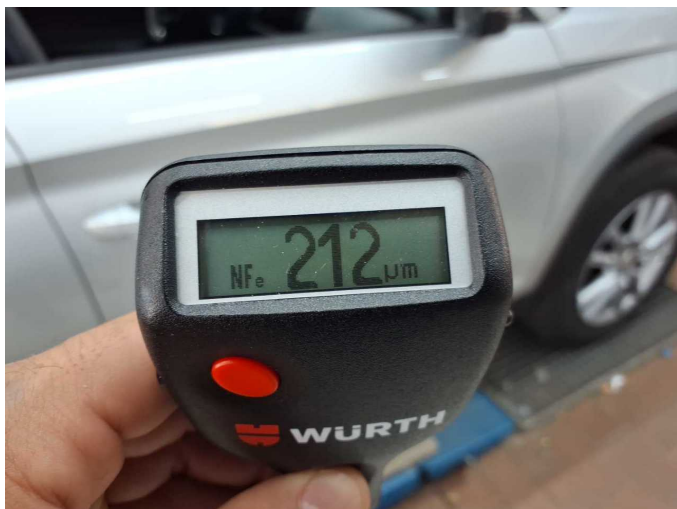
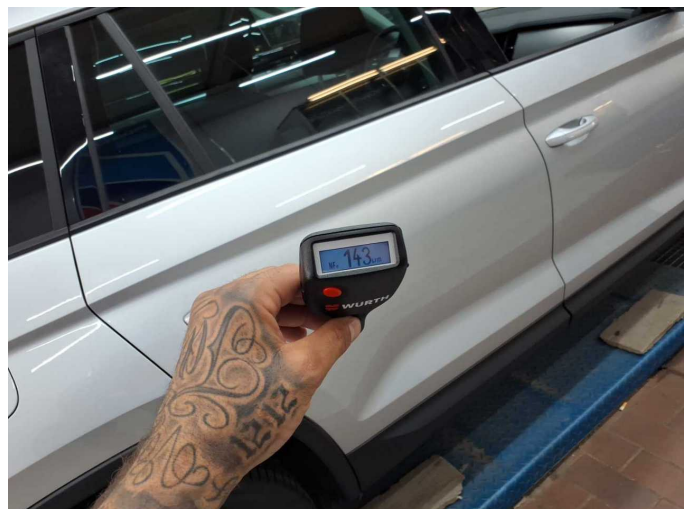
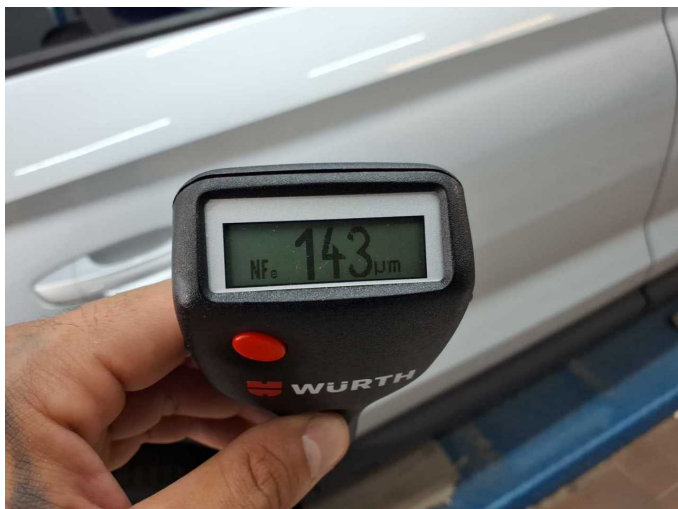
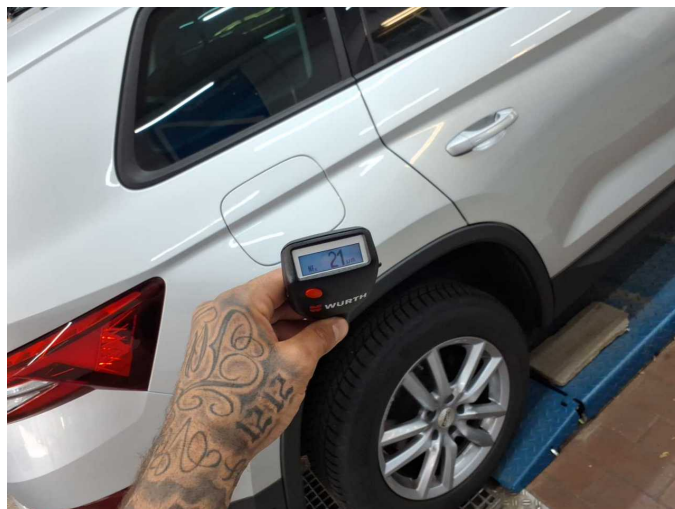
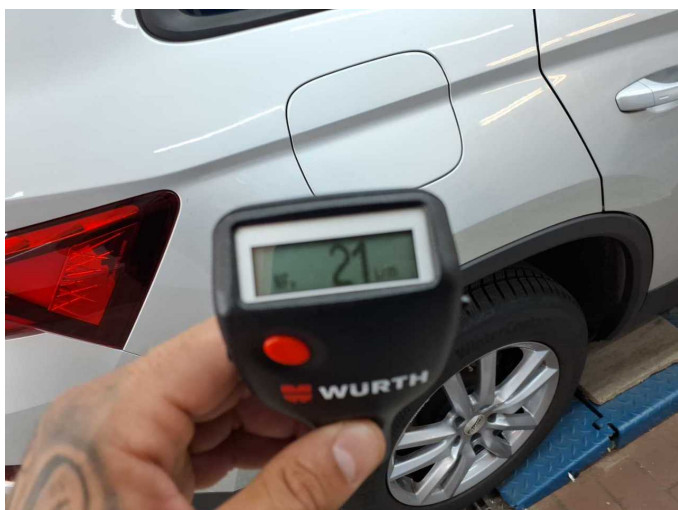
| No. | Previous damage | Extent of damage (Net) |
|---|---|---|
| 1 | Front, Side right, Provided by user / customer, from 29 Sept 2025 | 8.106,83 € |

According to available information previous damages were repaired at the vehicle. Traces of repairs, which allow conclusions about the area of repair, were not recognizable during the inspection.

**Previous damage 1:** Front, Side right

Previous damage 1: Front, Side right

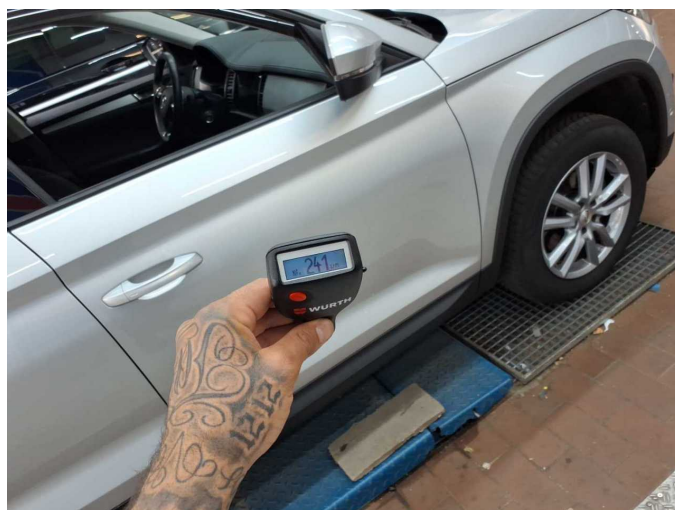
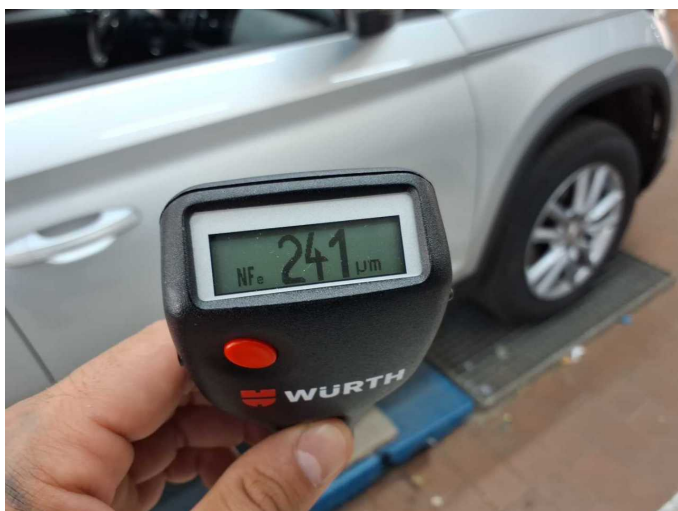
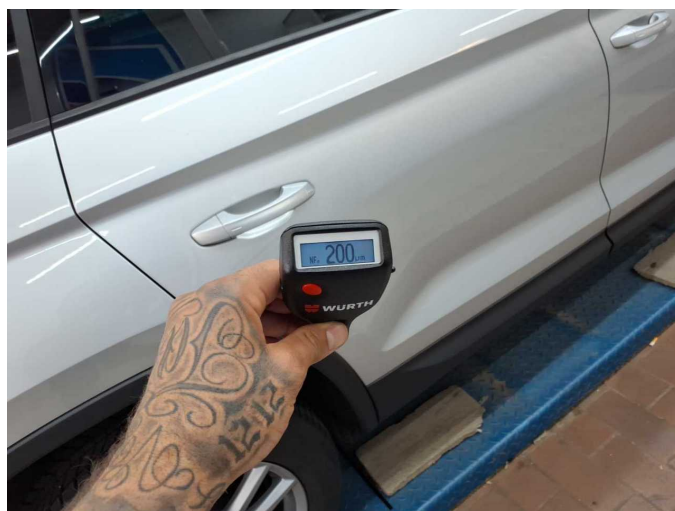
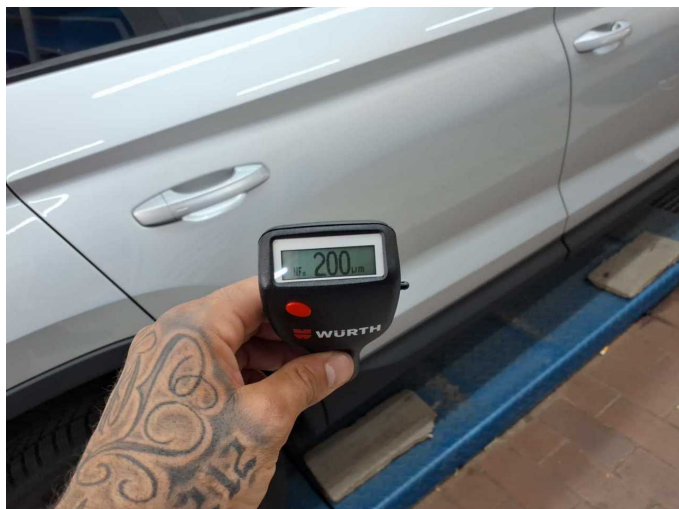
| No. | Repainting |
|---|---|
| 1 | Door - rear right side, Door - front right side, Professionally carried out |

**Repainting 1:** Door - rear right side, Door - front right side
