Expertise

Protocol number: 46537284  
Order No. / Reference: 26697579  
Inspection date: 10 Jul 2026

Manufacturer: Mazda

Model: CX-60 e-SKYACTIV-D 254 M HYBRID AWD HOMURA

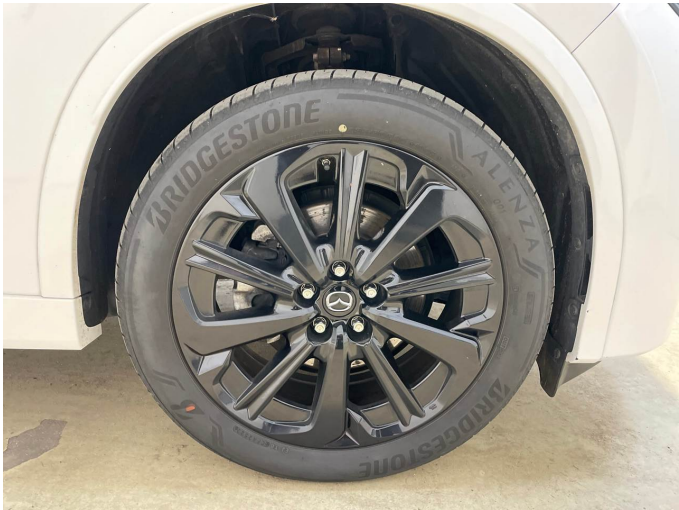
Figure 12: Mounted tyres

| Tyres | | | | |
|---|---|---|---|---|
| 1) | 235/50 R20 100W | Summer tyres on Light alloy | Bridgestone | 6mm / 6mm |
| 2) | 235/50 R20 100W | Summer tyres on Light alloy | Bridgestone | 6mm / 6mm |

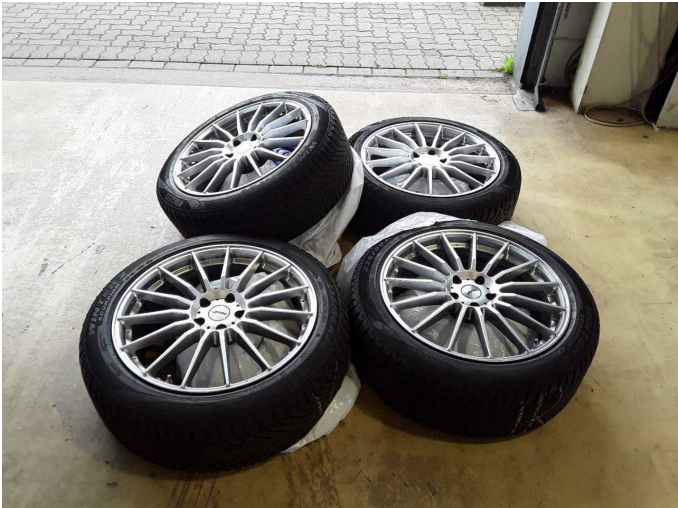
Figure 16: Additional tyres

| Tyres | | | | |
|---|---|---|---|---|
| 1) | 235/50 R20 104V | Winter tyres on Light alloy | Pirelli | 3mm / 3mm |
| 2) | 235/50 R20 104V | Winter tyres on Light alloy | Pirelli | 5mm / 5mm |

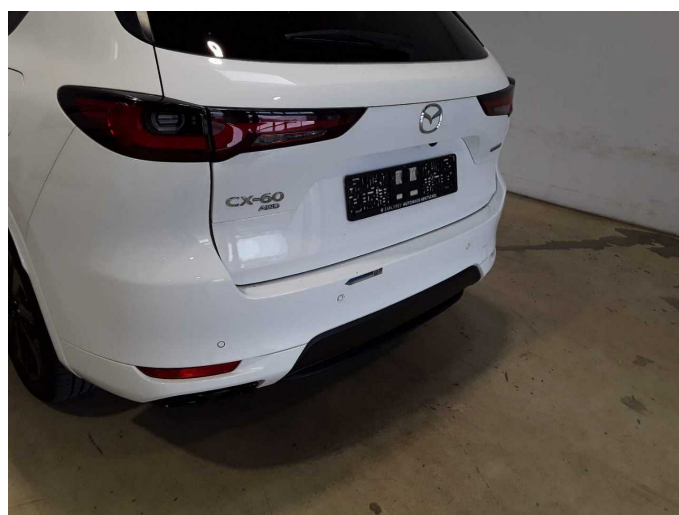
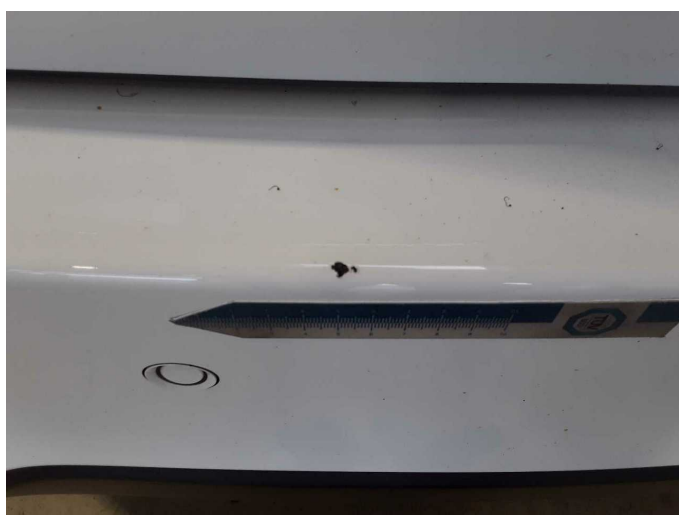
| No. | Component group | Description |
|---|---|---|
| 1 | Rear bumper | Rear bumper - Scratch(es) - Smart repair |

Damage 1: Rear bumper: Rear bumper - Scratch(es) - Smart repair

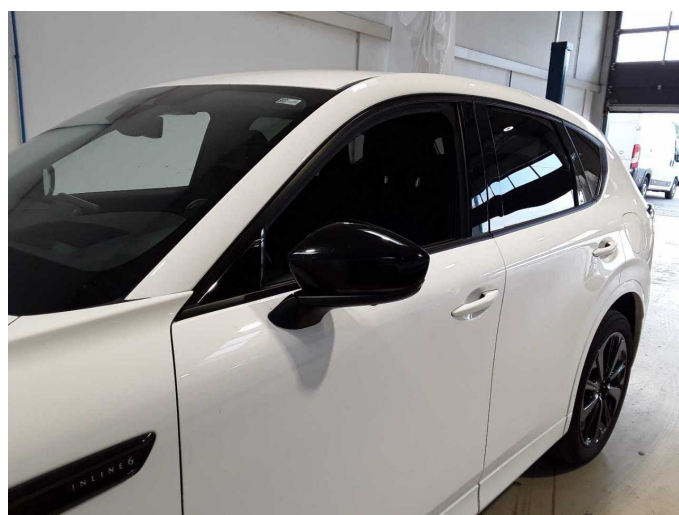
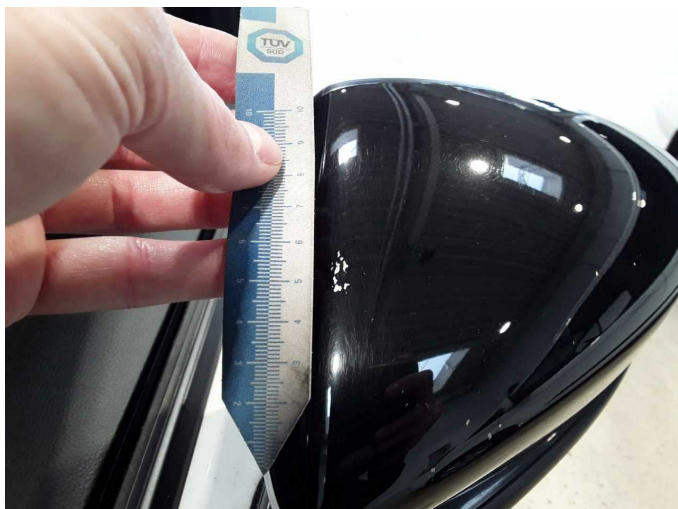
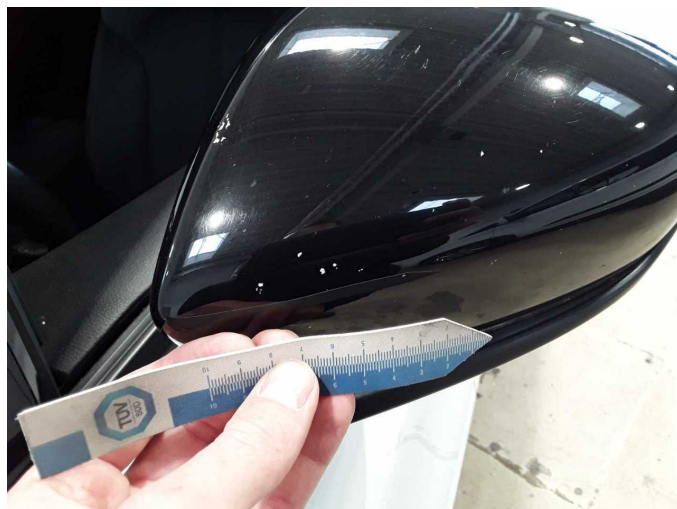
| No. | Component group | Description |
|---|---|---|
| 2 | Wing mirror - left side | Cap - Stone chips - Paint |

Damage 2: Wing mirror - left side: Cap - Stone chips - Paint

**Damage 2:** Wing mirror - left side: Cap - Stone chips - Paint
