Expertise

Protocol number: 46415259  
Order No. / Reference: 26566699  
Inspection date: 7 Jul 2026

Manufacturer: Volkswagen  
VIN: WVGZZCDZNW508917

Model: Golf Variant 2.0 TDI SCR DSG Style

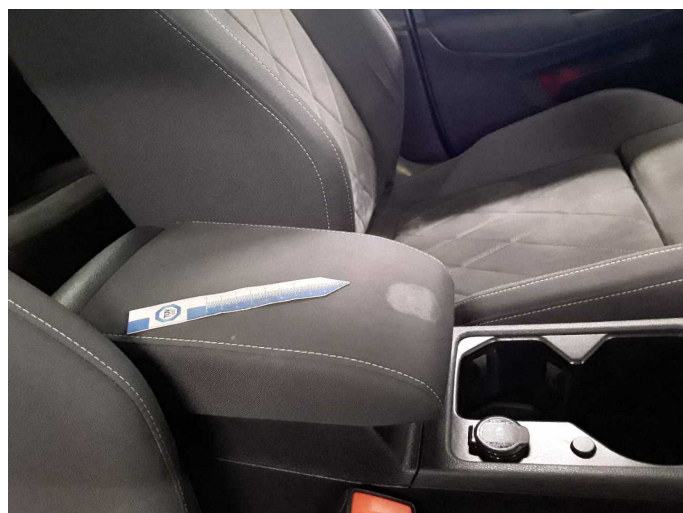
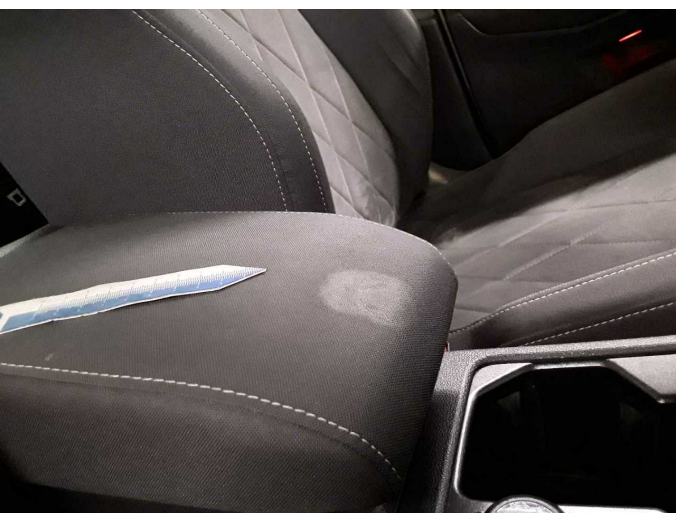
| No. | Component group | Description |
|---|---|---|
| 1 | Seat - front | armrests - Soiled - Clean |

Damage 1: Seat - front: armrests - Soiled - Clean

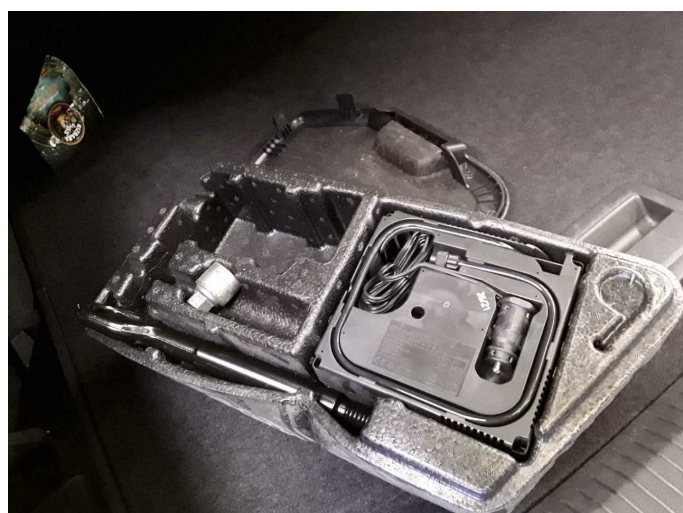
| No. | Component group | Description |
|---|---|---|
| 2 | Trim / covers | Trim / covers (Tirefit) - Missing - Replace |

Damage 2: Trim / covers: Trim / covers (Tirefit) - Missing - Replace

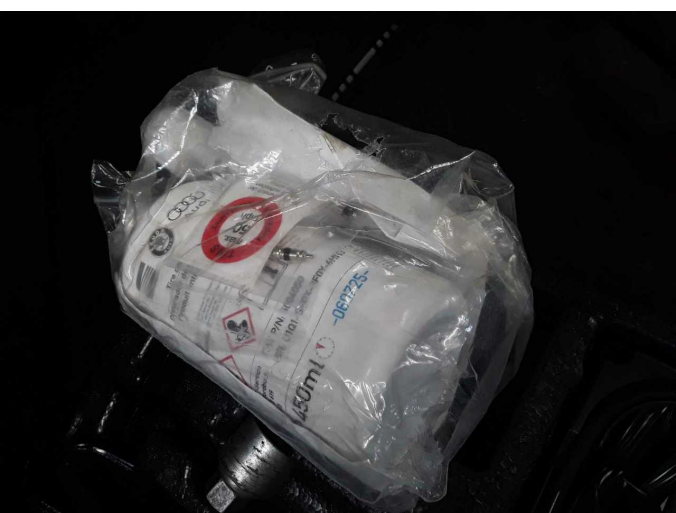
| No. | Component group | Description |
|---|---|---|
| 3 | Equipment | Tirefit filler - Expired - Replace |

Damage 3: Equipment: Tirefit filler - Expired - Replace

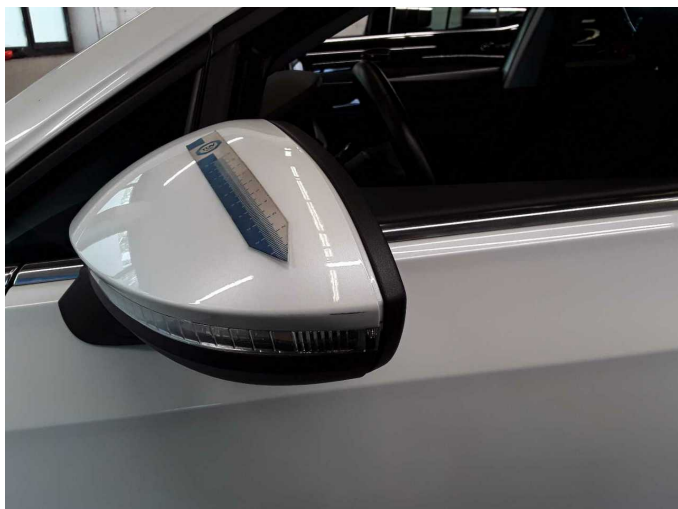
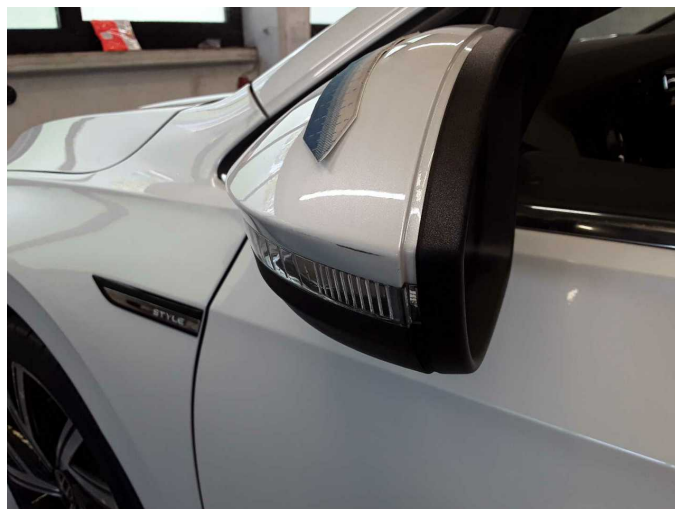
| No. | Component group | Description |
|---|---|---|
| 4 | Wing mirror - left side | Cap - Scratch(es) - Smart repair |

**Damage 4:** Wing mirror - left side: Cap - Scratch(es) - Smart repair

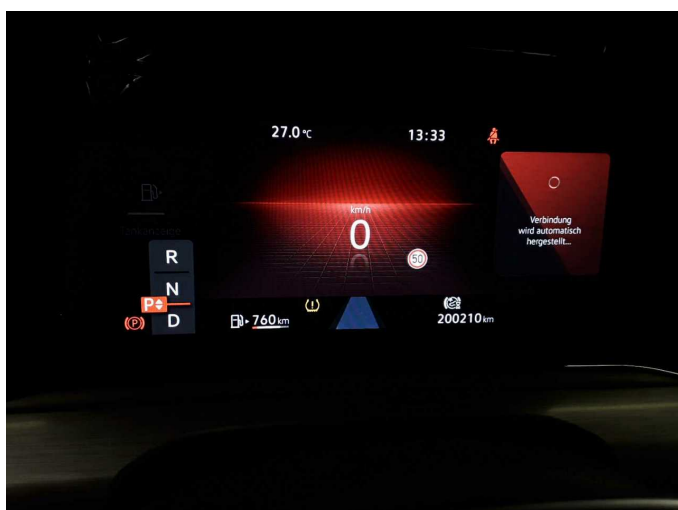
| No. | Component group | Description |
|---|---|---|
| 5 | Wheel / tyres | Pressure sensor - on - Perform diagnosis |

**Damage 5:** Wheel / tyres: Pressure sensor - on - Perform diagnosis

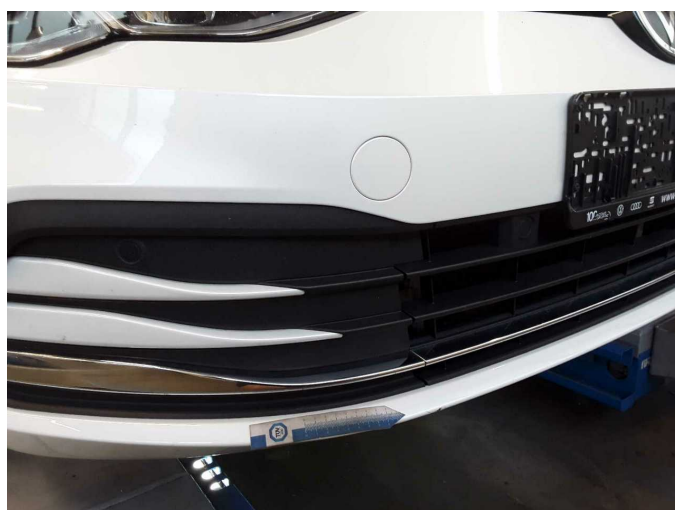
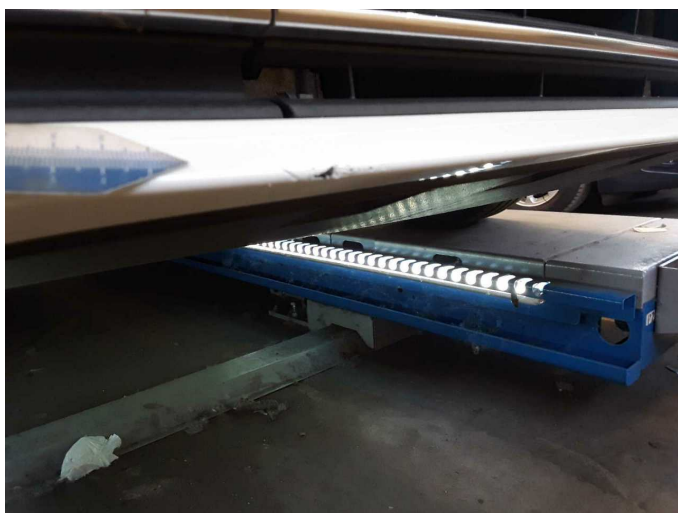
| No. | Component group | Description |
|---|---|---|
| 6 | Front bumper | Front bumper - Scratch(es) - Smart repair |

**Damage 6:** Front bumper: Front bumper - Scratch(es) - Smart repair

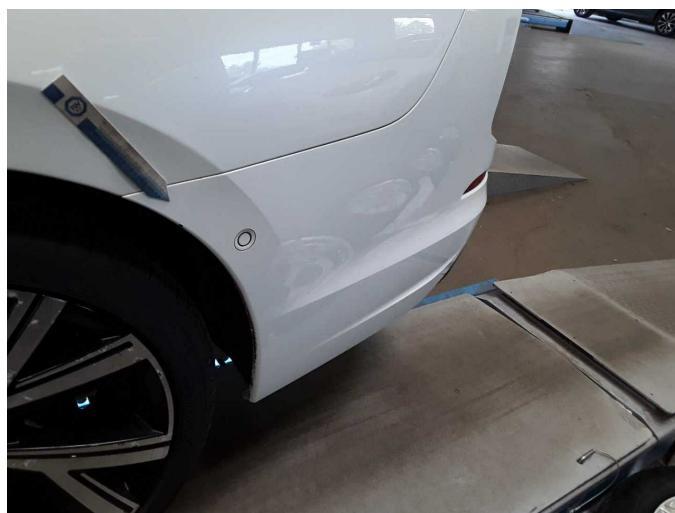
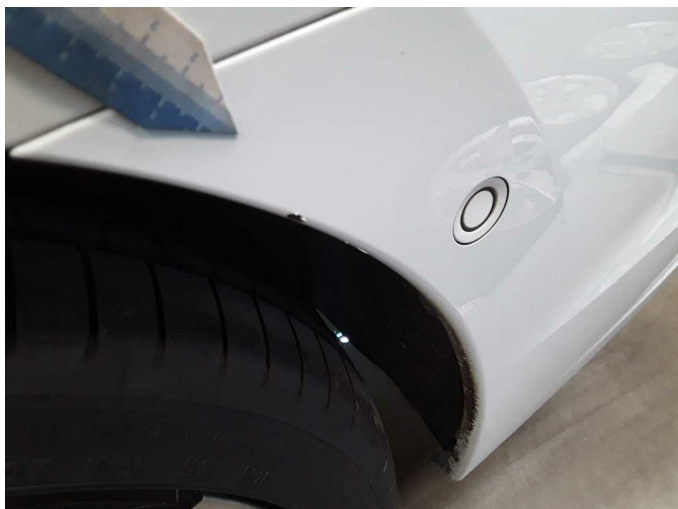
| No. | Component group | Description |
|---|---|---|
| 7 | Rear bumper | Rear bumper - Scratch(es) - Smart repair |

**Damage 7:** Rear bumper: Rear bumper - Scratch(es) - Smart repair

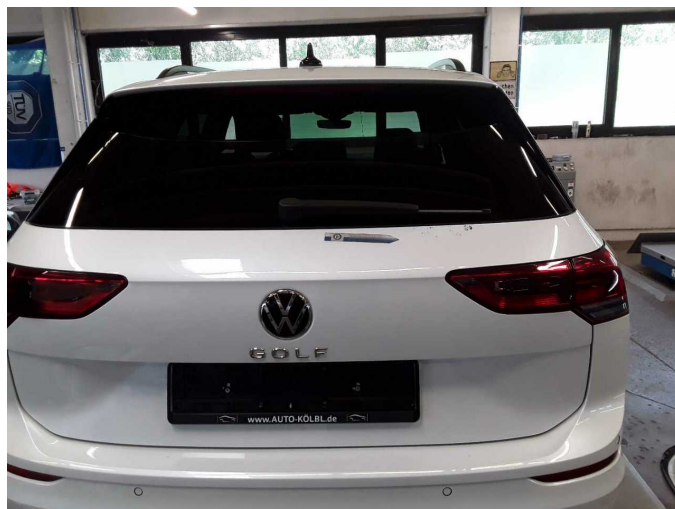
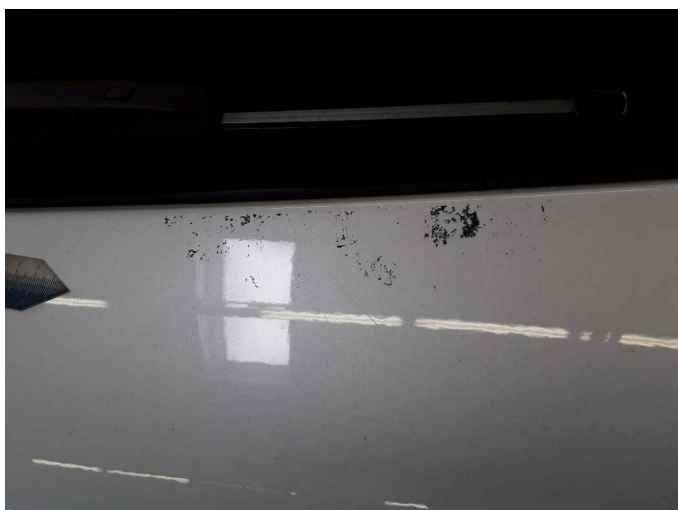
| No. | Component group | Description |
|---|---|---|
| 8 | Boot lid / rear door | Boot lid - Paint defect - Smart repair |

**Damage 8:** Boot lid / rear door: Boot lid - Paint defect - Smart repair

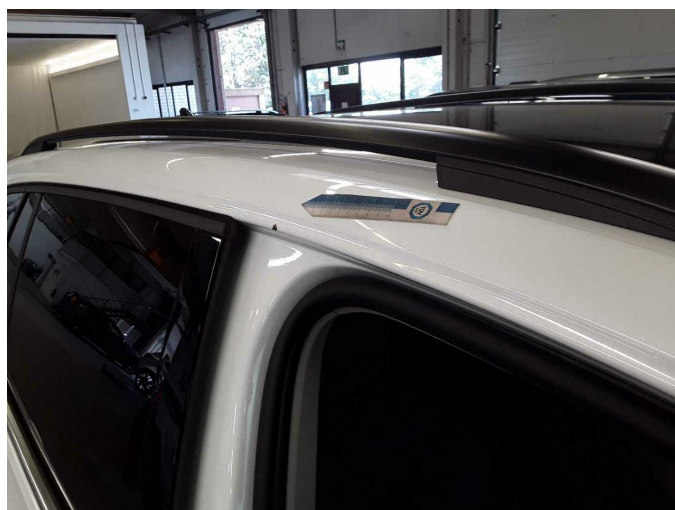
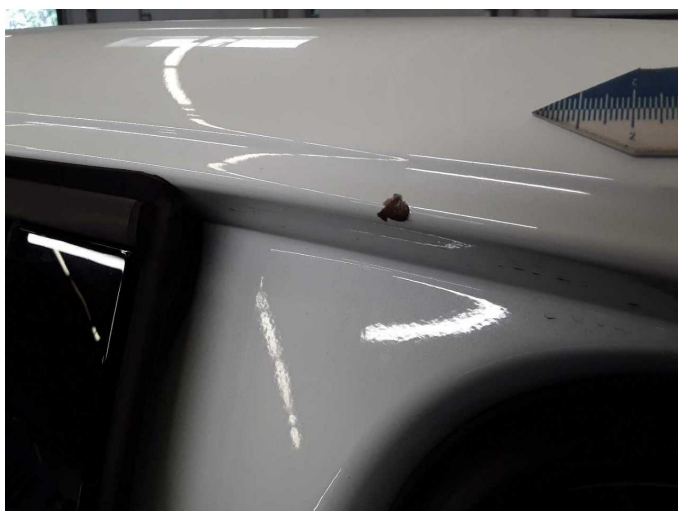
| No. | Component group | Description |
|---|---|---|
| 9 | Roof | Roof rail - right side - Corrosion - Smart repair |

**Damage 9:** Roof: Roof rail - right side - Corrosion - Smart repair

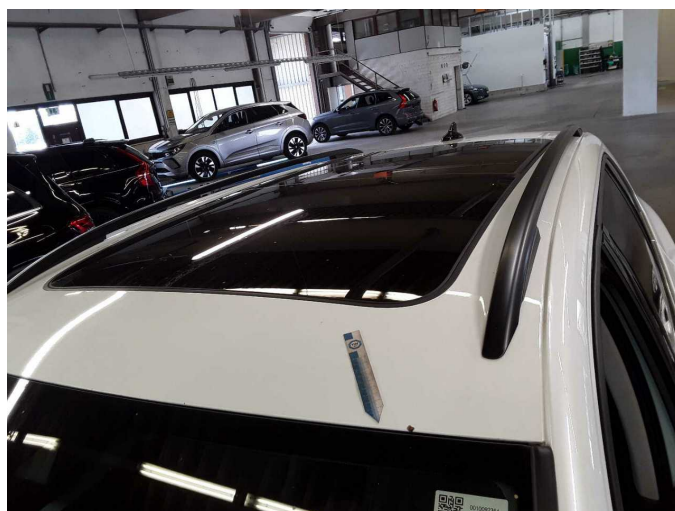
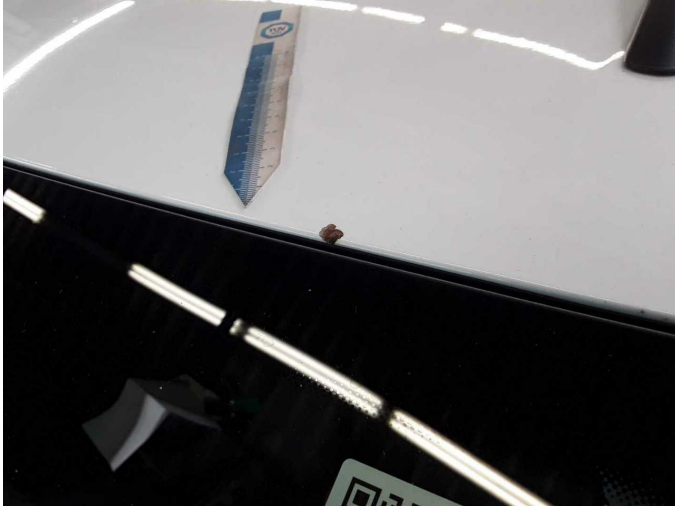
| No. | Component group | Description |
|---|---|---|
| 10 | Roof | Roof - Corrosion - Smart repair |

**Damage 10:** Roof: Roof - Corrosion - Smart repair

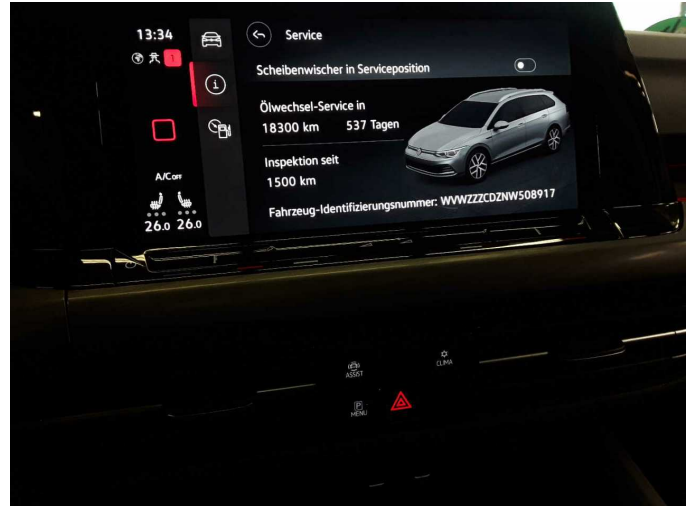
| No. | Component group | Description |
|---|---|---|
| 11 | Misc. | Inspection / maintenance - Due - Perform |

**Damage 11:** Misc.: Inspection / maintenance - Due - Perform

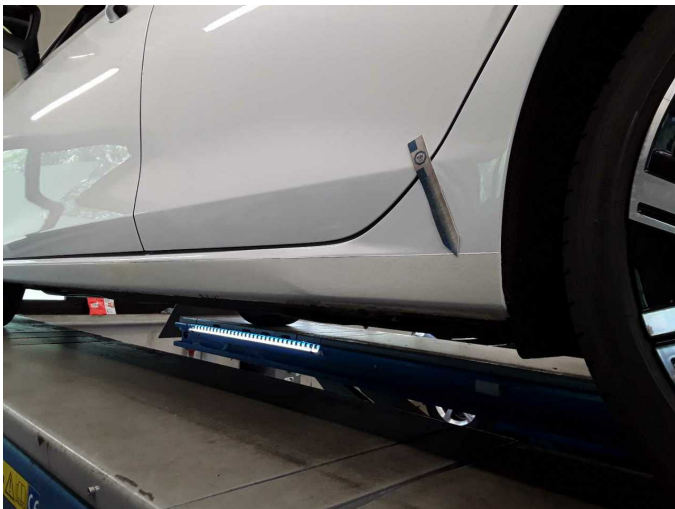
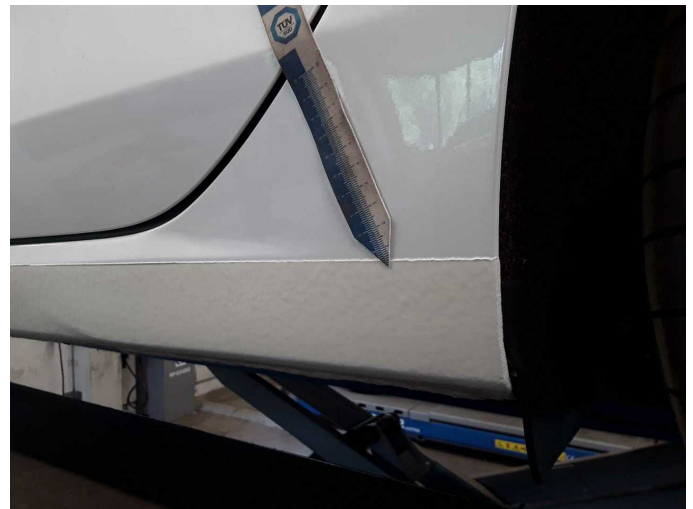
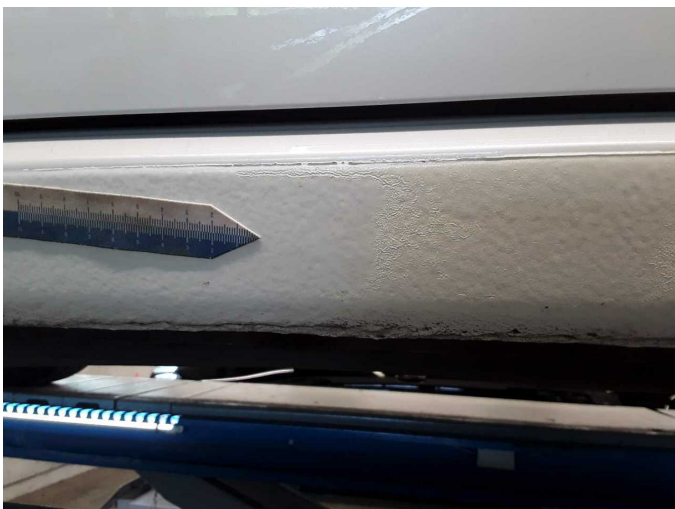
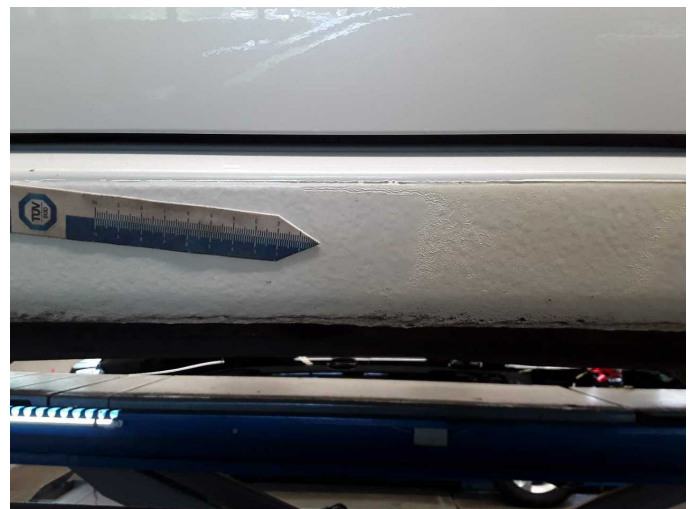
| No. | Component group | Description |
|---|---|---|
| 12 | Sill - left side | Sill (Farbabweichung) - Unprofessionally repaired - Paint |

**Damage 12:** Sill - left side: Sill (Farbabweichung) - Unprofessionally repaired - Paint

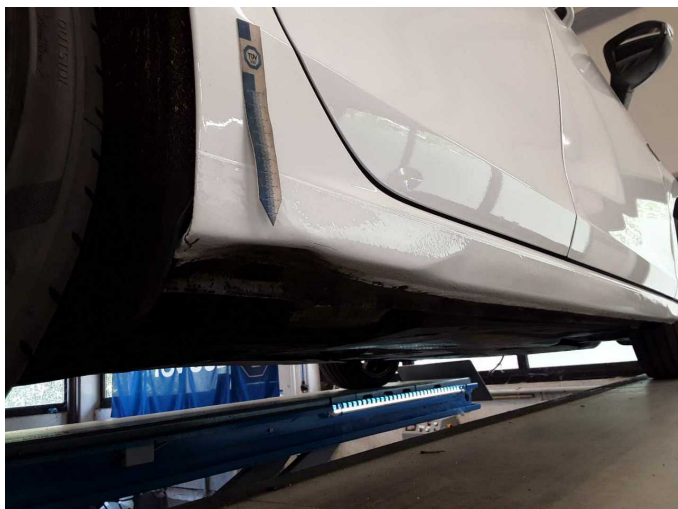
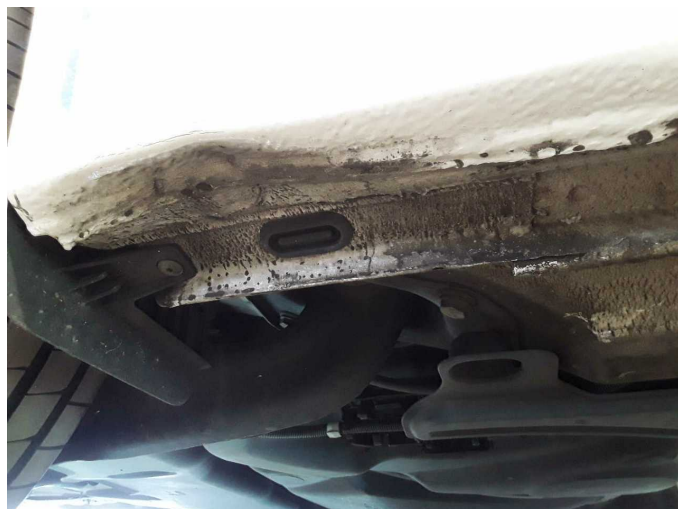
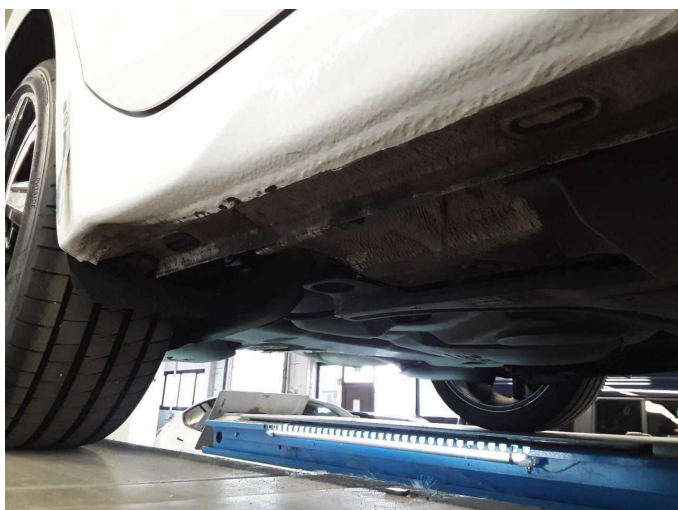
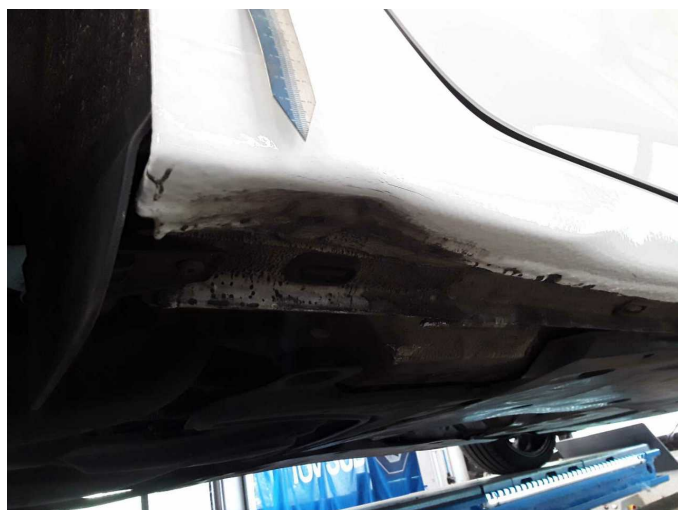
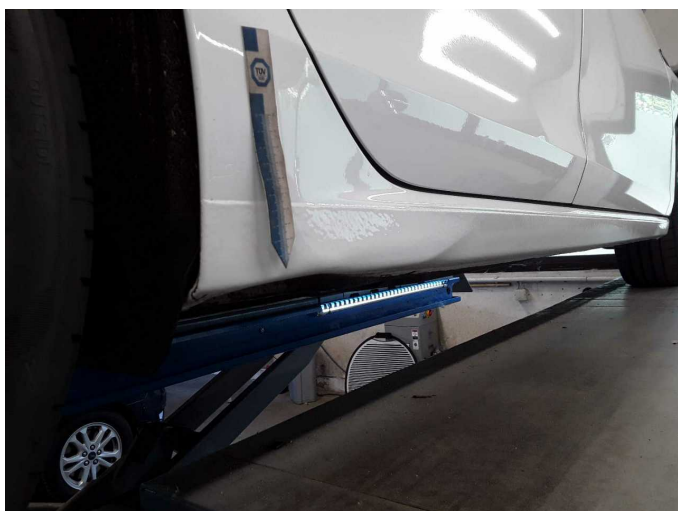
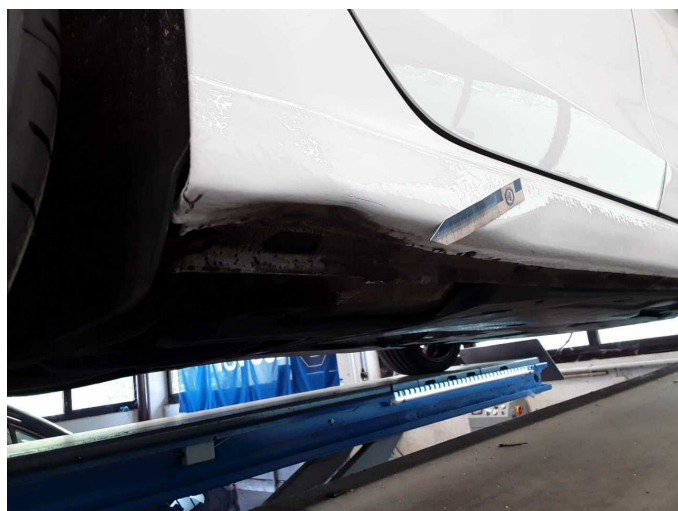
| No. | Component group | Description |
|---|---|---|
| 13 | Sill - right side | Sill - Deformed - Repair and paint |

**Damage 13:** Sill - right side: Sill - Deformed - Repair and paint

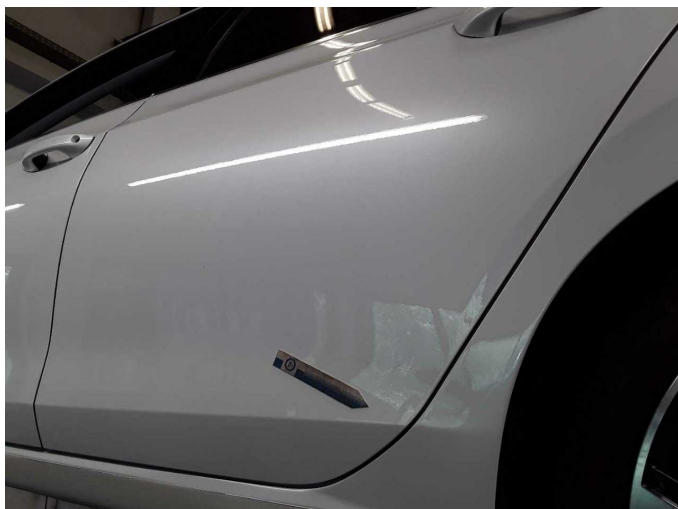
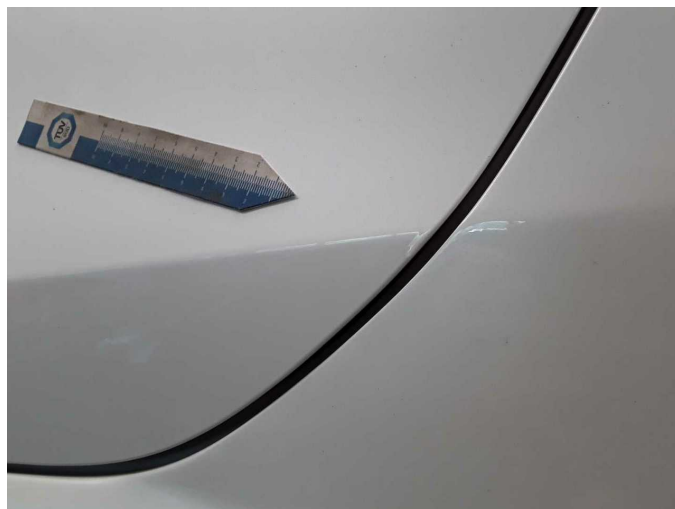
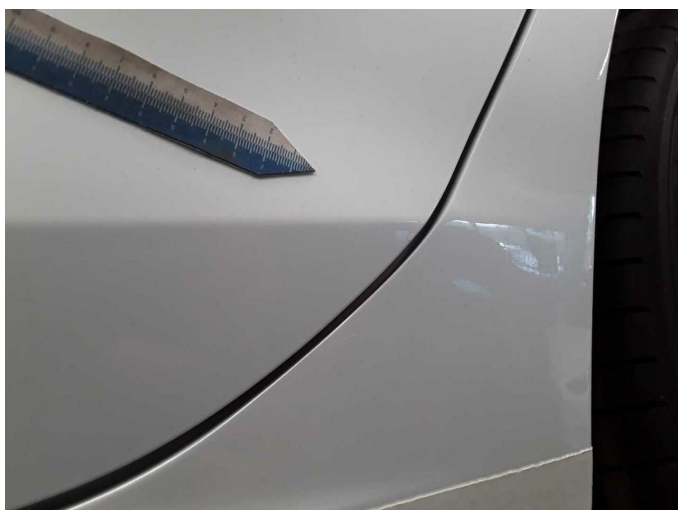
| No. | Component group | Description |
|---|---|---|
| 14 | Door - rear left side | Door (Klarlackläufer) - Unprofessionally repaired - Paint |

**Damage 14:** Door - rear left side: Door (Klarlackläufer) - Unprofessionally repaired - Paint

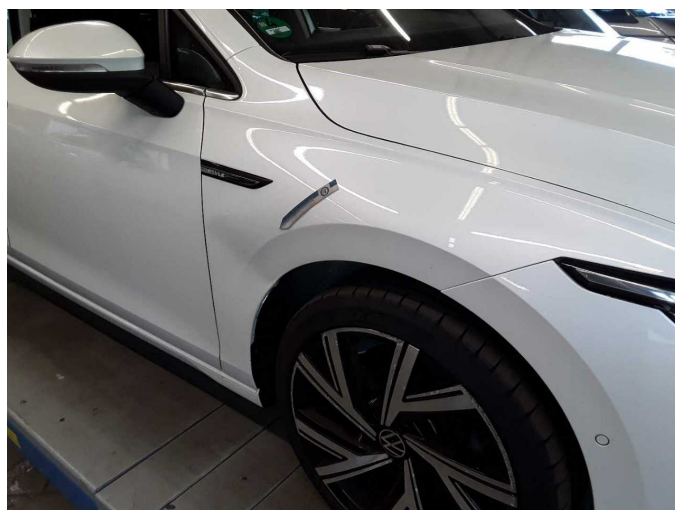
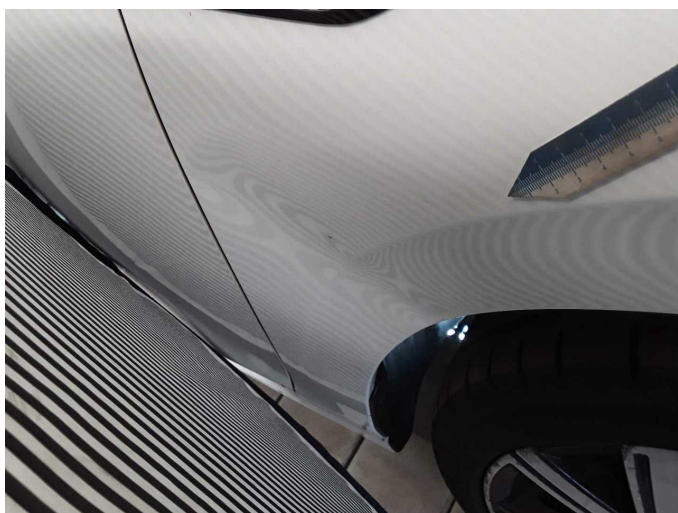
| No. | Component group | Description |
|---|---|---|
| 15 | Mudguard - right side | Mudguard - right side - Deformed - Replace |

**Damage 15:** Mudguard - right side: Mudguard - right side - Deformed - Replace

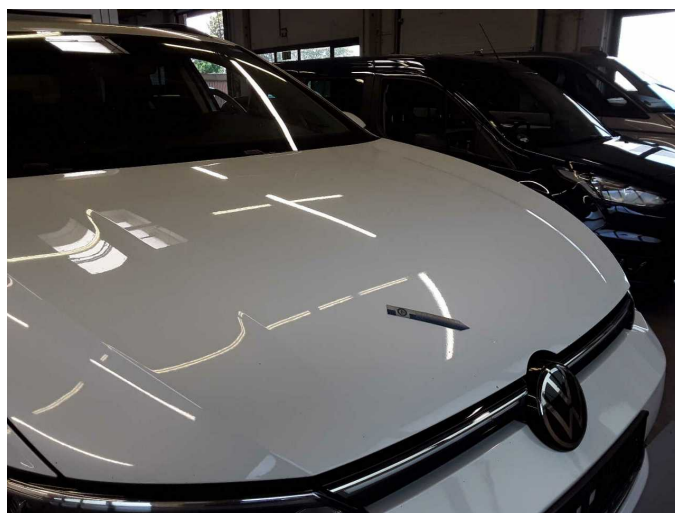
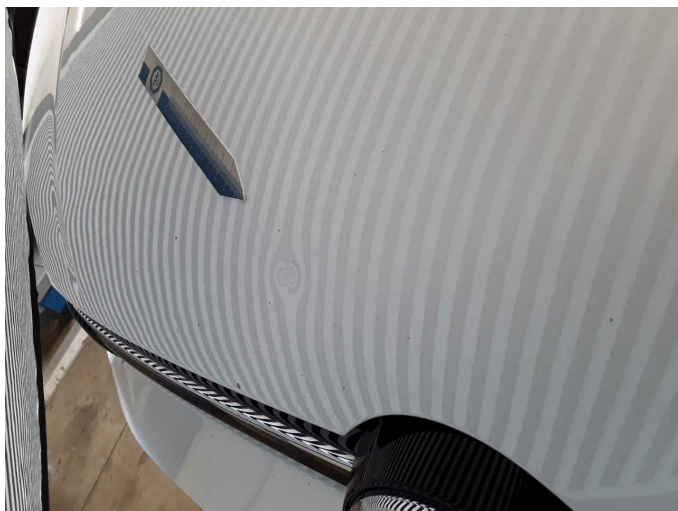
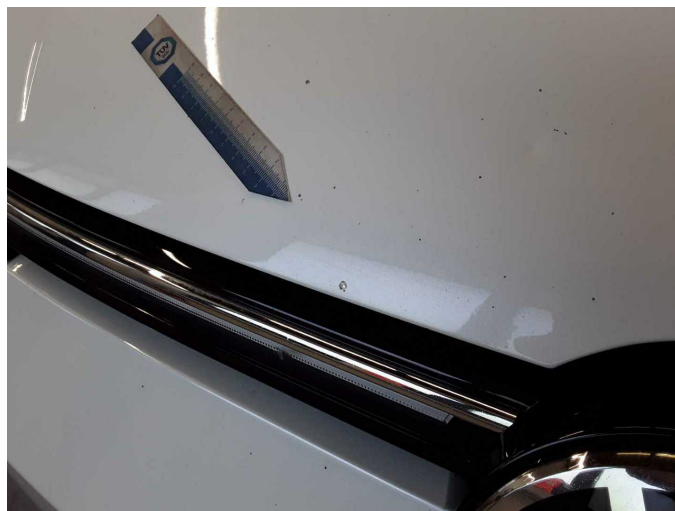
| No. | Component group | Description |
|---|---|---|
| 16 | Bonnet | Bonnet - Dent / paintcoat damage - Repair and paint |

**Damage 16:** Bonnet: Bonnet - Dent / paintcoat damage - Repair and paint

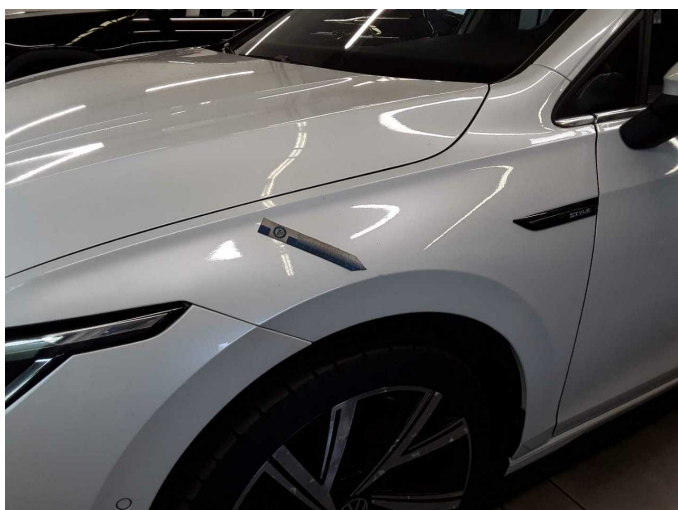
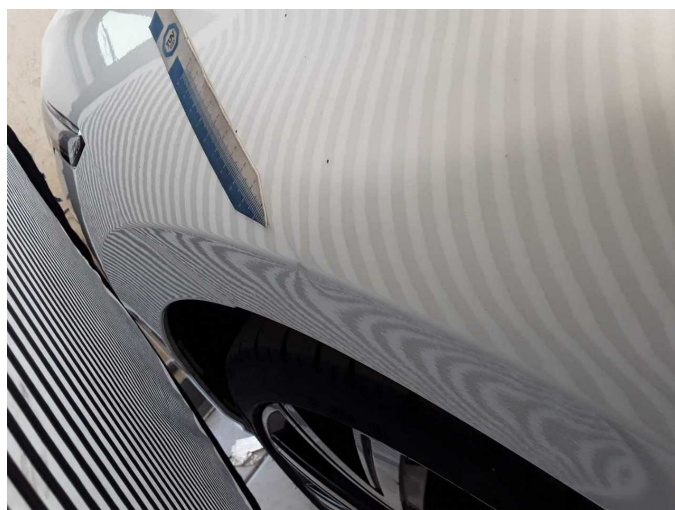
| No. | Component group | Description |
|---|---|---|
| 17 | Mudguard - left side | Mudguard - left side - Dent / paintcoat damage - Repair and paint |

**Damage 17:** Mudguard - left side: Mudguard - left side - Dent / paintcoat damage - Repair and paint

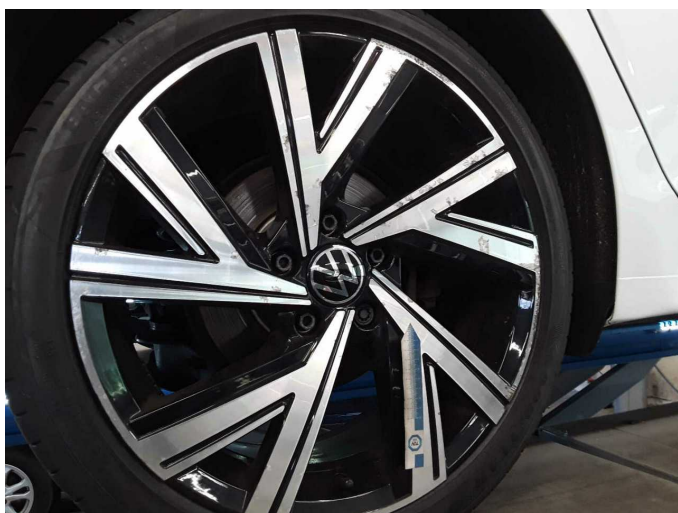
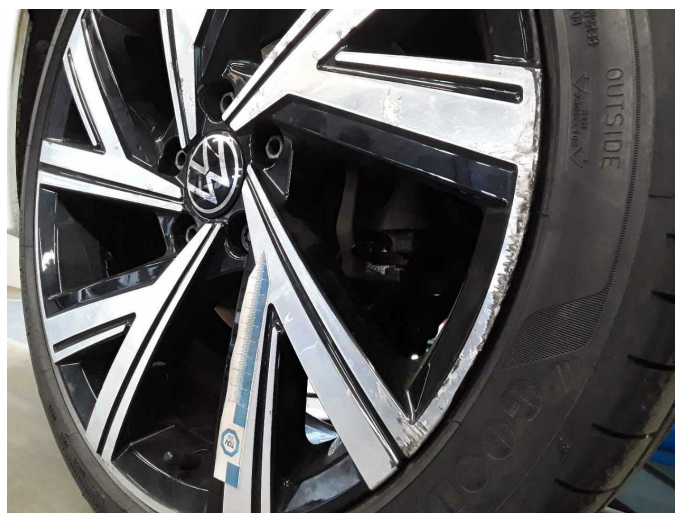
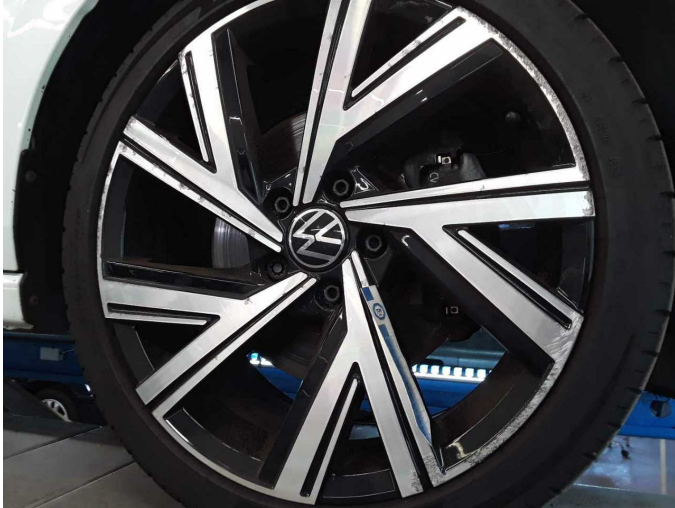
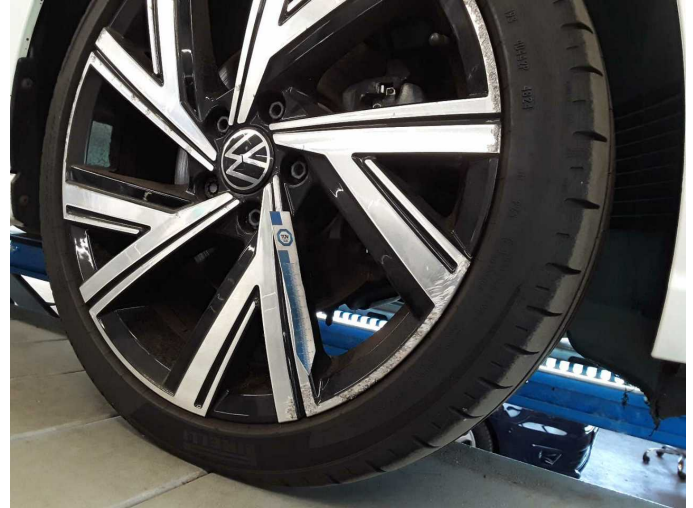
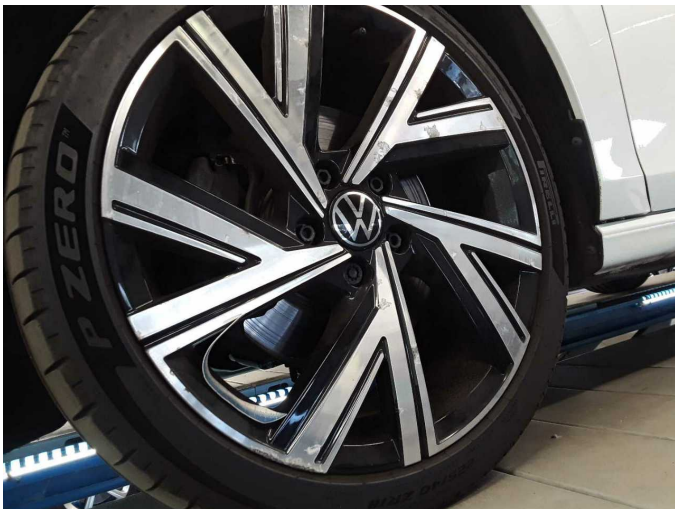
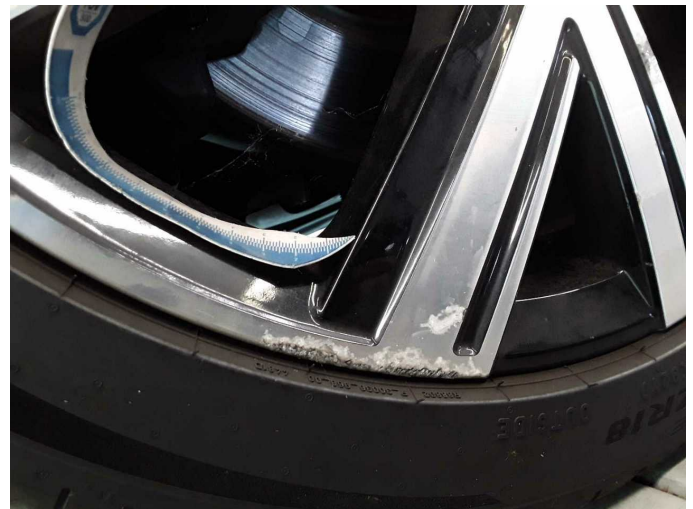
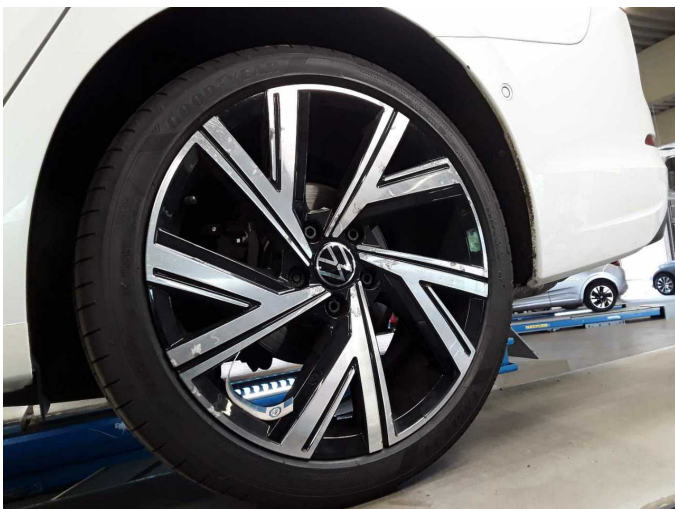
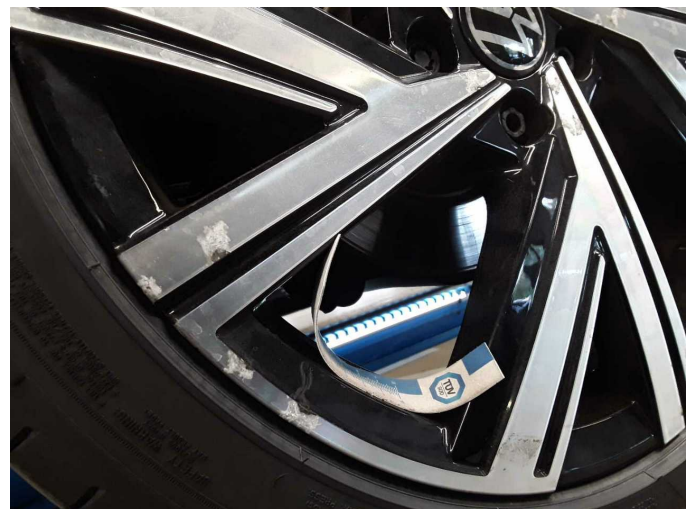
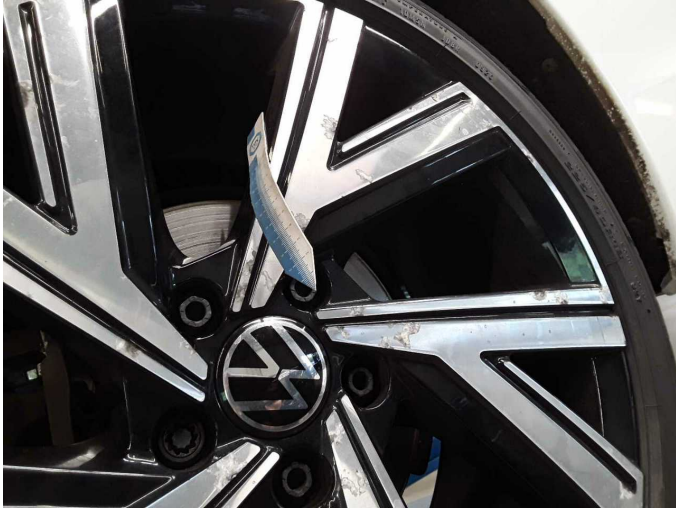
| No. | Component group | Description |
|---|---|---|
| 18 | Wheel / tyres | Wheel rims - complete set - Scratched - Replace |

**Damage 18:** Wheel / tyres: Wheel rims - complete set - Scratched - Replace

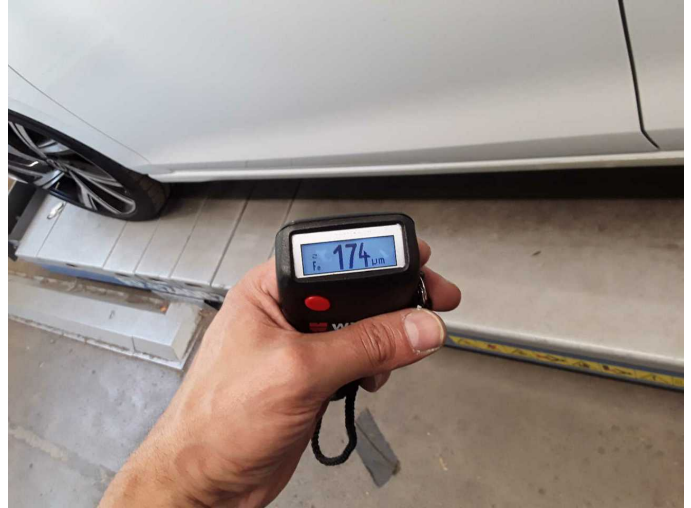
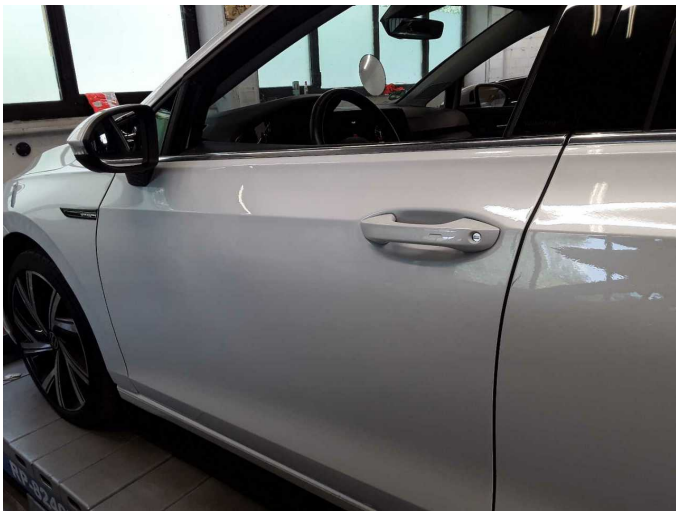
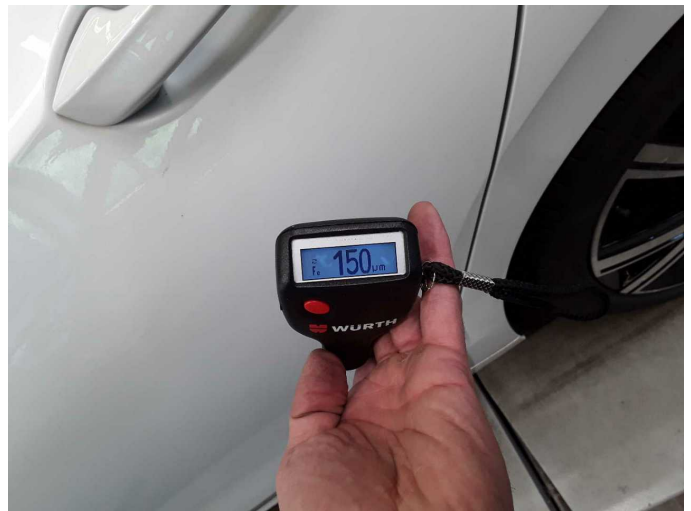
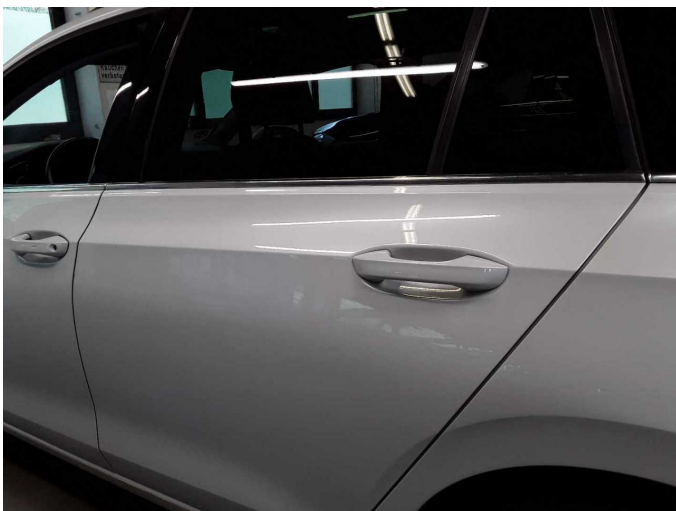
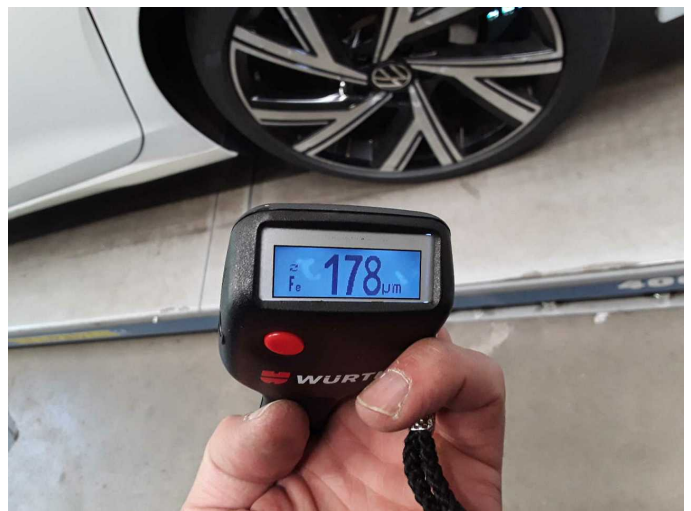
| No. | Repainting |
|---|---|
| 1 | Side panel - rear left side, Door - rear left side, Door - front left side, Unprofessionally carried out, Invoice of repair done Non-existent |

**Repainting 1:** Side panel - rear left side, Door - rear left side, Door - front left side

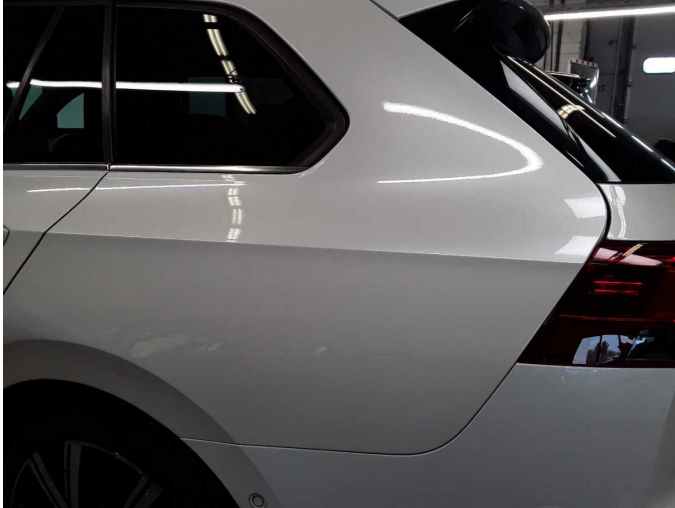
**Repainting 1:** Side panel - rear left side, Door - rear left side, Door - front left side
