Expertise

Protocol number: 46179645  
Order No. / Reference: 26438870  
Inspection date: 16 Jun 2026

Manufacturer: Opel

Model: Insignia Sports Tourer 1.5 Diesel Elegance

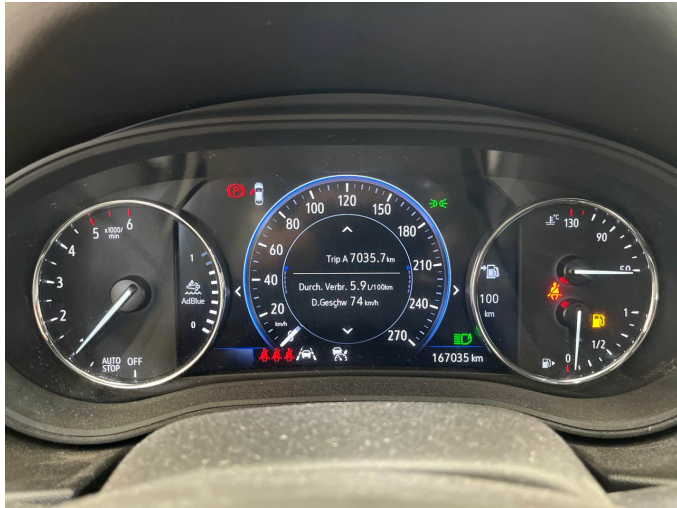
Figure 7: Instrument cluster

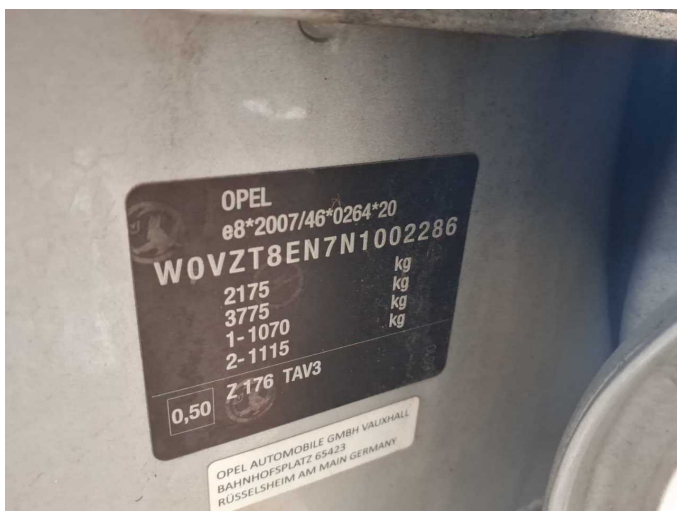
Figure 11: VIN

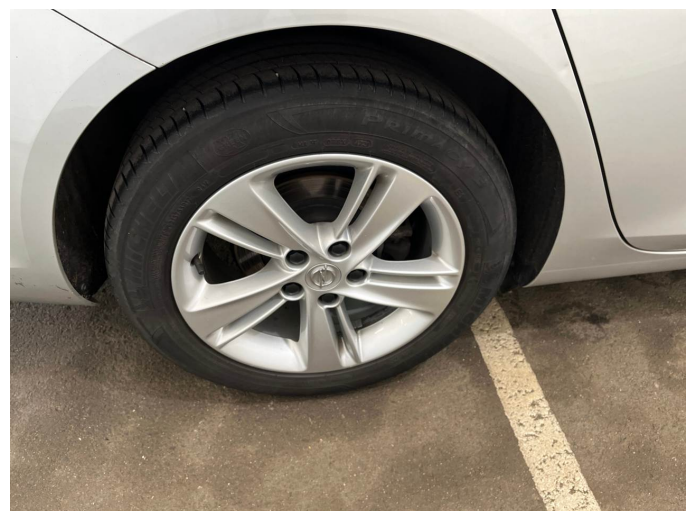
Figure 12: Mounted tyres

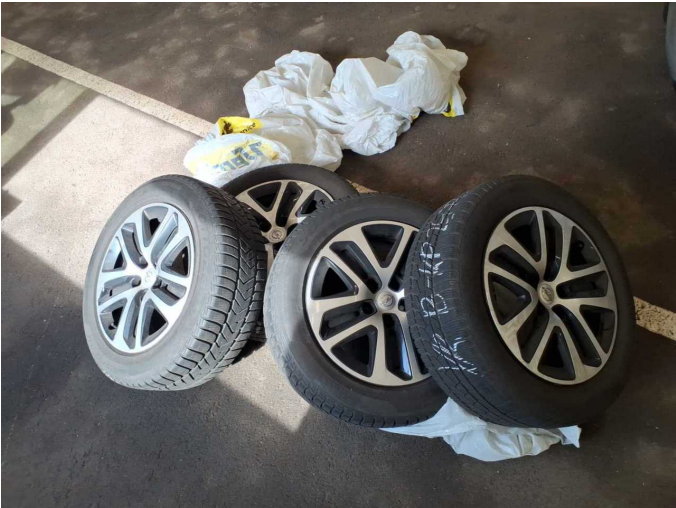
Figure 15: Additional tyres

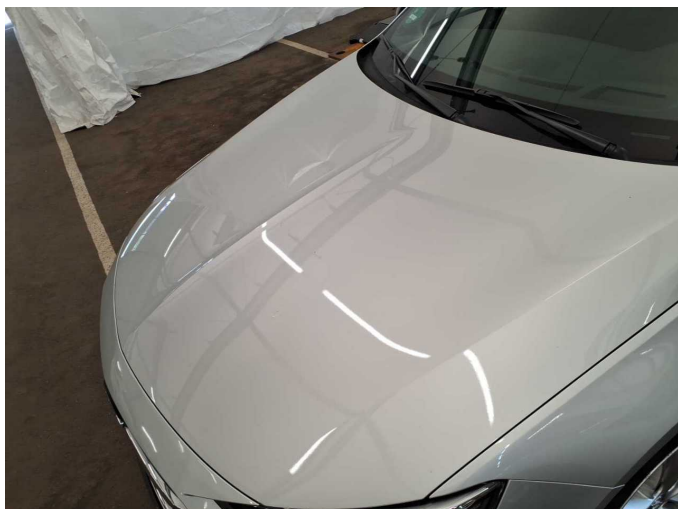
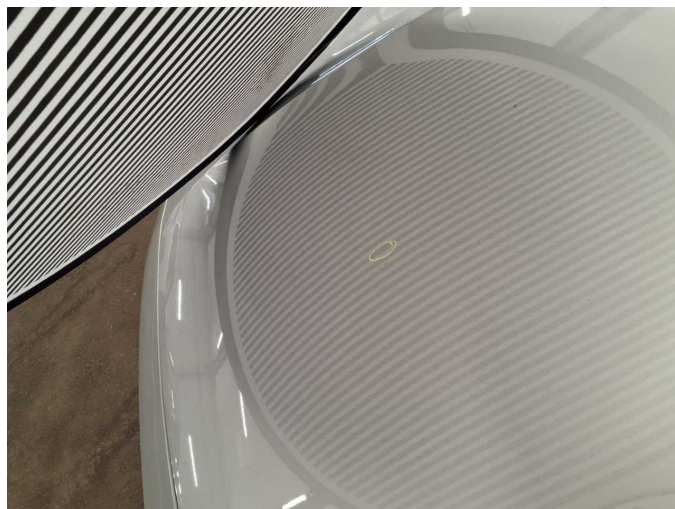
| No. | Component group | Description |
|---|---|---|
| 1 | Bonnet | Bonnet - dent(s) - No deduction |

**Damage 1:** Bonnet: Bonnet - dent(s) - No deduction

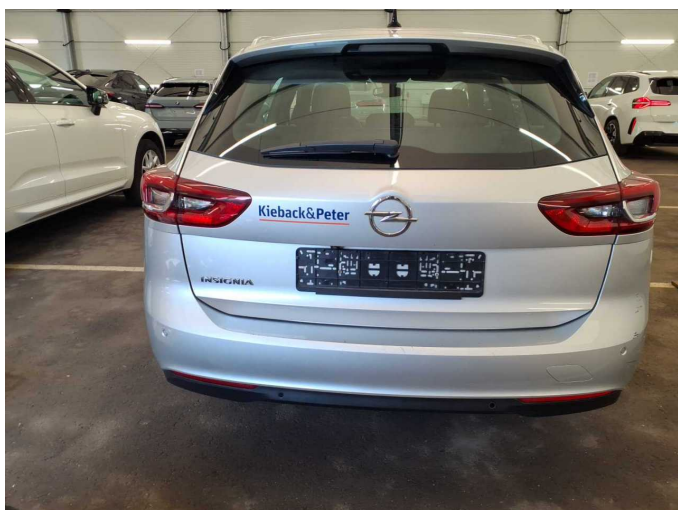
| No. | Component group | Description |
|---|---|---|
| 2 | Boot lid / rear door | Boot lid - Glued / labelled - De-glue / neutralise |

**Damage 2:** Boot lid / rear door: Boot lid - Glued / labelled - De-glue / neutralise

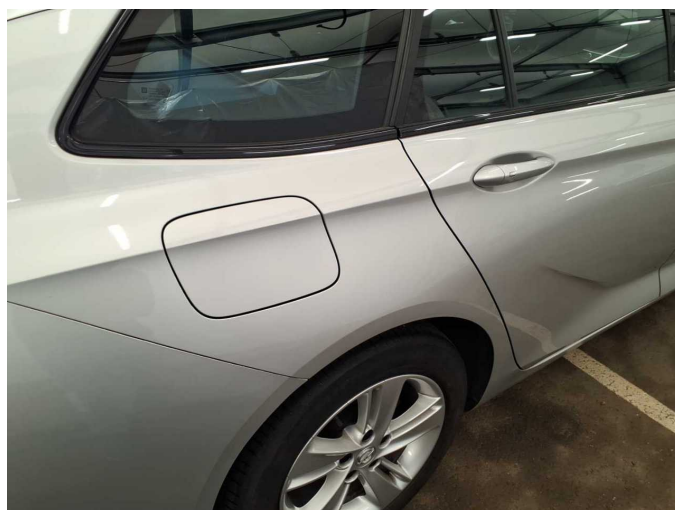
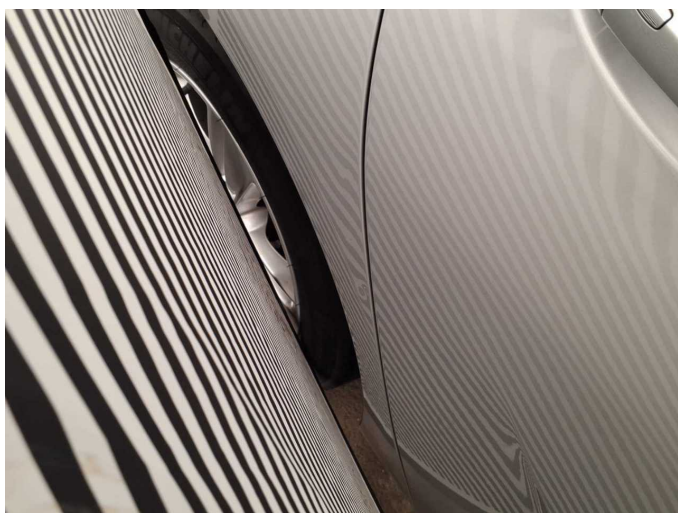
| No. | Component group | Description |
|---|---|---|
| 3 | Side panel - rear right side | Side panel - dent(s) - Smooth repair work |

**Damage 3:** Side panel - rear right side: Side panel - dent(s) - Smooth repair work

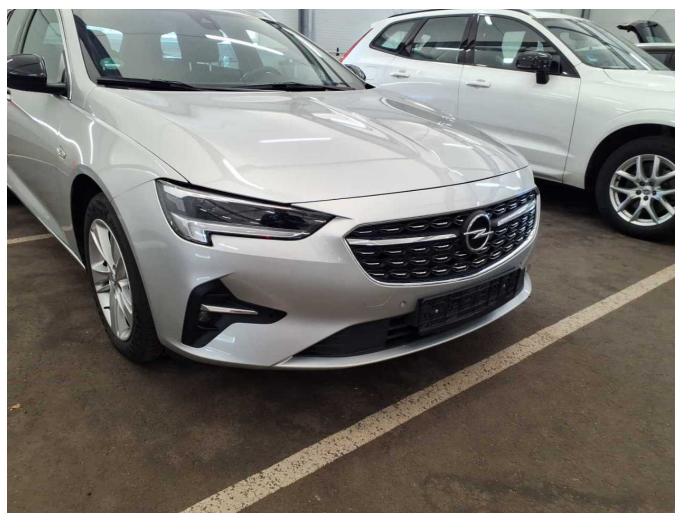
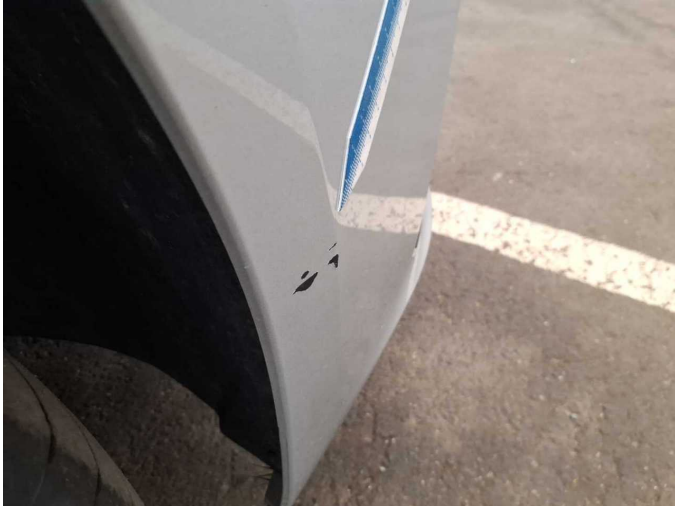
| No. | Component group | Description |
|---|---|---|
| 4 | Front bumper | Front bumper - Scratched - Smart repair |

**Damage 4:** Front bumper: Front bumper - Scratched - Smart repair

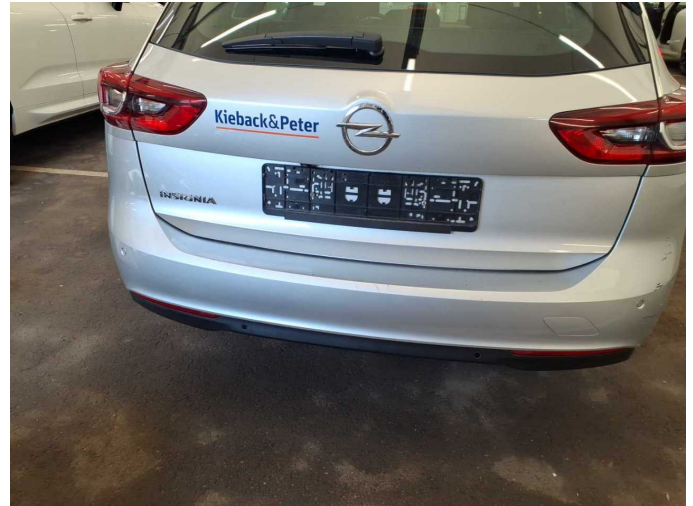
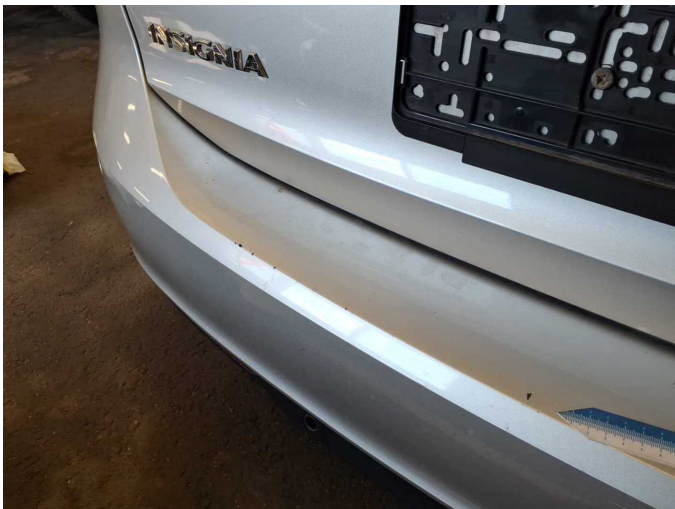
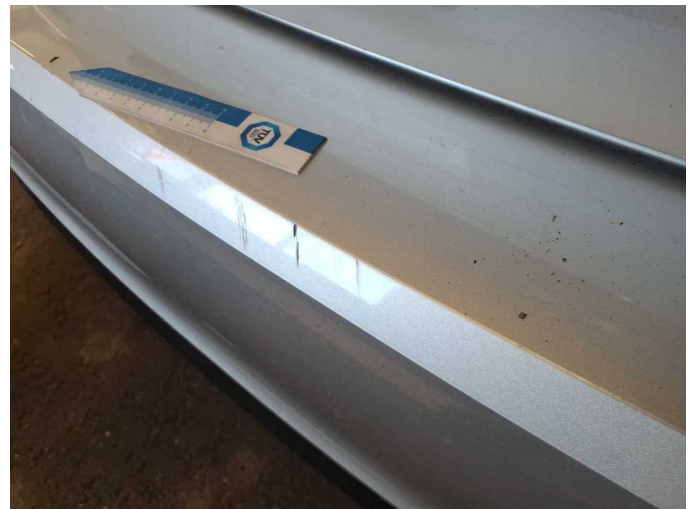
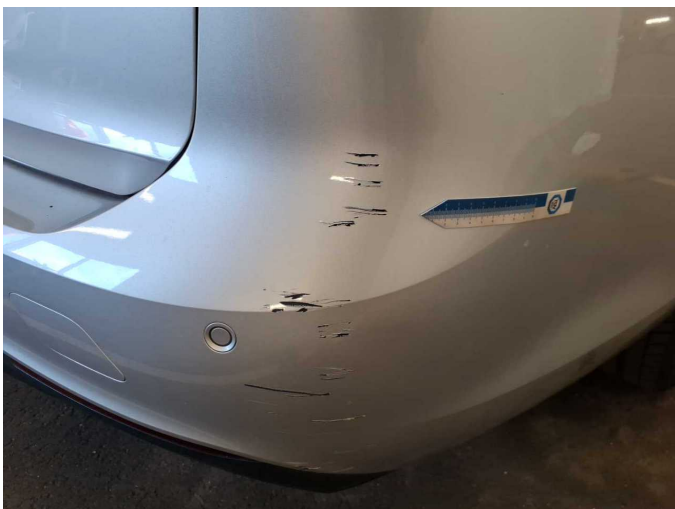
| No. | Component group | Description |
|---|---|---|
| 5 | Rear bumper | Rear bumper - Scratched - Repair and paint |

**Damage 5:** Rear bumper: Rear bumper - Scratched - Repair and paint
