Expertise

Protocol number: 46495036  
Order No. / Reference: 26587836  
Inspection date: 10 Jul 2026

| Manufacturer: Opel | Model: Grandland 1.5 D Automatik Business Elegance |

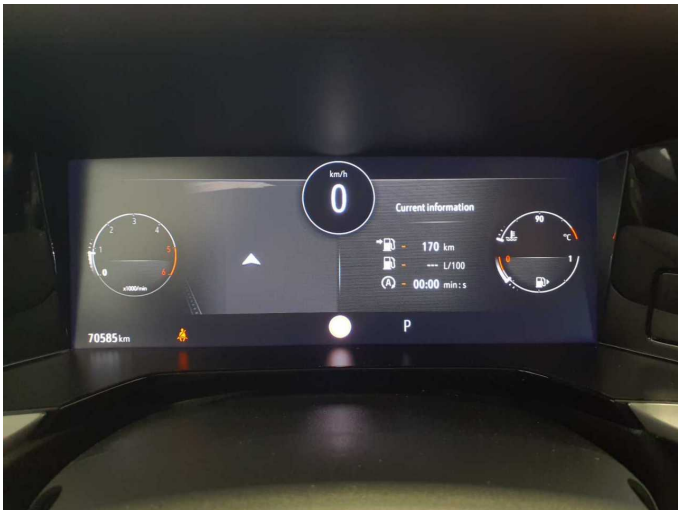
| Vehicle details | |
|---|---|
| Mileage (Read) | 70,585 km |

Figure 7: Instrument cluster

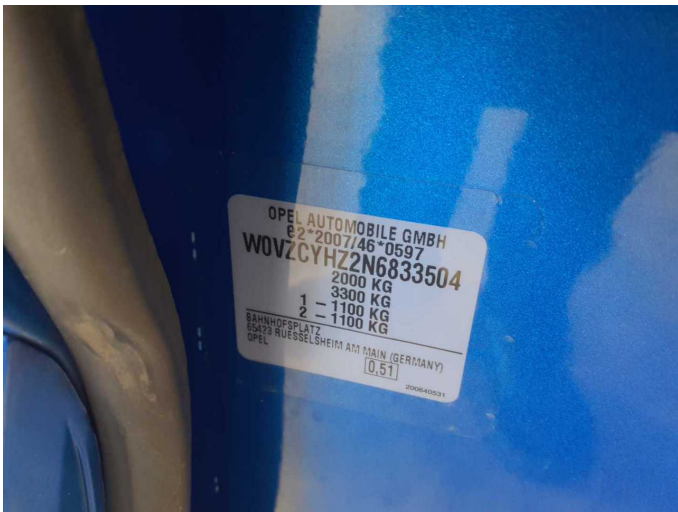
Figure 11: VIN

| VIN comparison | The vehicle identification number (VIN) was read from the vehicle and its conformity with the submitted documents was confirmed by the undersigned during the inspection. |

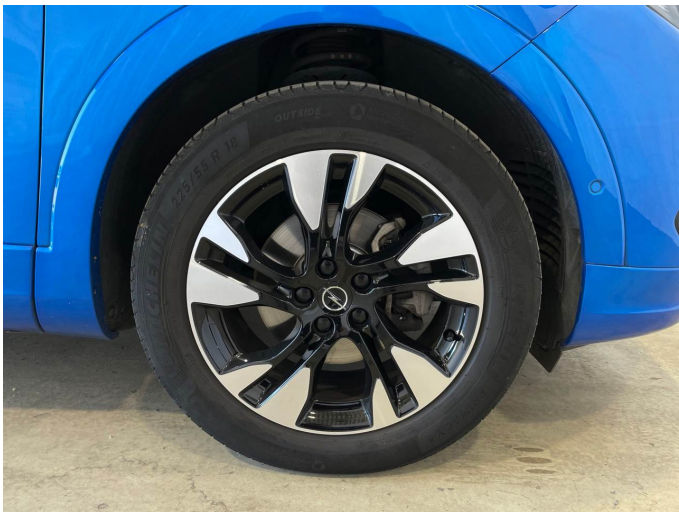
Figure 12: Mounted tyres

| # | Tyre size | Type of tyre | Manufacturer | Tread depth |
|---|---|---|---|---|
| 1) | 225/55 R18 102V | Summer tyres on Light alloy | Michelin | 4mm / 4mm |
| 2) | 225/55 R18 102V | Summer tyres on Light alloy | Michelin | 5mm / 5mm |

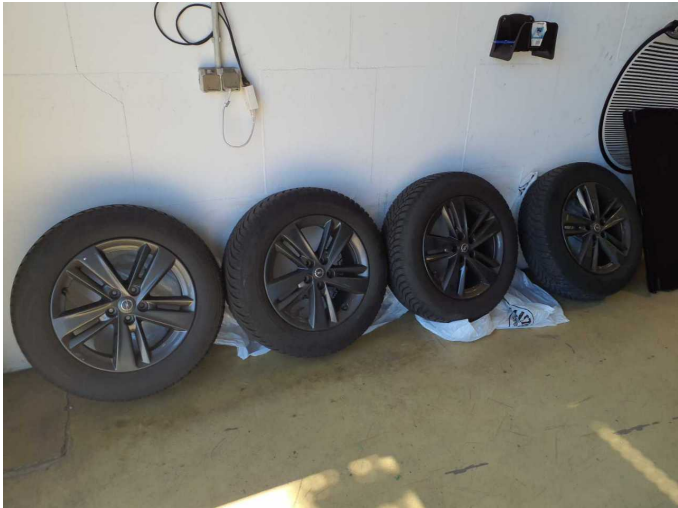
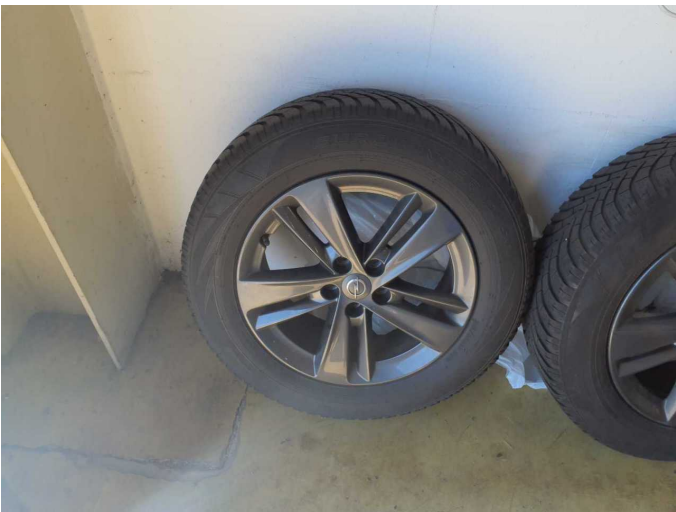
| # | Tyre size | Type of tyre | Manufacturer | Tread depth |
|---|---|---|---|---|
| 1) | 215/65 R17 99H | Winter tyres on Light alloy | Falken | 4mm / 4mm |
| 2) | 215/65 R17 99H | Winter tyres on Light alloy | Falken | 4mm / 4mm |

| No. | Component group | Description |
|---|---|---|
| 1 | 2nd wheel set | Tyres - complete set (Über 4mm) - No deduction |

Figure 16: Additional tyres

Figure 17: Additional tyres

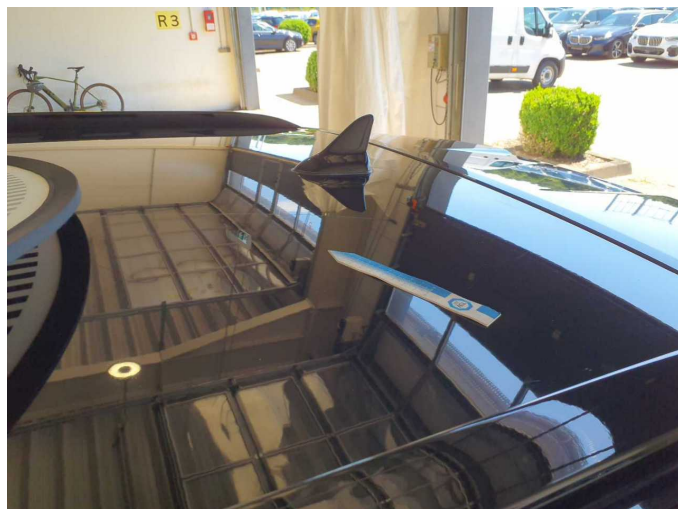
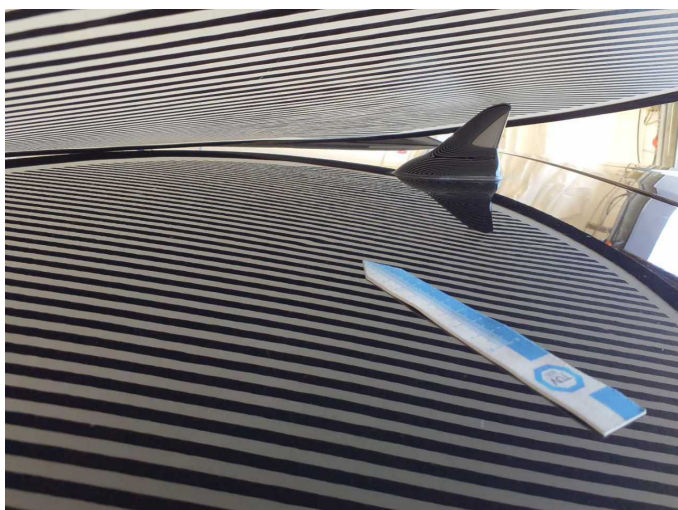
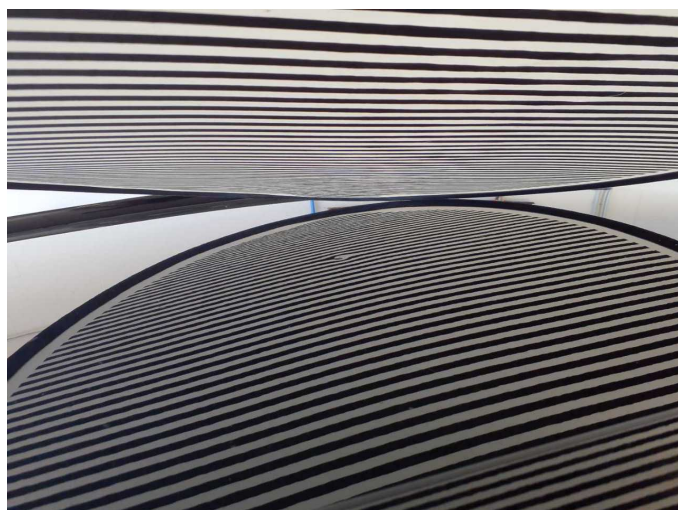
| No. | Component group | Description |
|---|---|---|
| 1 | Roof | Roof - dent(s) - Smooth repair work |

**Damage 1:** Roof: Roof - dent(s) - Smooth repair work

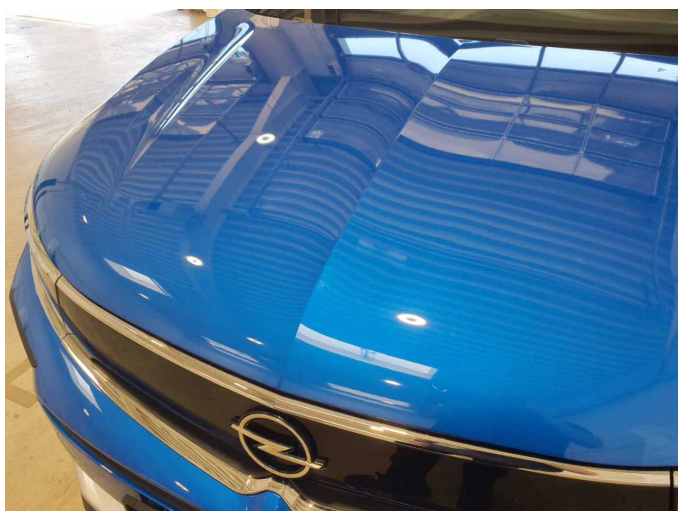
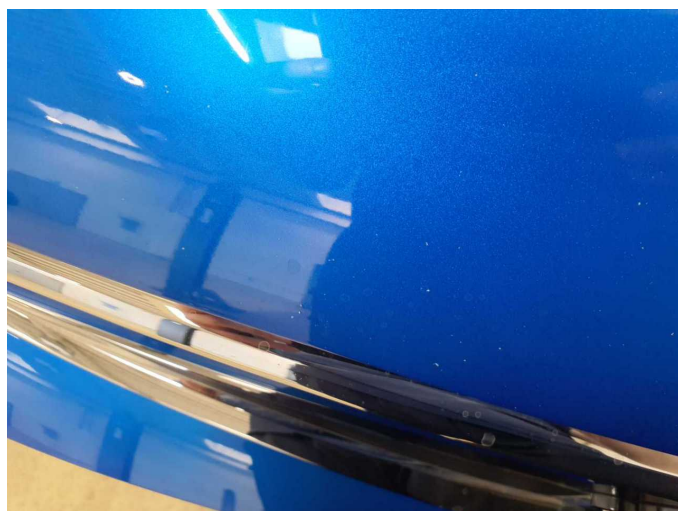
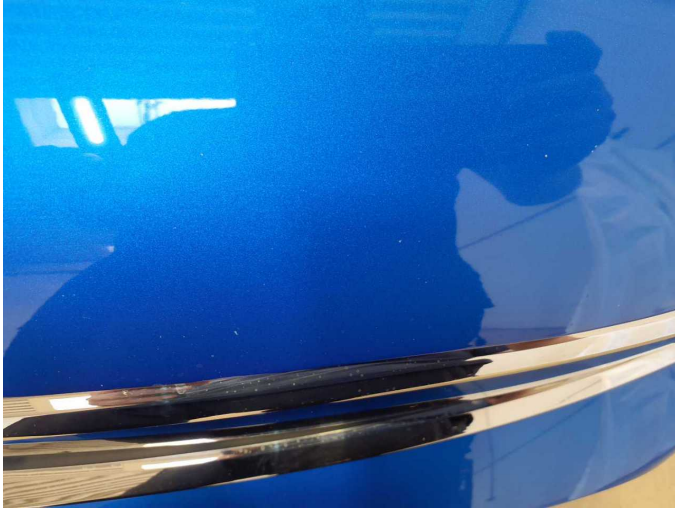
| No. | Component group | Description |
|---|---|---|
| 2 | Bonnet | Bonnet - Stone chips - Loss in value |

**Damage 2:** Bonnet: Bonnet - Stone chips - Loss in value

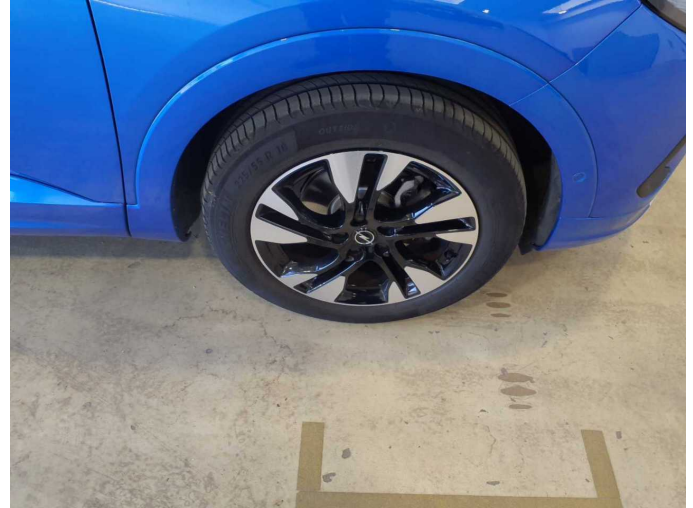
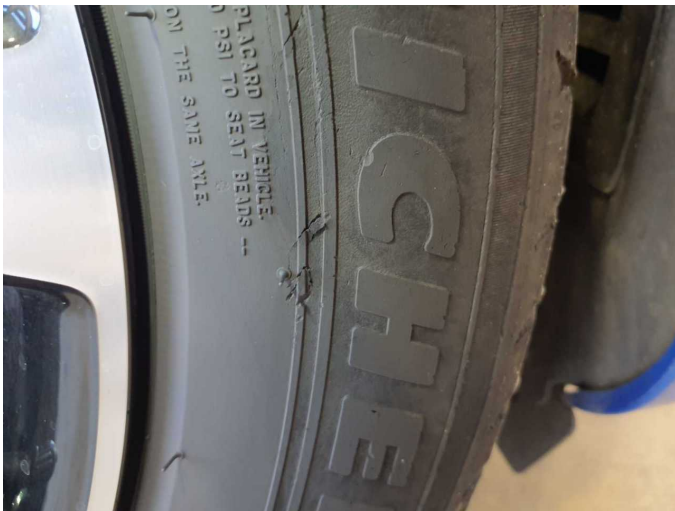
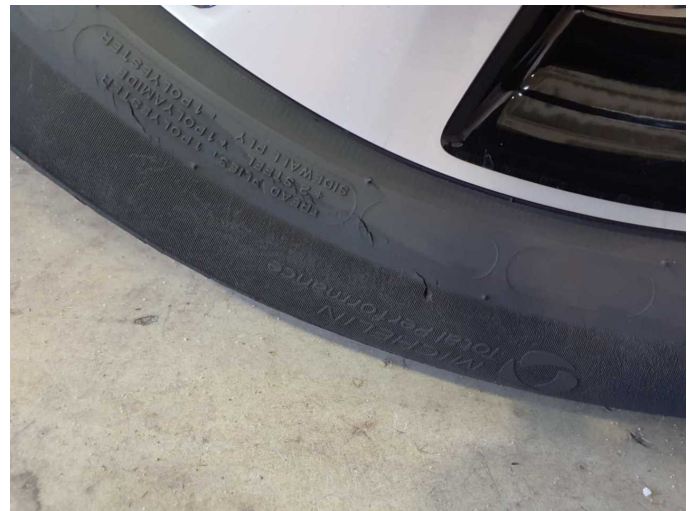
| No. | Component group | Description |
|---|---|---|
| 3 | Wheel / tyres | Tyre - front right side - Broken / torn - Replace |

**Damage 3:** Wheel / tyres: Tyre - front right side - Broken / torn - Replace

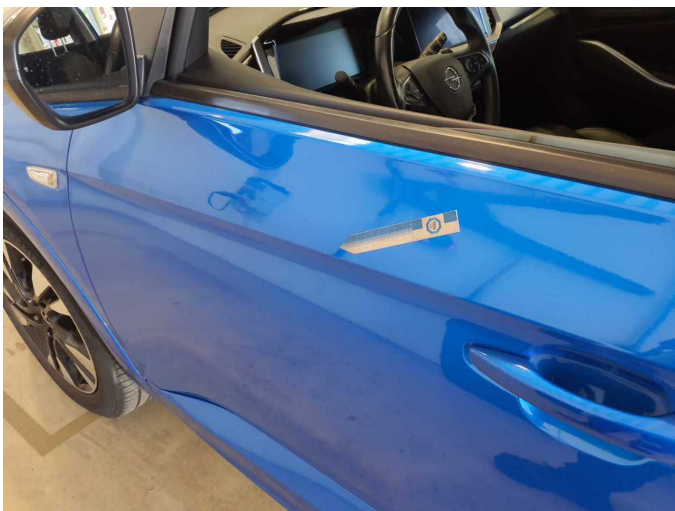
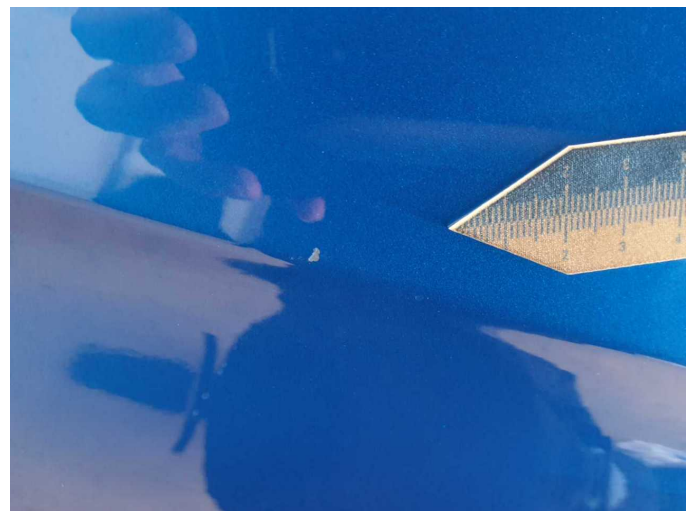
| No. | Component group | Description |
|---|---|---|
| 4 | Door - front left side | Door - Scratch(es) - Loss in value |

**Damage 4:** Door - front left side: Door - Scratch(es) - Loss in value

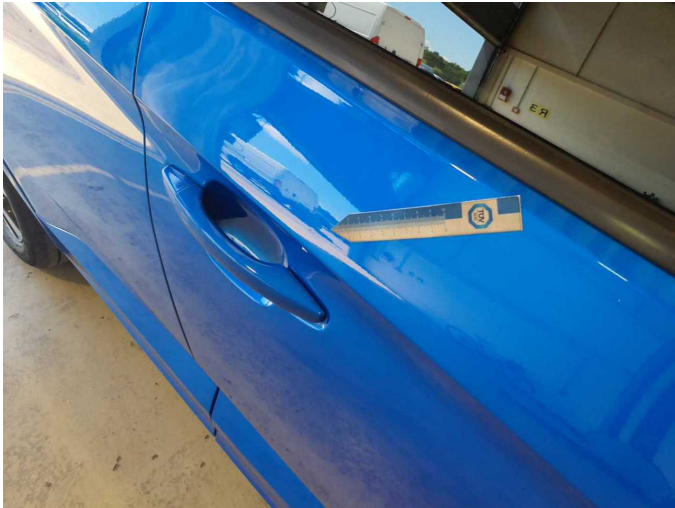
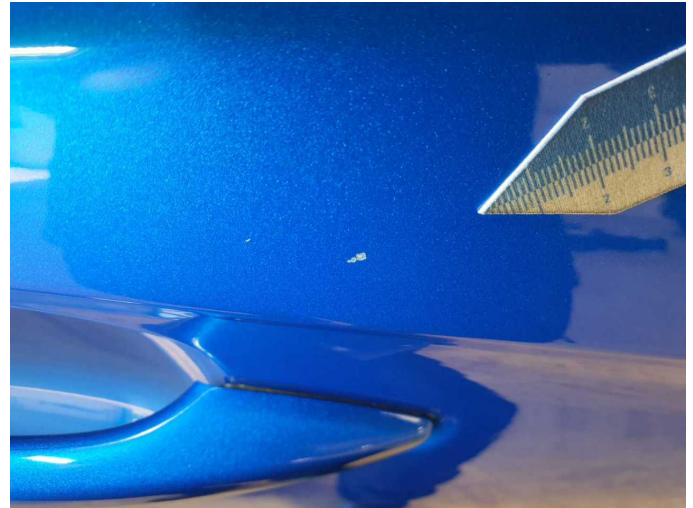
| No. | Component group | Description |
|---|---|---|
| 5 | Door - front right side | Door - Stone chips - Loss in value |

**Damage 5:** Door - front right side: Door - Stone chips - Loss in value

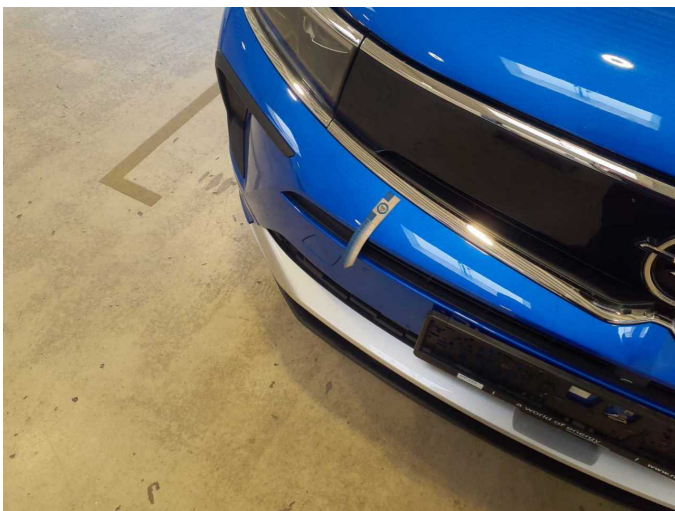
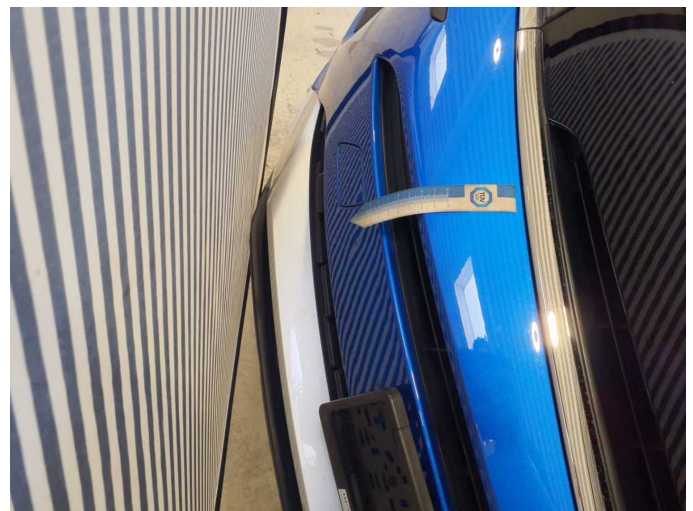
| No. | Component group | Description |
|---|---|---|
| 6 | Front bumper | Front bumper - dent(s) - Smart repair |

**Damage 6:** Front bumper: Front bumper - dent(s) - Smart repair

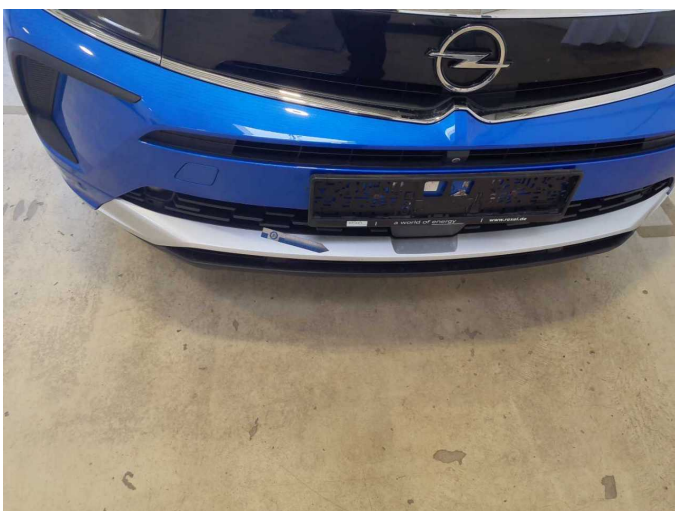
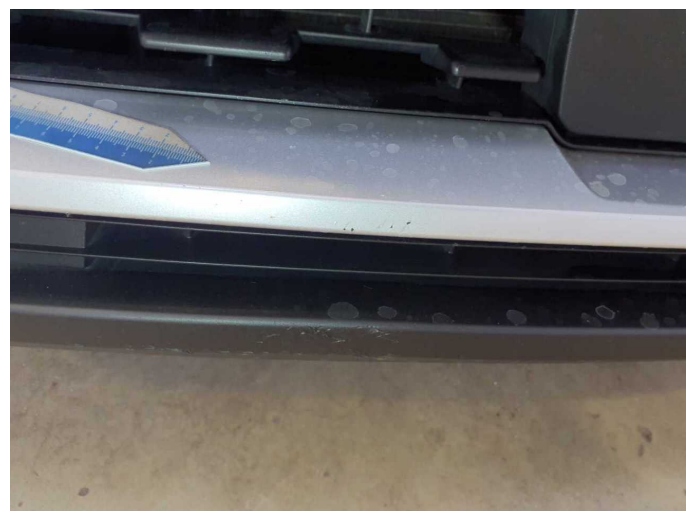
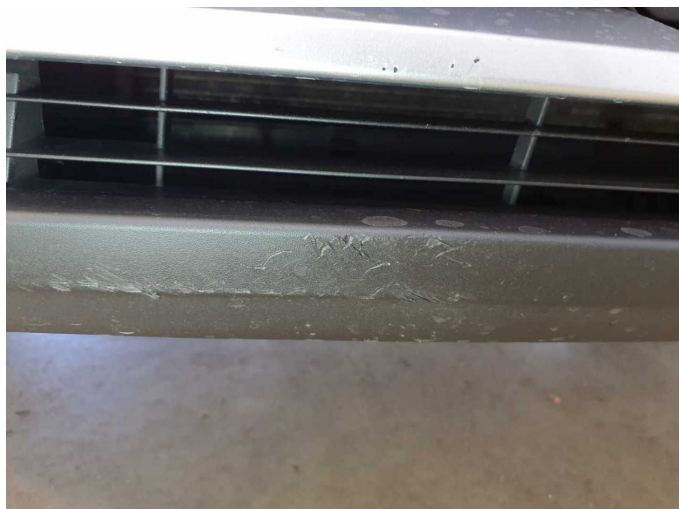
| No. | Component group | Description |
|---|---|---|
| 7 | Front bumper | Spoiler - Scratch(es) - Replace |

**Damage 7:** Front bumper: Spoiler - Scratch(es) - Replace

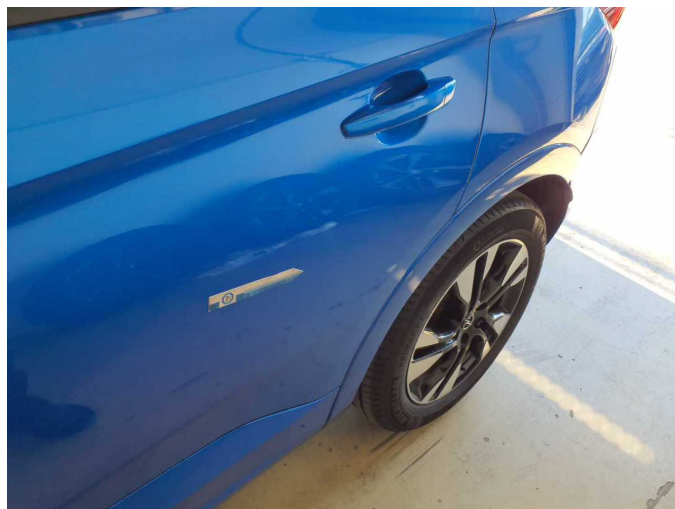
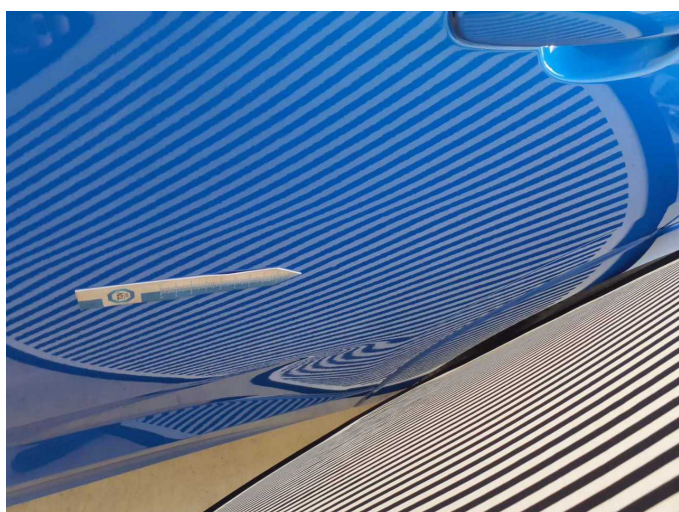
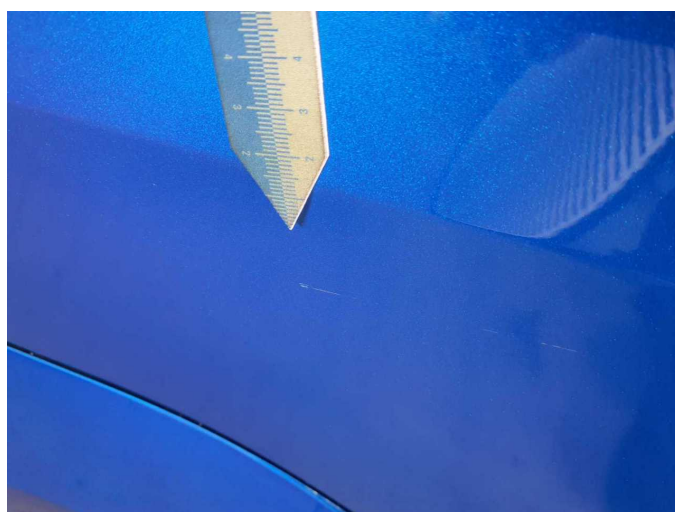
| No. | Component group | Description |
|---|---|---|
| 8 | Door - rear left side | Door - Dent / paintcoat damage - Repair and paint |

**Damage 8:** Door - rear left side: Door - Dent / paintcoat damage - Repair and paint

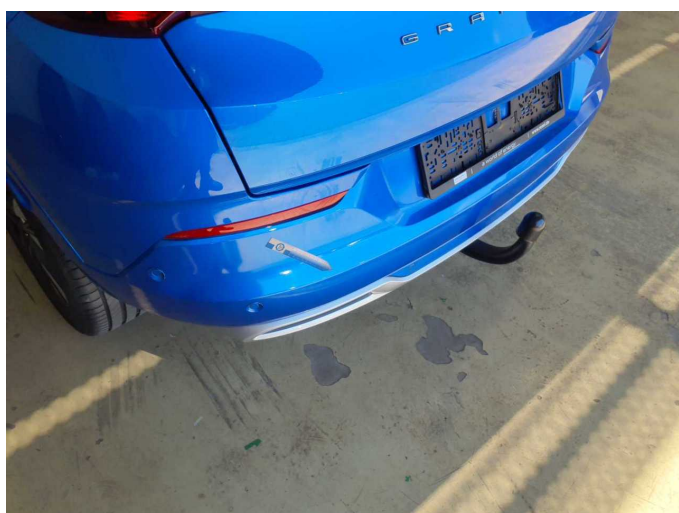
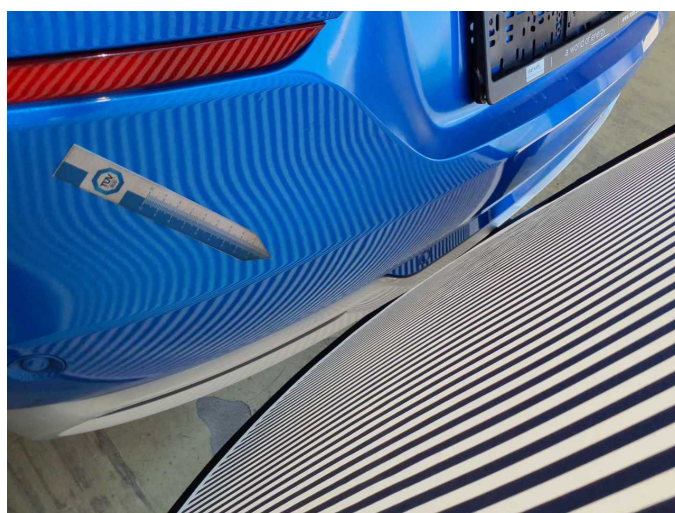
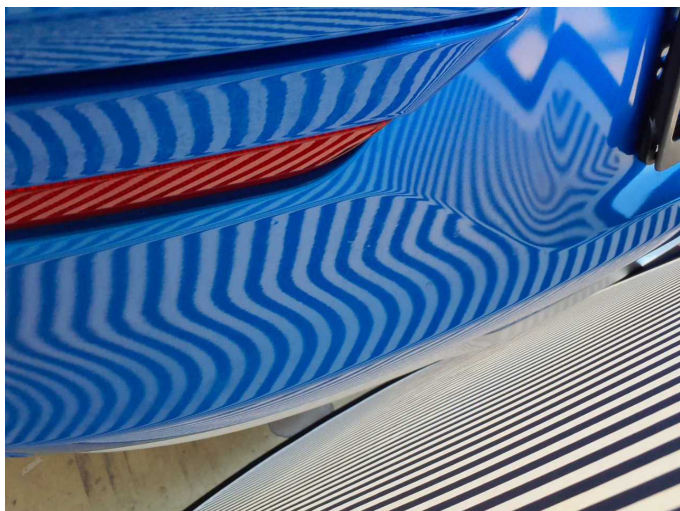
| No. | Component group | Description |
|---|---|---|
| 9 | Rear bumper | Rear bumper (Matt und einschlässe) - Paint defect - Repair and paint |

| No. | Repainting |
|---|---|
| 1 | Bumper rear, Unprofessionally carried out, Invoice of repair done Non-existent |

**Damage 9:** Rear bumper: Rear bumper (Matt und einschüsse) - Paint defect - Repair and paint
