Expertise

Protocol number: 46456371  
Order No. / Reference: 26661862  
Inspection date: 10 Jul 2026

Manufacturer: Mercedes-Benz  
VIN: W1N9M0BBXPN033409

Model: EQB 250 Progressive

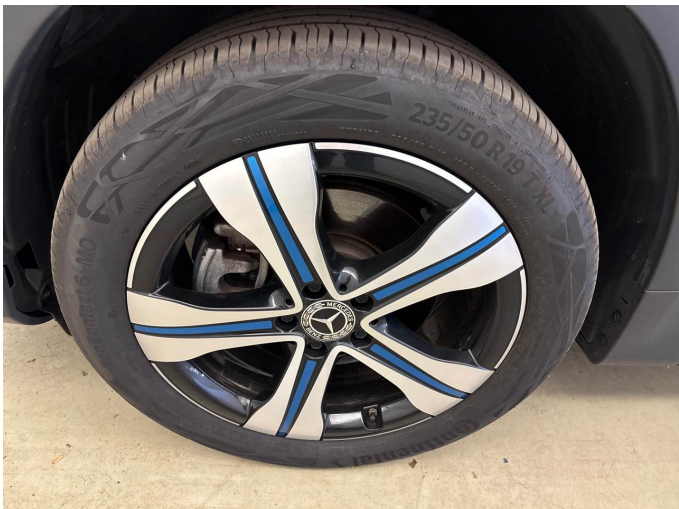
| # | Tyre size | Type of tyre | Manufacturer | Tread depth |
|---|---|---|---|---|
| 1) | 235/50 R19 103T | Summer tyres on Light alloy | Continental | 4mm / 4mm |
| 2) | 235/50 R19 103T | Summer tyres on Light alloy | Continental | 5mm / 5mm |

Figure 12: Mounted tyres

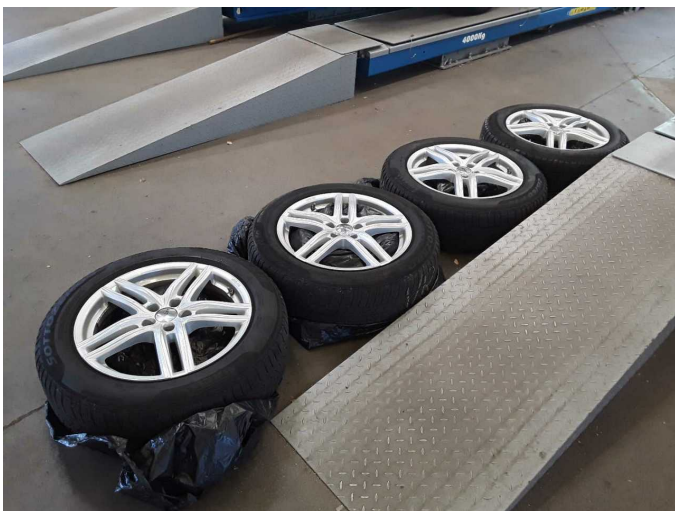
| # | Tyre size | Type of tyre | Manufacturer | Tread depth |
|---|---|---|---|---|
| 1) | 215/60 R18 102T | Winter tyres on Light alloy | Pirelli | 5mm / 5mm |
| 2) | 215/60 R18 102T | Winter tyres on Light alloy | Pirelli | 5mm / 5mm |

Figure 17: Additional tyres

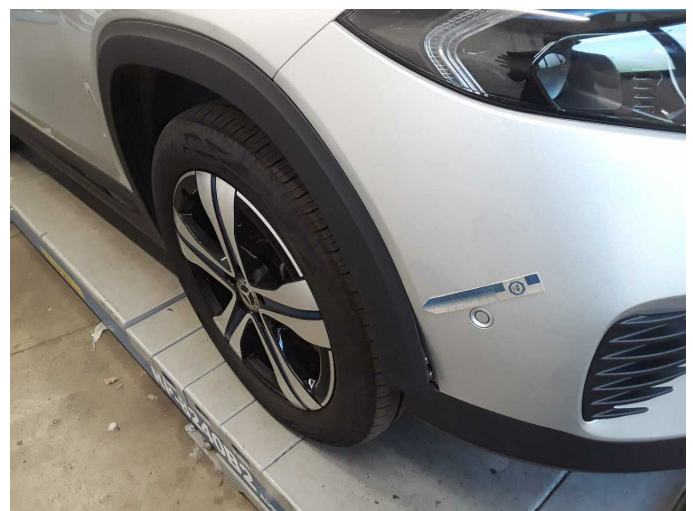
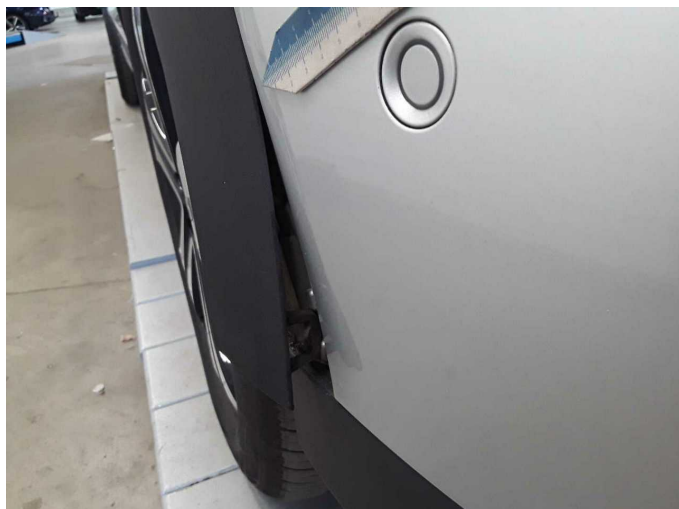
| No. | Component group | Description |
|---|---|---|
| 1 | Mudguard - right side | Wheel arch - Loose - Un- / install |

Damage 1: Mudguard - right side: Wheel arch - Loose - Un- / install

**Damage 1:** Mudguard - right side: Wheel arch - Loose - Un- / install

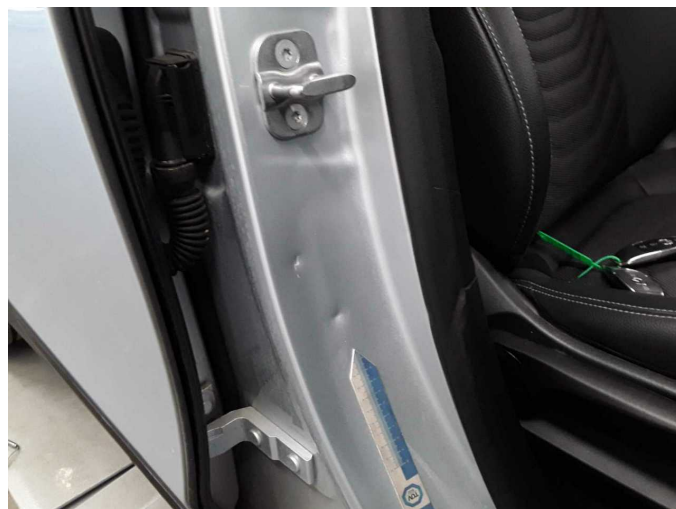
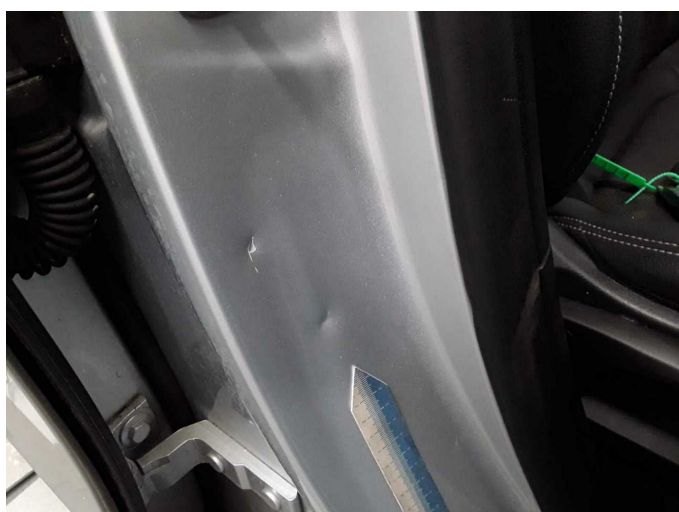
| No. | Component group | Description |
|---|---|---|
| 2 | Sill - right side | Sill - Dent / paintcoat damage - Smart repair |

**Damage 2:** Sill - right side: Sill - Dent / paintcoat damage - Smart repair

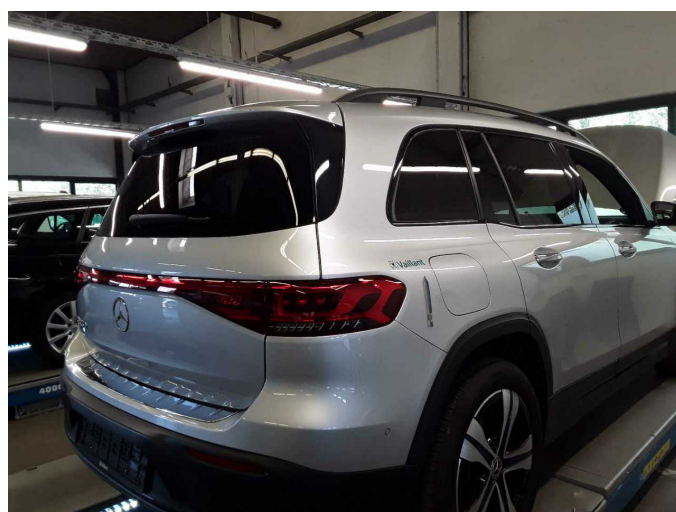
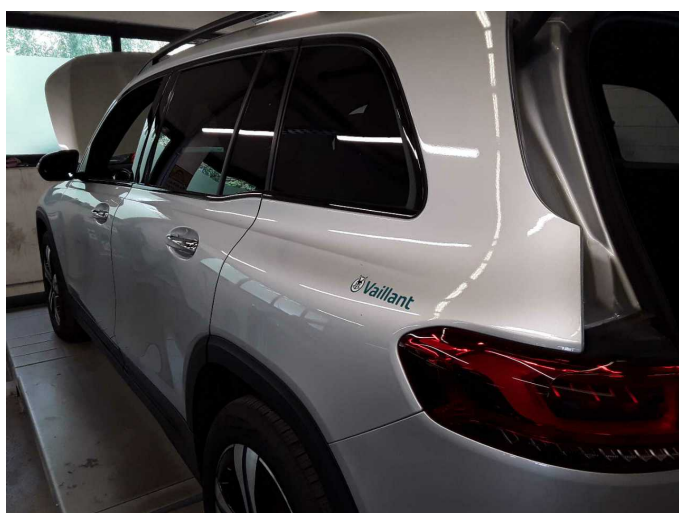
| No. | Component group | Description |
|---|---|---|
| 3 | Body | Body - Glued / labelled - De-glue / neutralise |

**Damage 3:** Body: Body - Glued / labelled - De-glue / neutralise

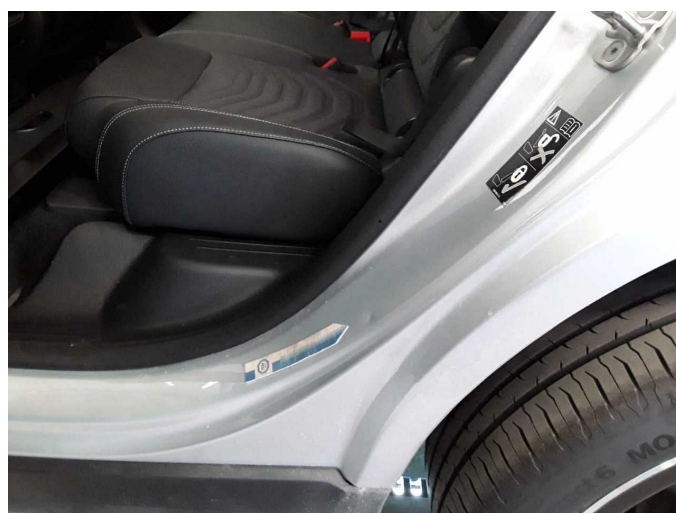
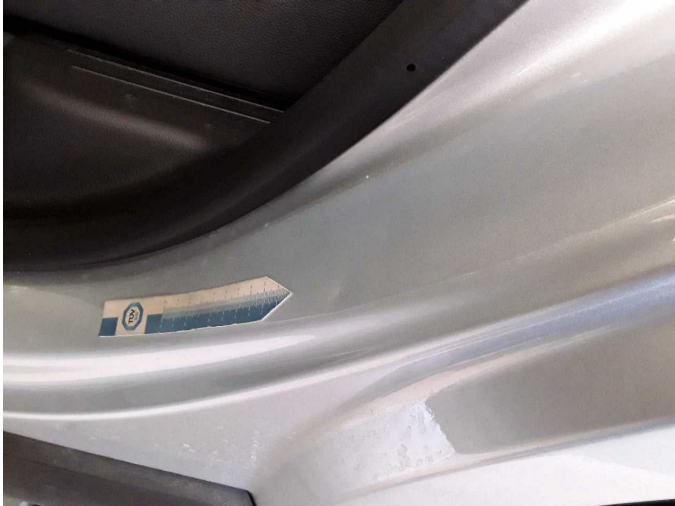
| No. | Component group | Description |
|---|---|---|
| 5 | Side panel - rear left side | Sill - dent(s) - No deduction |

**Wear and tear 5:** Side panel - rear left side: Sill - dent(s) - No deduction

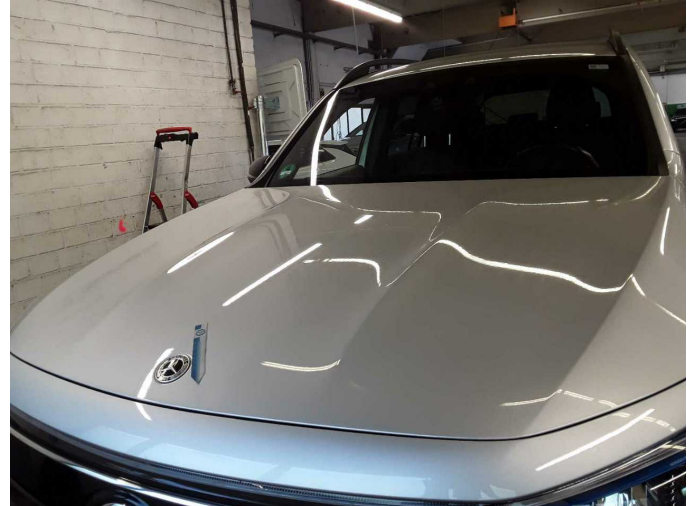
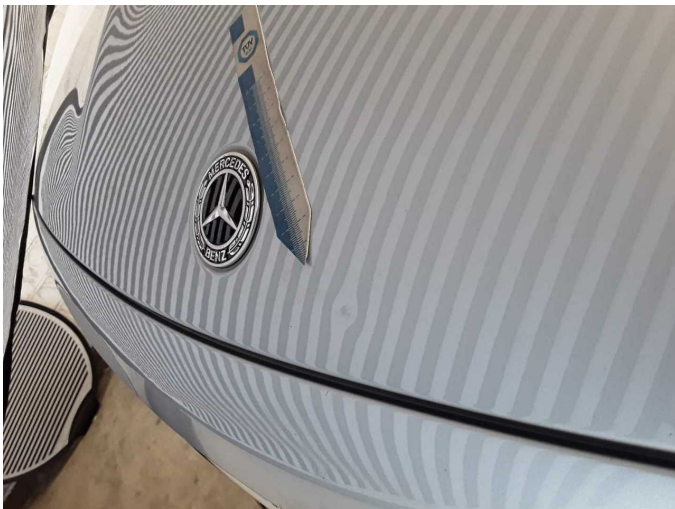
| No. | Component group | Description |
|---|---|---|
| 6 | Bonnet | Bonnet - dent(s) - No deduction |

**Wear and tear 6:** Bonnet: Bonnet - dent(s) - No deduction

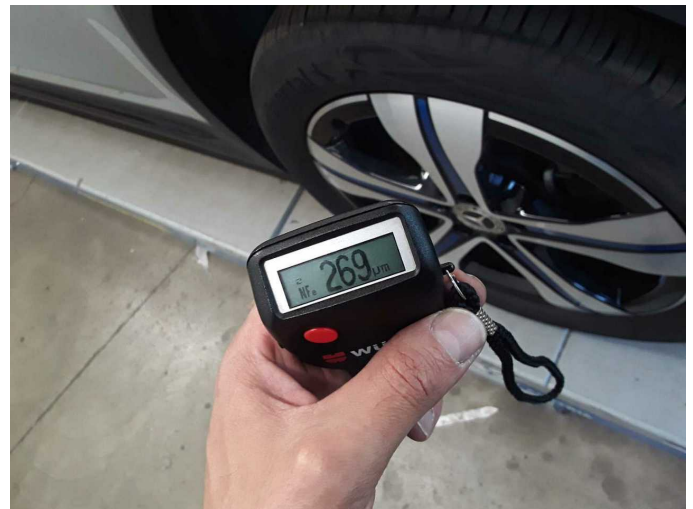
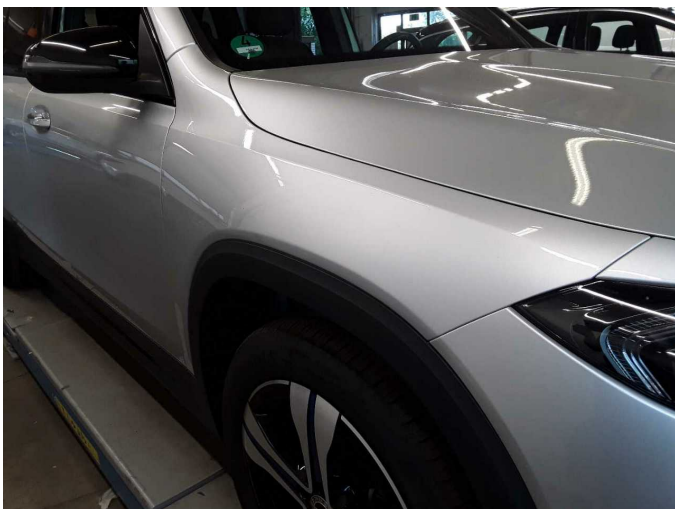
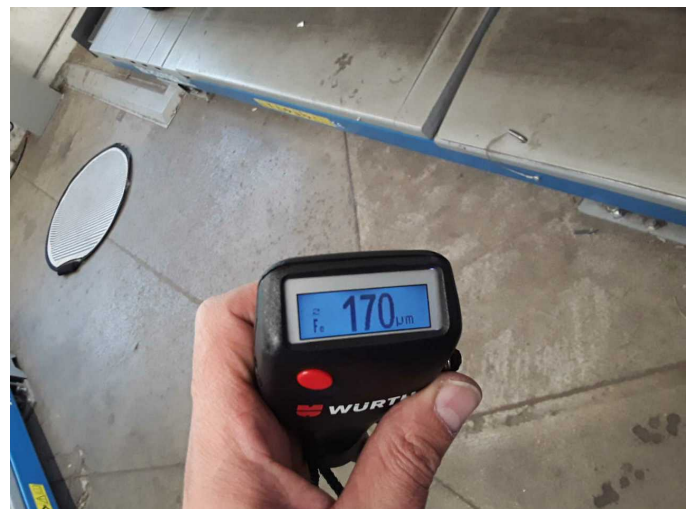
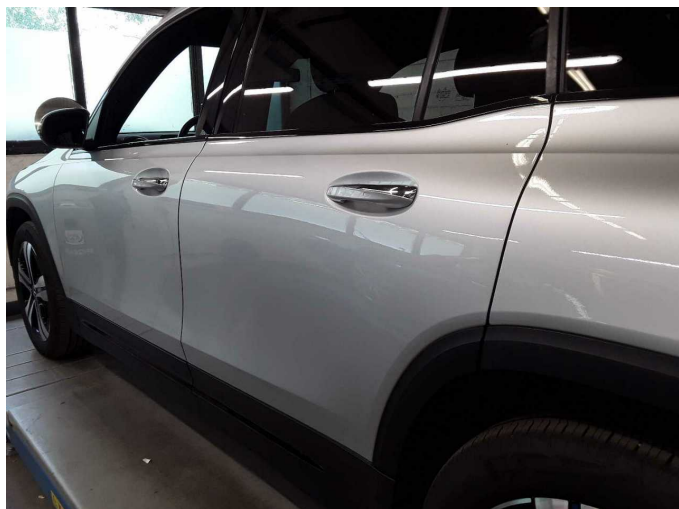
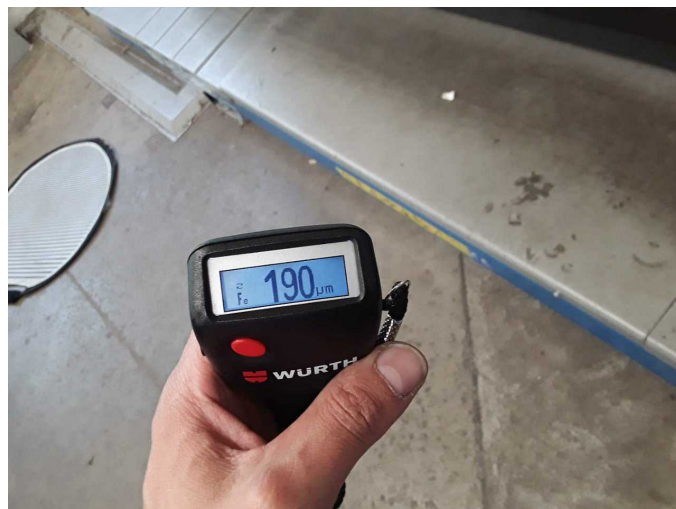
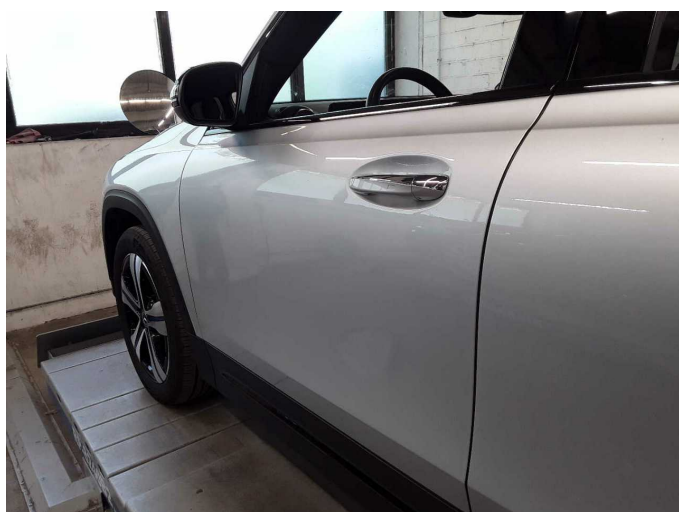
| No. | Repainting |
|---|---|
| 1 | Mudguard - left side, Mudguard - right side, Door - rear left side, Door - front left side, Professionally carried out, Invoice of repair done Non-existent |

| Mudguard - left side | 165 µm | Mudguard - right side | 269 µm |
| Door - rear left side | 170 µm | Door - front left side | 190 µm |

**Repainting 1:** Mudguard - left side, Mudguard - right side, Door - rear left side, Door - front left side
