Expertise

Protocol number: 47194430  
Order No. / Reference: 26848159  
Inspection date: 17 Aug 2026

Manufacturer: Mercedes-Benz

Model: GLE 350 de 4Matic 9G-TRONIC AMG Line

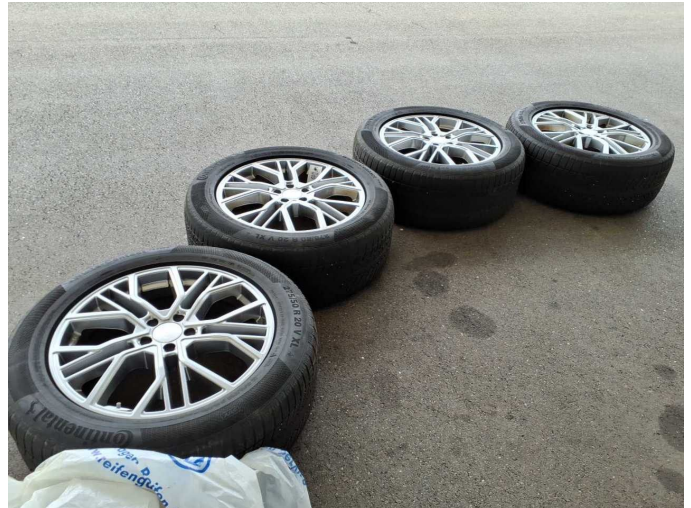
Figure 14: Additional tyres

- Der angegebene Winterradsatz ist kein Bestandteil des Auslieferungsumfangs.
- Ein Nachweis über die Zulässigkeit des beiliegenden Radsatzes wurde nicht erbracht.

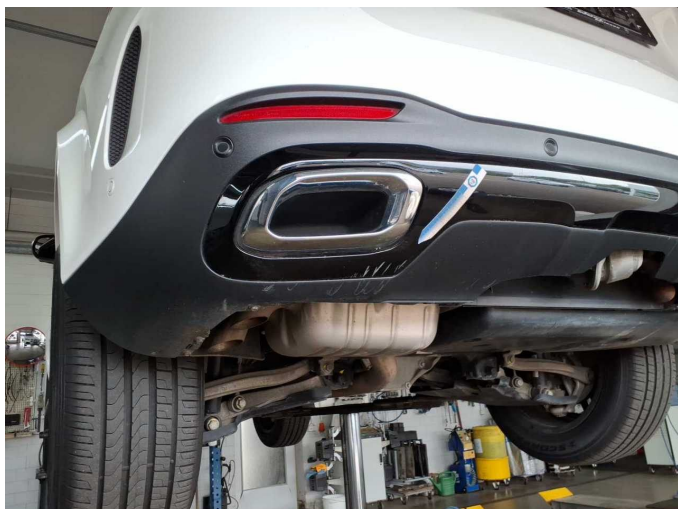
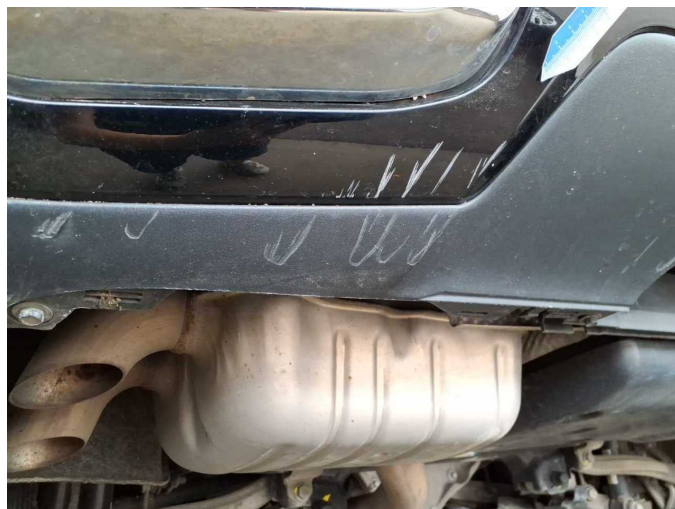
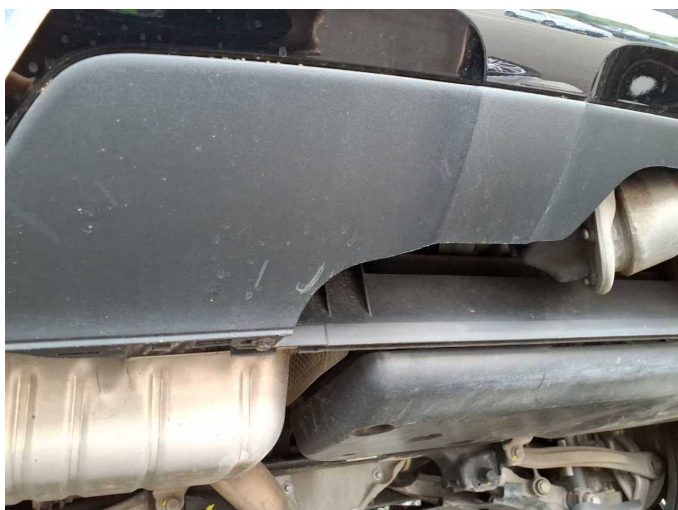
**Damage 2:** Rear bumper: Spoiler (Kunststoffbauteil) - Scratch(es) - Loss in value

| No. | Component group | Description |
|---|---|---|
| 2 | Rear bumper | Spoiler (Kunststoffbauteil) - Scratch(es) - Loss in value |

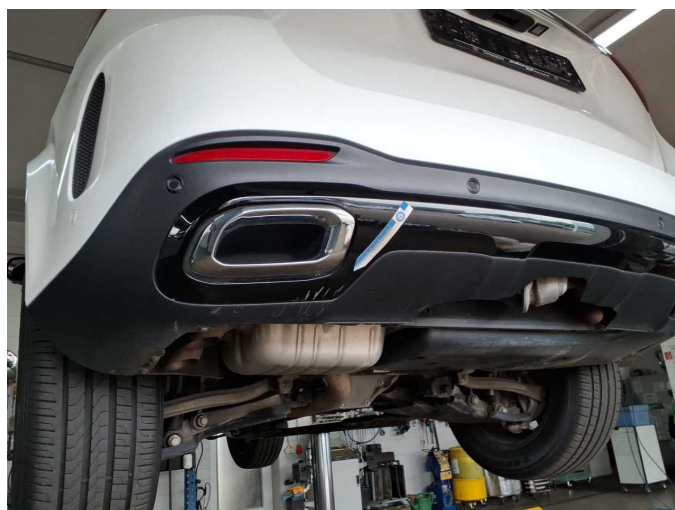
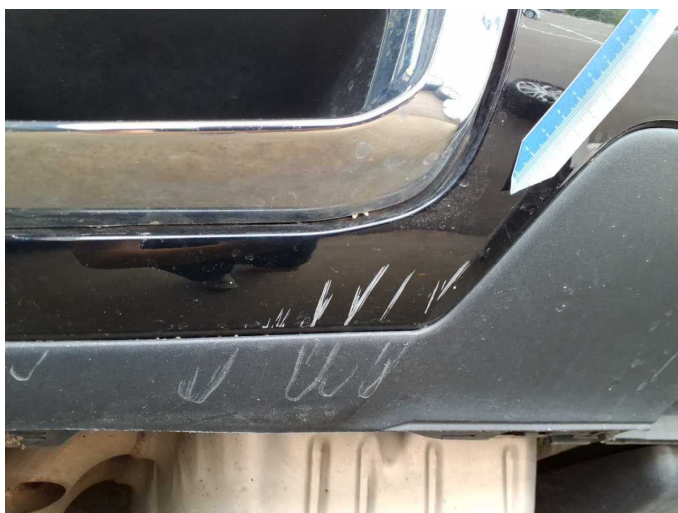
**Damage 3:** Rear bumper: Bumper - rear centre (Blende Stoßfänger unten) - Scratched - Smart repair

| No. | Component group | Description |
|---|---|---|
| 3 | Rear bumper | Bumper - rear centre (Blende Stoßfänger unten) - Scratched - Smart repair |

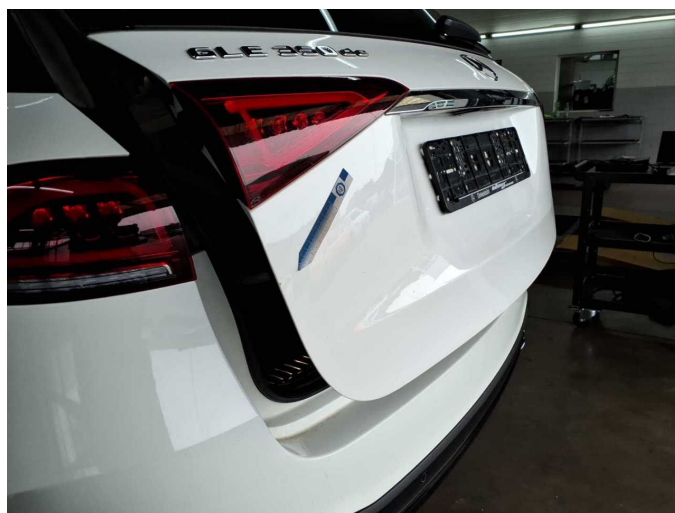
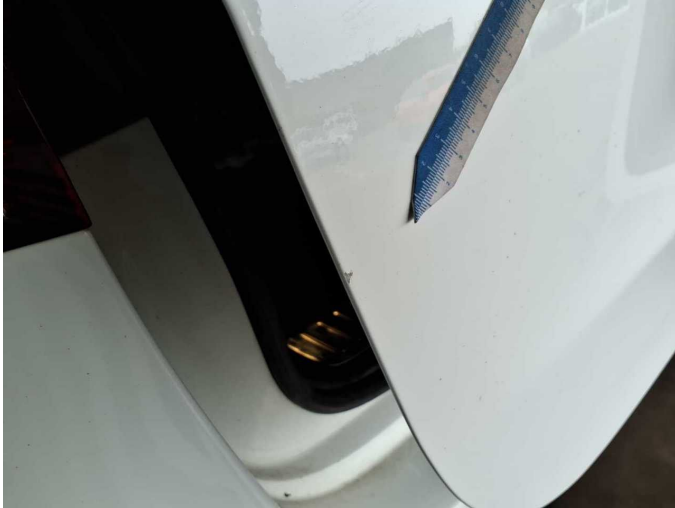
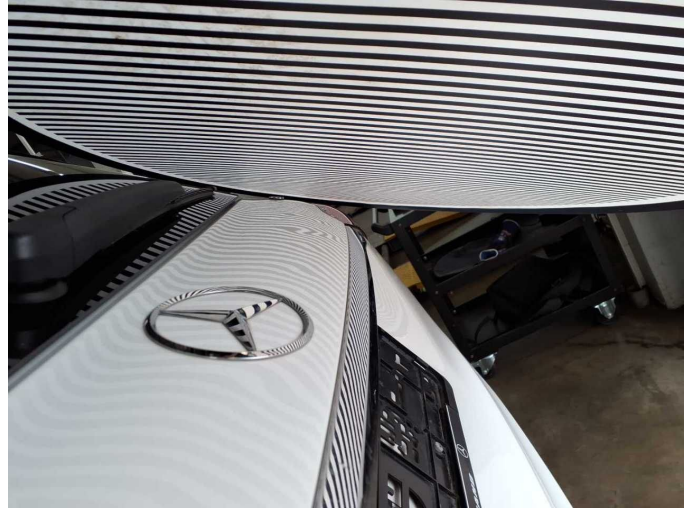
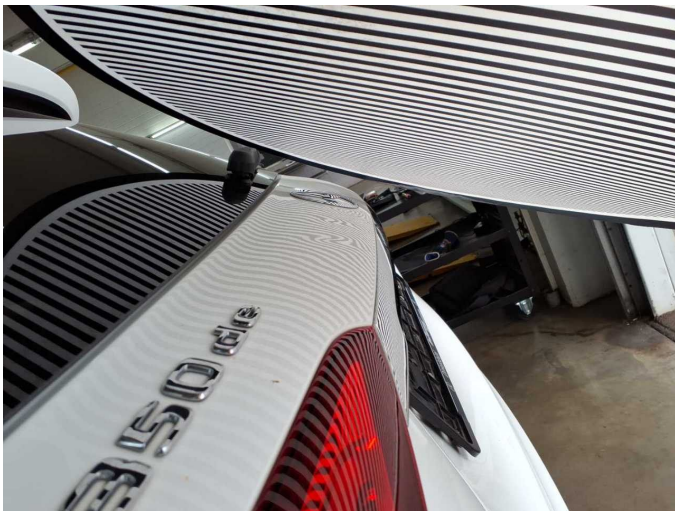
**Damage 4:** Boot lid / rear door: Boot lid - Dent / paintcoat damage - Smart repair

| No. | Component group | Description |
|---|---|---|
| 4 | Boot lid / rear door | Boot lid - Dent / paintcoat damage - Smart repair |

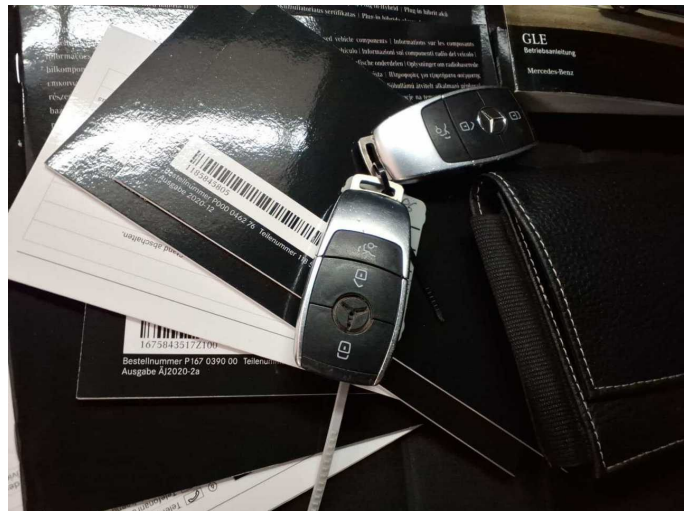
**Damage 6:** Equipment: Vehicle key (Emblem fehlt, starke Abnutzungsspuren) - Differs from the original configuration - Replace

| No. | Component group | Description |
|---|---|---|
| 6 | Equipment | Vehicle key (Emblem fehlt, starke Abnutzungsspuren) - Differs from the original configuration - Replace |

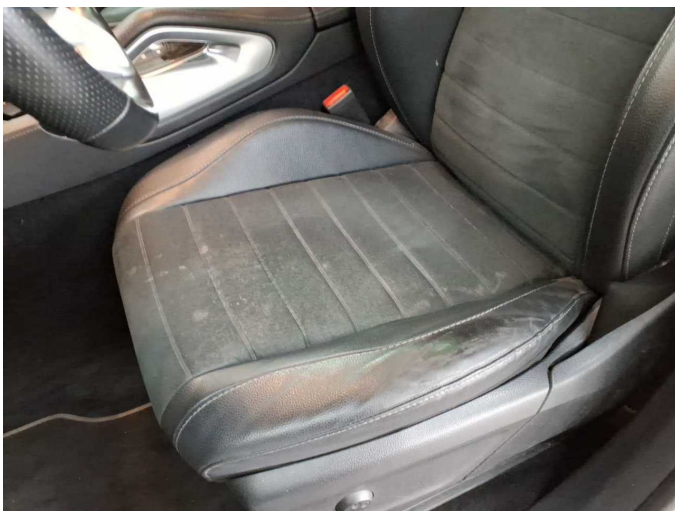
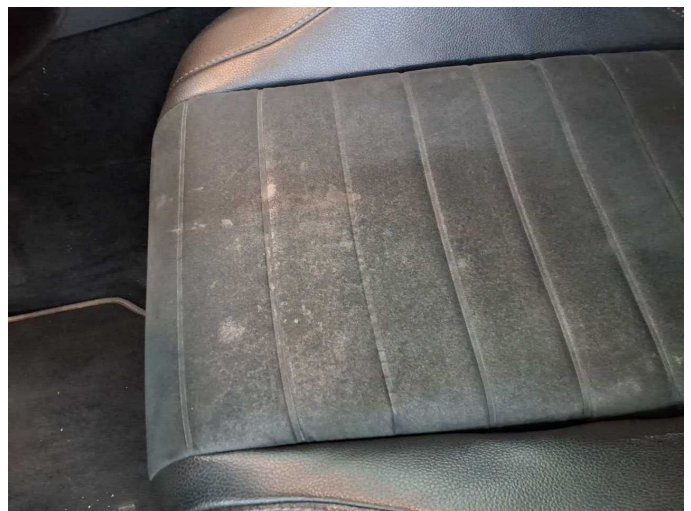
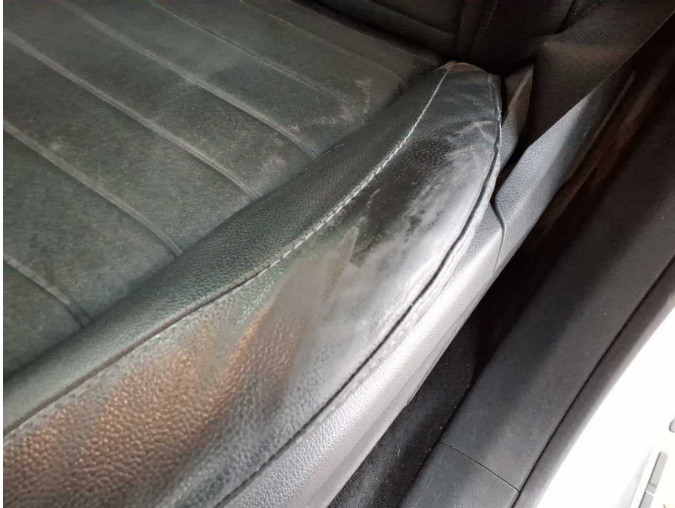
**Damage 7:** Seat - front: Seat cover - left side - Damaged - Replace

| No. | Component group | Description |
|---|---|---|
| 7 | Seat - front | Seat cover - left side - Damaged - Replace |

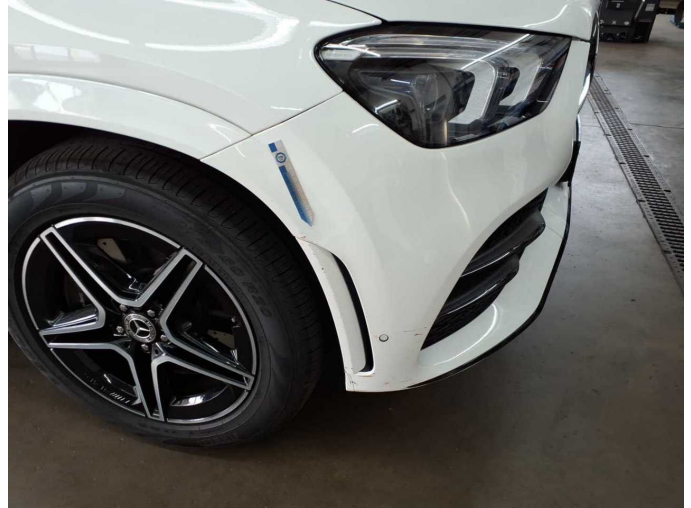
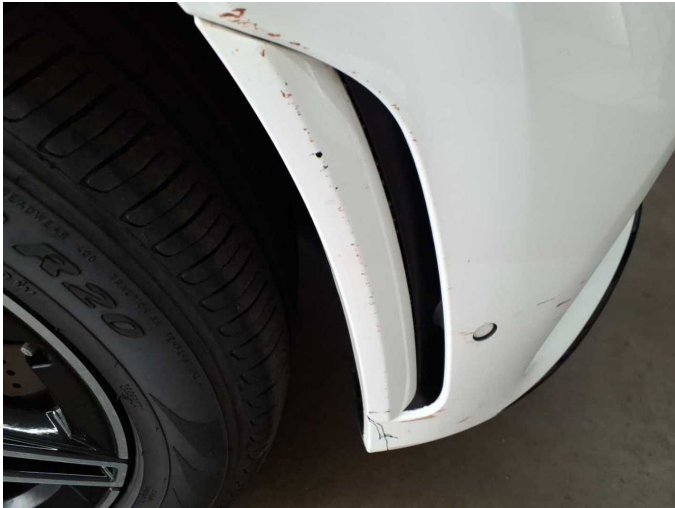
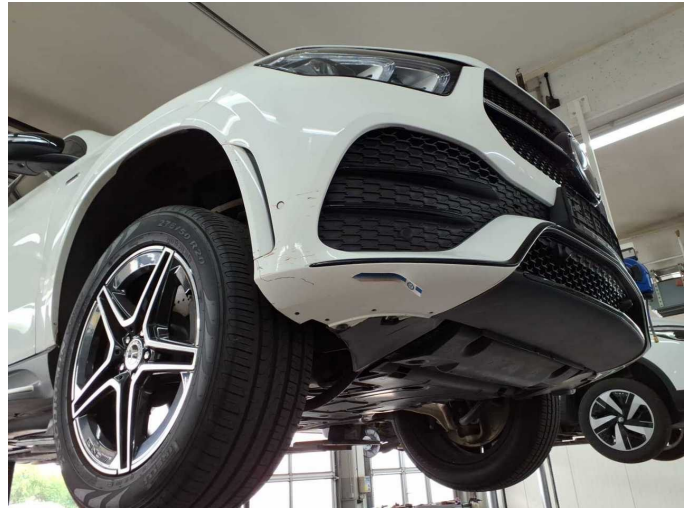
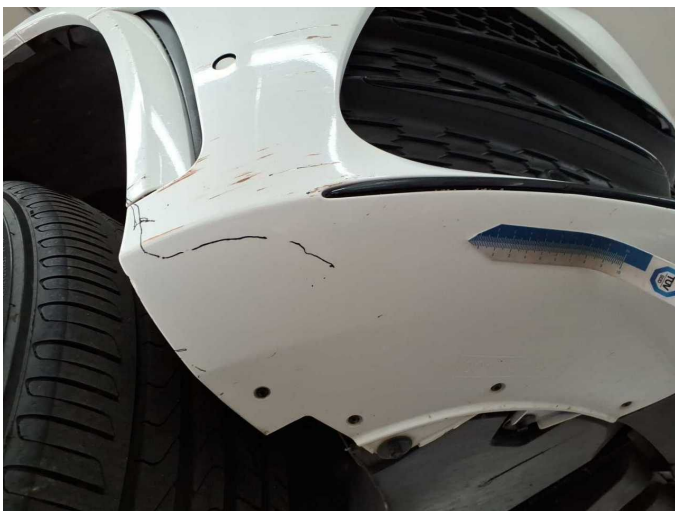
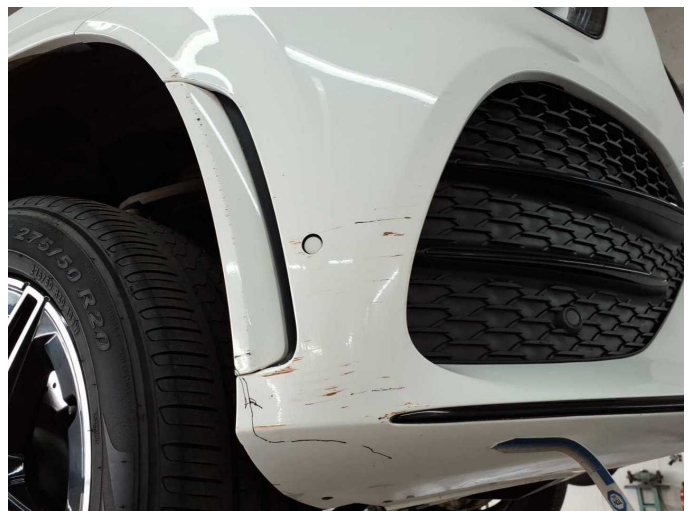
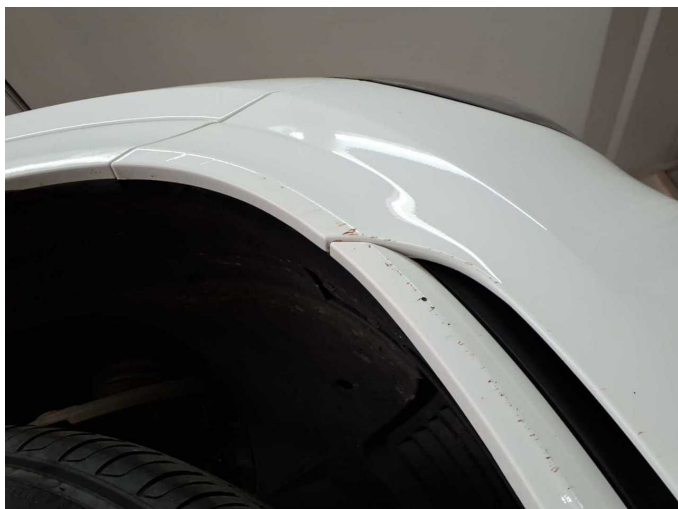
**Damage 8:** Front bumper: Front bumper - Scratch(es) - Paint

| No. | Component group | Description |
|---|---|---|
| 8 | Front bumper | Front bumper - Scratch(es) - Paint |

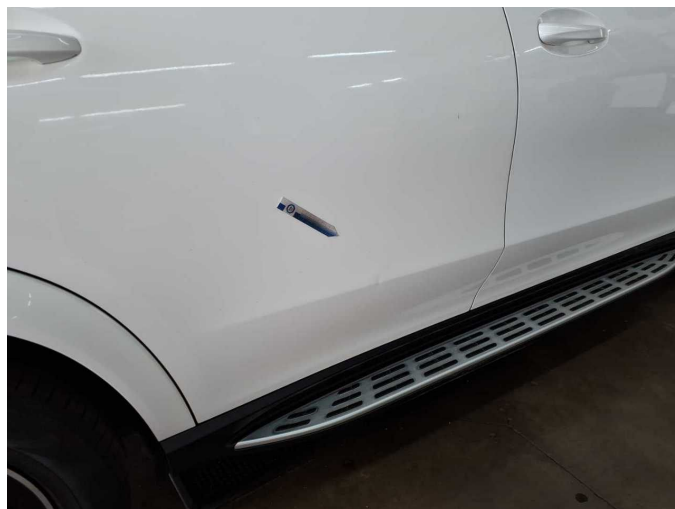
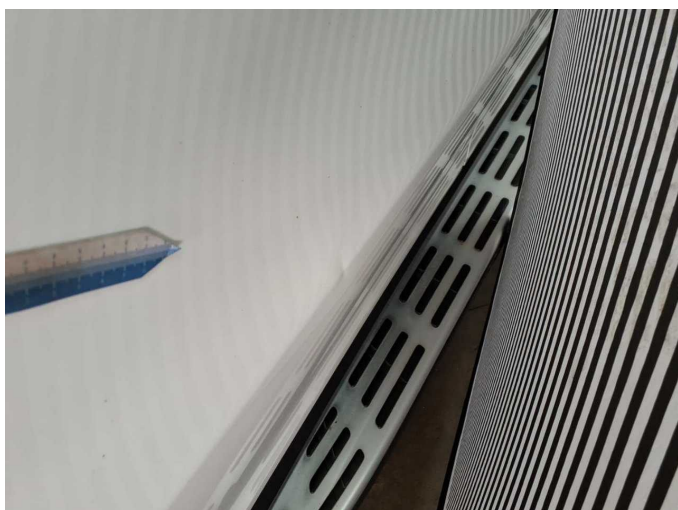
**Wear and tear 8:** Door - rear right side: Door - dent(s) - No deduction

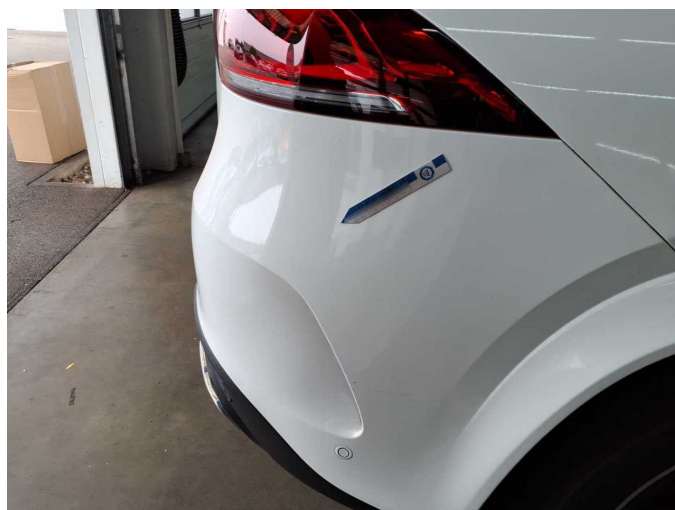
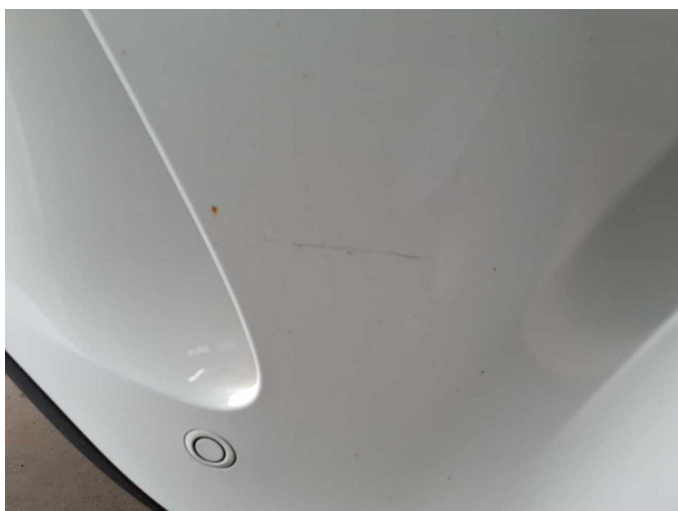
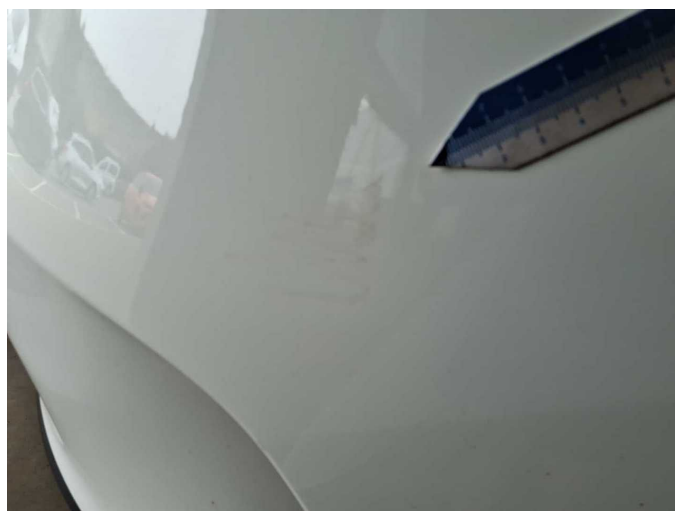
**Wear and tear 9:** Rear bumper: Rear bumper - Scratch(es) - No deduction

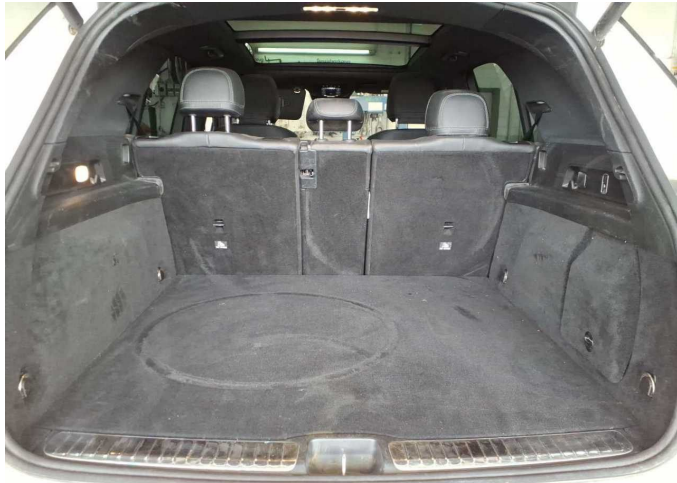
**Missing part 1:** Interior: Boot cover / roller cover - Missing - Replace

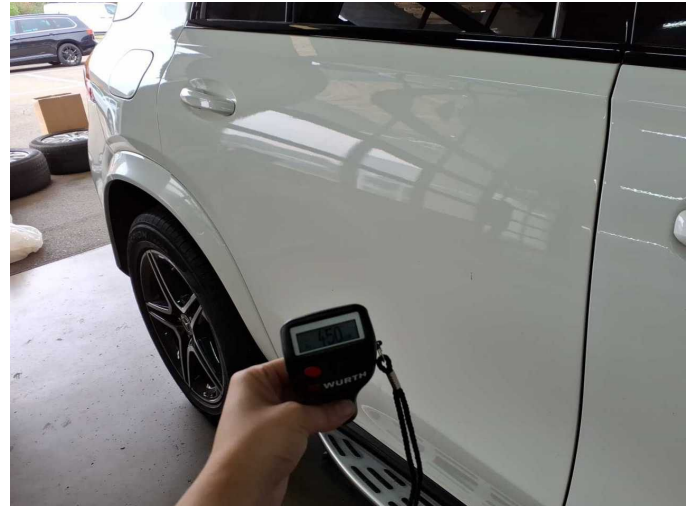
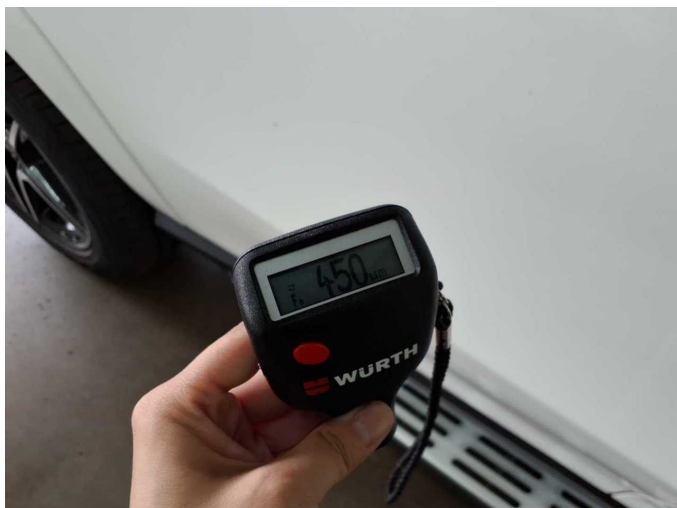
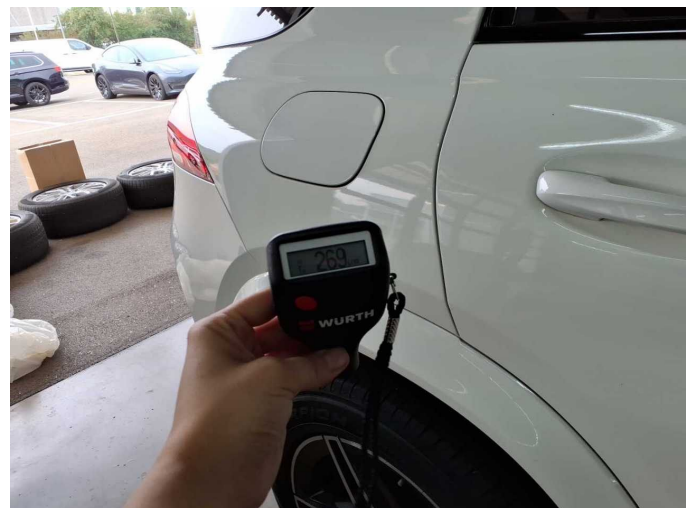
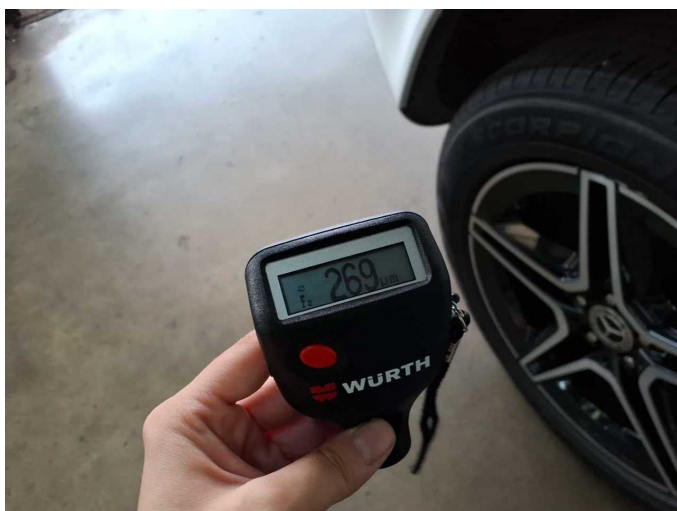
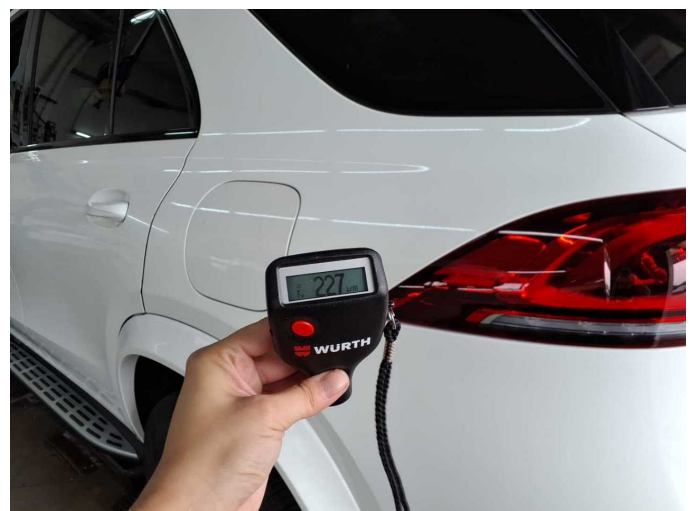
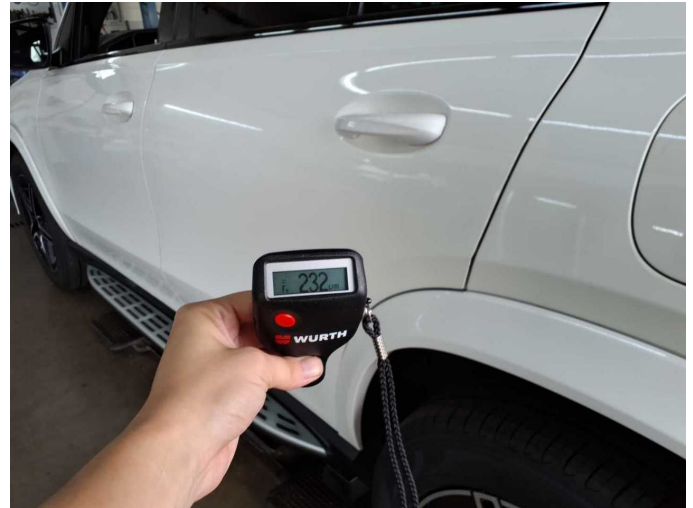
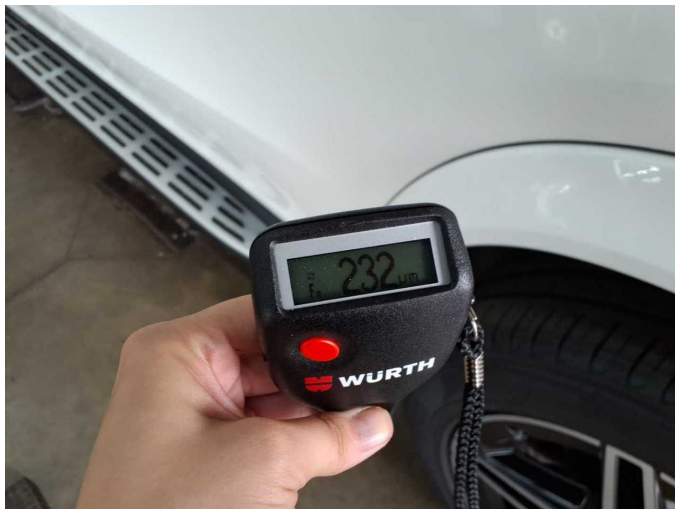
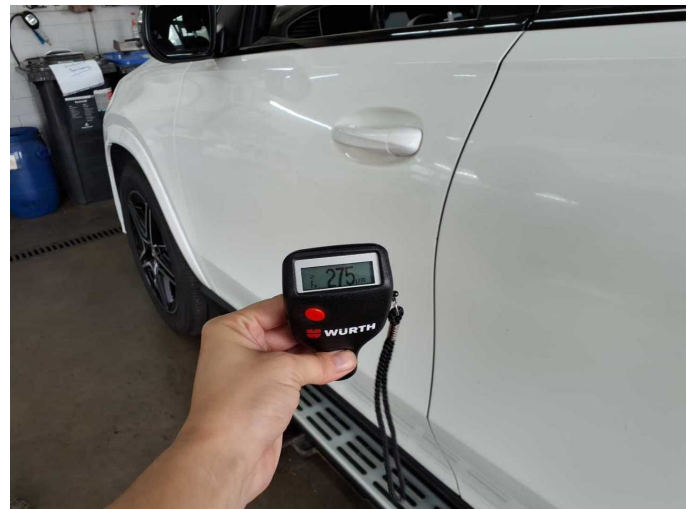
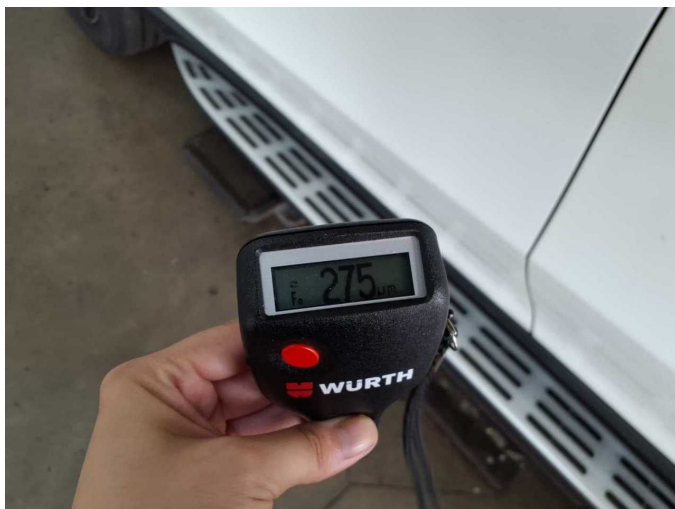
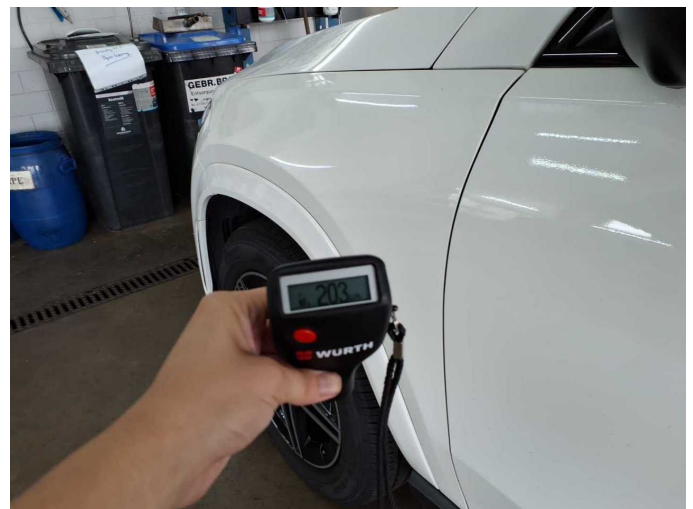
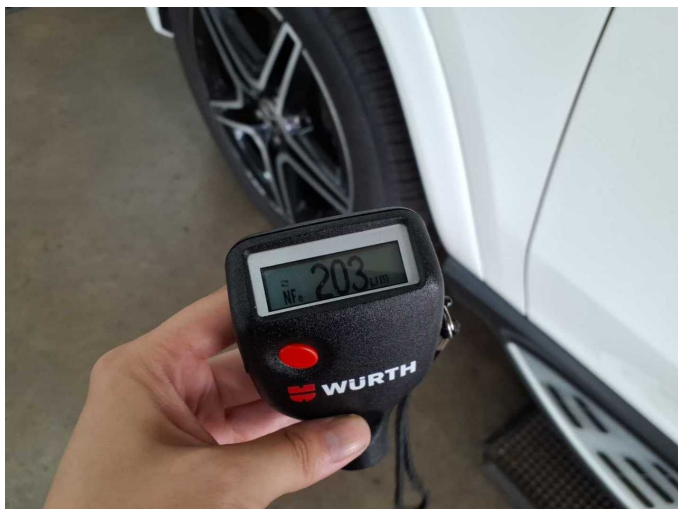
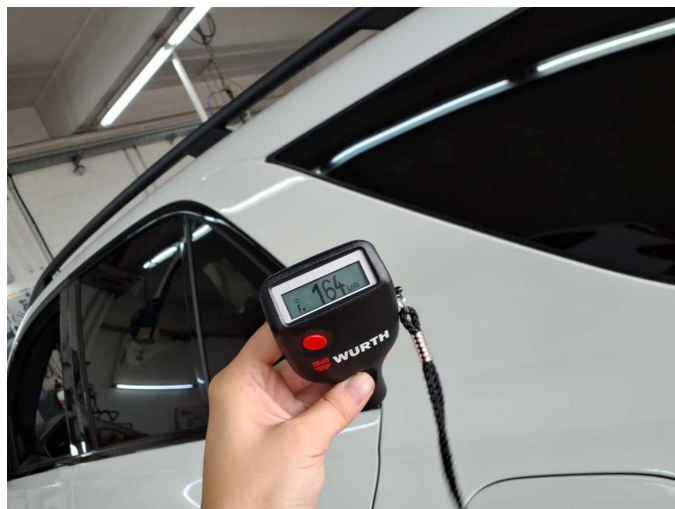
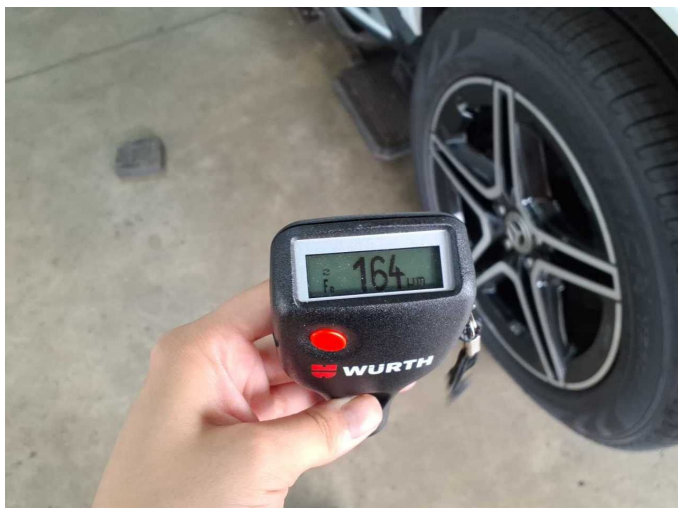
- 1 Roof rail - left side, Mudguard - left side, Side panel - rear left side, Side panel - rear right side, Door - rear left side, Door - rear right side, Door - front left side, Professionally carried out, Invoice of repair done Non-existent

**Repainting 1:** Roof rail - left side, Mudguard - left side, Side panel - rear left side, Side panel - rear right side, Door - rear left side, Door - rear right side, Door - front left side

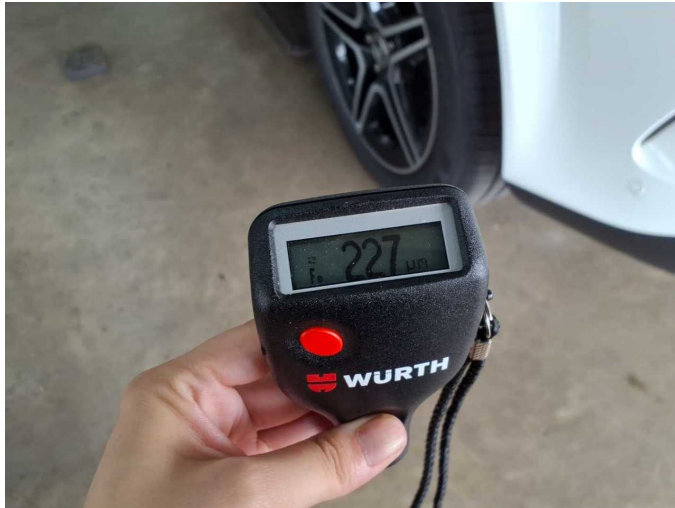
**Repainting 1:** Roof rail - left side, Mudguard - left side, Side panel - rear left side, Side panel - rear right side, Door - rear left side, Door - rear right side, Door - front left side

According to available information previous damages were repaired at the vehicle. Traces of repairs, which allow conclusions about the area of repair, were not recognizable during the inspection.
