Expertise

Protocol number: 45255100
Order No. / Reference: 26323544
Inspection date: 28 Apr 2026

Model: Passat Variant 2.0 TDI SCR DSG Business

VIN: WVVZZZ3CZPE036830

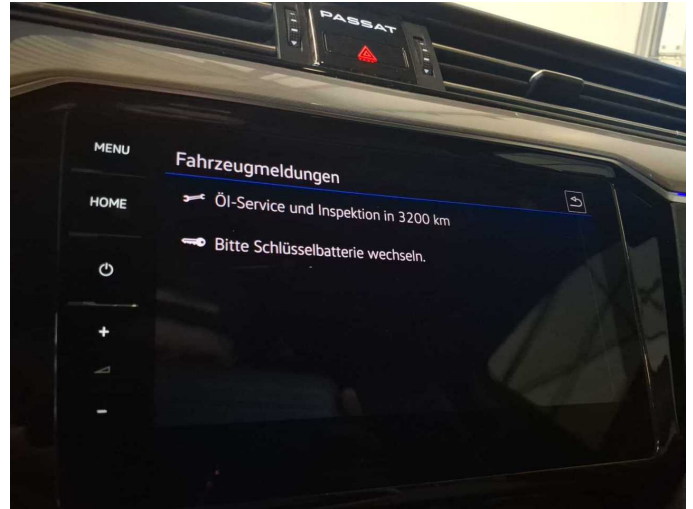
| No. | Component group | Description |
|---|---|--|
| 1 | Equipment | Vehicle key (Batterie wechseln) - Electrical fault - Perform diagnosis |

Damage 1: Equipment: Vehicle key (Batterie wechseln) - Electrical fault - Perform diagnosis

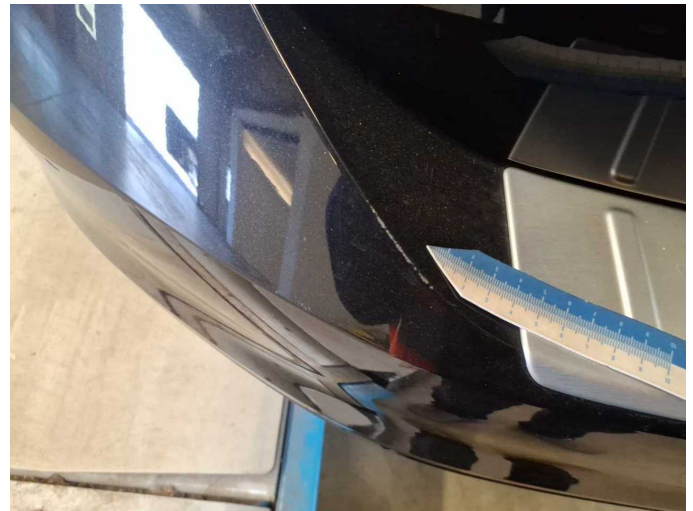
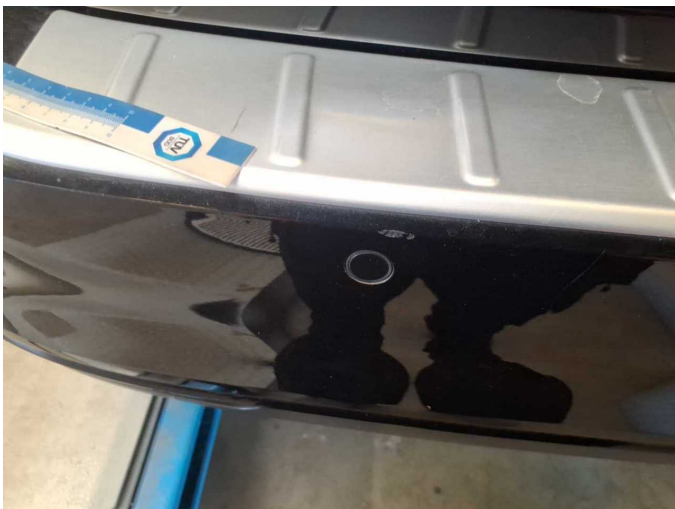
| No. | Component group | Description |
|---|---|--|
| 2 | Rear bumper | Rear bumper - Scratched - Smart repair |

Damage 2: Rear bumper: Rear bumper - Scratched - Smart repair

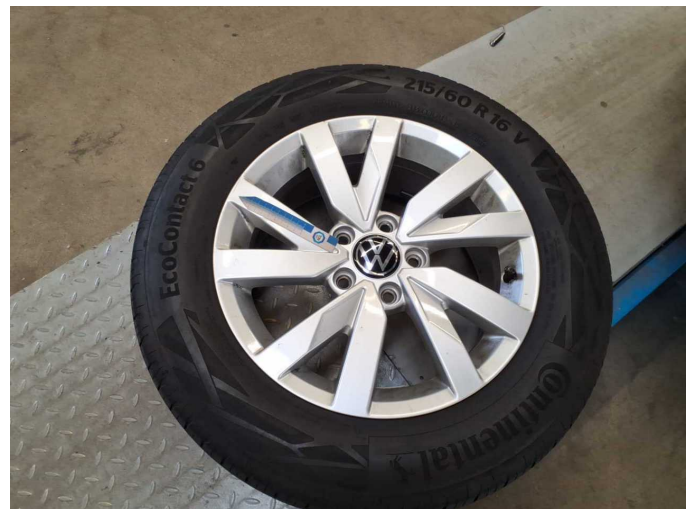
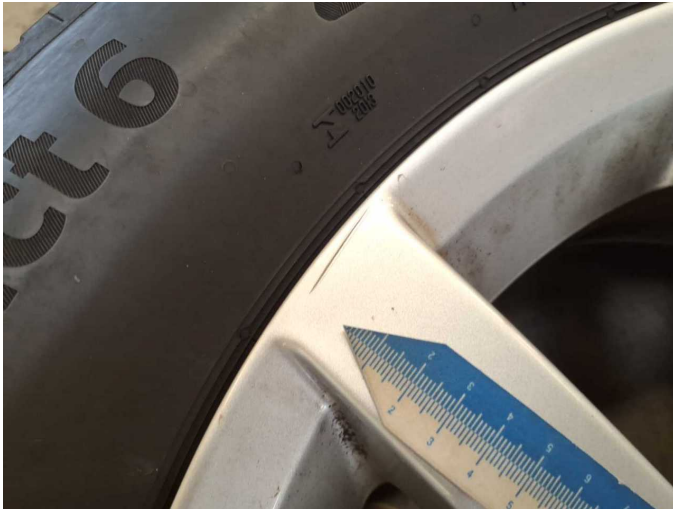
| No. | Component group | Description |
|---|---|--|
| 3 | 2nd wheel set | 1 alloy rim - Scratch(es) - Loss in value |

Damage 3: 2nd wheel set: 1 alloy rim - Scratch(es) - Loss in value

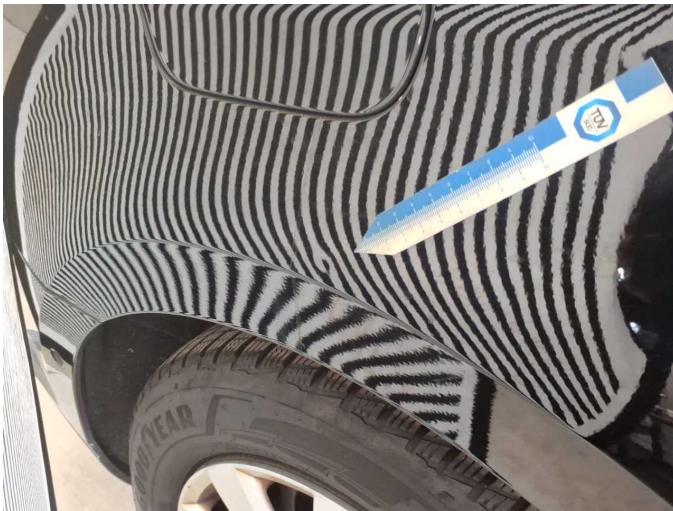
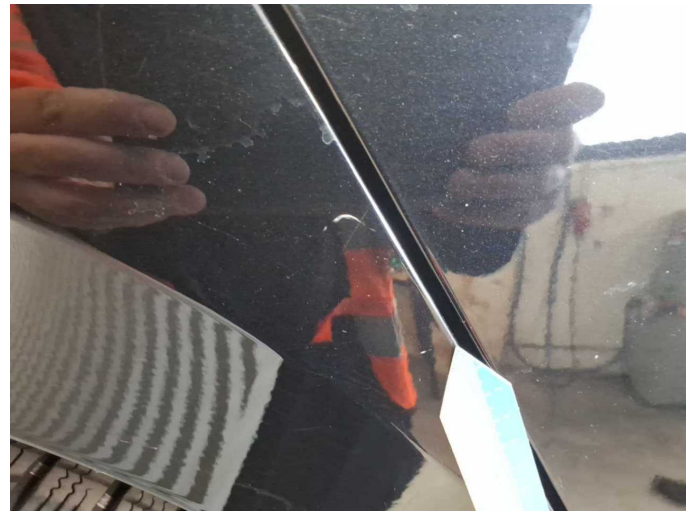
| No. | Component group | Description |
|---|---|--|
| 4 | Side panel - rear right side | Side panel - Dent / paintcoat damage - Paint |

Damage 4: Side panel - rear right side: Side panel - Dent / paintcoat damage - Paint

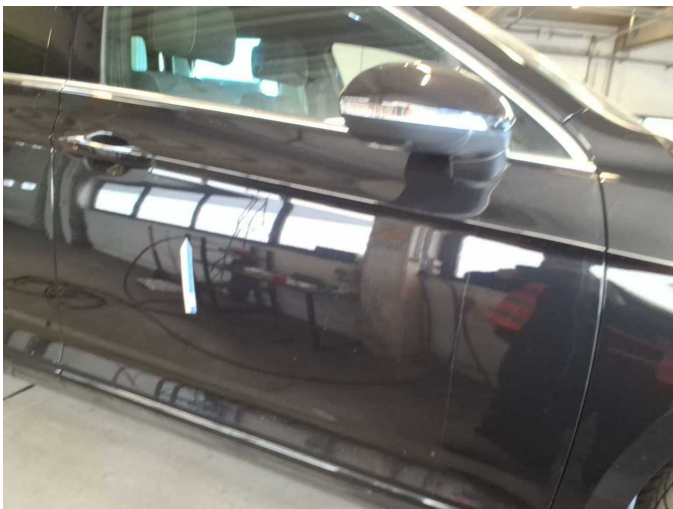
| No. | Component group | Description |
|---|---|--|
| 5 | Door - front right side | Door - Scratch(es) - Paint |

Damage 5: Door - front right side: Door - Scratch(es) - Paint

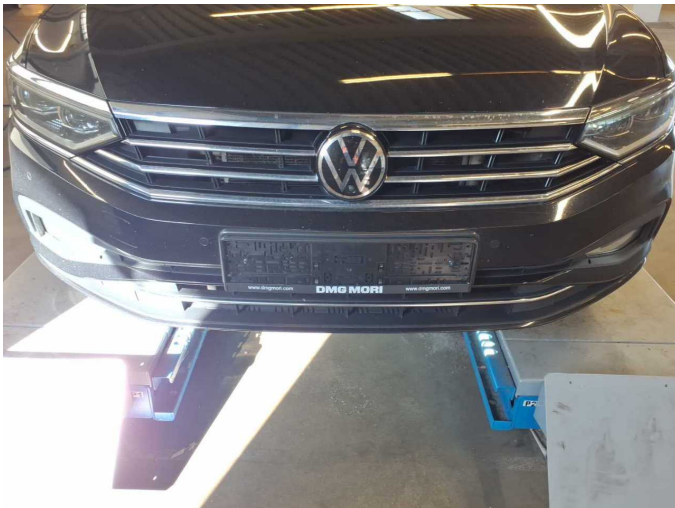
| No. | Component group | Description |
|---|---|---|
| 1 | Front bumper | Front bumper - Stone chips - No deduction |

Wear and tear 1: Front bumper: Front bumper - Stone chips - No deduction

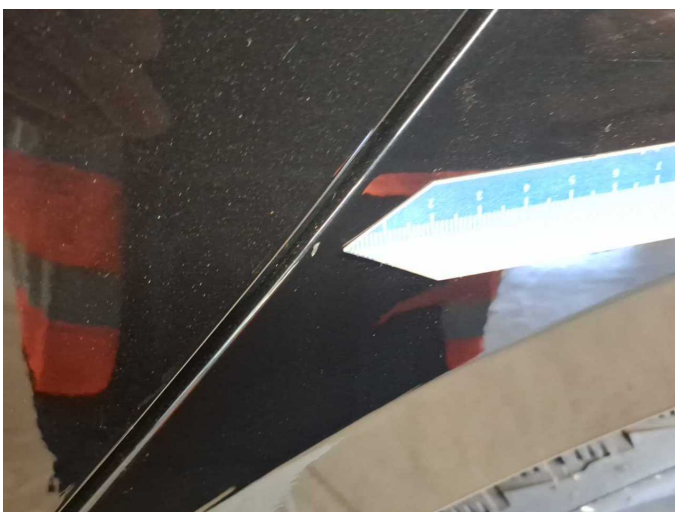
| No. | Component group | Description |
|---|---|---|
| 3 | Side panel - rear left side | Side panel - Stone chips - No deduction |

Wear and tear 3: Side panel - rear left side: Side panel - Stone chips - No deduction

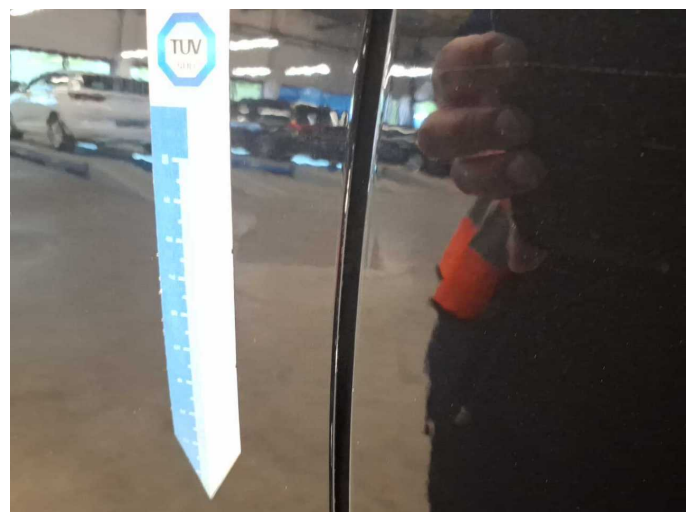
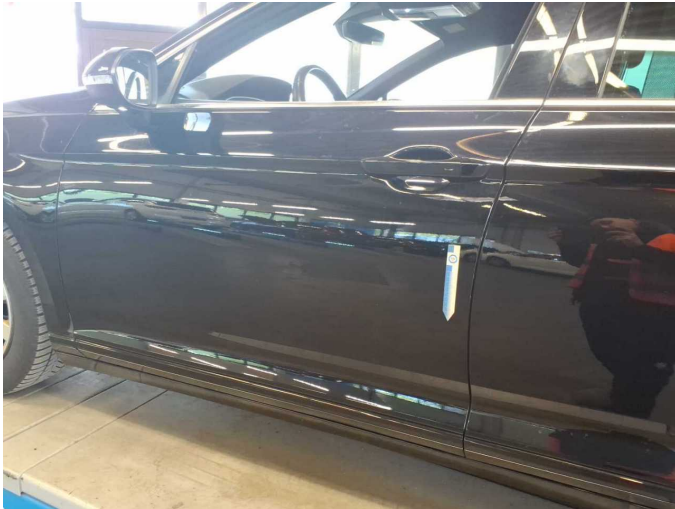
| No. | Component group | Description |
|---|---|---|
| 4 | Door - front left side | Door edge - Scratched - No deduction |

Wear and tear 4: Door - front left side: Door edge - Scratched - No deduction

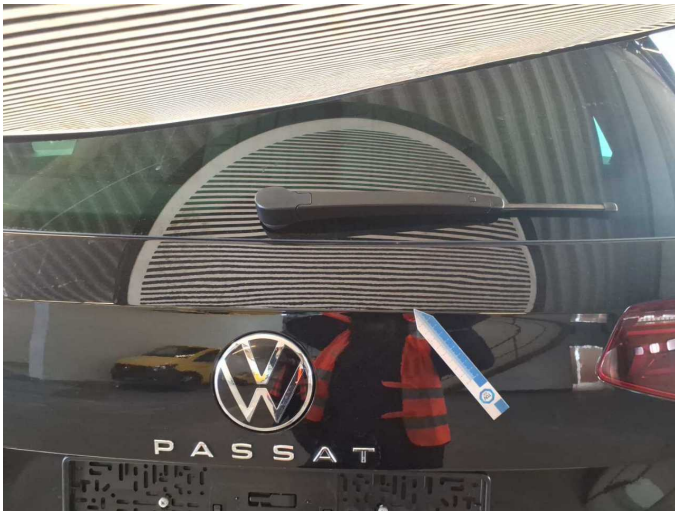
| No. | Component group | Description |
|---|---|---|
| 5 | Boot lid / rear door | Boot lid - dent(s) - No deduction |

Wear and tear 5: Boot lid / rear door: Boot lid - dent(s) - No deduction
