## Condition Report / Loss of Value Assessment II

| Type / sales designation | A6 Avant 50 TDI quattro advanced | Kilometres read | 28,777 km |

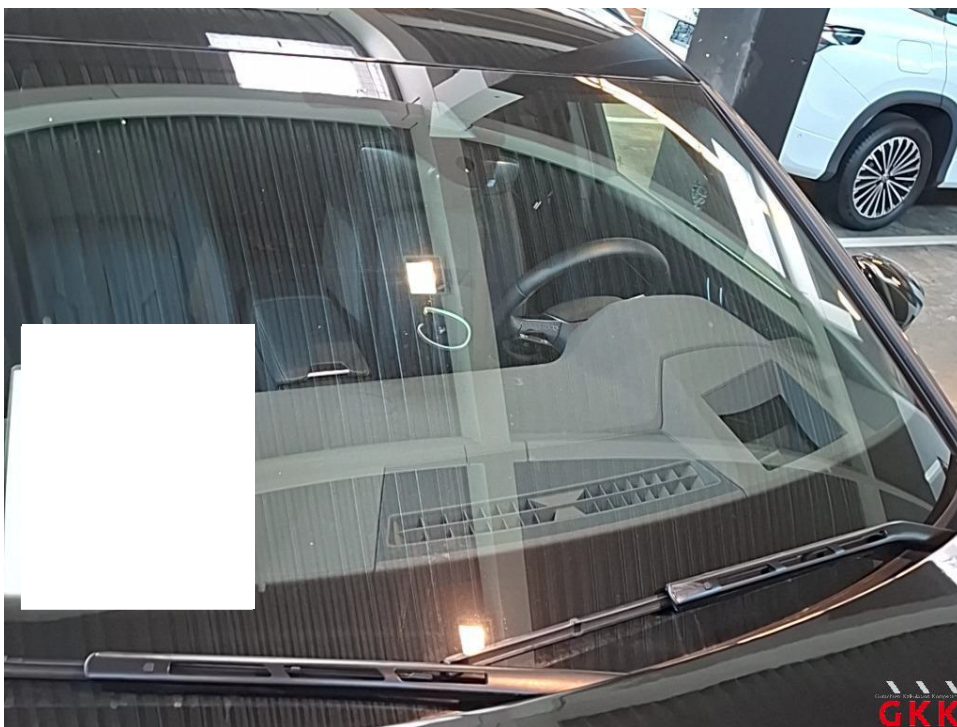
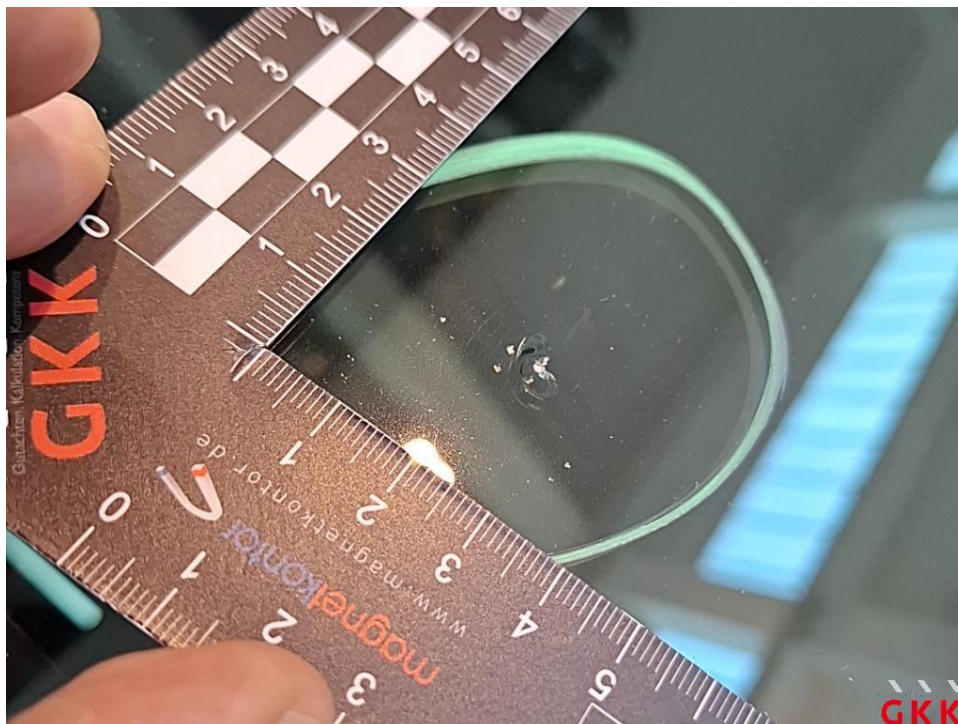
front screen with rain sensor and frontcamera, chipping, repair (Image 18, Image 19)

Picture 18 front screen, with rain sensor and frontcamera, chipping, repair

Picture 19 front screen, with rain sensor and frontcamera, chipping, repair

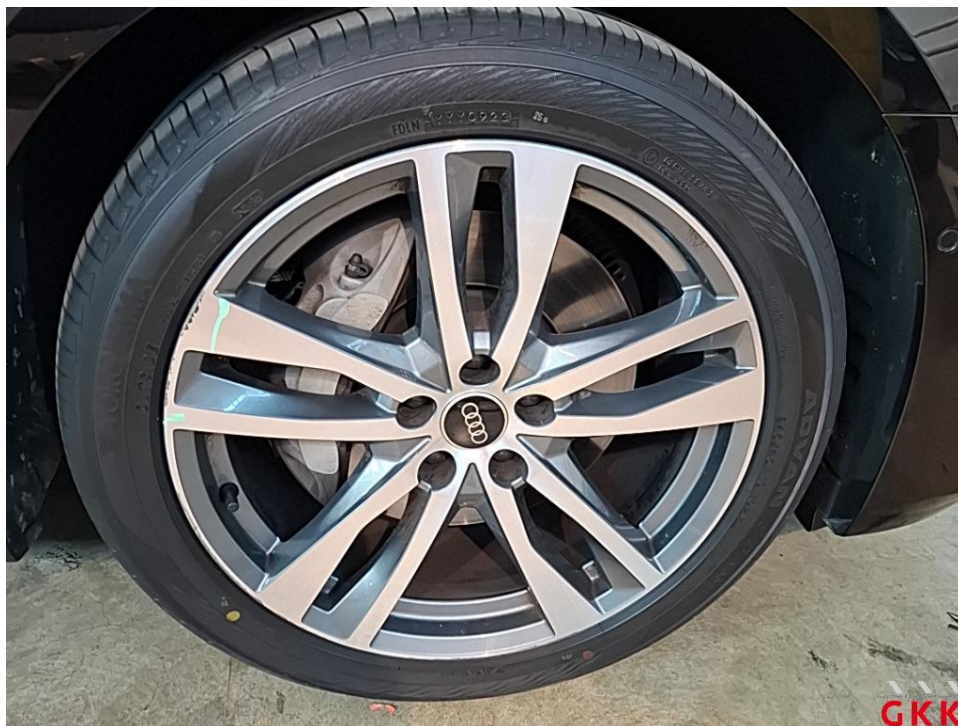
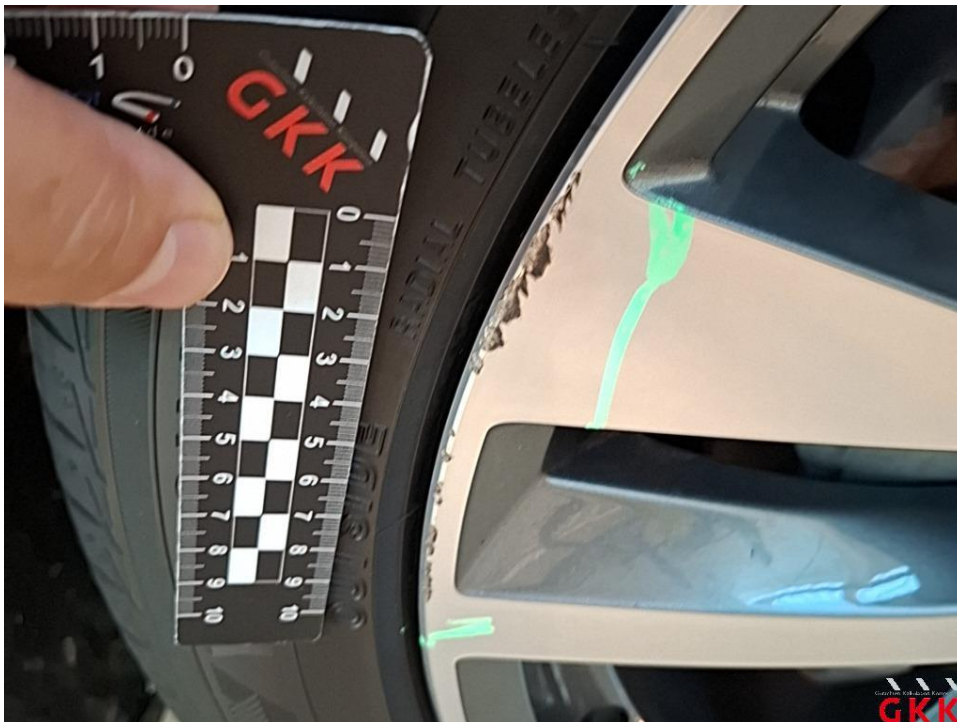
LM wheel front right, scratched, replace (Image 20, Image 21)

Picture 20 LM wheel, front right, scratched, replace

Picture 21 LM wheel, front right, scratched, replace

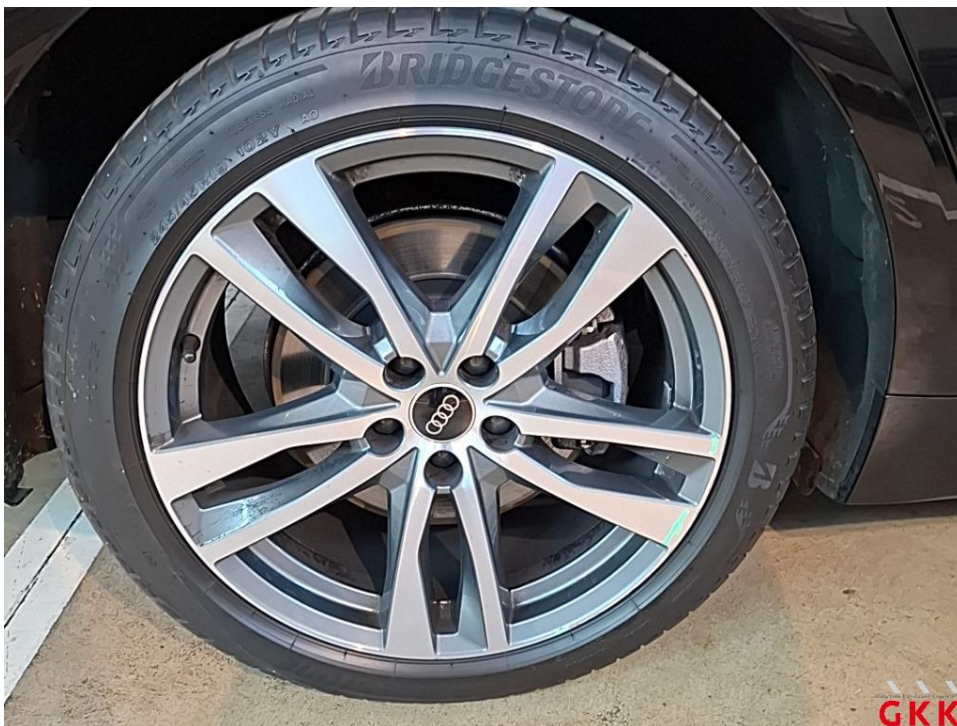
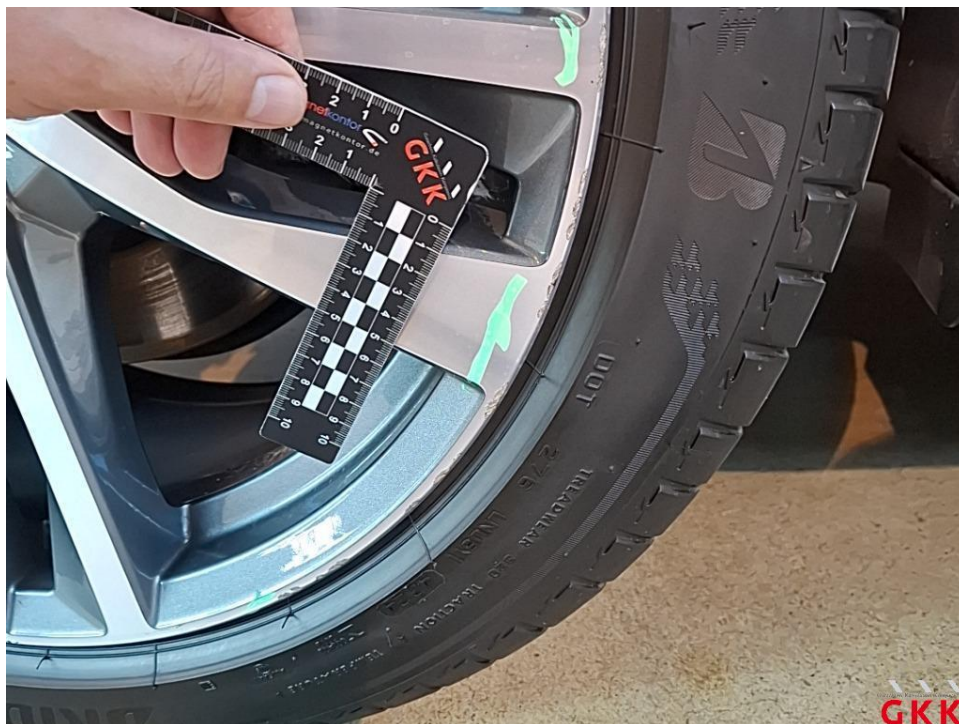
LM wheel rear right, scratched, replace (Image 22, Image 23)

Picture 22 LM wheel, rear right, scratched, replace

Picture 23 LM wheel, rear right, scratched, replace

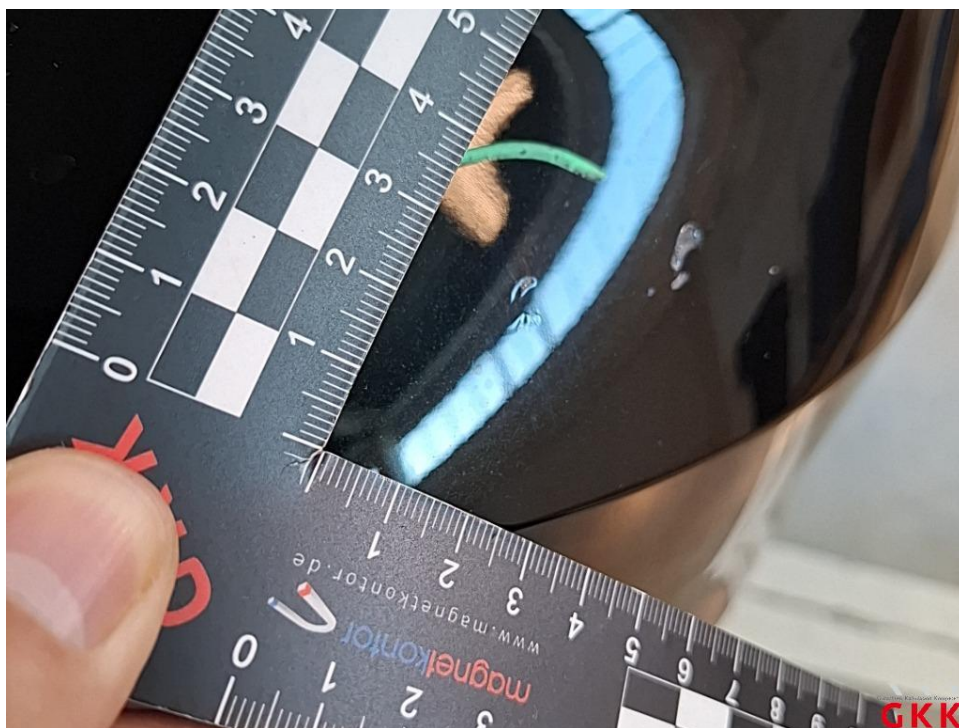
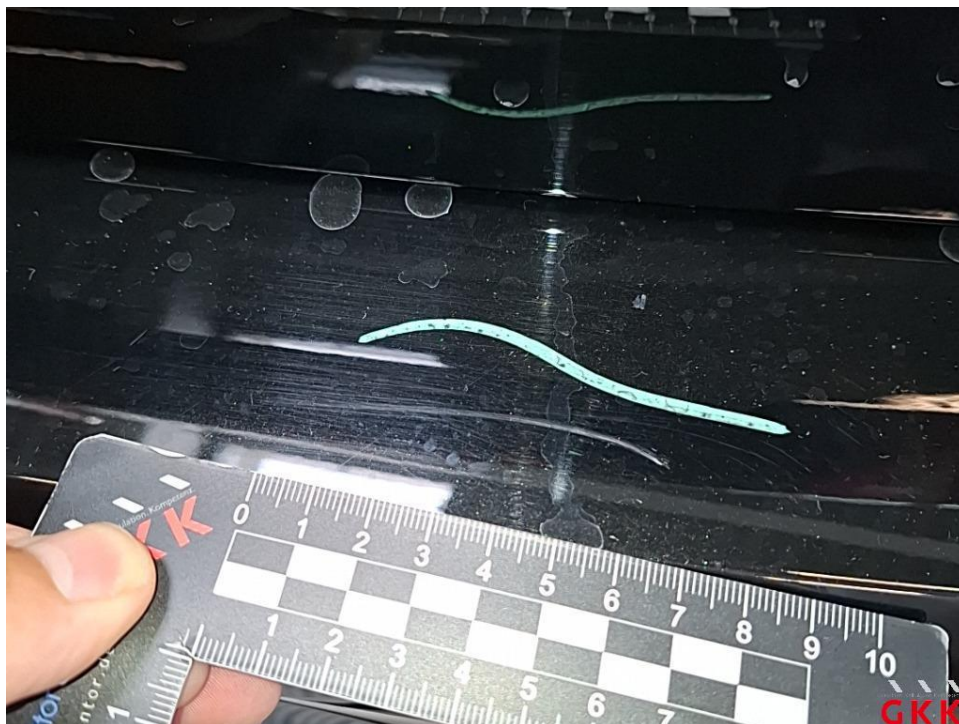
bumper rear panel -painted-, scratched, paint (Image 24, Image 25)

Picture 24 bumper rear, panel -painted-, scratched, paint

Picture 25 bumper rear, panel -painted-, scratched, paint

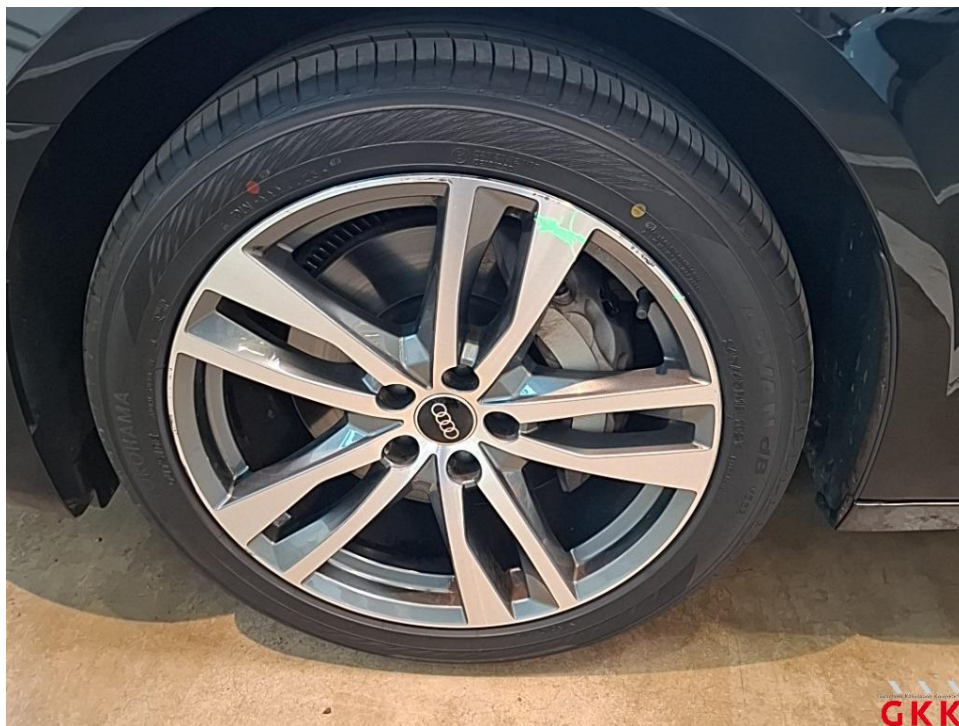
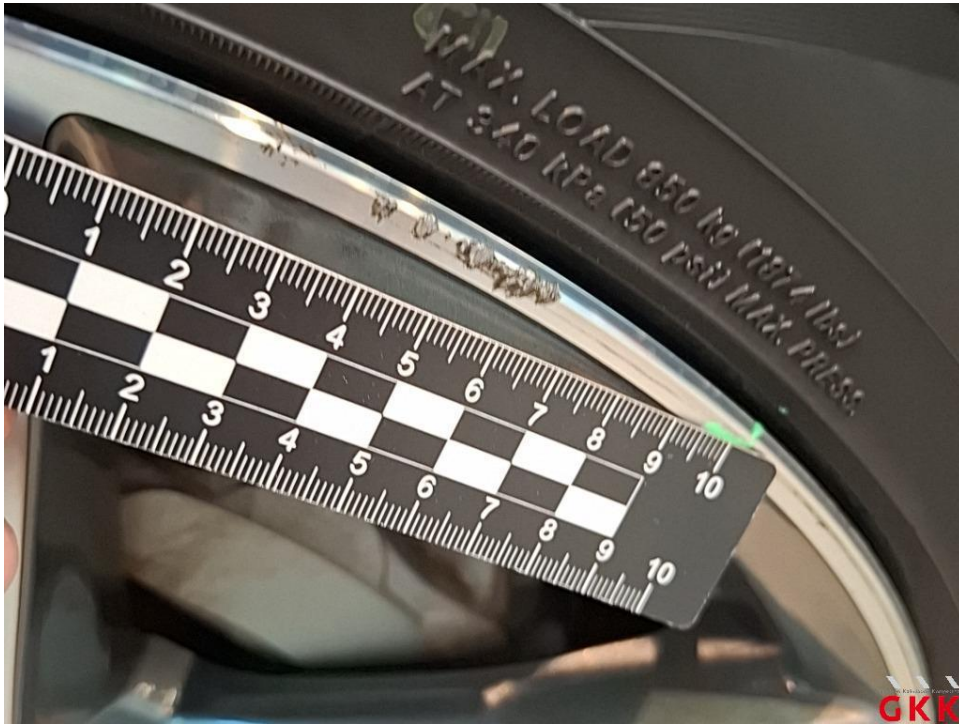
LM wheel front left, scratched, depreciation (Image 26, Image 27)

Picture 26 LM wheel, front left, scratched, depreciation

Picture 27 LM wheel, front left, scratched, depreciation
