Expertise

Protocol number: 46139806  
Order No. / Reference: 26521071  
Inspection date: 25 Jun 2026

Manufacturer: Volvo

Model: V60 B4 D Plus Dark

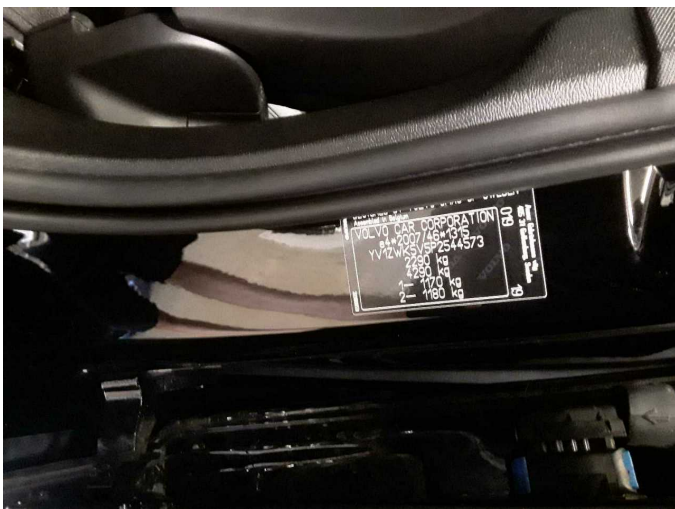
Figure 11: VIN

| VIN comparison | The vehicle identification number (VIN) was read from the vehicle and its conformity with the submitted documents was confirmed by the undersigned during the inspection. |

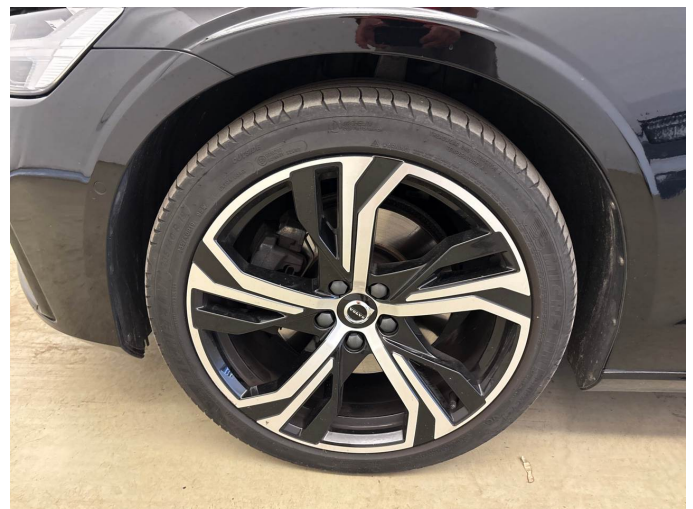
| # | Tyre size | Type of tyre | Manufacturer | Tread depth |
|---|---|---|---|---|
| 1) | 235/40 R19 96W | Summer tyres on Light alloy | Michelin | 4mm / 4mm |
| 2) | 235/40 R19 96W | Summer tyres on Light alloy | Michelin | 4mm / 4mm |

Figure 12: Mounted tyres

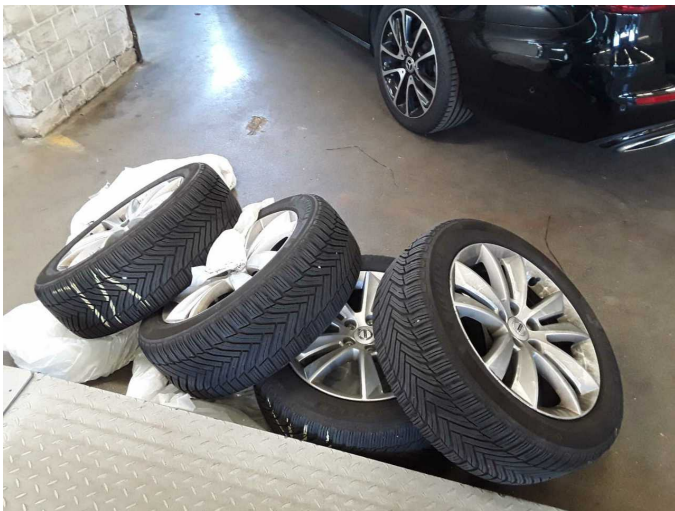
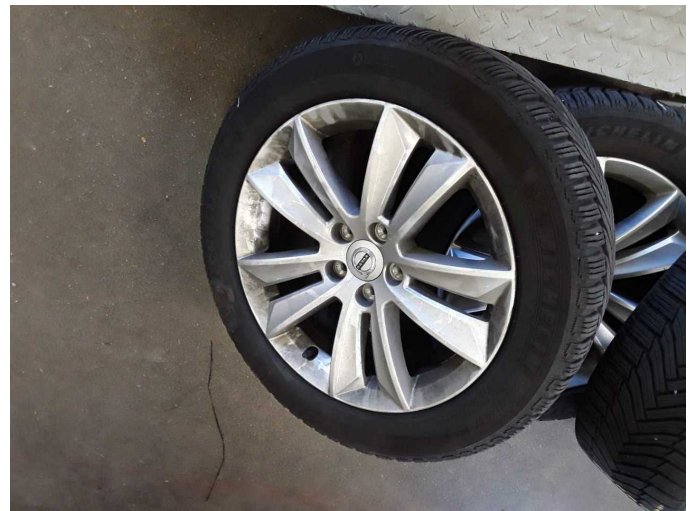
| # | Tyre size | Type of tyre | Manufacturer | Tread depth |
|---|---|---|---|---|
| 1) | 225/50 R17 98V | Winter tyres on Light alloy | Michelin | 5mm / 5mm |
| 2) | 225/50 R17 98V | Winter tyres on Light alloy | Michelin | 5mm / 5mm |

Figure 15: Additional tyres

Figure 16: Additional tyres

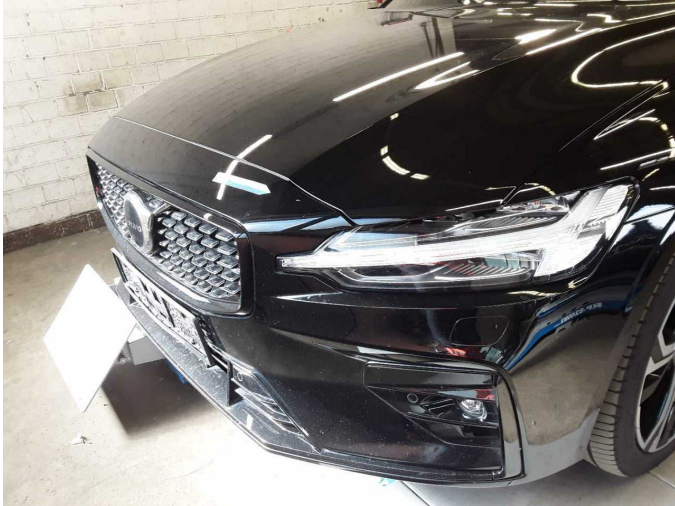
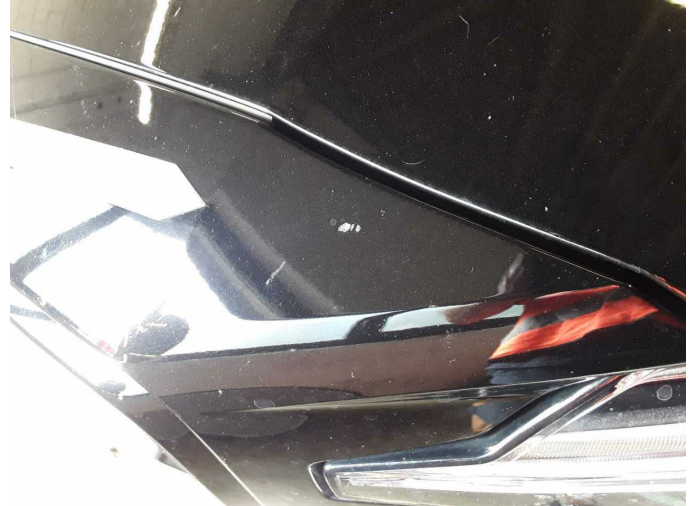
| No. | Component group | Description |
|---|---|---|
| 1 | Front bumper | Front bumper - Scratch(es) - Smart repair |

**Damage 1:** Front bumper: Front bumper - Scratch(es) - Smart repair

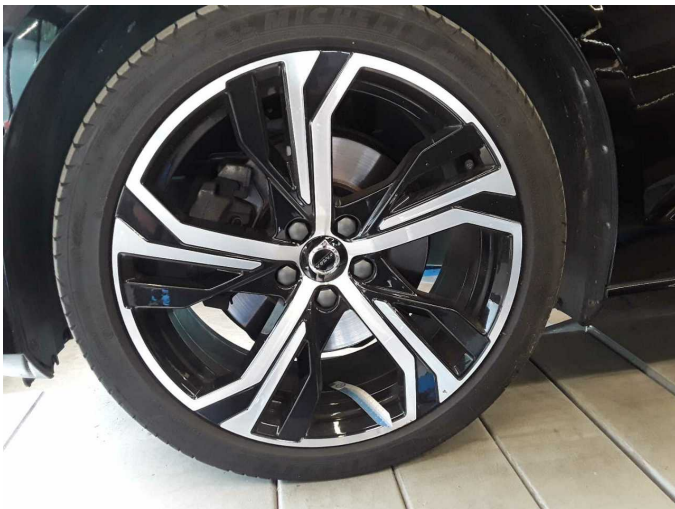
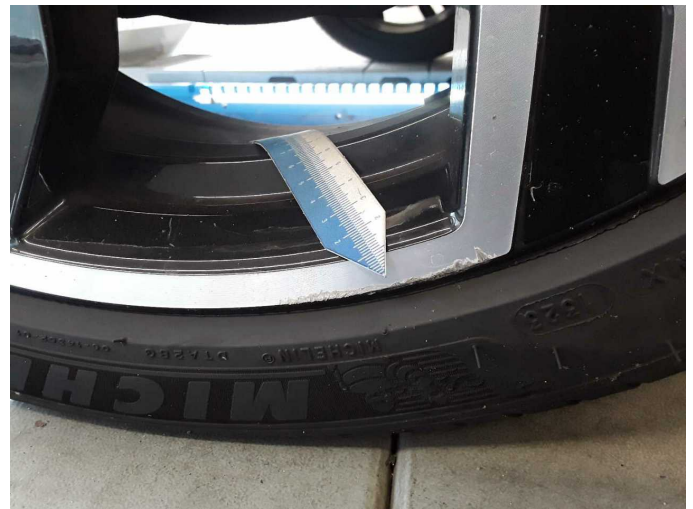
| No. | Component group | Description |
|---|---|---|
| 2 | Wheel / tyres | Alloy rim - front left side - Scratched - Loss in value |

**Damage 2:** Wheel / tyres: Alloy rim - front left side - Scratched - Loss in value

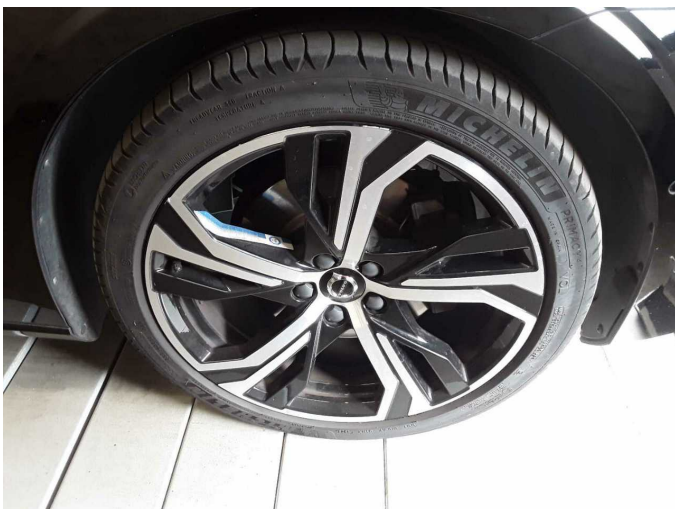
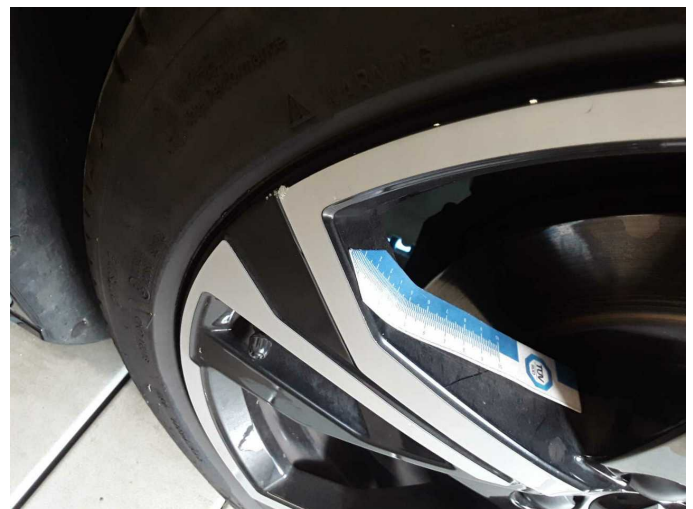
| No. | Component group | Description |
|---|---|---|
| 3 | Wheel / tyres | Alloy rim - front right side - Scratch(es) - Loss in value |

**Damage 3:** Wheel / tyres: Alloy rim - front right side - Scratch(es) - Loss in value

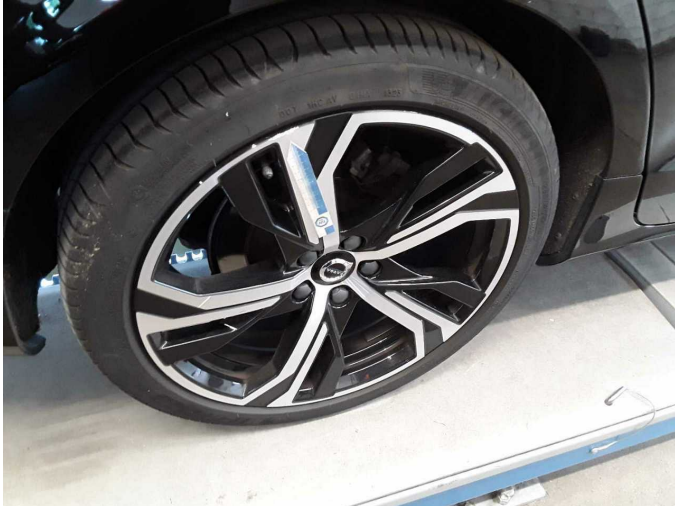
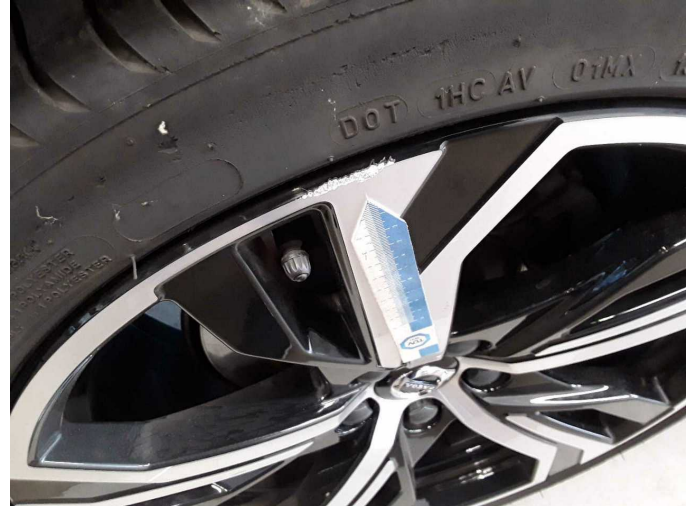
| No. | Component group | Description |
|---|---|---|
| 4 | Wheel / tyres | Alloy rim - rear right side - Scratched - Loss in value |

**Damage 4:** Wheel / tyres: Alloy rim - rear right side - Scratched - Loss in value

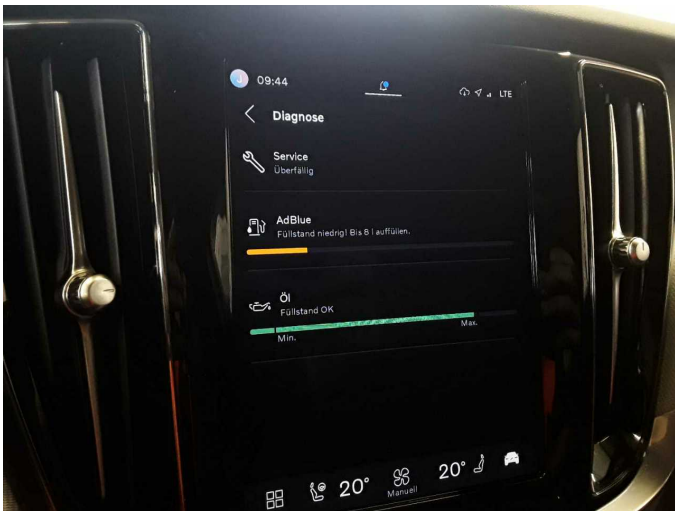
| No. | Component group | Description |
|---|---|---|
| 5 | Misc. | Inspection / maintenance - Due - Perform |

**Damage 5:** Misc.: Inspection / maintenance - Due - Perform

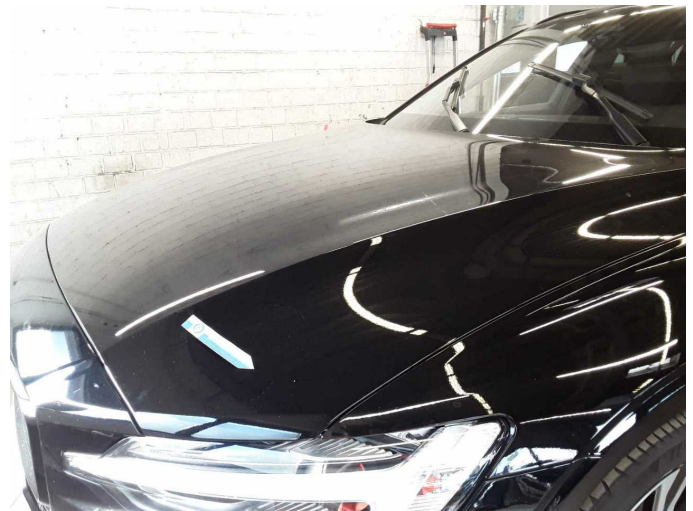
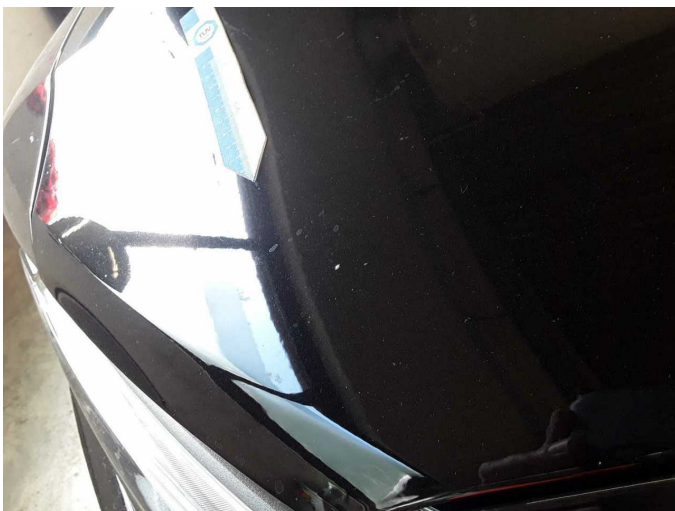
| No. | Component group | Description |
|---|---|---|
| 1 | Bonnet | Bonnet - Stone chips - No deduction |

**Wear and tear 1:** Bonnet: Bonnet - Stone chips - No deduction

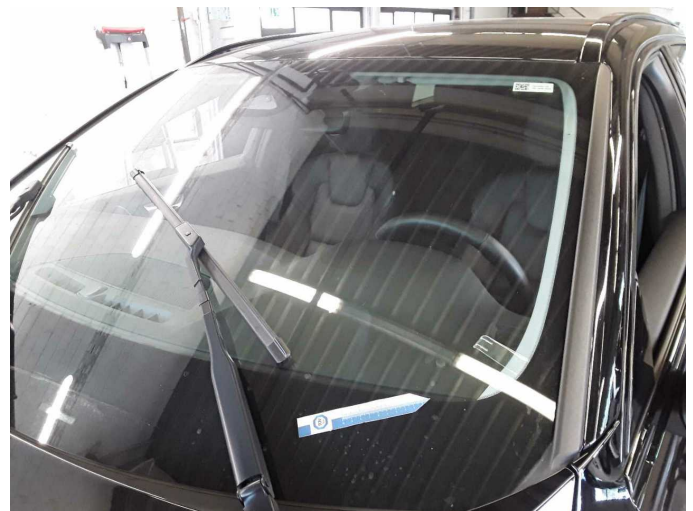
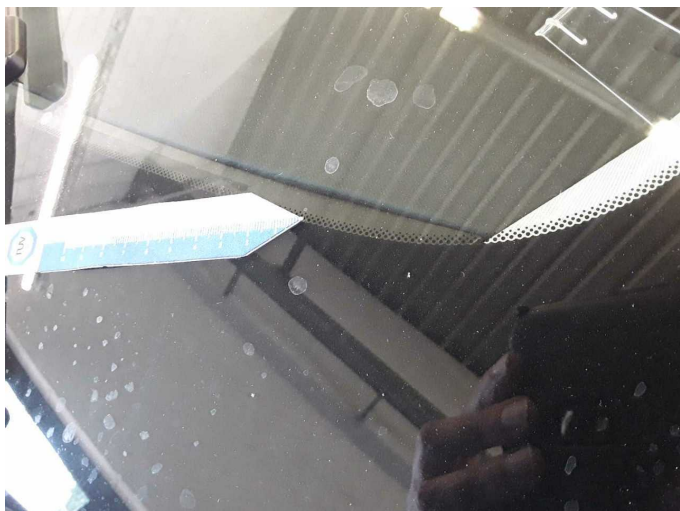
| No. | Component group | Description |
|---|---|---|
| 2 | Vehicle glazing | Windscreen - Stone chips - No deduction |

**Wear and tear 2:** Vehicle glazing: Windscreen - Stone chips - No deduction
