Expertise

Protocol number: 45900514
Order No. / Reference: 26479469
Inspection date: 11 Jun 2026

Model: Tarraco 2.0 TDI SCR DSG FR

VIN: VSSZZZKN5PW007221

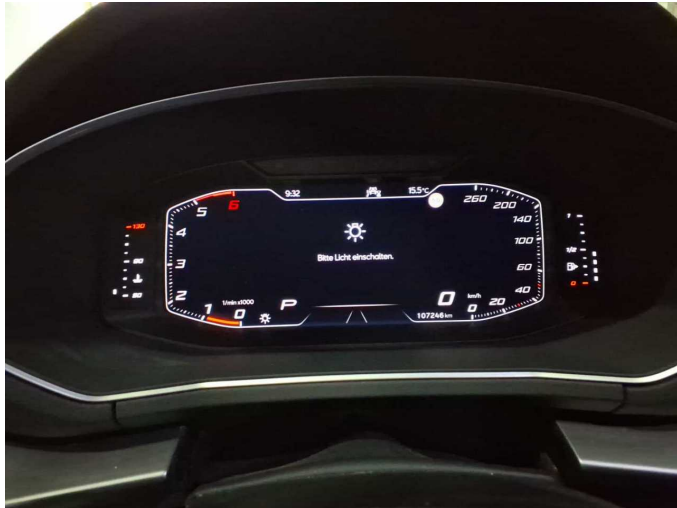
Figure 7: Instrument cluster

Mileage (Read) 107,246 km

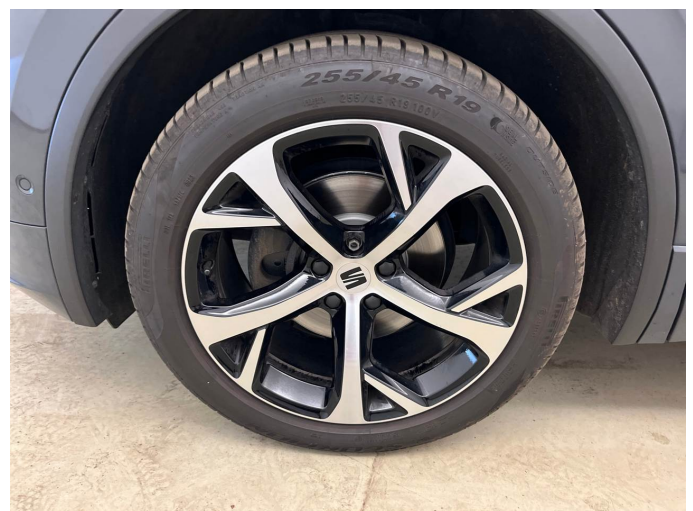
Figure 12: Mounted tyres

#	Tyre size	Type of tyre	Manufacturer	Tread depth
1)	255/45 R19 100V	Summer tyres on Light alloy	Pirelli	4mm / 4mm
2)	255/45 R19 100V	Summer tyres on Light alloy	Pirelli	4mm / 4mm

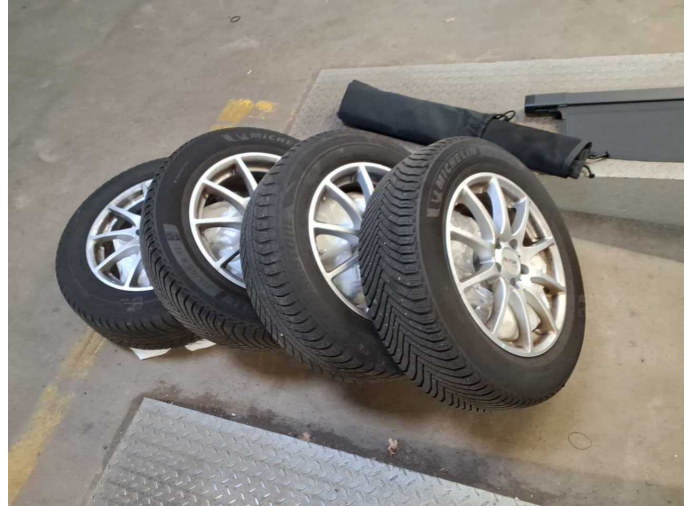
Figure 14: Additional tyres

#	Tyre size	Type of tyre	Manufacturer	Tread depth
1)	215/65 R17 99H	Winter tyres on Light alloy	Michelin	4mm / 4mm
2)	215/65 R17 99H	Winter tyres on Light alloy	Michelin	6mm / 6mm

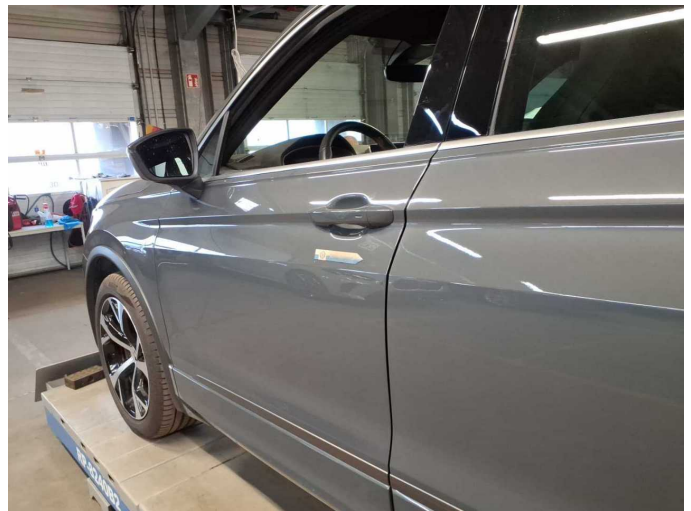
Damage 2: Door - front left side: Door - dent(s) - Smooth repair work

No.	Component group	Description
1	Equipment	Vehicle key (Batterie) - Empty - Replace
2	Door - front left side	Door - dent(s) - Smooth repair work

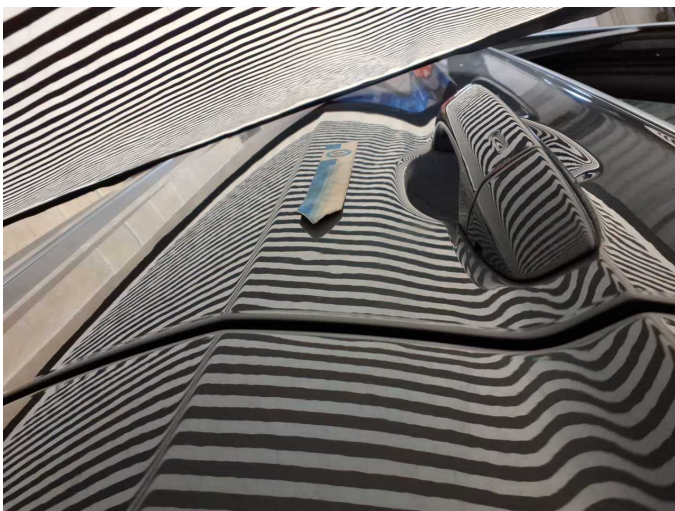
Damage 2: Door - front left side: Door - dent(s) - Smooth repair work
