Expertise

Protocol number: 46028429
Order No. / Reference: 26494723
Inspection date: 17 Jun 2026

Model: Astra Sports Tourer 1.5 D Automatik GS

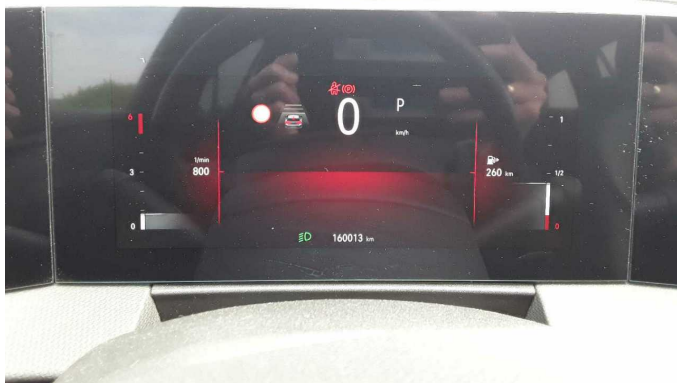
Figure 7: Instrument cluster

Mileage (Read) 160,013 km

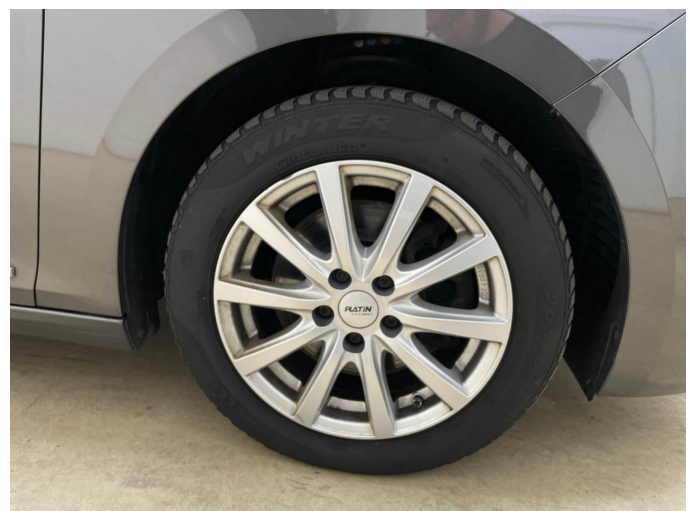
Figure 12: Mounted tyres

#	Tyre size	Type of tyre	Manufacturer	Tread depth
1)	205/55 R16 91H	Winter tyres on Light alloy	Pirelli	3mm / 3mm
2)	205/55 R16 91H	Winter tyres on Light alloy	Pirelli	3mm / 3mm

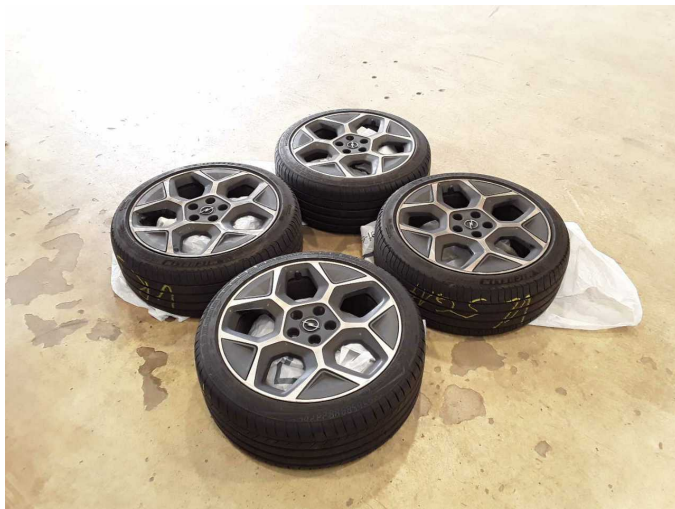
Figure 15: Additional tyres

#	Tyre size	Type of tyre	Manufacturer	Tread depth
1)	225/40 R18 92Y	Summer tyres on Light alloy	Michelin	5mm / 5mm
2)	225/40 R18 92Y	Summer tyres on Light alloy	Vredestein	7mm / 7mm

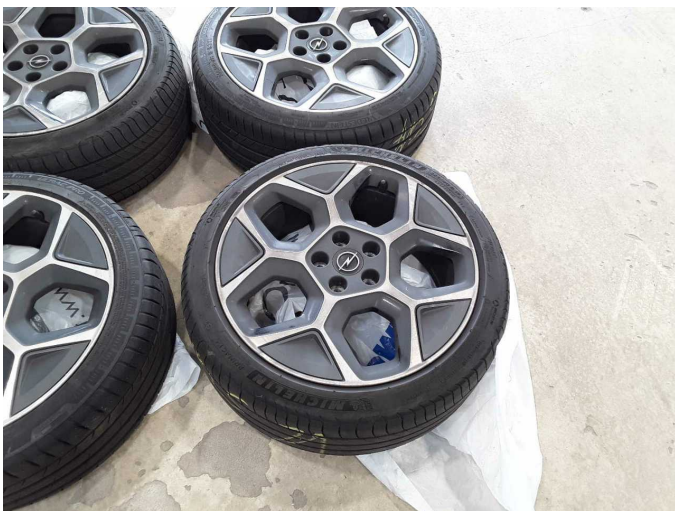
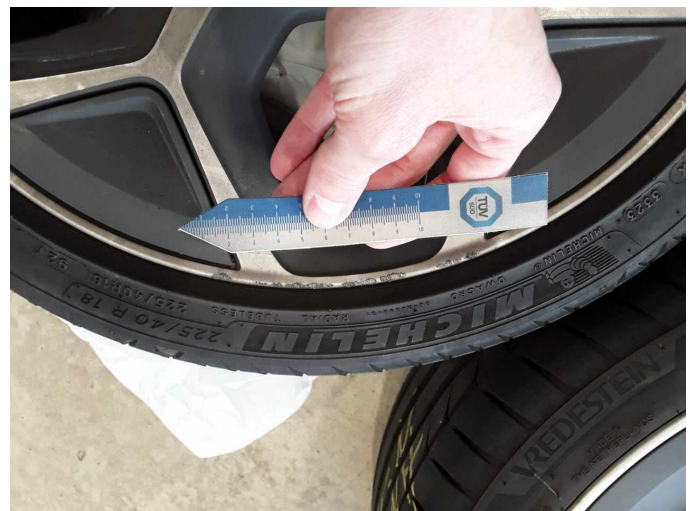
No.	Component group	Description
1	2nd wheel set	1 alloy rim - Scratch(es) - Loss in value
2	Roof	Roof (Anätzung) - Paint defect - Repair and paint

Damage 1: 2nd wheel set: 1 alloy rim - Scratch(es) - Loss in value

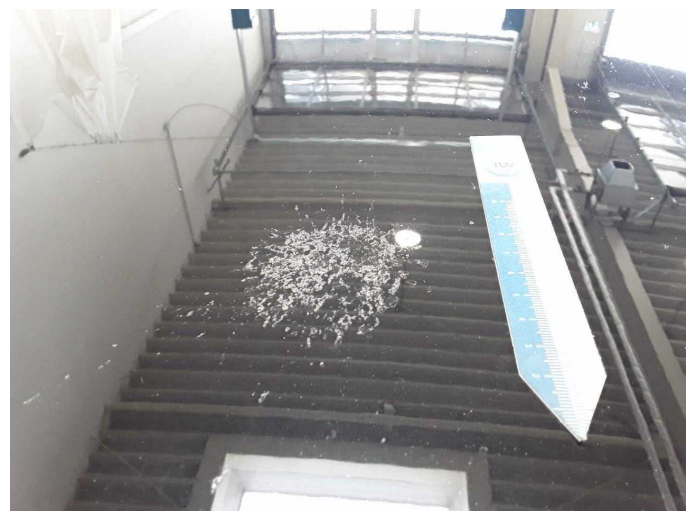
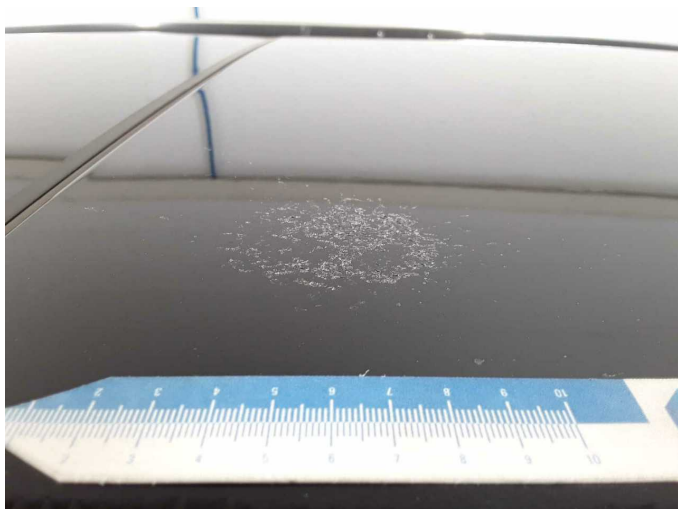
Damage 2: Roof: Roof (Anätzung) - Paint defect - Repair and paint
