Expertise

Protocol number: 46523919  
Order No. / Reference: 26711233  
Inspection date: 15 Jul 2026

Manufacturer: Ford

Model: Mondeo Turnier 2.0 EcoBlue Aut. Titanium

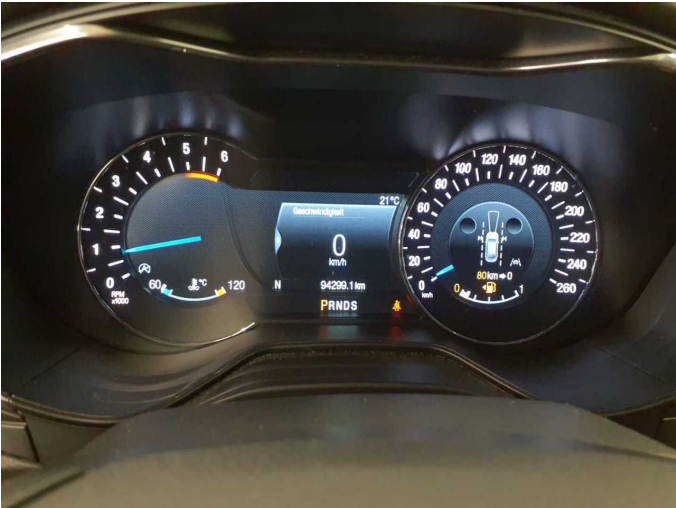
| Vehicle details | |
|---|---|
| Mileage (Read) | 94,299 km |

Figure 7: Instrument cluster

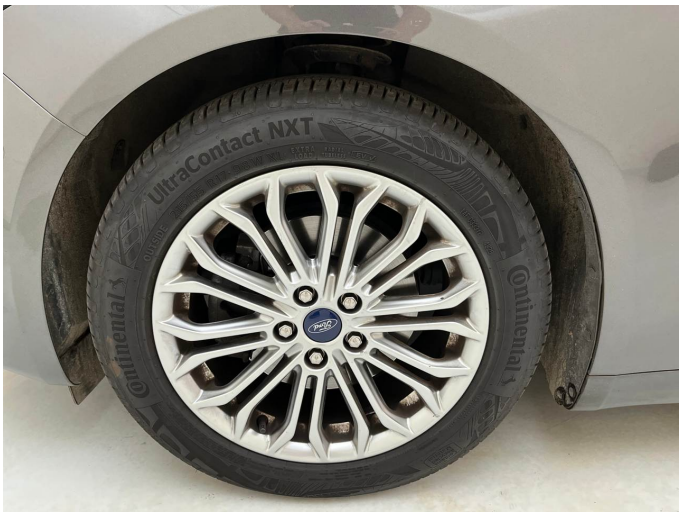
| # | Tyre size | Type of tyre | Manufacturer | Tread depth |
|---|---|---|---|---|
| 1) | 215/55 R17 98W | Summer tyres on Light alloy | Goodyear | 5mm / 5mm |
| 2) | 215/55 R17 98W | Summer tyres on Light alloy | Goodyear | 5mm / 5mm |

Figure 12: Mounted tyres

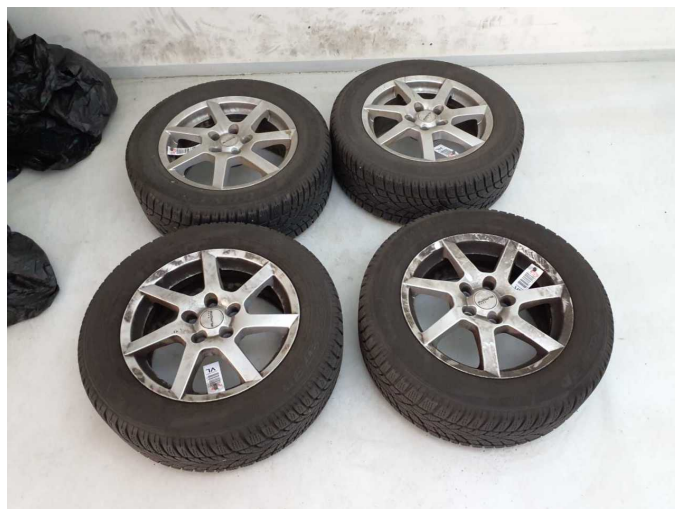
| # | Tyre size | Type of tyre | Manufacturer | Tread depth |
|---|---|---|---|---|
| 1) | 215/60 R16 99H | Winter tyres on Light alloy | Dunlop | 5mm / 5mm |
| 2) | 215/60 R16 99H | Winter tyres on Light alloy | Dunlop | 5mm / 5mm |

Figure 14: Additional tyres

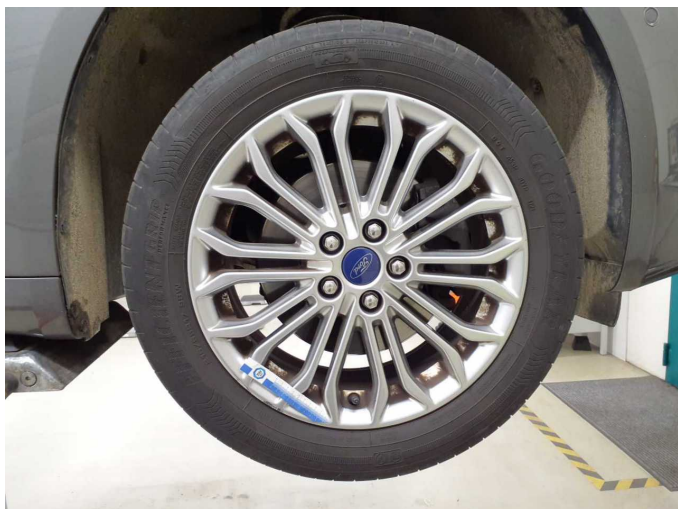
**Damage 1:** Wheel / tyres: Alloy rim - front right side - Scratched - Smart repair

| No. | Component group | Description |
|---|---|---|
| 1 | Wheel / tyres | Alloy rim - front right side - Scratched - Smart repair |

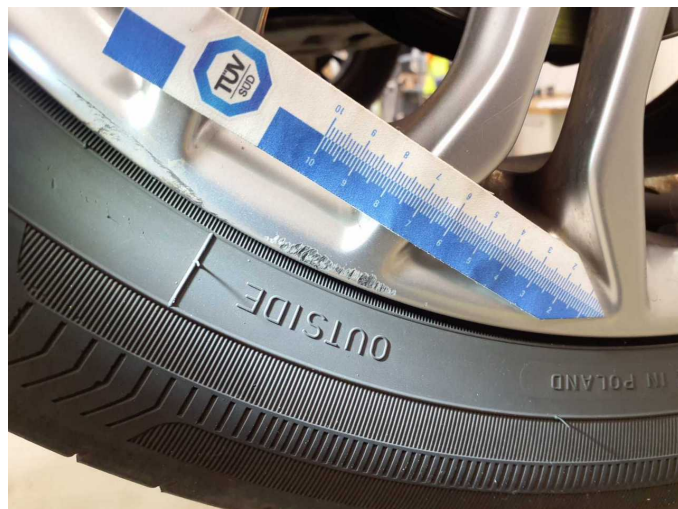
**Damage 1:** Wheel / tyres: Alloy rim - front right side - Scratched - Smart repair

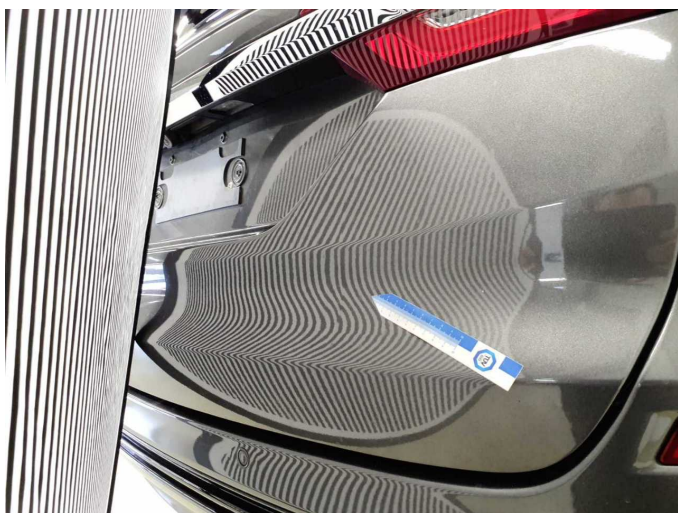
**Damage 2:** Boot lid / rear door: Boot lid - dent(s) - Smart repair

| No. | Component group | Description |
|---|---|---|
| 2 | Boot lid / rear door | Boot lid - dent(s) - Smart repair |

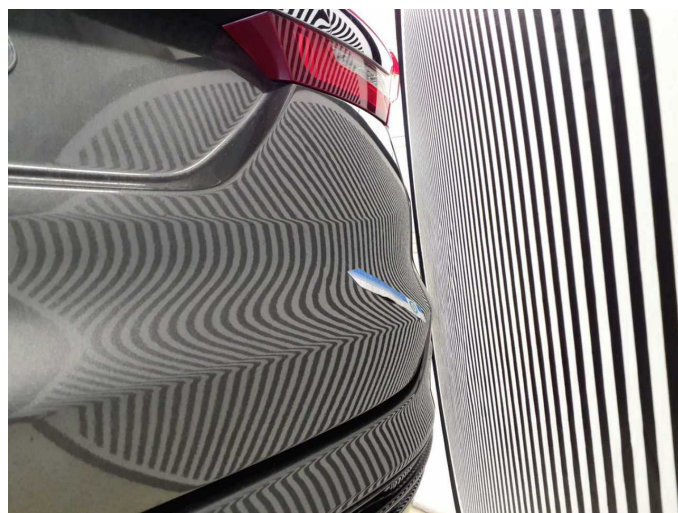
**Damage 2:** Boot lid / rear door: Boot lid - dent(s) - Smart repair

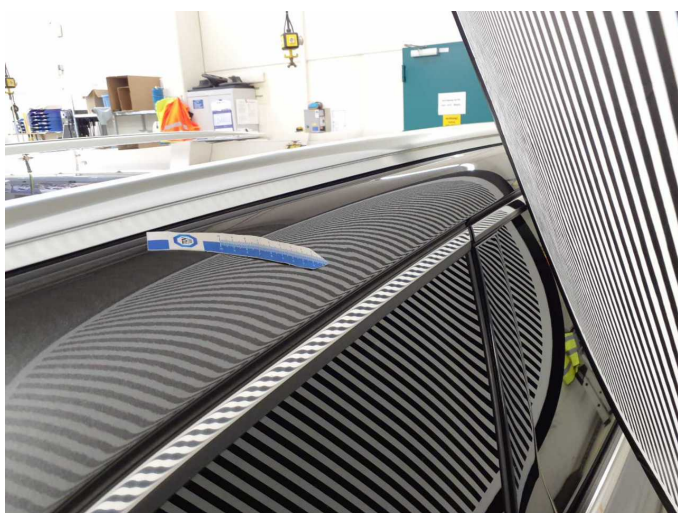
**Damage 3:** Roof: Roof rail - right side - dent(s) - Smart repair

| No. | Component group | Description |
|---|---|---|
| 3 | Roof | Roof rail - right side - dent(s) - Smart repair |

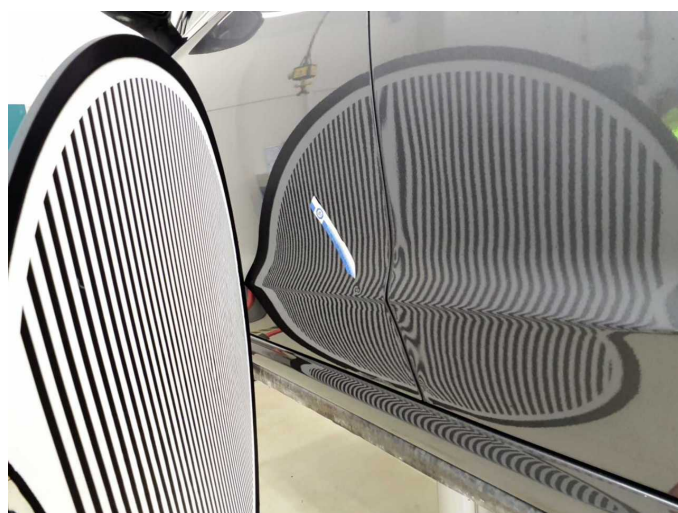
**Damage 4:** Door - front left side: Door - Dent / paintcoat damage - Repair and paint

| No. | Component group | Description |
|---|---|---|
| 4 | Door - front left side | Door - Dent / paintcoat damage - Repair and paint |

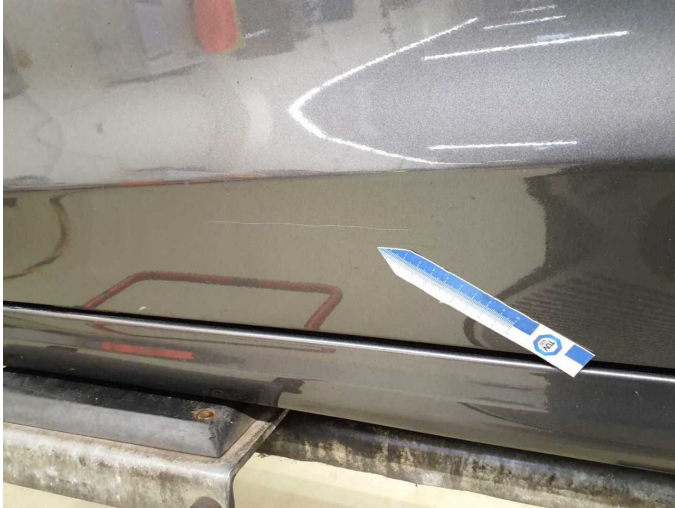
**Damage 4:** Door - front left side: Door - Dent / paintcoat damage - Repair and paint

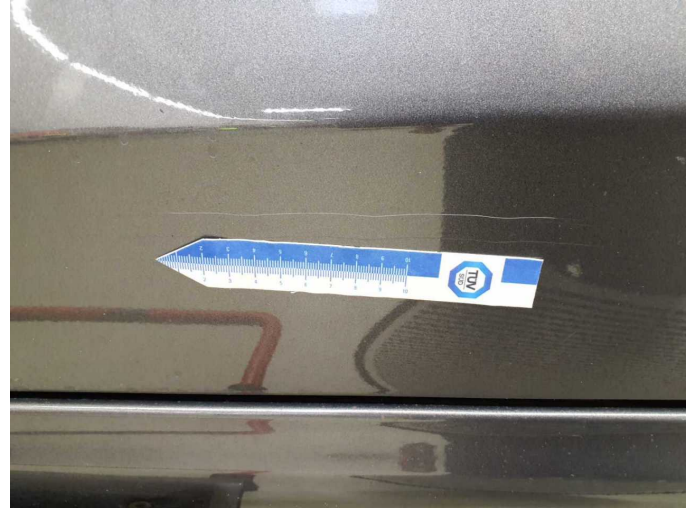
**Damage 4:** Door - front left side: Door - Dent / paintcoat damage - Repair and paint
