Expertise

Protocol number: 45489987  
Order No. / Reference: 26461692  
Inspection date: 15 May 2026

Manufacturer: Mercedes-Benz

Model: E 220 d T 9G-TRONIC Avantgarde

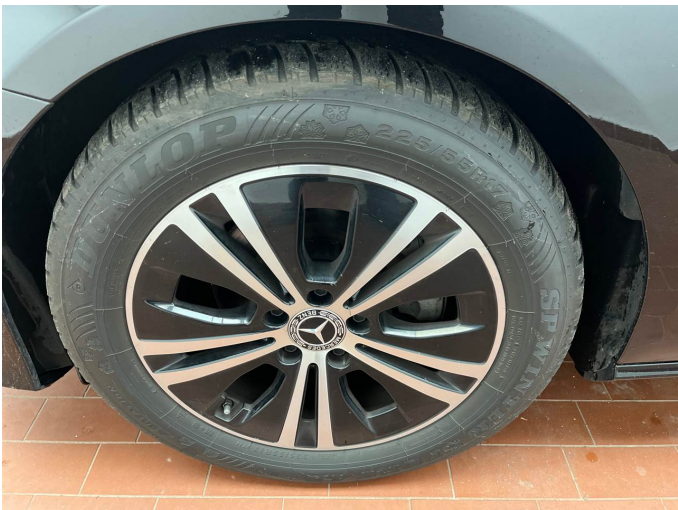
Figure 12: Mounted tyres

| # | Tyre size | Type of tyre | Manufacturer | Tread depth |
|---|---|---|---|---|
| 1) | 225/55 R17 97H | Winter tyres on Light alloy | Dunlop | 5mm / 5mm |
| 2) | 225/55 R17 97H | Winter tyres on Light alloy | Dunlop | 7mm / 7mm |

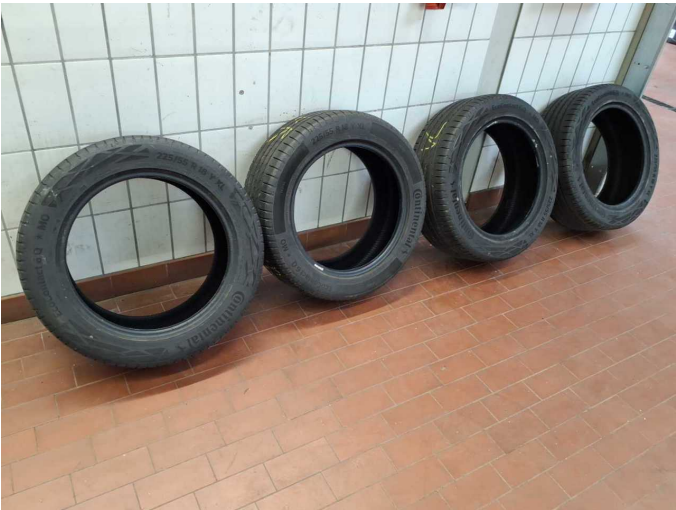
Figure 15: Additional tyres

| # | Tyre size | Type of tyre | Manufacturer | Tread depth |
|---|---|---|---|---|
| 1) | 225/55 R18 102Y | Summer tyres (Without wheel rim) | Continental | 6mm / 6mm |
| 2) | 225/55 R18 102Y | Summer tyres (Without wheel rim) | Continental | 6mm / 6mm |

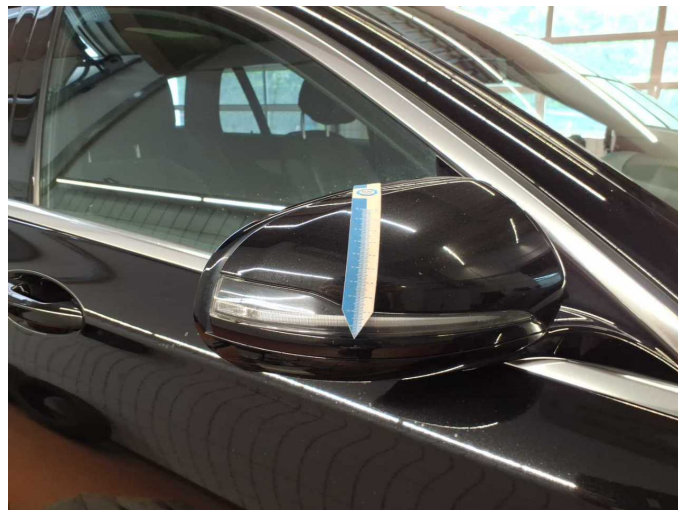
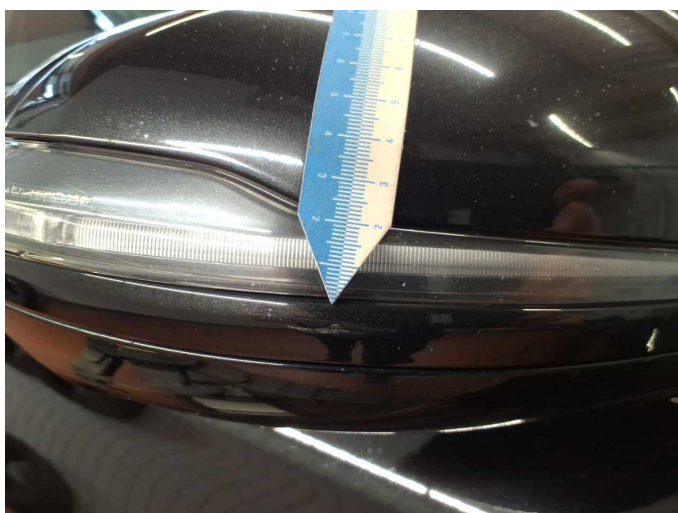
| No. | Component group | Description |
|---|---|---|
| 1 | Wing mirror - right side | Cap - Scratch(es) - Smart repair |

**Damage 1:** Wing mirror - right side: Cap - Scratch(es) - Smart repair

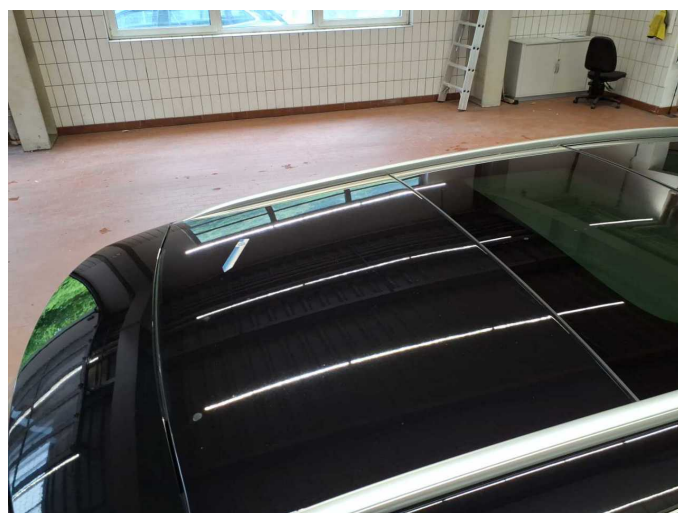
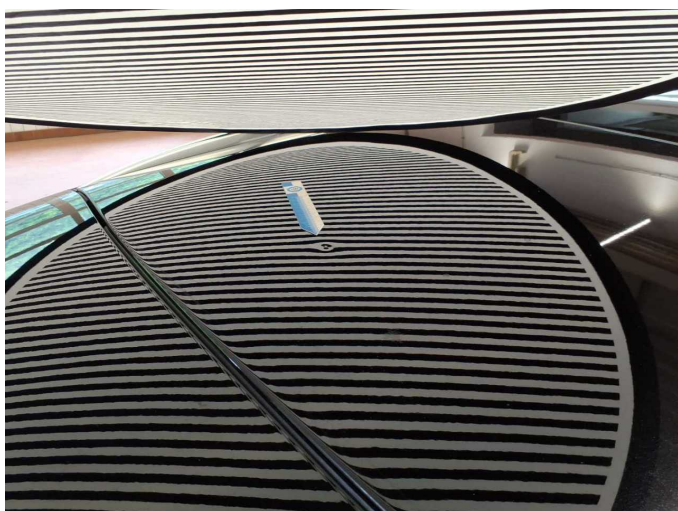
| No. | Component group | Description |
|---|---|---|
| 2 | Roof | Roof - dent(s) - Smart repair |

**Damage 2:** Roof: Roof - dent(s) - Smart repair

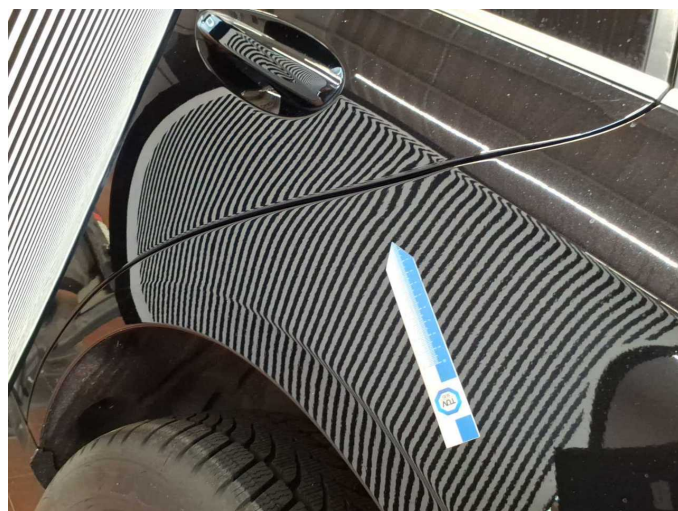
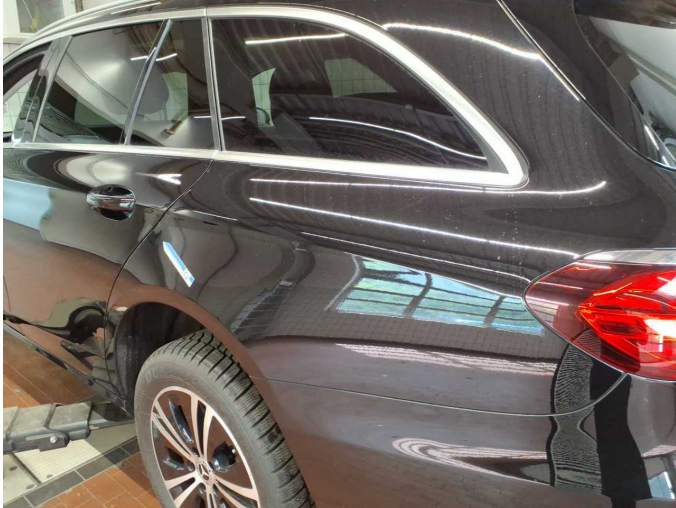
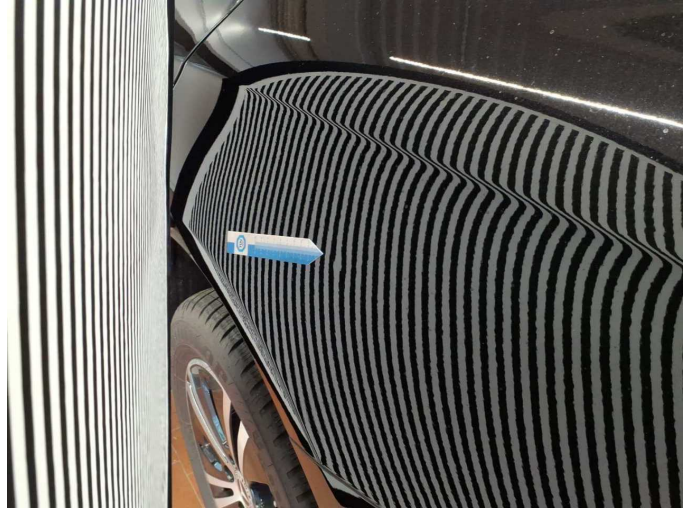
| No. | Component group | Description |
|---|---|---|
| 3 | Side panel - rear left side | Side panel - dent(s) - Smart repair |

**Damage 3:** Side panel - rear left side: Side panel - dent(s) - Smart repair

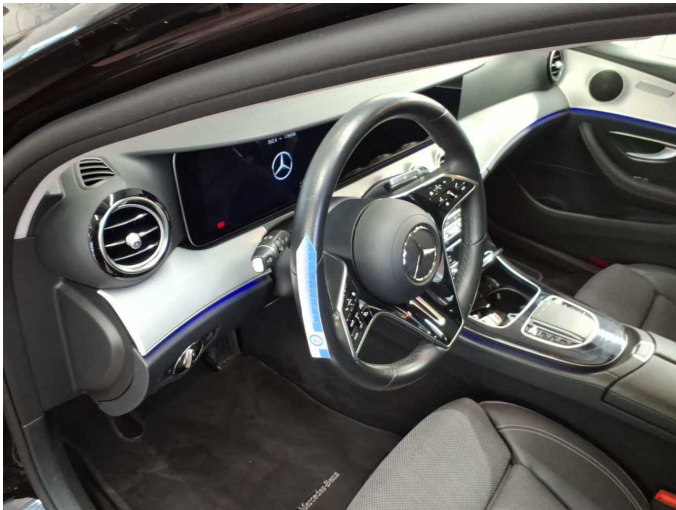
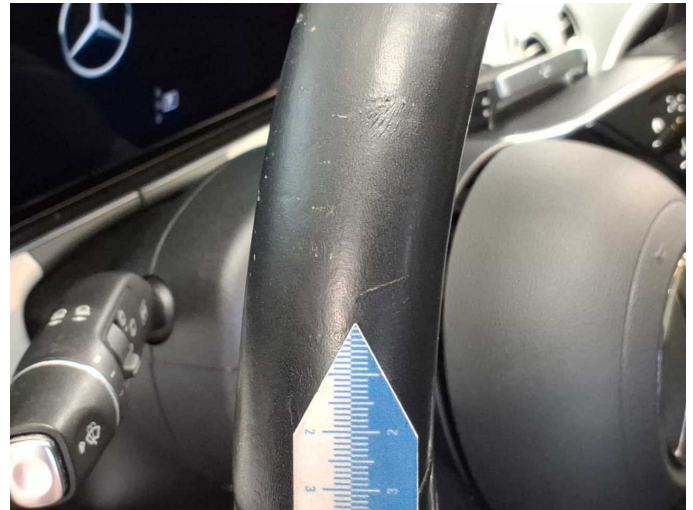
| No. | Component group | Description |
|---|---|---|
| 4 | Steering system | Steering wheel - Scratch(es) - Smart repair |

**Damage 4:** Steering system: Steering wheel - Scratch(es) - Smart repair

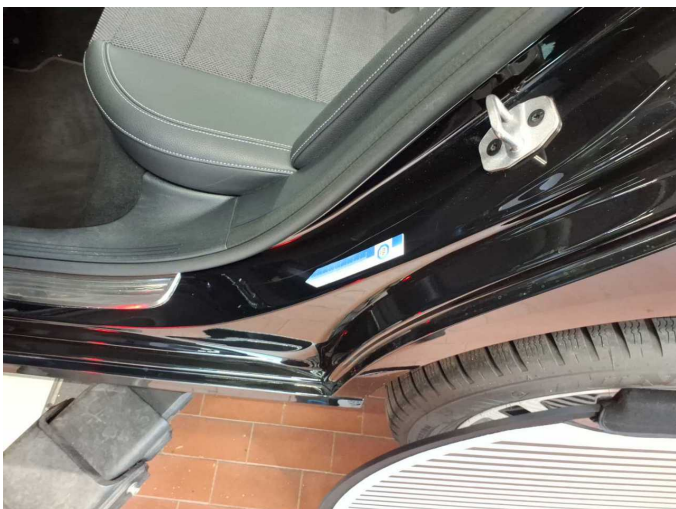
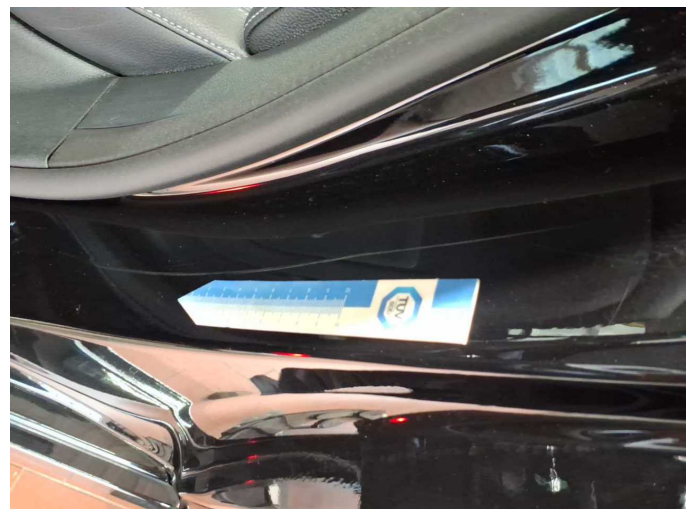
| No. | Component group | Description |
|---|---|---|
| 5 | Side panel - rear left side | Sill - Scratch(es) - Smart repair |

**Damage 5:** Side panel - rear left side: Sill - Scratch(es) - Smart repair

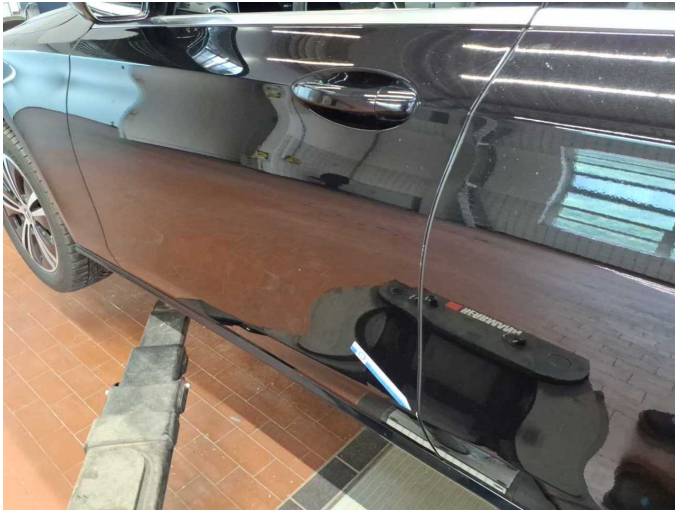
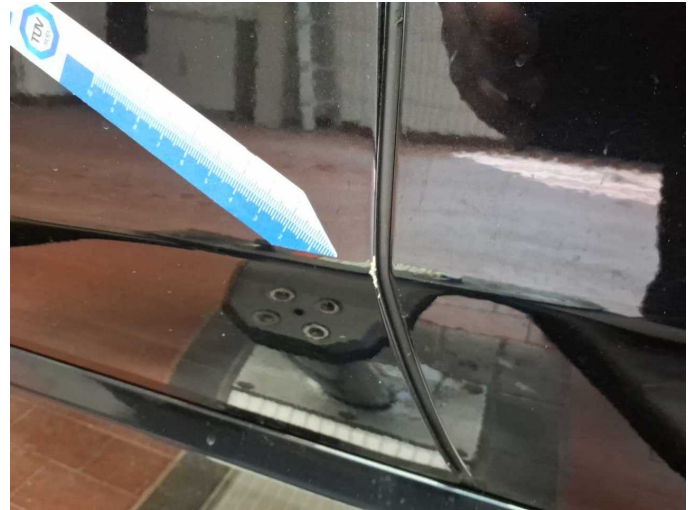
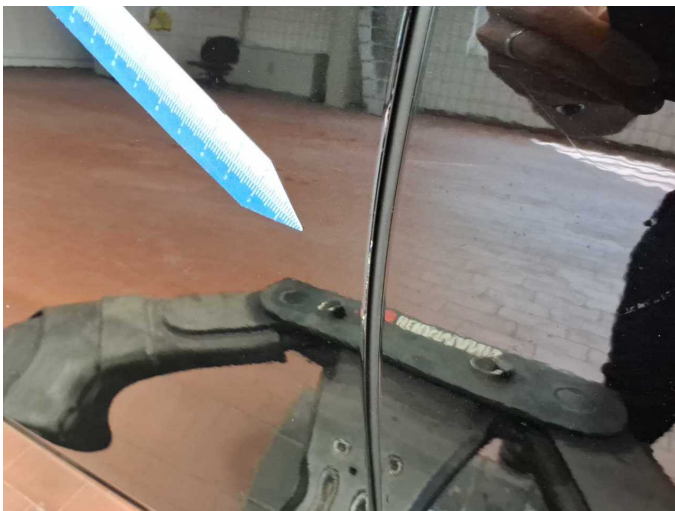
| No. | Component group | Description |
|---|---|---|
| 6 | Door - front left side | Door - Scratch(es) - Smart repair |

**Damage 6:** Door - front left side: Door - Scratch(es) - Smart repair

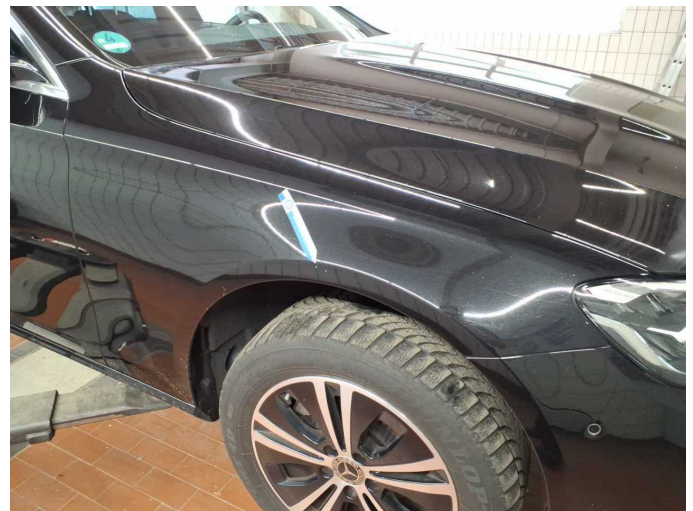
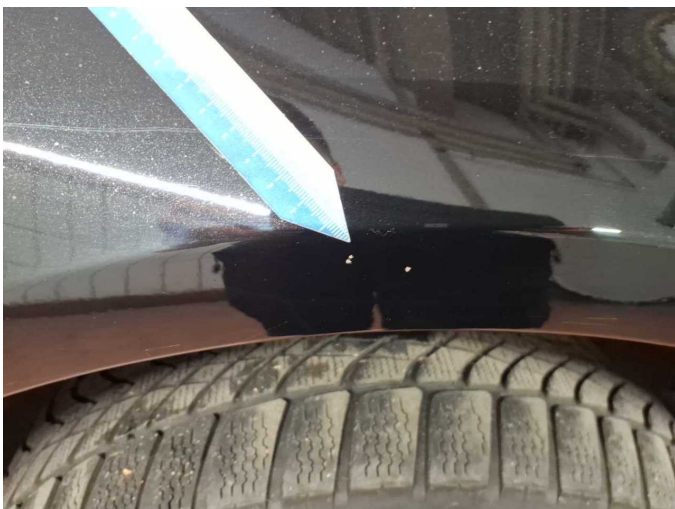
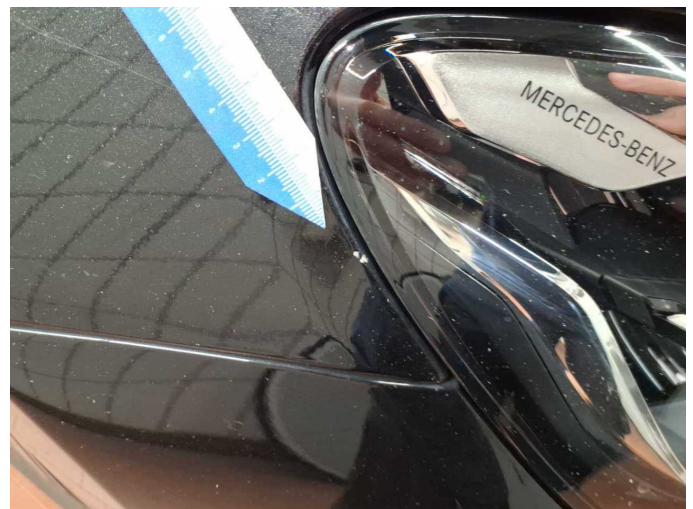
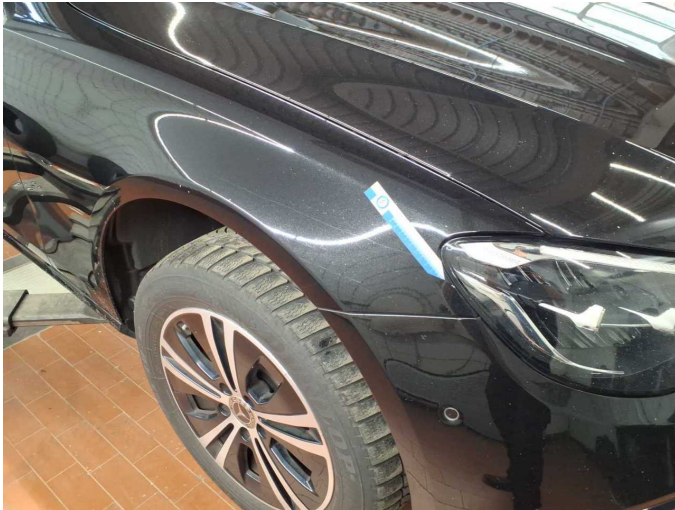
| No. | Component group | Description |
|---|---|---|
| 7 | Mudguard - right side | Mudguard - right side - Stone chips - Paint |

**Damage 7:** Mudguard - right side: Mudguard - right side - Stone chips - Paint

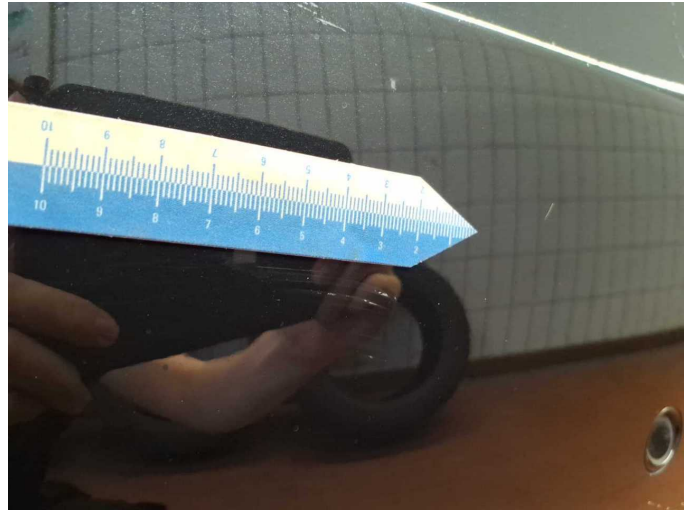
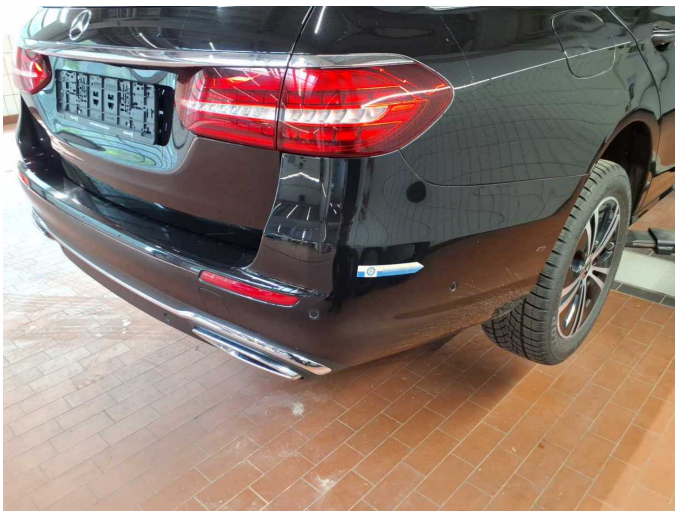
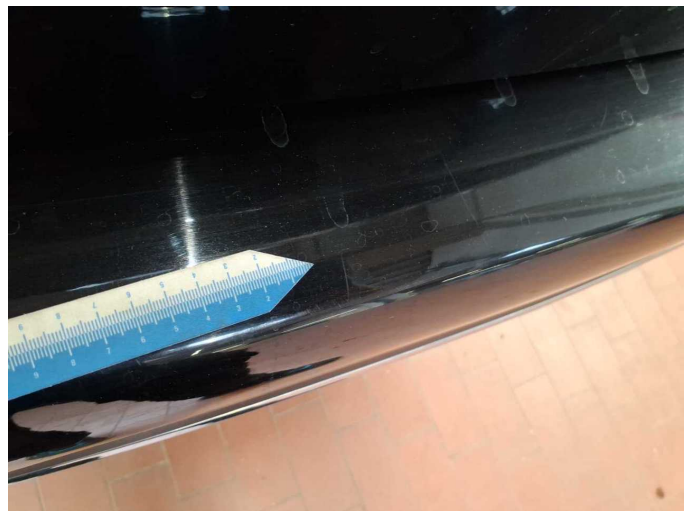
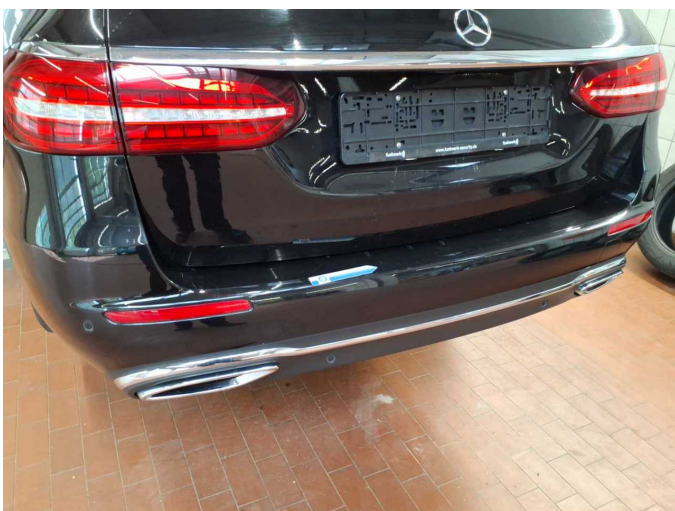
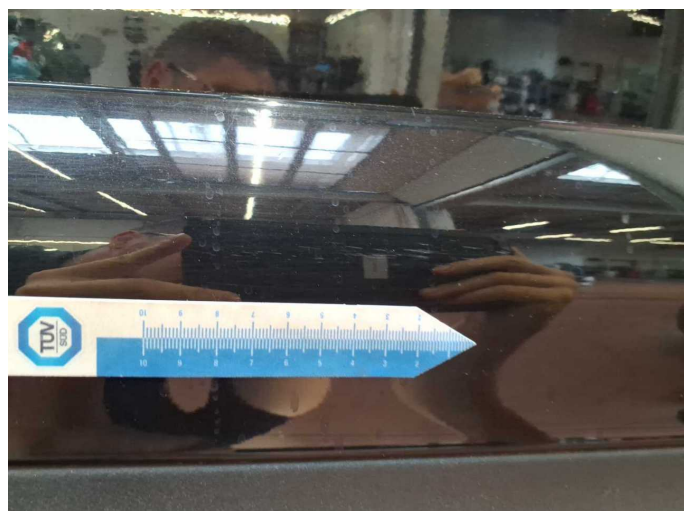
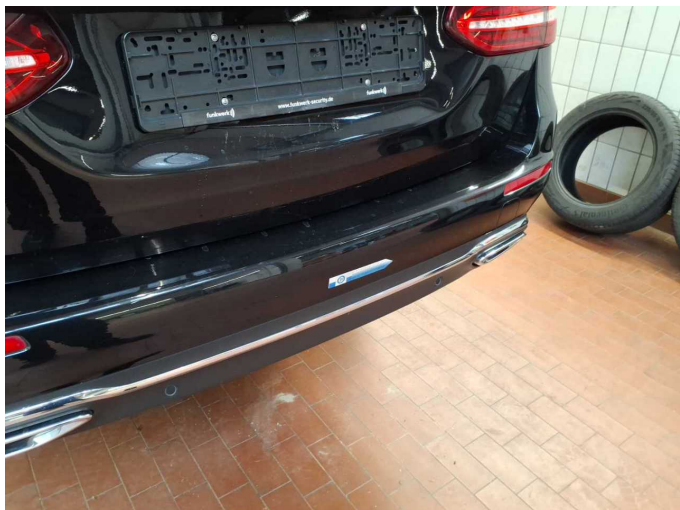
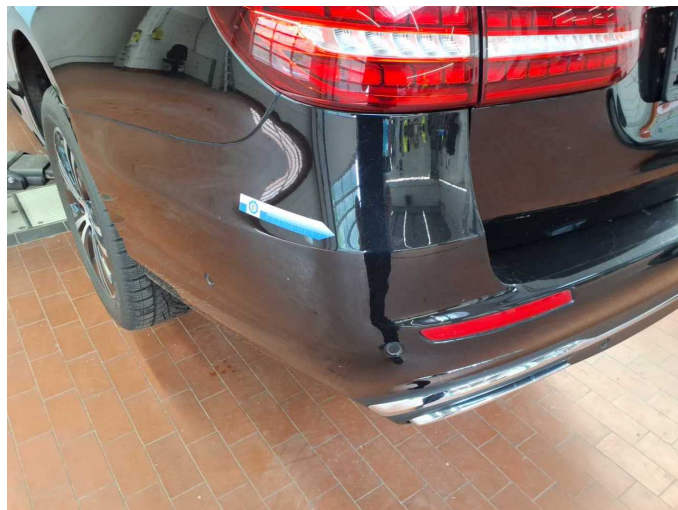
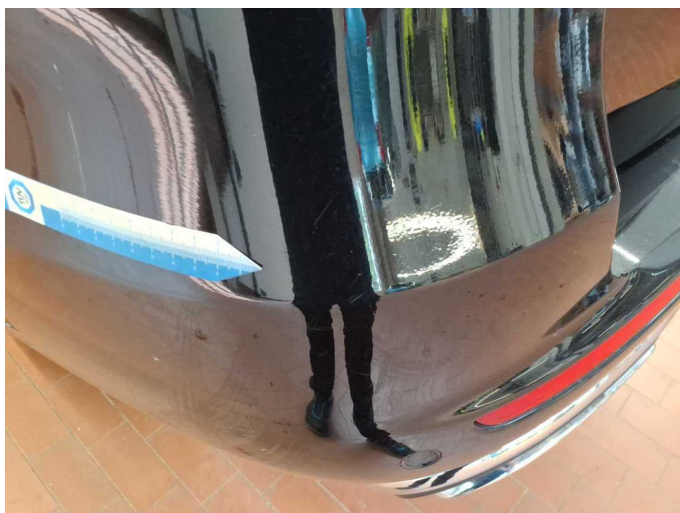
| No. | Component group | Description |
|---|---|---|
| 8 | Rear bumper | Rear bumper - Scratch(es) - Paint |

**Damage 8:** Rear bumper: Rear bumper - Scratch(es) - Paint

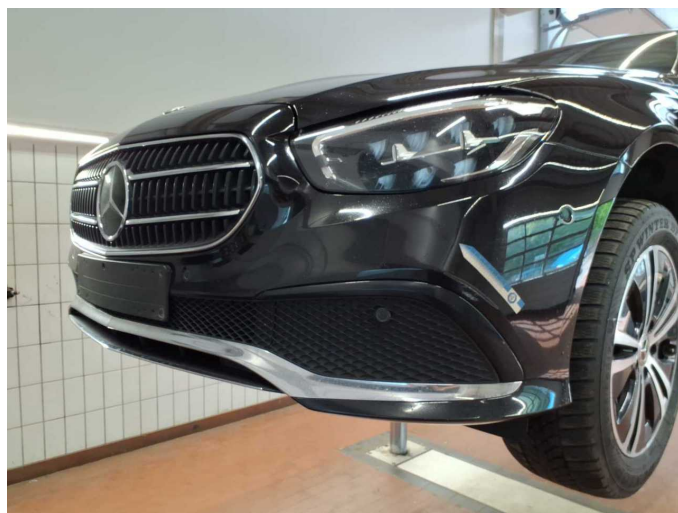
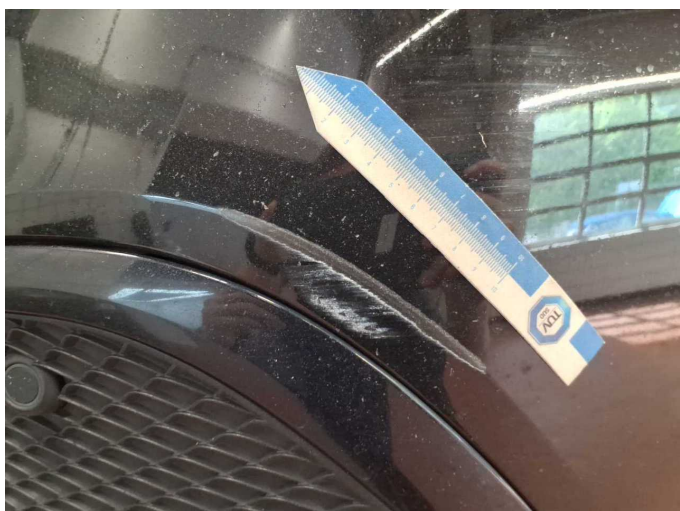
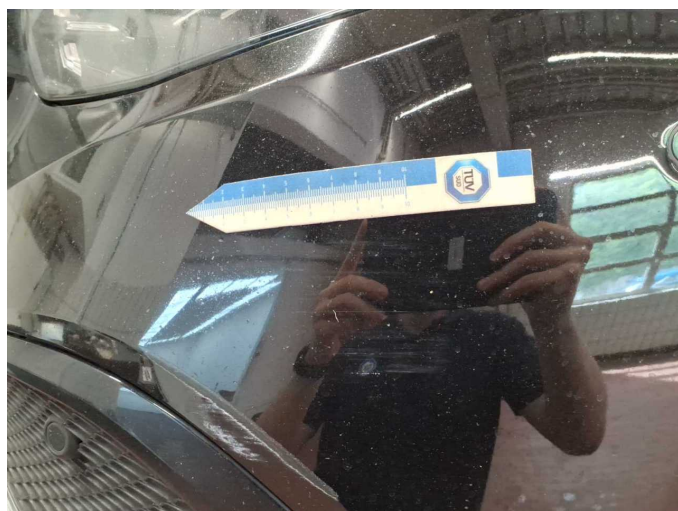
| No. | Component group | Description |
|---|---|---|
| 9 | Front bumper | Front bumper - Scratched - Paint |

**Damage 9:** Front bumper: Front bumper - Scratched - Paint

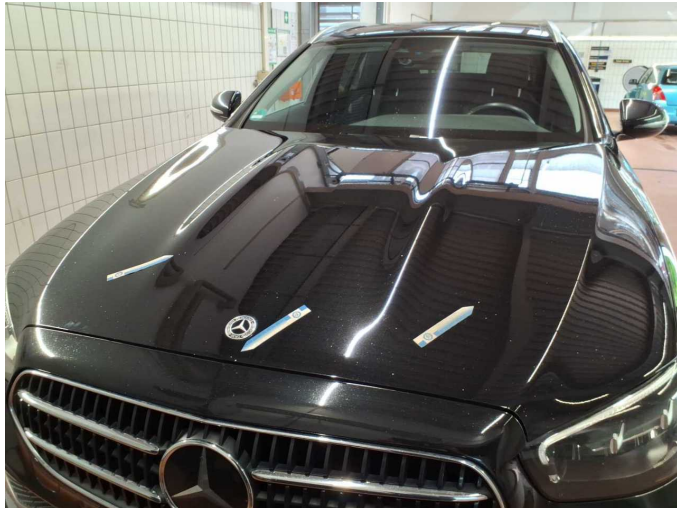
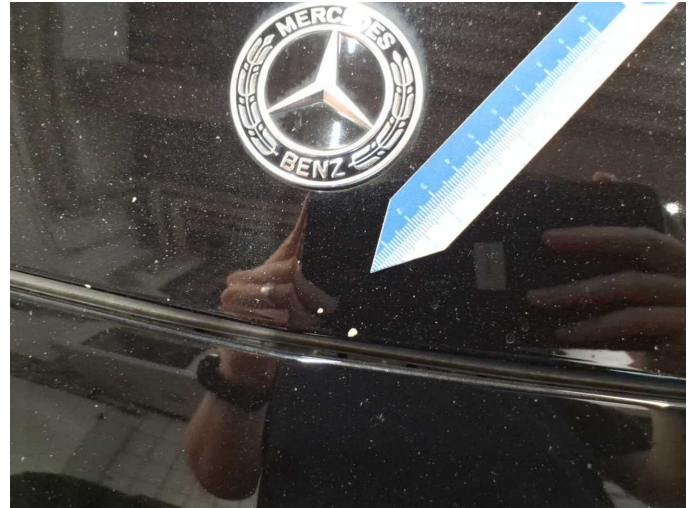
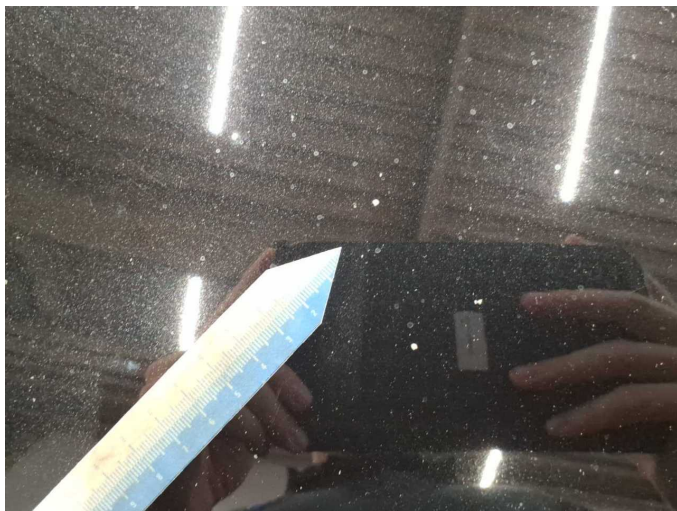
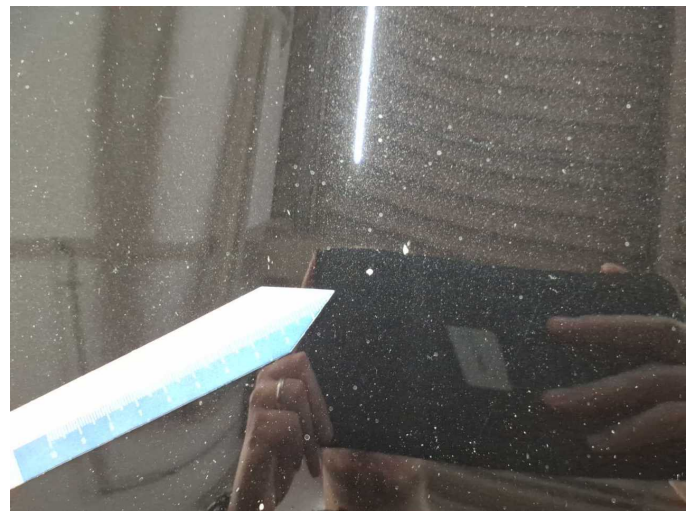
| No. | Component group | Description |
|---|---|---|
| 10 | Bonnet | Bonnet - Stone chips - Paint |

**Damage 10:** Bonnet: Bonnet - Stone chips - Paint

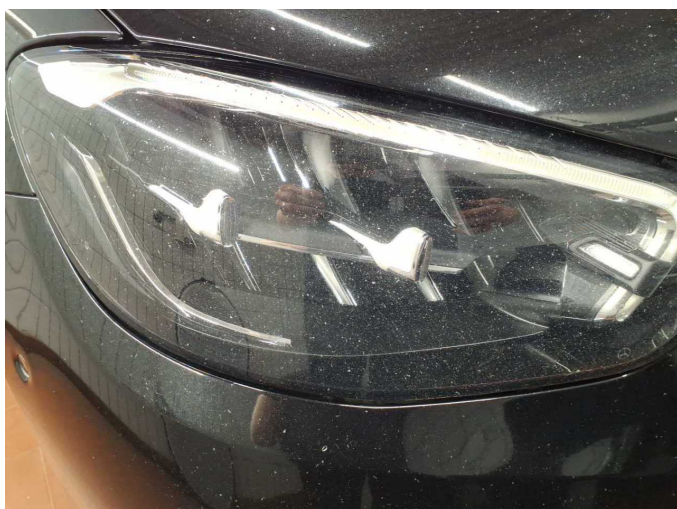
| No. | Component group | Description |
|---|---|---|
| 2 | Headlight | Headlight - right side - Stone chips - No deduction |

**Wear and tear 2:** Headlight: Headlight - right side - Stone chips - No deduction

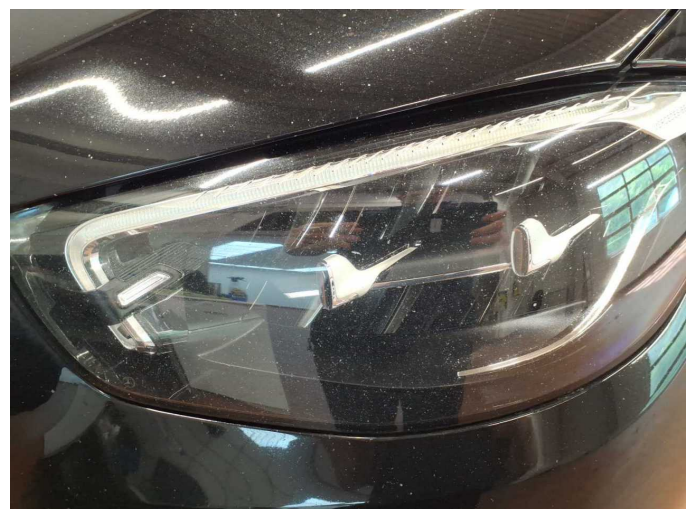
| No. | Component group | Description |
|---|---|---|
| 3 | Headlight | Headlight - left side - Stone chips - No deduction |

**Wear and tear 3:** Headlight: Headlight - left side - Stone chips - No deduction

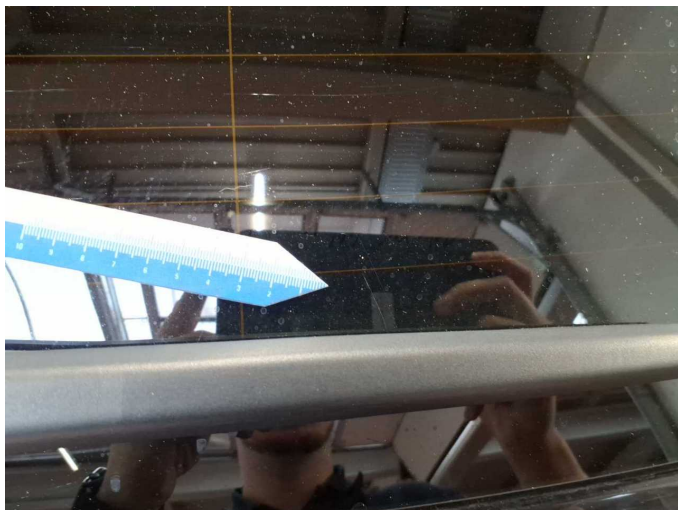
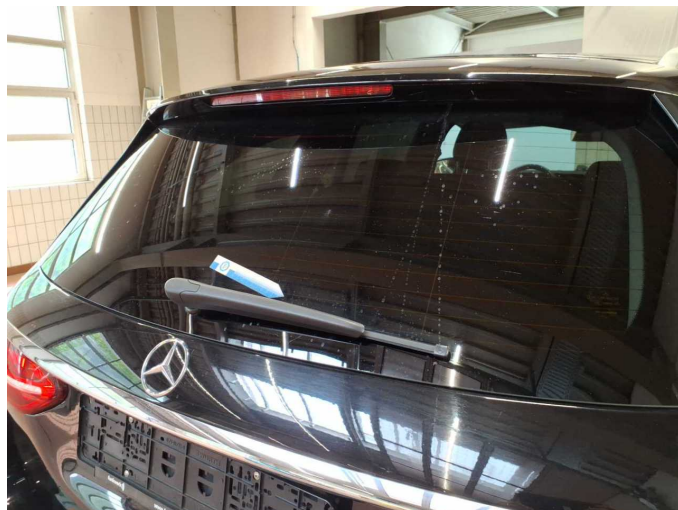
| No. | Component group | Description |
|---|---|---|
| 5 | Vehicle glazing | Rear window - Scratch(es) - No deduction |

**Wear and tear 5:** Vehicle glazing: Rear window - Scratch(es) - No deduction
