## Expertise

Protocol number: 46215954  
Order No. / Reference: 26478903-1  
Inspection date: 24 Jun 2026

Manufacturer: Audi

Model: e-tron 50 quattro

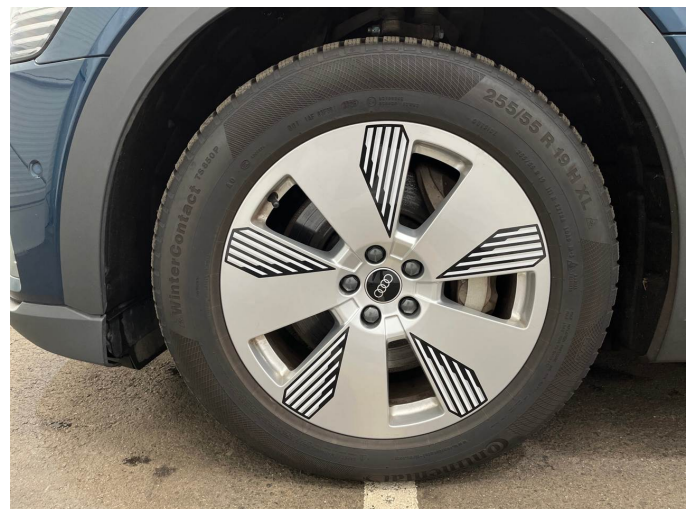
Figure 12: Mounted tyres

#	Tyre size	Type of tyre	Manufacturer	Tread depth
1)	255/55 R19 111H	Winter tyres on Light alloy	Continental	8mm / 8mm
2)	255/55 R19 111H	Winter tyres on Light alloy	Continental	6mm / 6mm

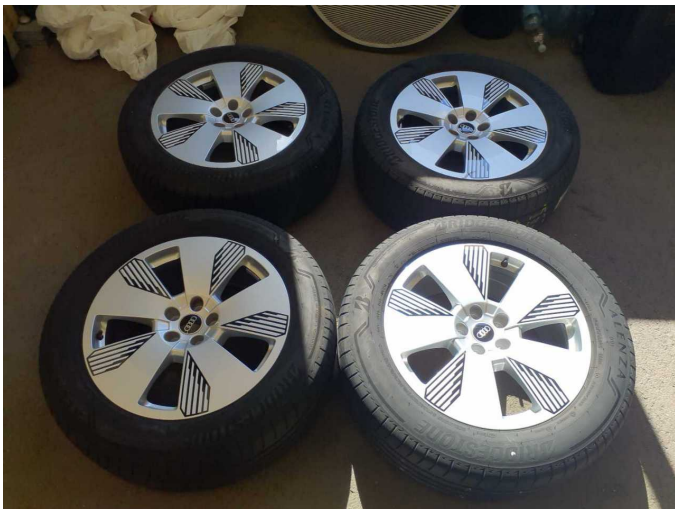
Figure 17: Additional tyres

#	Tyre size	Type of tyre	Manufacturer	Tread depth
1)	255/55 R19 111H	Summer tyres on Light alloy	Bridgestone	5mm / 5mm
2)	255/55 R19 111H	Summer tyres on Light alloy	Bridgestone	5mm / 5mm

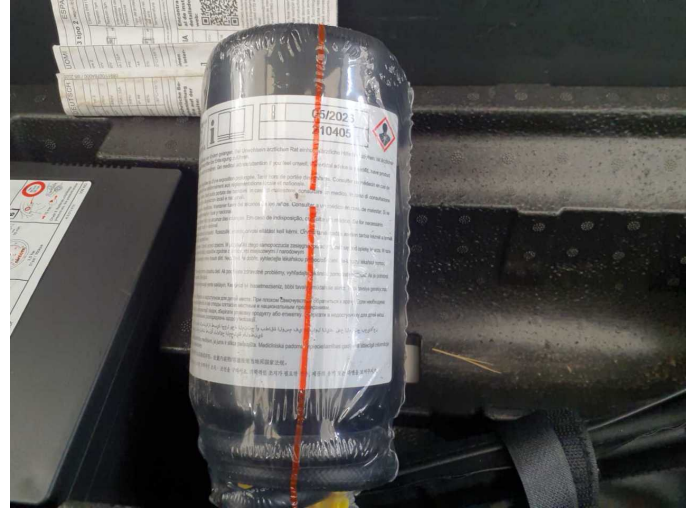
Damage 2: Equipment: Tirefit filler - Expired - Replace

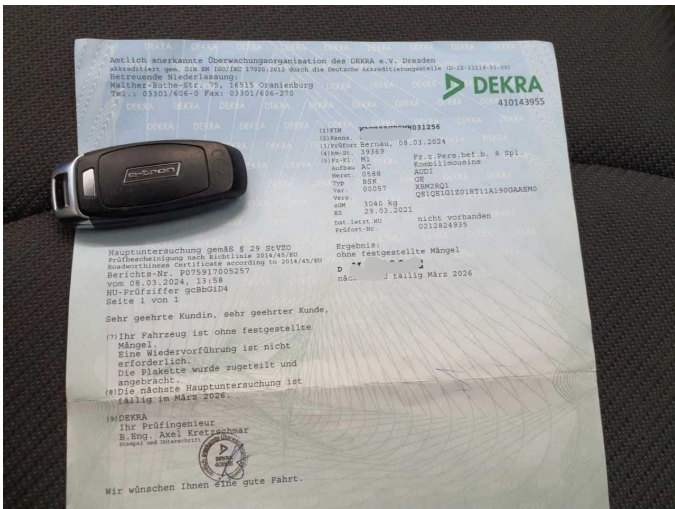
Damage 3: Misc.: Main inspection - Expired - Replace

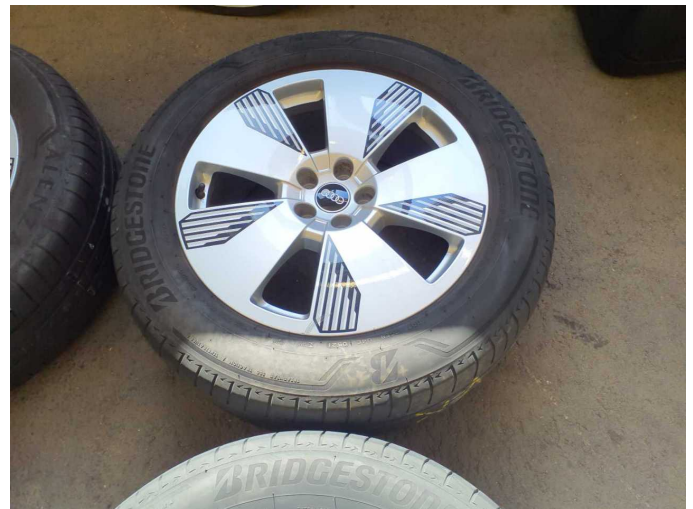
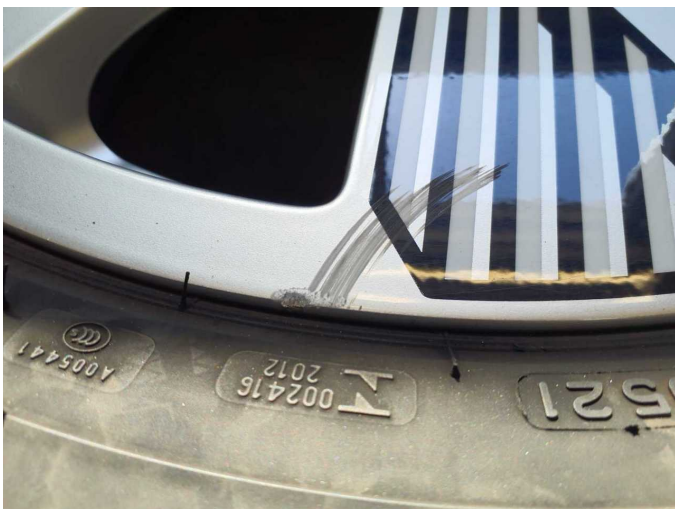
Damage 4: 2nd wheel set: 1 alloy rim - Scratch(es) - Loss in value

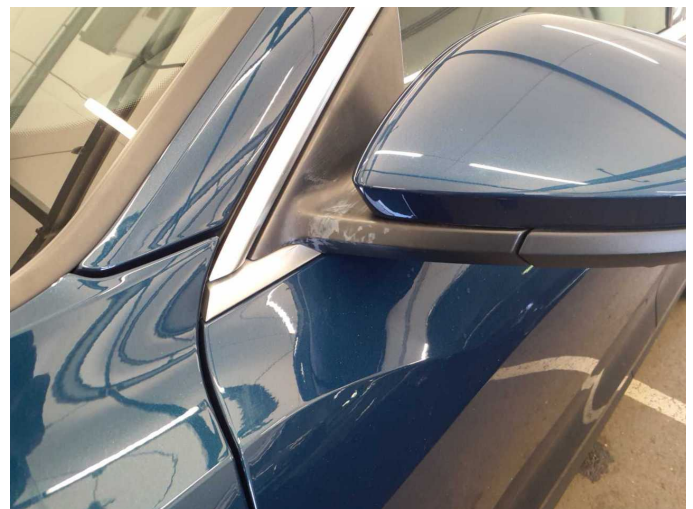
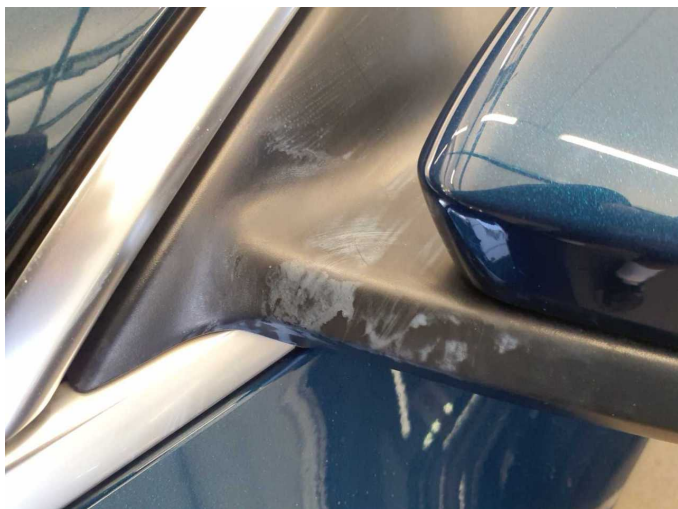
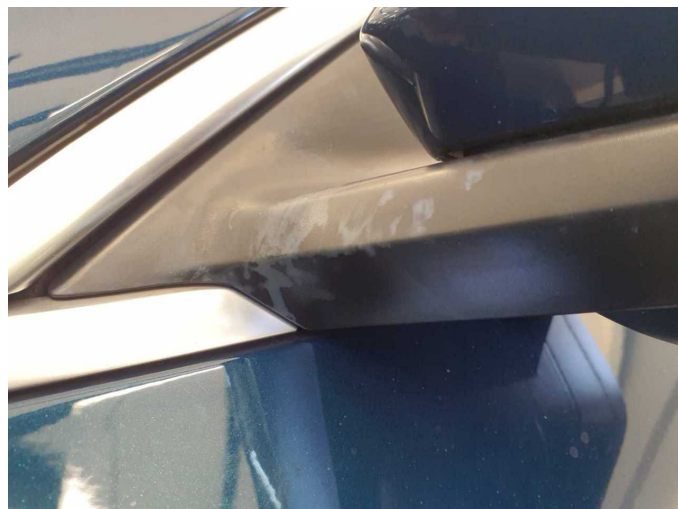
Damage 5: Wing mirror - left side: Mirror bracket (Verätzung) - Paint defect - Replace

**Damage 5:** Wing mirror - left side: Mirror bracket (Verätzung) - Paint defect - Replace
