Expertise

Protocol number: 46605159  
Order No. / Reference: 26505030  
Inspection date: 17 Jul 2026

Manufacturer: Skoda  
VIN: TMBJJ9NS5N8053902

Model: Kodiahq 2.0 TDI DSG Clever

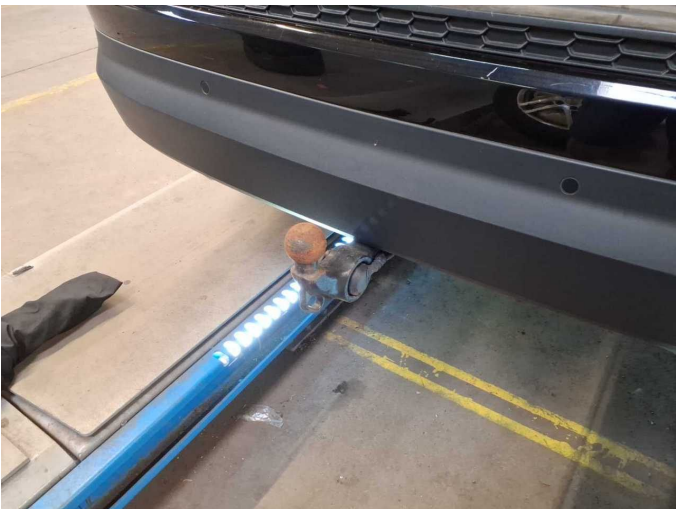
| No. | Component group | Description |
|---|---|---|
| 2 | Equipment | Tirefit filler - Expired - Replace |

Damage 2: Equipment: Tirefit filler - Expired - Replace

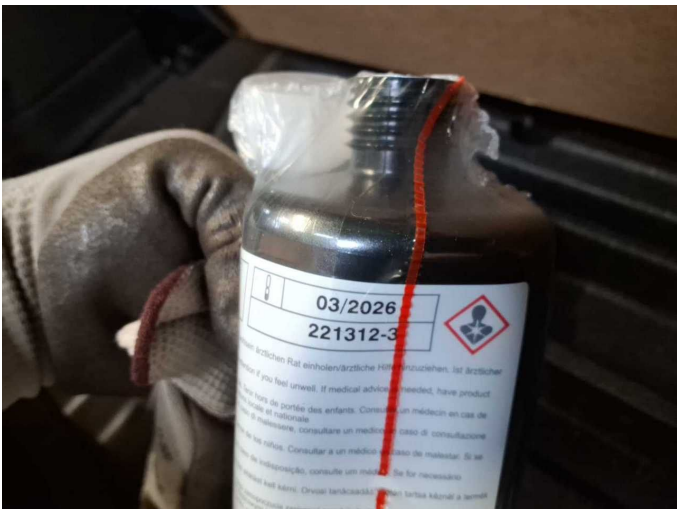
| No. | Component group | Description |
|---|---|---|
| 3 | Side panel - rear right side | Side panel - Scratch(es) - Smart repair |

**Damage 3:** Side panel - rear right side: Side panel - Scratch(es) - Smart repair

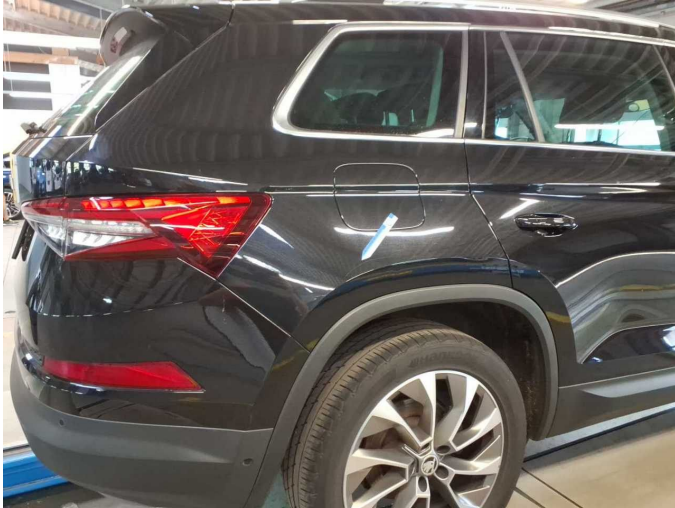
**Damage 3:** Side panel - rear right side: Side panel - Scratch(es) - Smart repair

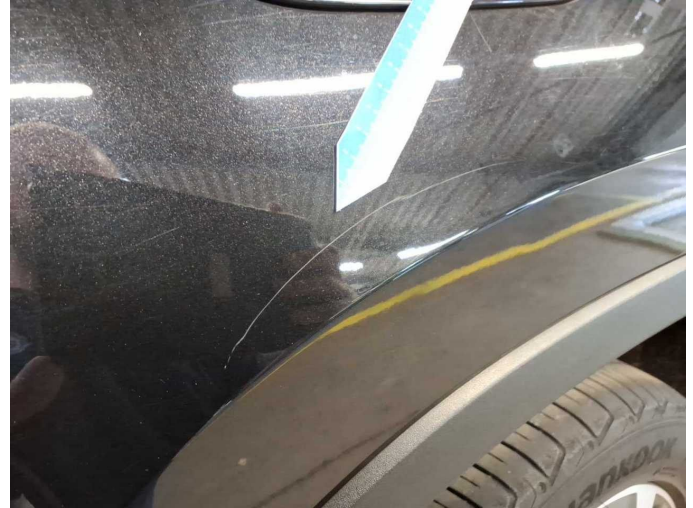
| No. | Component group | Description |
|---|---|---|
| 4 | Wheel / tyres | Tyre - rear right side (Flanke,nicht fahrbereit) - Damaged - Replace |

**Damage 4:** Wheel / tyres: Tyre - rear right side (Flanke, nicht fahrbereit) - Damaged - Replace

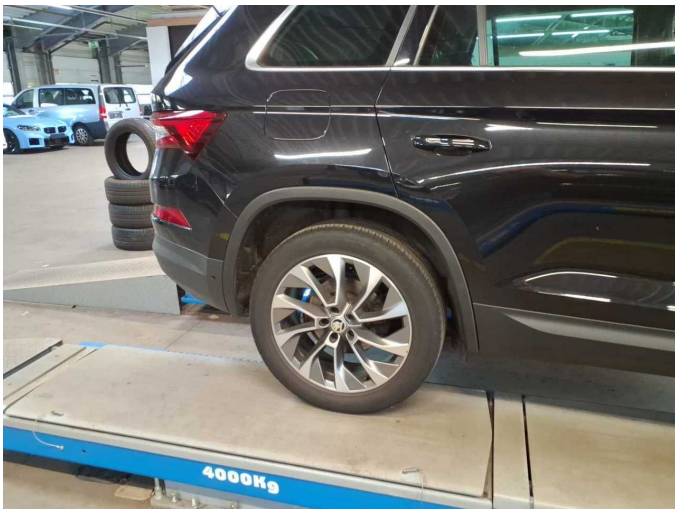
**Damage 4:** Wheel / tyres: Tyre - rear right side (Flanke, nicht fahrbereit) - Damaged - Replace

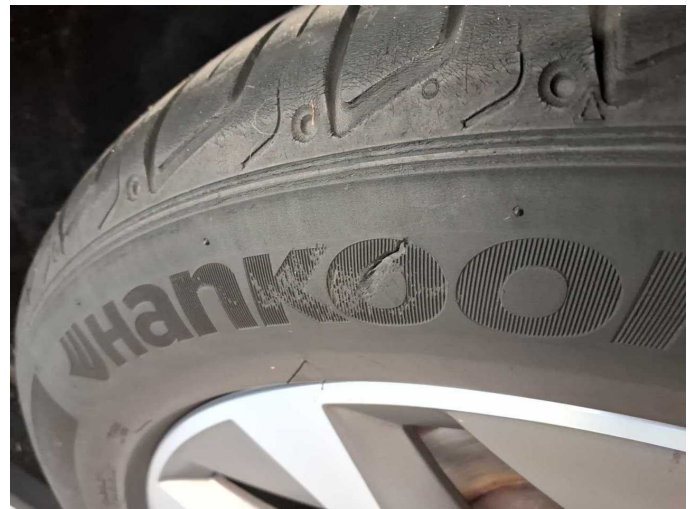
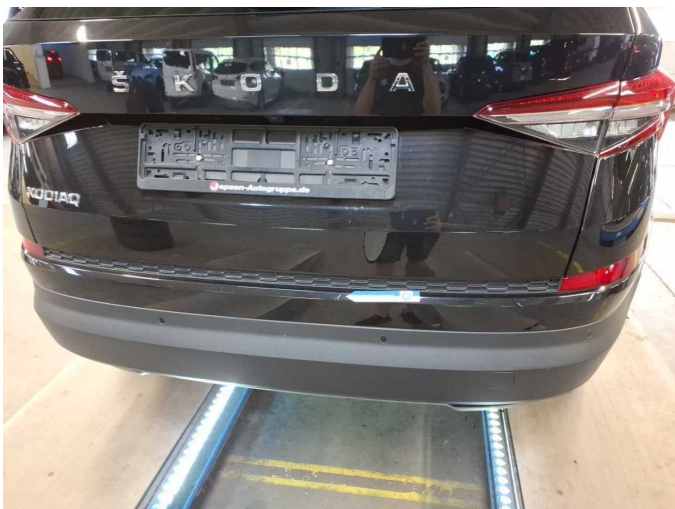
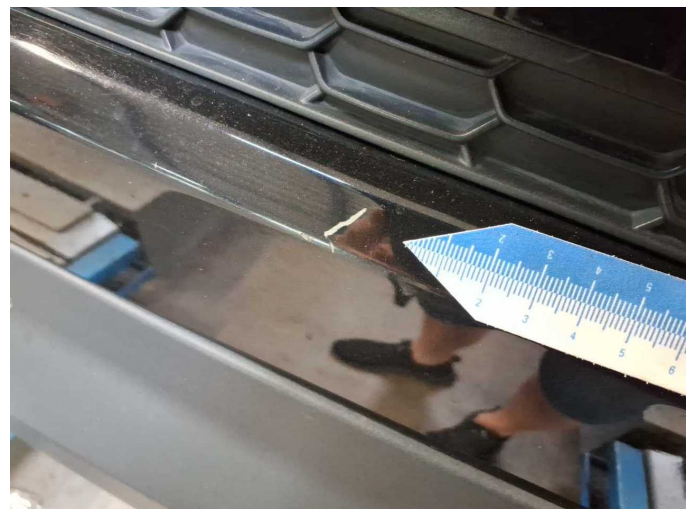
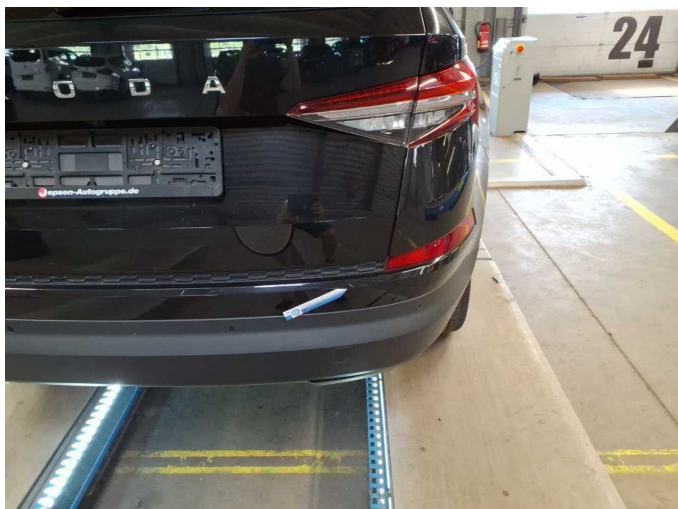
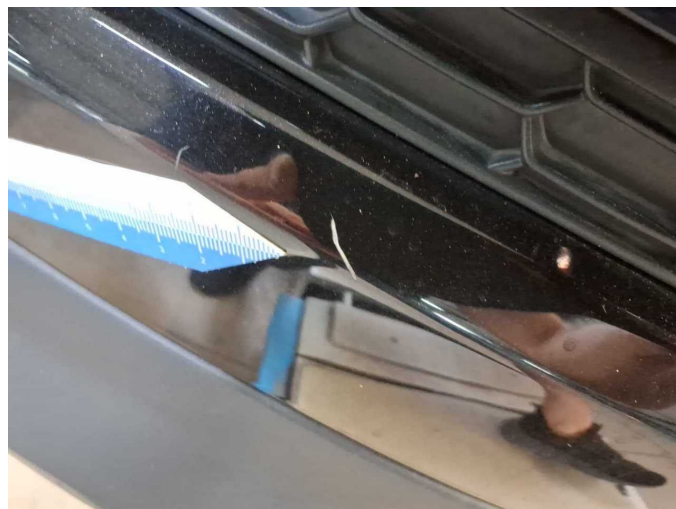
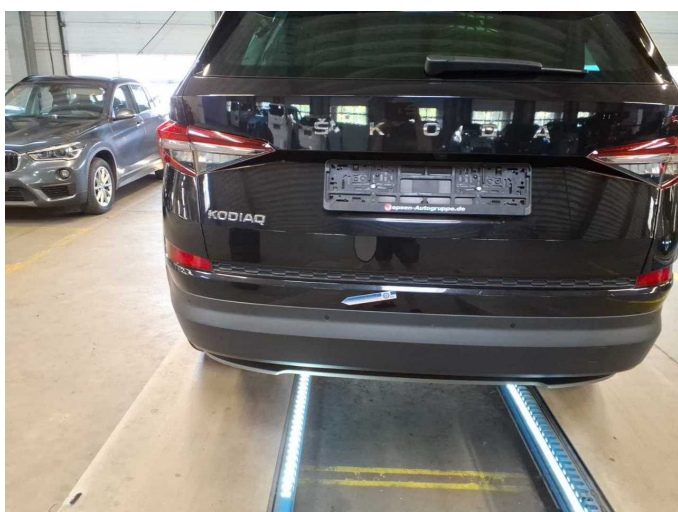
| No. | Component group | Description |
|---|---|---|
| 5 | Rear bumper | Rear bumper - Scratched - Paint |

**Damage 5:** Rear bumper: Rear bumper - Scratched - Paint

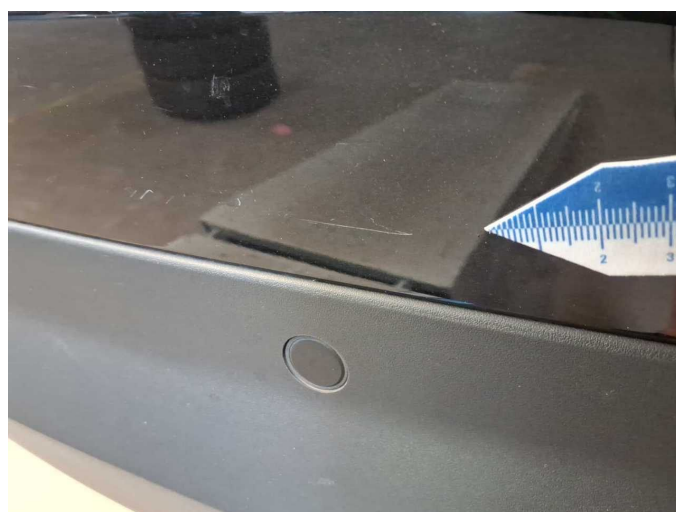
**Damage 5:** Rear bumper: Rear bumper - Scratched - Paint

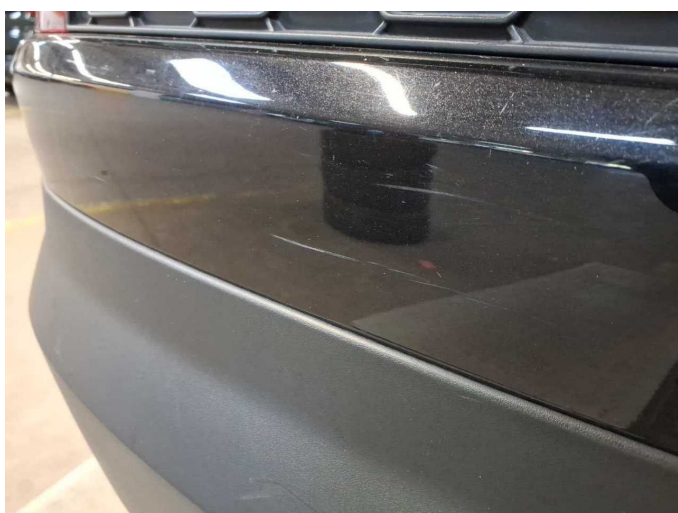
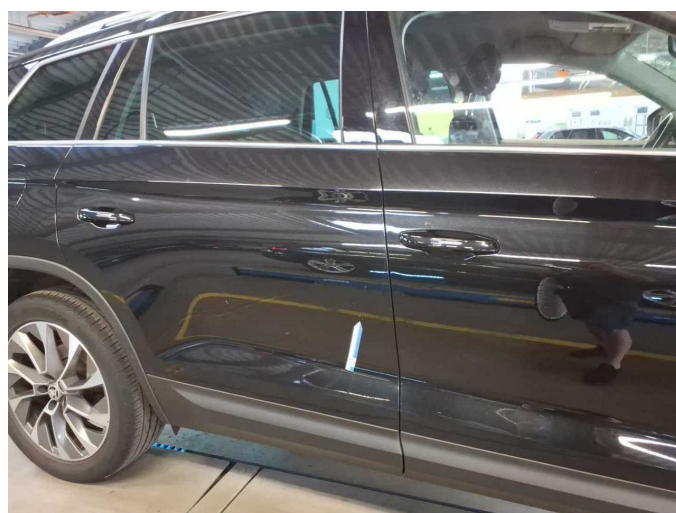
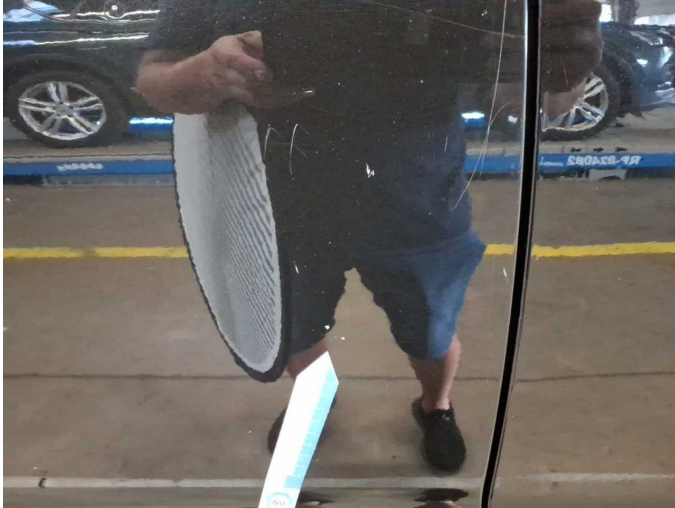
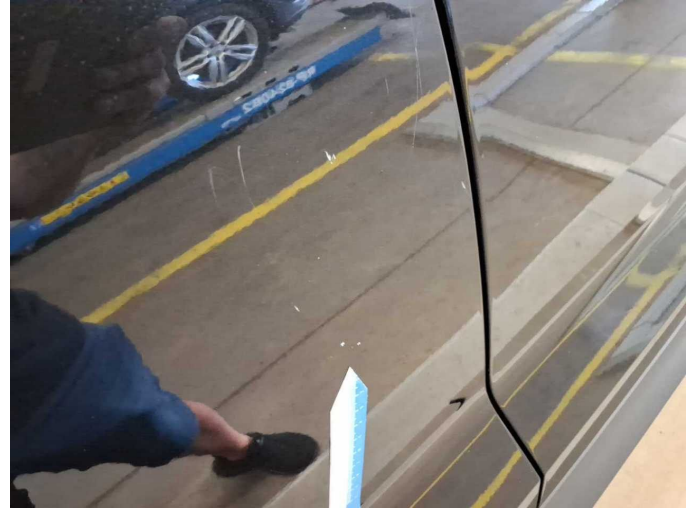
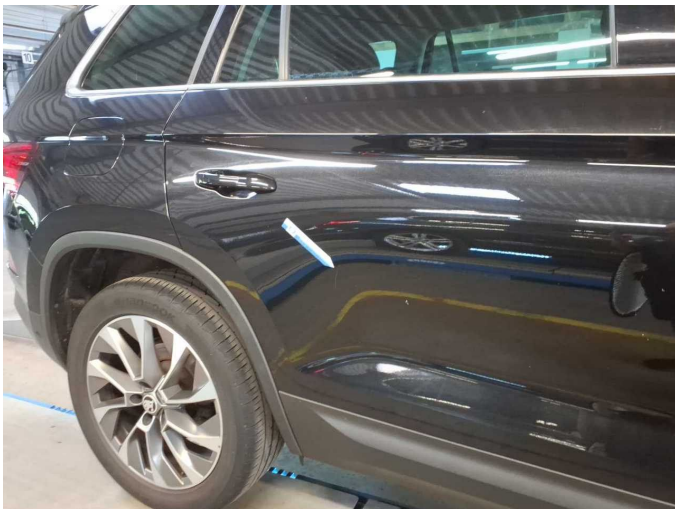
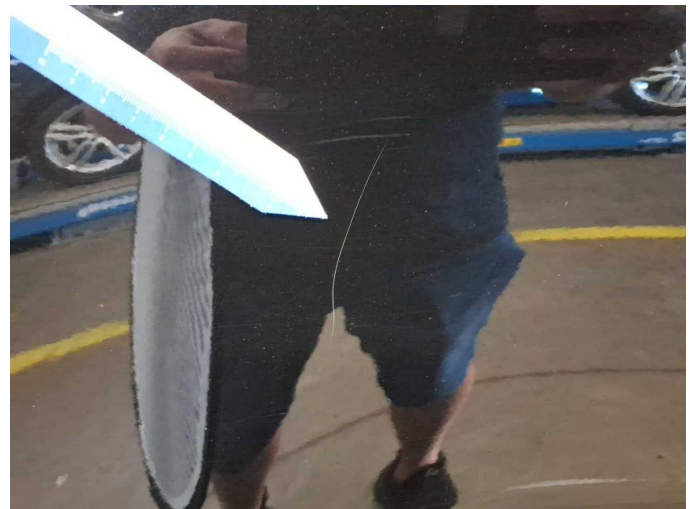
| No. | Component group | Description |
|---|---|---|
| 6 | Door - rear right side | Door - Dent / paintcoat damage - Repair and paint |

**Damage 6:** Door - rear right side: Door - Dent / paintcoat damage - Repair and paint

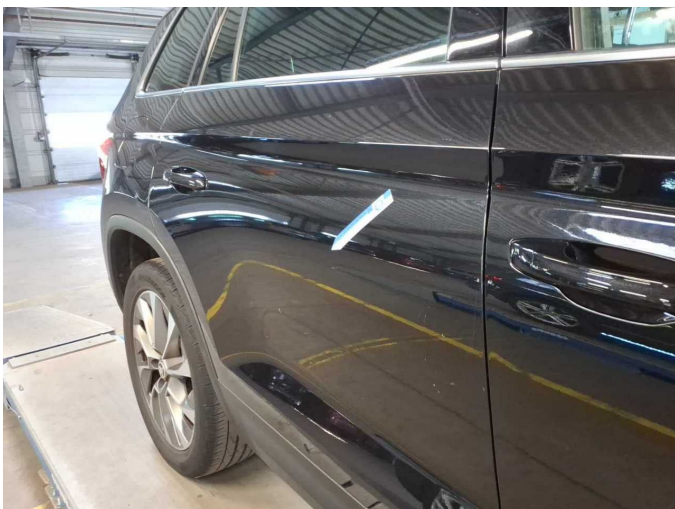
**Damage 6:** Door - rear right side: Door - Dent / paintcoat damage - Repair and paint

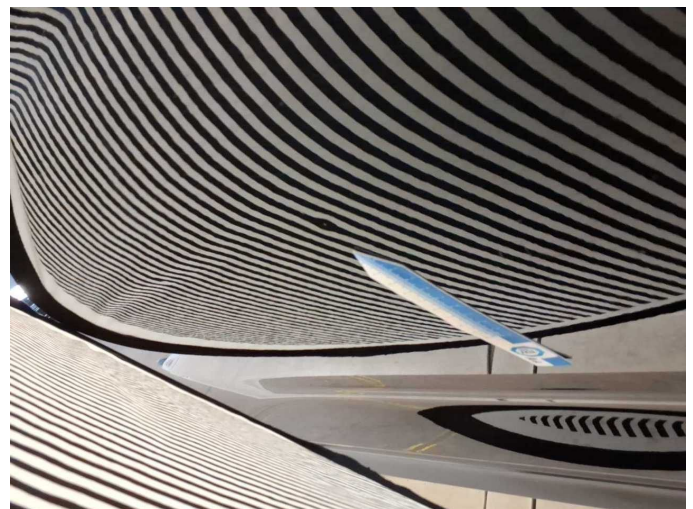
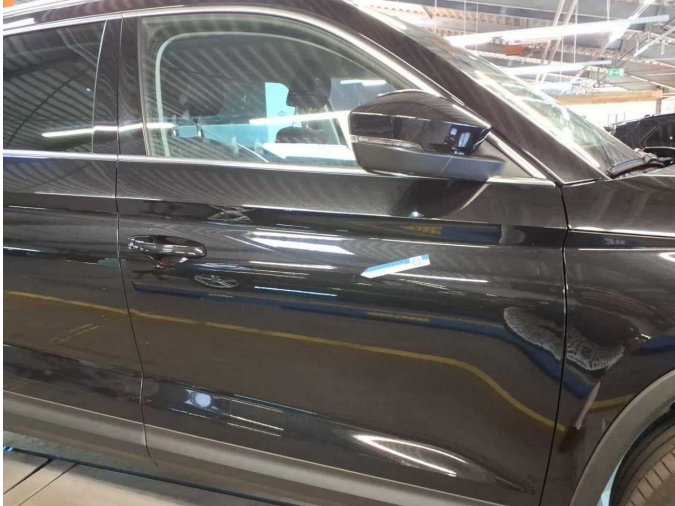
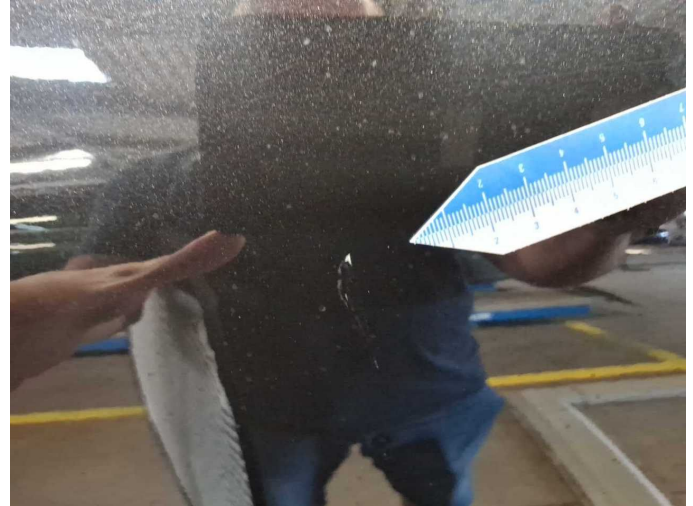
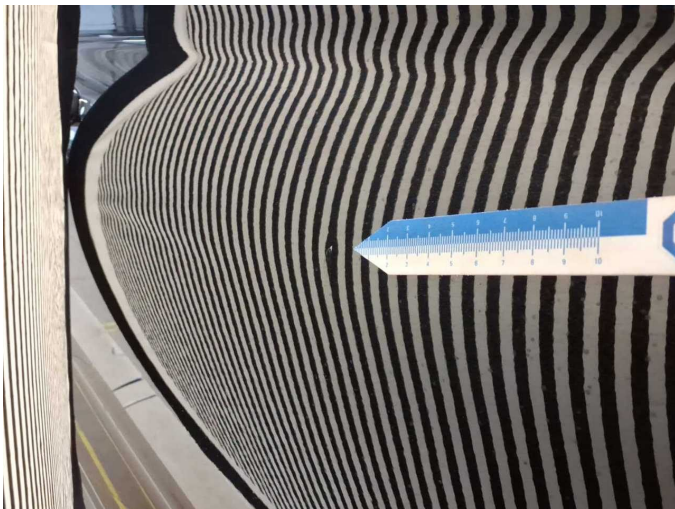
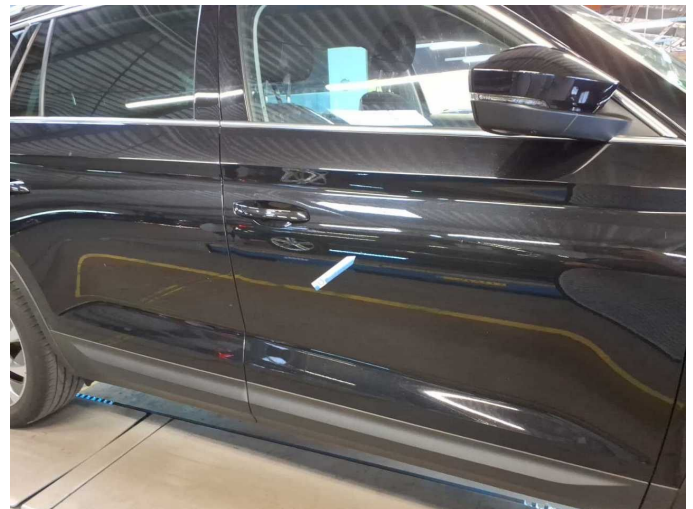
| No. | Component group | Description |
|---|---|---|
| 7 | Door - front right side | Door - Dent / paintcoat damage - Repair and paint |

**Damage 7:** Door - front right side: Door - Dent / paintcoat damage - Repair and paint

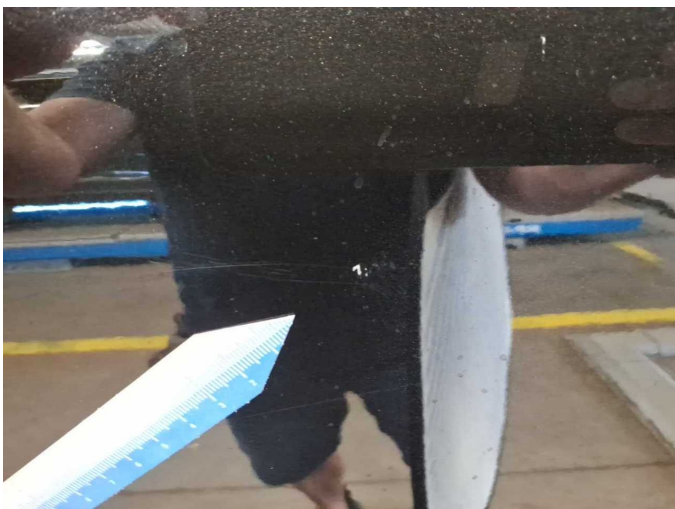
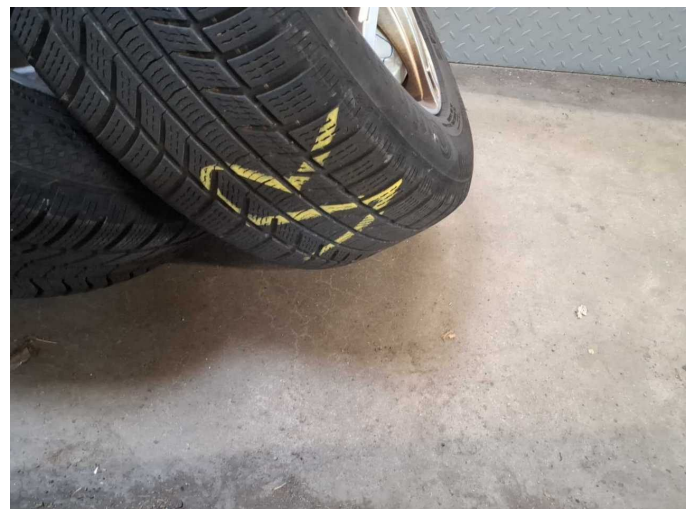
| No. | Component group | Description |
|---|---|---|
| 3 | 2nd wheel set | 1 tyre - Damaged - No deduction |

**Wear and tear 3:** 2nd wheel set: 1 tyre - Damaged - No deduction
