Expertise

Protocol number: 46467035  
Order No. / Reference: 26535100  
Inspection date: 9 Jul 2026

| Manufacturer: Volvo | Model: V90 T6 Recharge AWD Geartronic Inscription Expression |
| VIN: YV1PWH1VDN1182977 | |

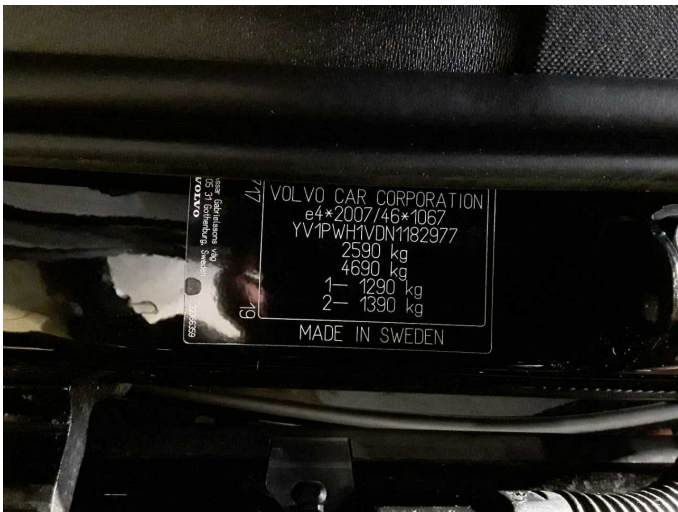
| VIN comparison | The vehicle identification number (VIN) was read from the vehicle and its conformity with the submitted documents was confirmed by the undersigned during the inspection. |

Figure 11: VIN

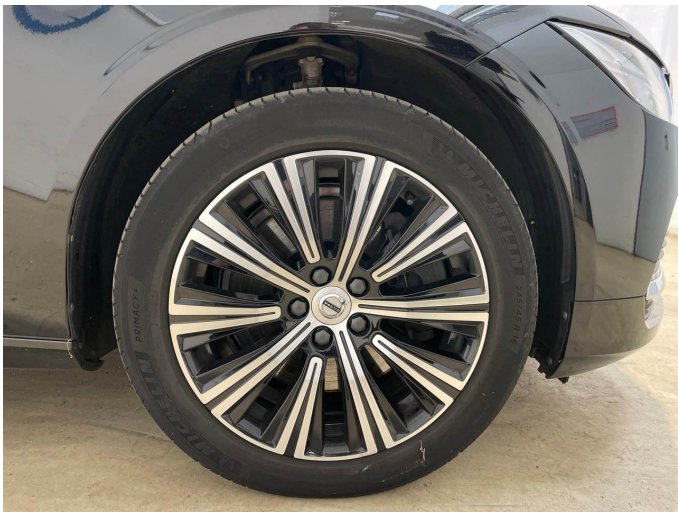
| # | Tyre size | Type of tyre | Manufacturer | Tread depth |
|---|---|---|---|---|
| 1) | 245/45 R18 100W | Summer tyres on Light alloy | Michelin | 3mm / 3mm |
| 2) | 245/45 R18 100W | Summer tyres on Light alloy | Michelin | 3mm / 3mm |

Figure 12: Mounted tyres

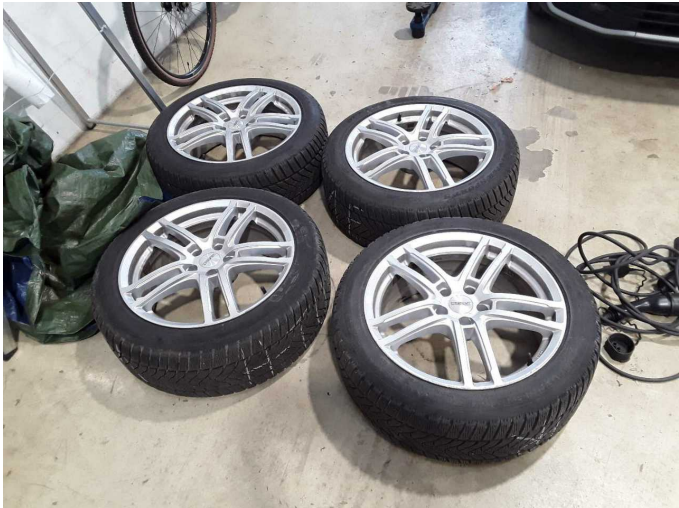
| # | Tyre size | Type of tyre | Manufacturer | Tread depth |
|---|---|---|---|---|
| 1) | 245/45 R18 100V | Winter tyres on Light alloy | Dunlop | 6mm / 6mm |
| 2) | 245/45 R18 100V | Winter tyres on Light alloy | Dunlop | 7mm / 7mm |

Figure 16: Additional tyres

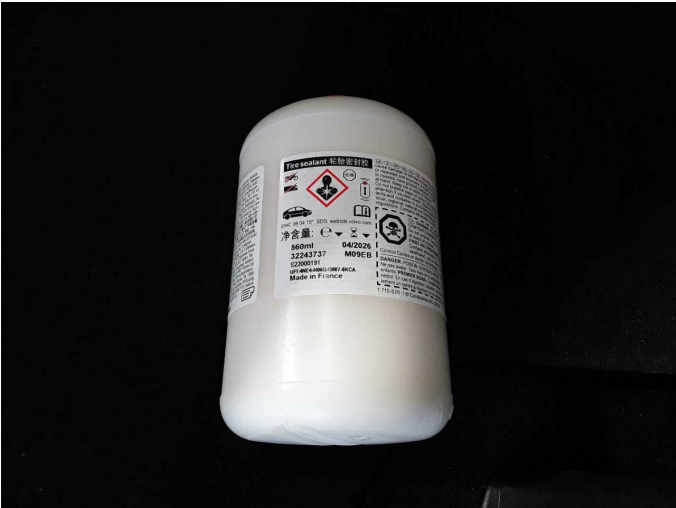
Damage 1: Equipment: Tirefit filler - Expired - Replace

| No. | Component group | Description |
|---|---|---|
| 1 | Equipment | Tirefit filler - Expired - Replace |

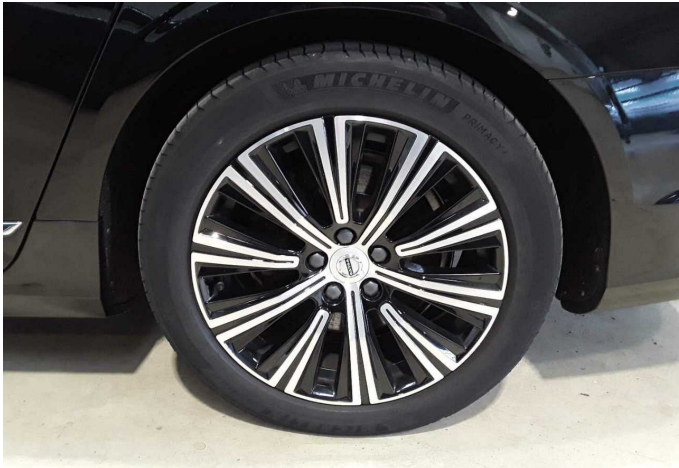
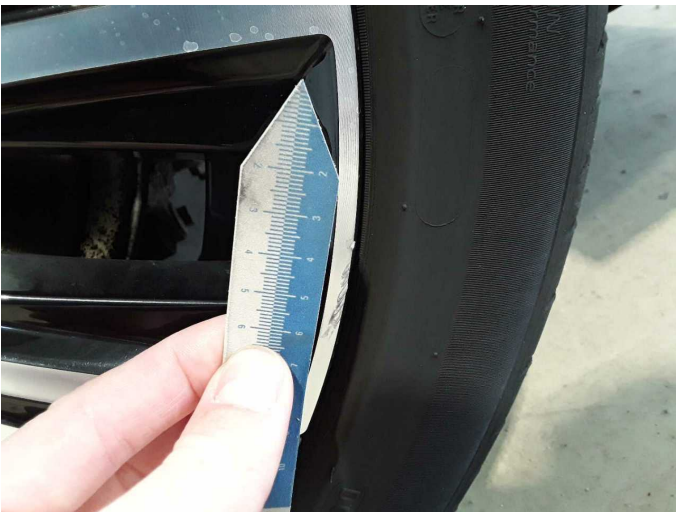
Damage 2: Wheel / tyres: Alloy rim - rear left side - Scratch(es) - Loss in value

| No. | Component group | Description |
|---|---|---|
| 2 | Wheel / tyres | Alloy rim - rear left side - Scratch(es) - Loss in value |

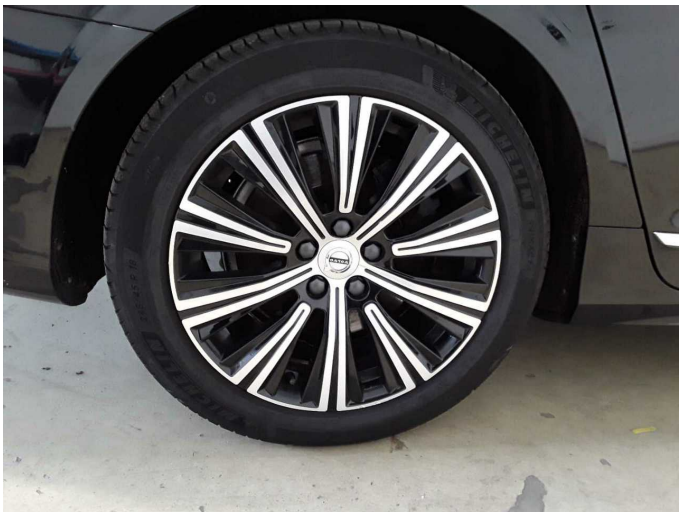
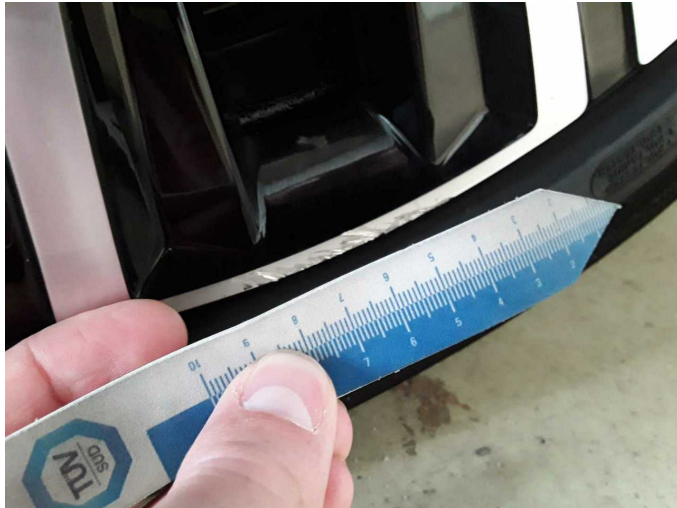
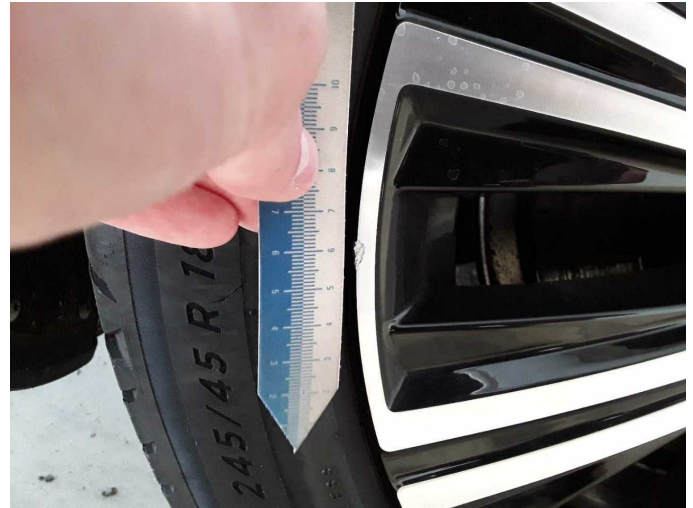
Damage 3: Wheel / tyres: Alloy rim - rear right side - Scratch(es) - Loss in value

**Damage 3:** Wheel / tyres: Alloy rim - rear right side - Scratch(es) - Loss in value

| No. | Component group | Description |
|---|---|---|
| 3 | Wheel / tyres | Alloy rim - rear right side - Scratch(es) - Loss in value |

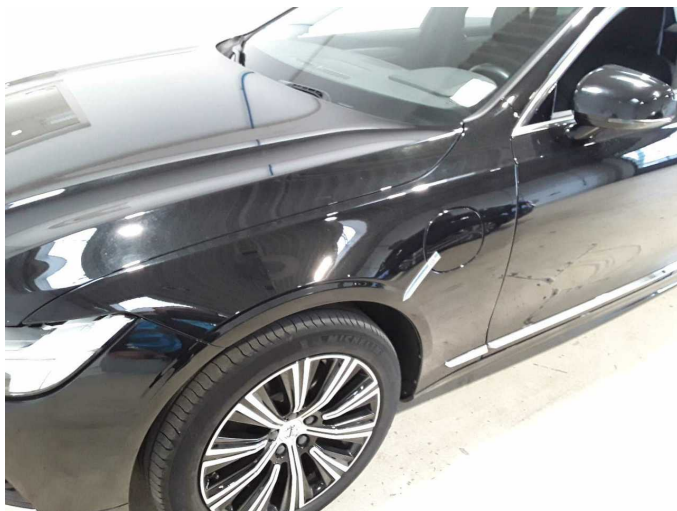
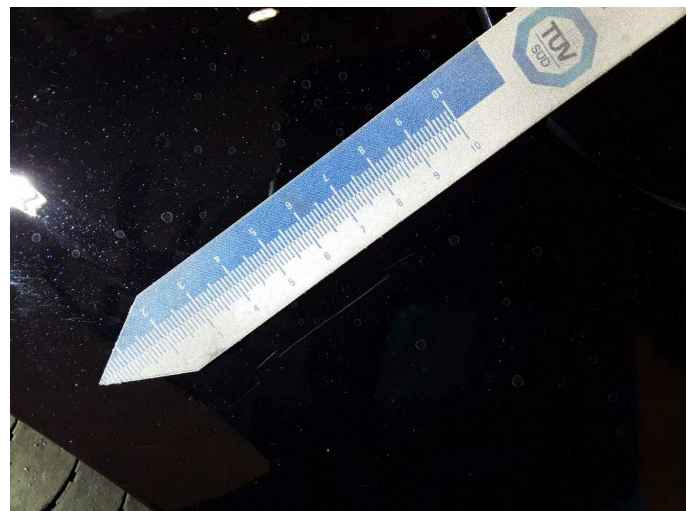
**Damage 4:** Mudguard - left side: Mudguard - left side - Scratch(es) - Paint

| No. | Component group | Description |
|---|---|---|
| 4 | Mudguard - left side | Mudguard - left side - Scratch(es) - Paint |

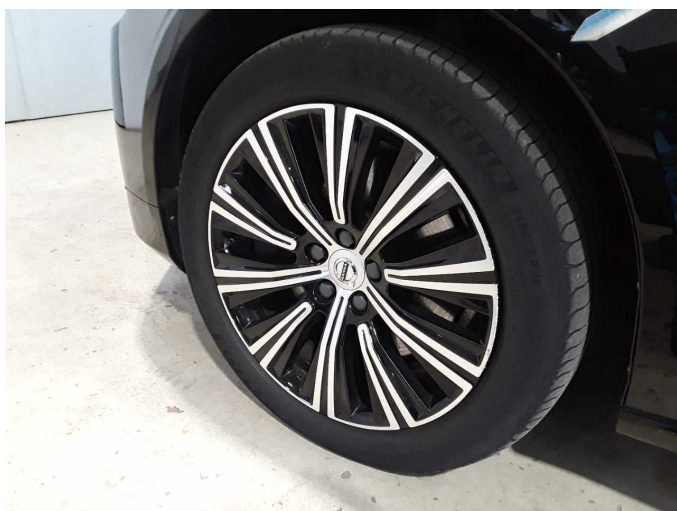
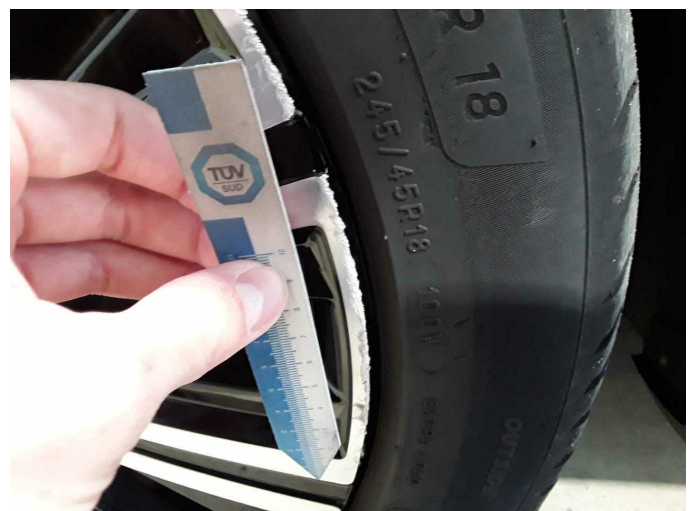
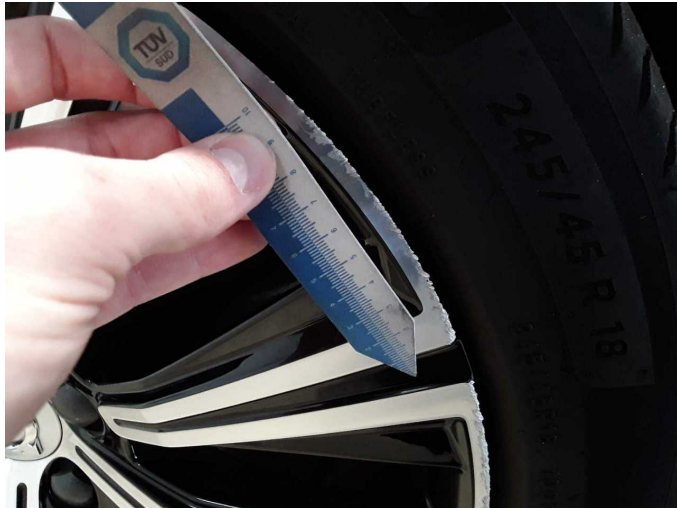
**Damage 5:** Wheel / tyres: Alloy rim - front left side - Scratched - Replace

| No. | Component group | Description |
|---|---|---|
| 5 | Wheel / tyres | Alloy rim - front left side - Scratched - Replace |

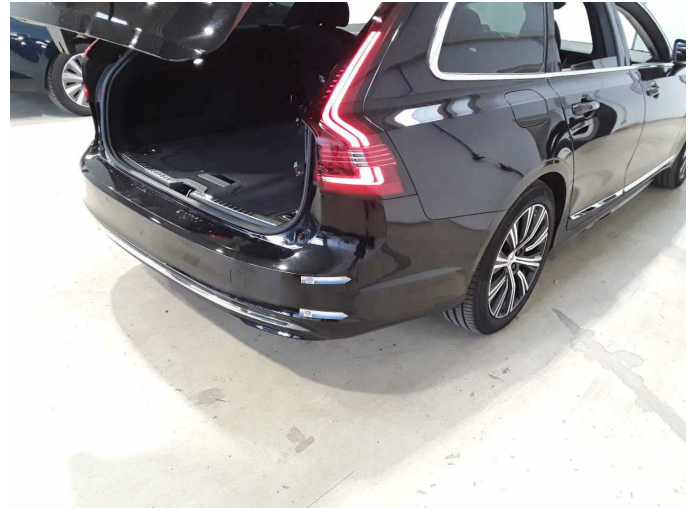
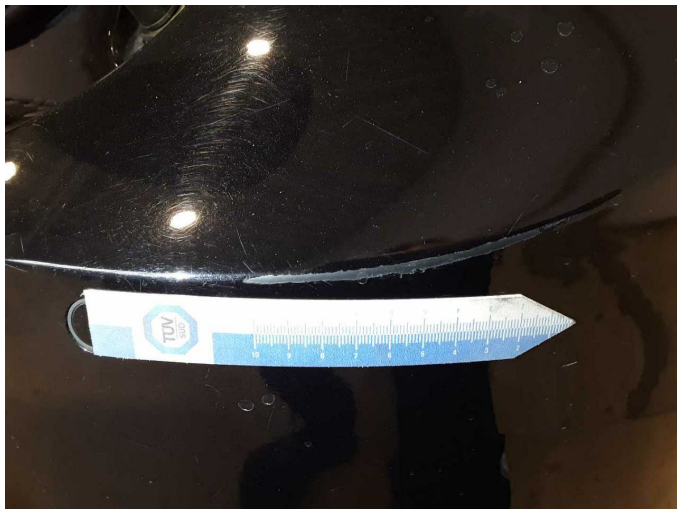
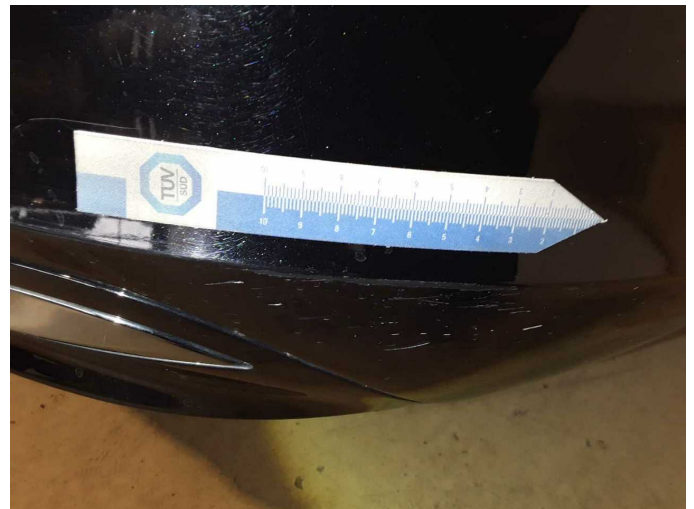
**Damage 6:** Rear bumper: Rear bumper - Scratch(es) - Paint

| No. | Component group | Description |
|---|---|---|
| 6 | Rear bumper | Rear bumper - Scratch(es) - Paint |
