Expertise

Protocol number: 46624351  
Order No. / Reference: 26577641-1  
Inspection date: 26 Jun 2026

Manufacturer: Opel

Model: Insignia Grand Sport 2.0 Diesel Automatik Business

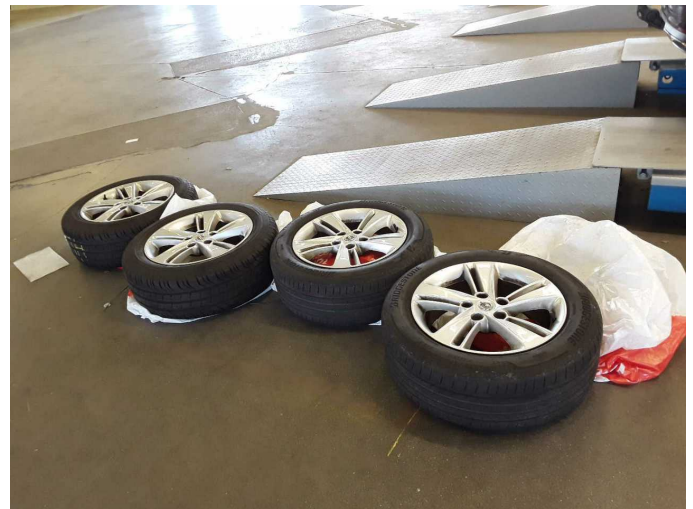
| # | Tyre size | Type of tyre | Manufacturer | Tread depth |
|---|---|---|---|---|
| 1) | 225/55 R17 97W | Summer tyres on Light alloy | Bridgestone | 4mm / 4mm |
| 2) | 225/55 R17 97W | Summer tyres on Light alloy | Continental | 5mm / 5mm |

Figure 16: Additional tyres

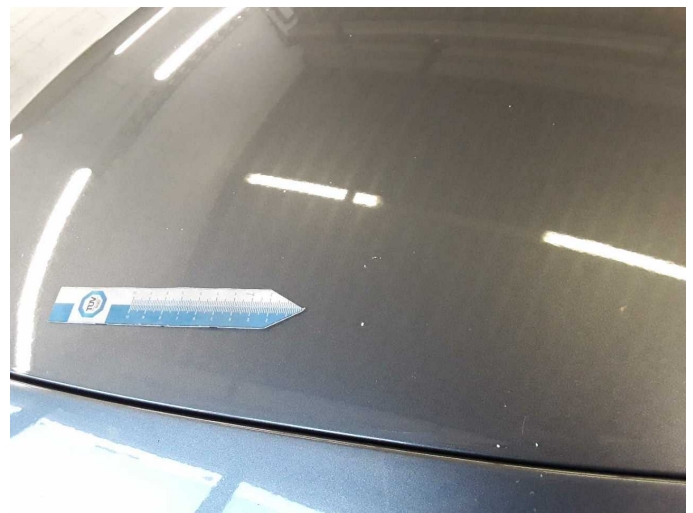
**Wear and tear 1:** Bonnet: Bonnet - Stone chips - No deduction

| No. | Component group | Description |
|---|---|---|
| 1 | Bonnet | Bonnet - Stone chips - No deduction |

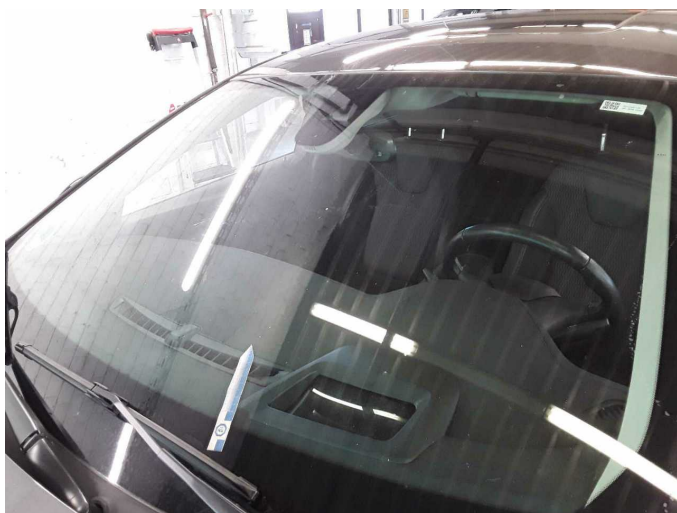
**Wear and tear 2:** Vehicle glazing: Windscreen - Stone chips - No deduction

| No. | Component group | Description |
|---|---|---|
| 2 | Vehicle glazing | Windscreen - Stone chips - No deduction |

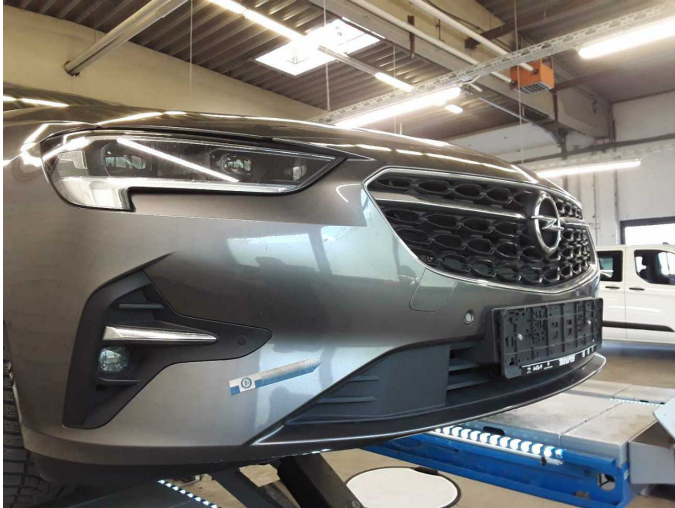
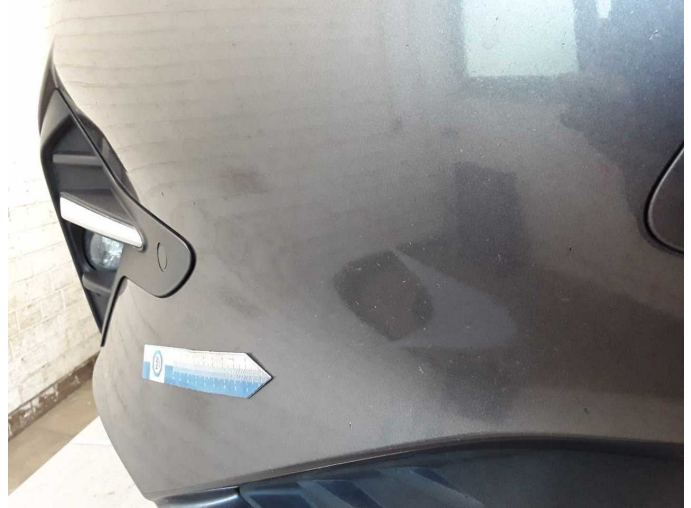
**Wear and tear 3:** Front bumper: Front bumper - Stone chips - No deduction

| No. | Component group | Description |
|---|---|---|
| 3 | Front bumper | Front bumper - Stone chips - No deduction |

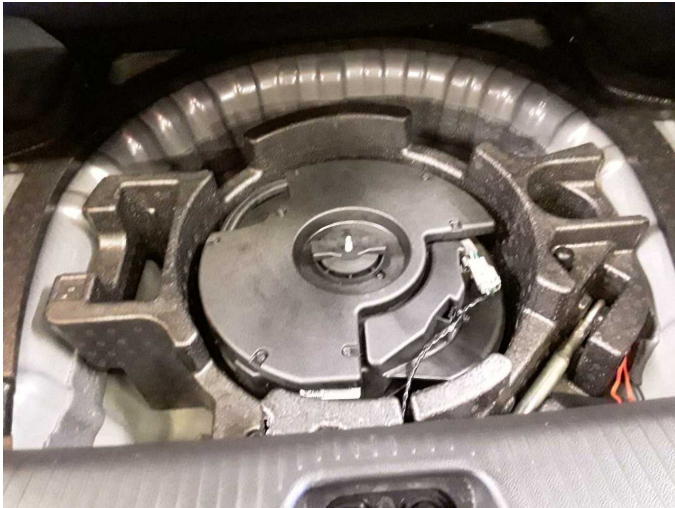
**Missing part 1:** Equipment: Tirefit complete - Missing - Replace

Equipment - Tirefit complete

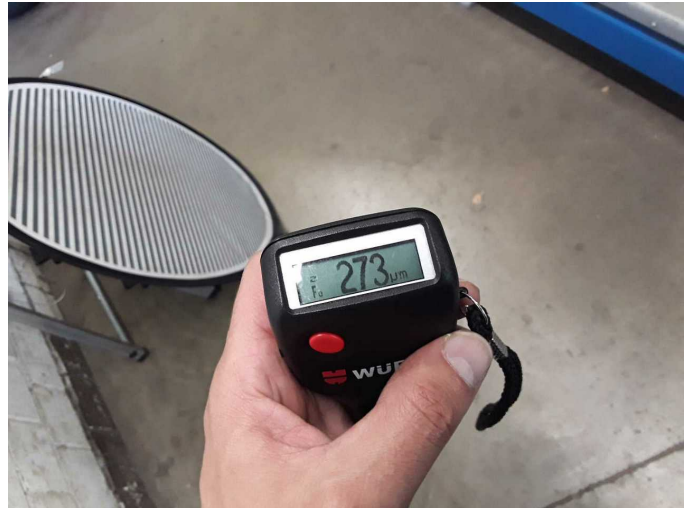
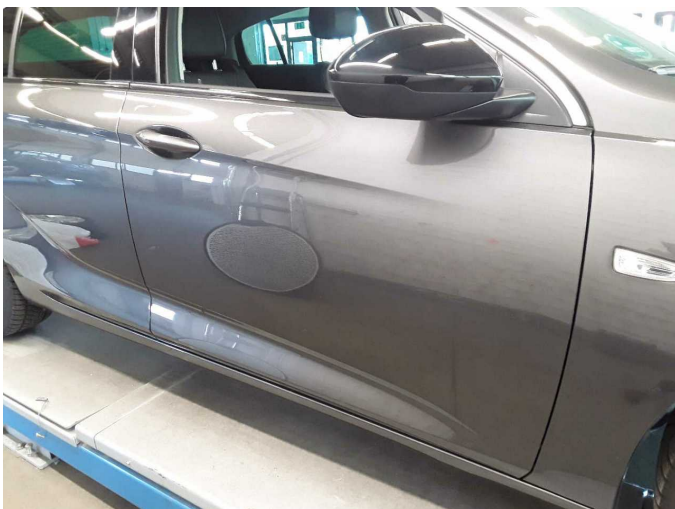
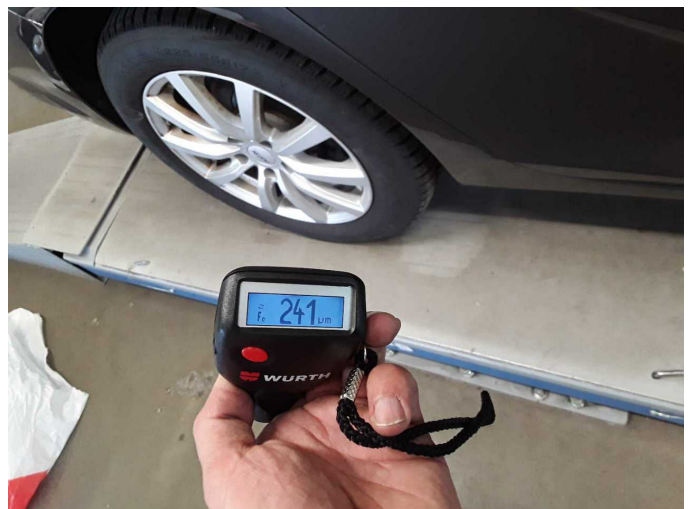
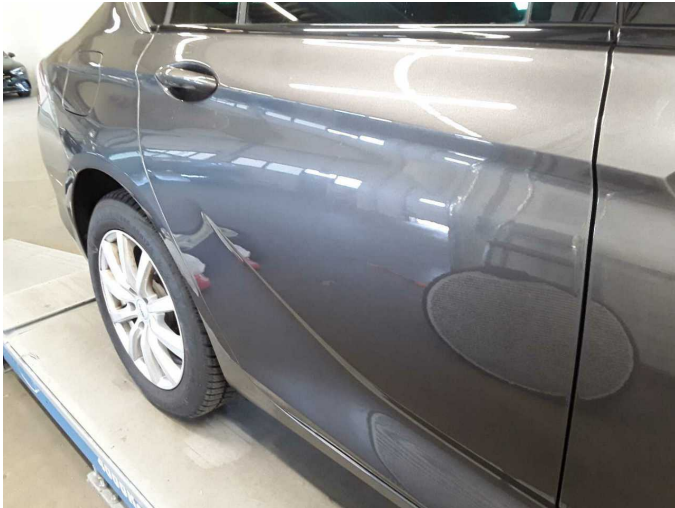
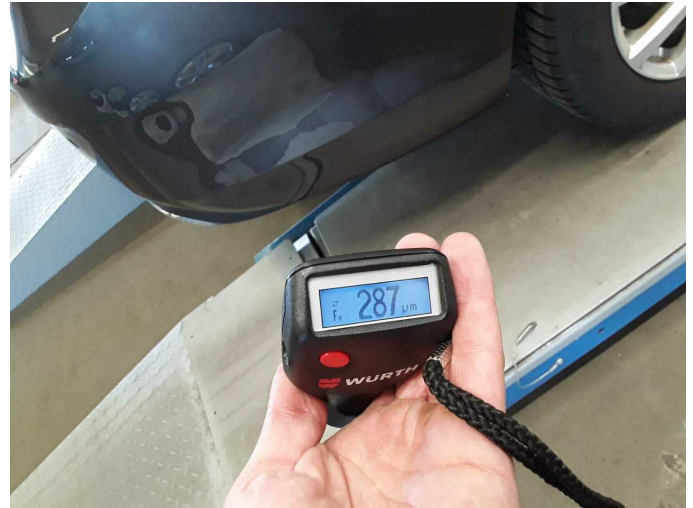
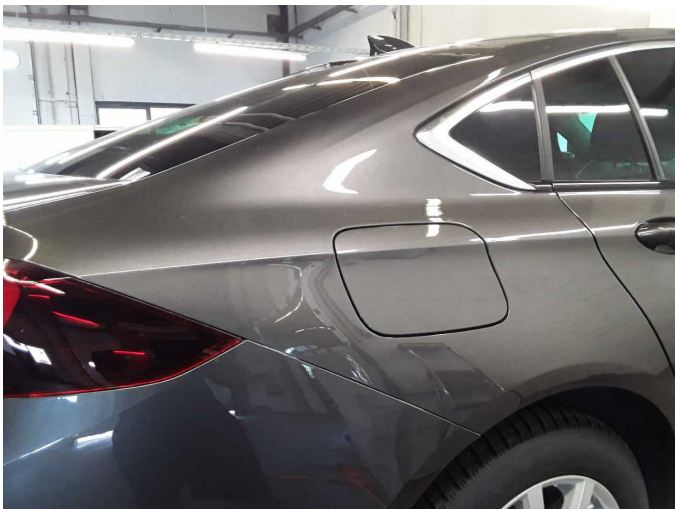
| No. | Repainting |
|---|---|
| 1 | Roof, Side panel - rear right side, Door - rear left side, Door - rear right side, Door - front left side, Door - front right side, Professionally carried out, Invoice of repair done Non-existent |

| Roof | 301 µm | Boot lid / rear door | 301 µm |
| Side panel - rear right side | 287 µm | Door - rear left side | 167 µm |
| Door - rear right side | 241 µm | Door - front left side | 266 µm |
| Door - front right side | 273 µm | | |

**Repainting 1:** Roof, Side panel - rear right side, Door - rear left side, Door - rear right side, Door - front left side, Door - front right side

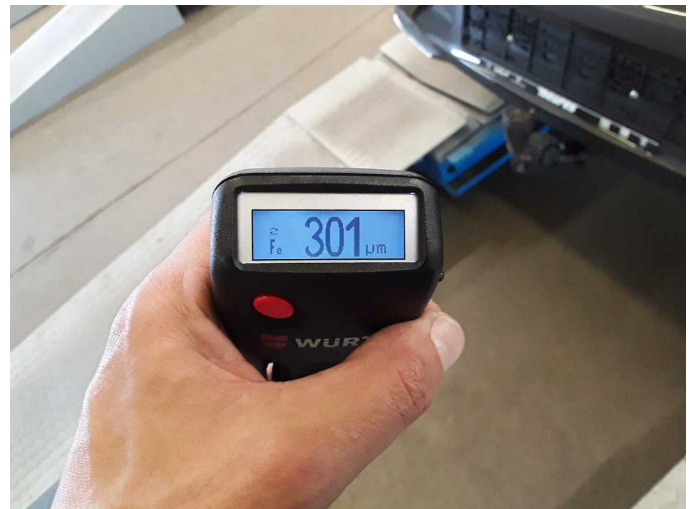
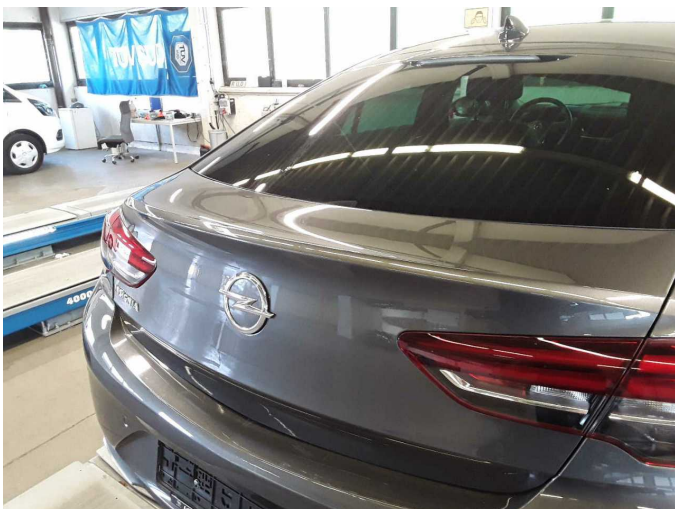
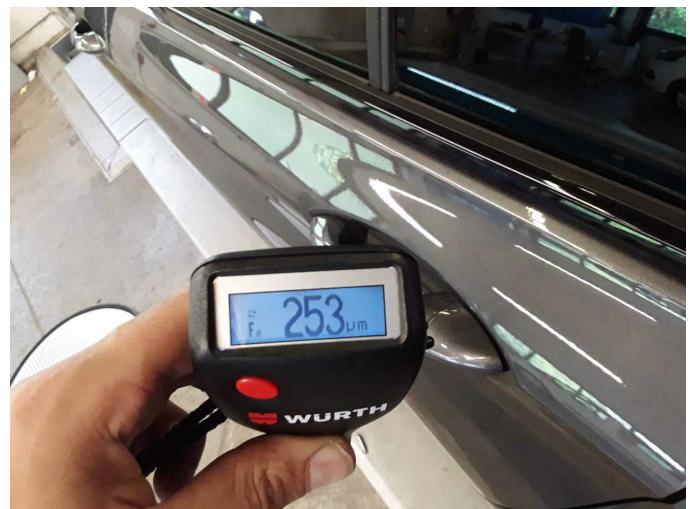
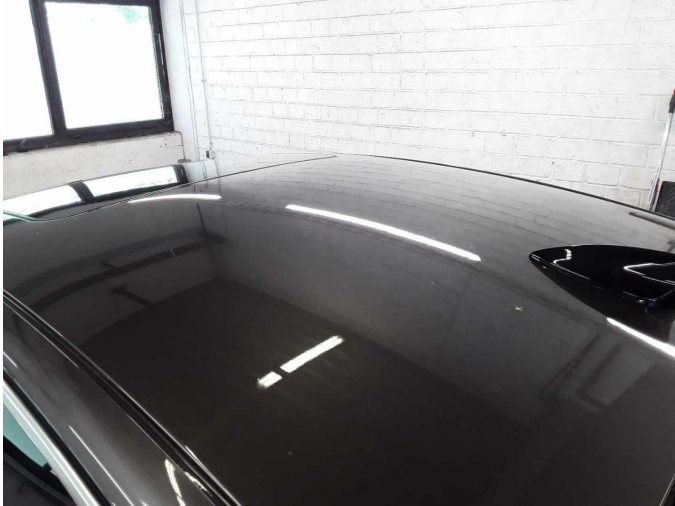
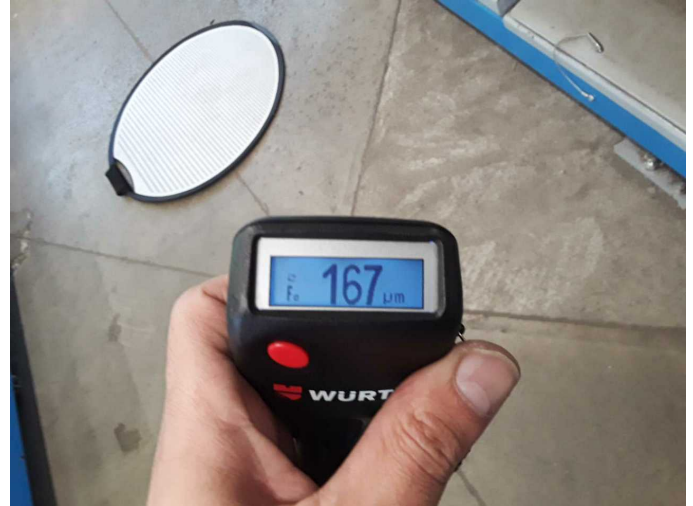
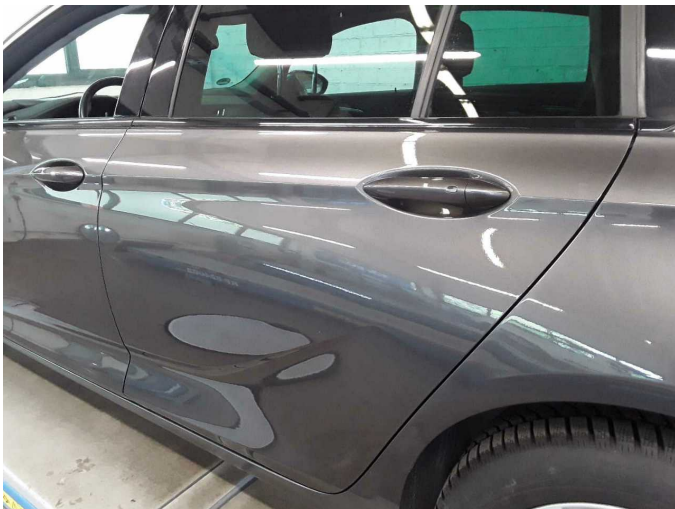
**Repainting 1:** Roof, Side panel - rear right side, Door - rear left side, Door - rear right side, Door - front left side, Door - front right side

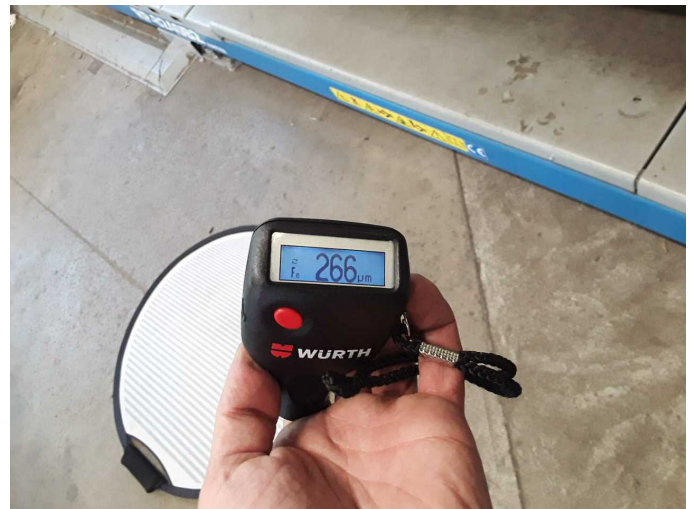
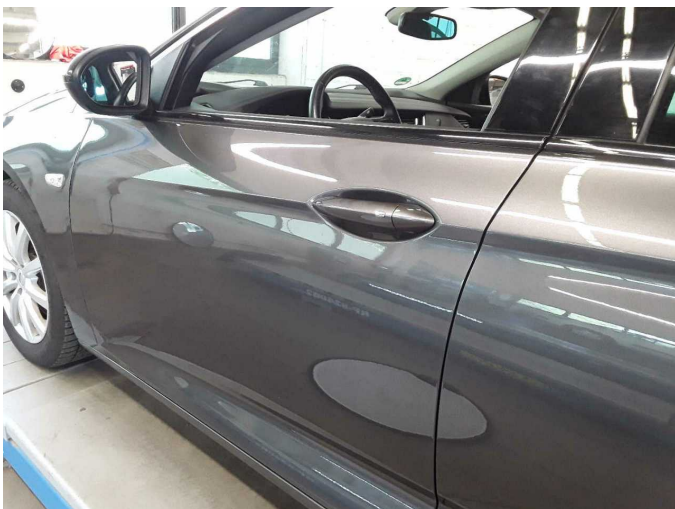
**Repainting 1:** Roof, Side panel - rear right side, Door - rear left side, Door - rear right side, Door - front left side, Door - front right side
