Protocol number: 46104904  
Order No. / Reference: 26479652  
Inspection date: 23 Jun 2026

Manufacturer: Opel

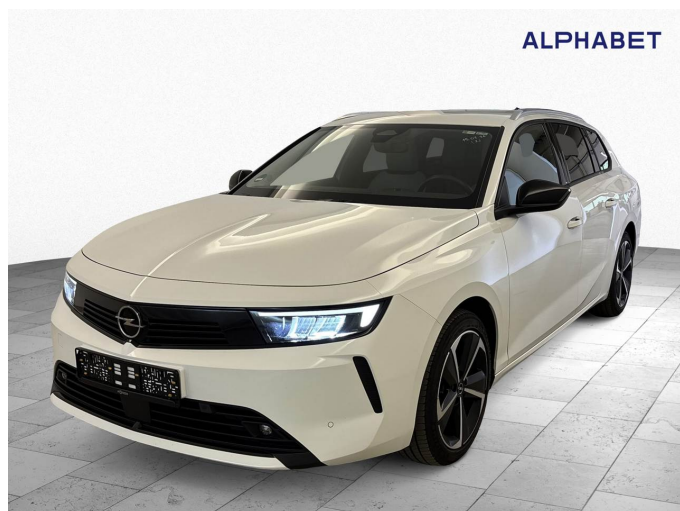
**Figure 1:** Diagonal front (left)

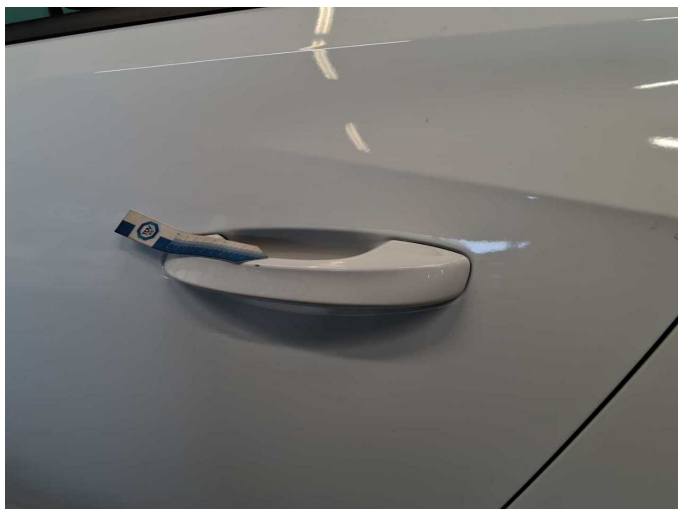
**Damage 1:** Door - rear left side: Door handle - outside - Scratch(es) - Smart repair

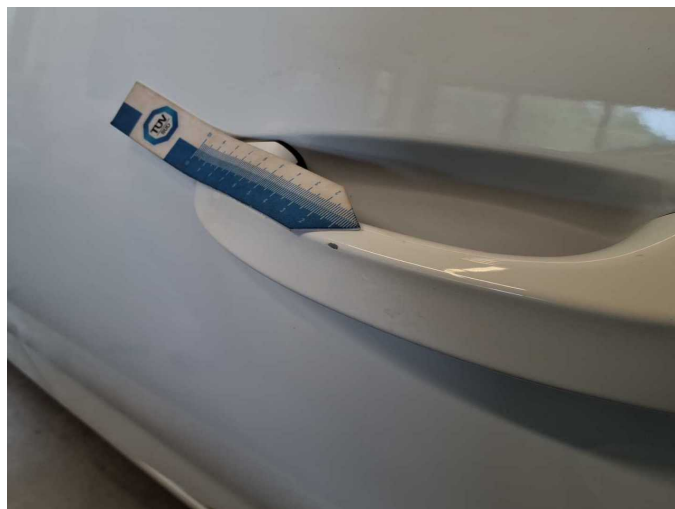
**Damage 1:** Door - rear left side: Door handle - outside - Scratch(es) - Smart repair

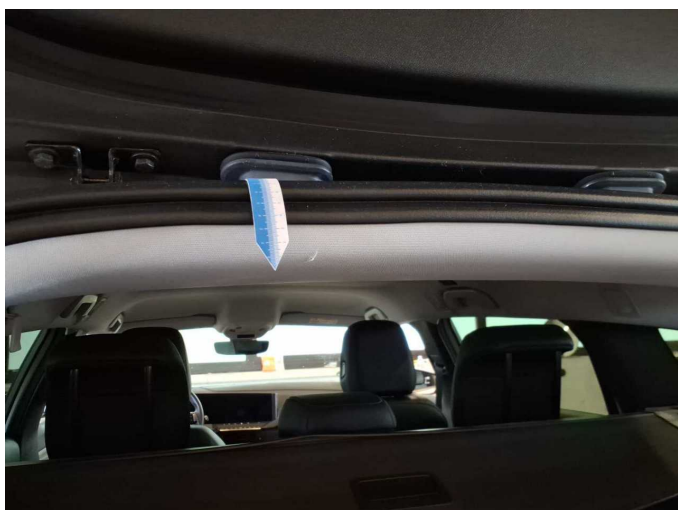
**Damage 2:** Trim / covers: Roof lining - Holes - Smart repair

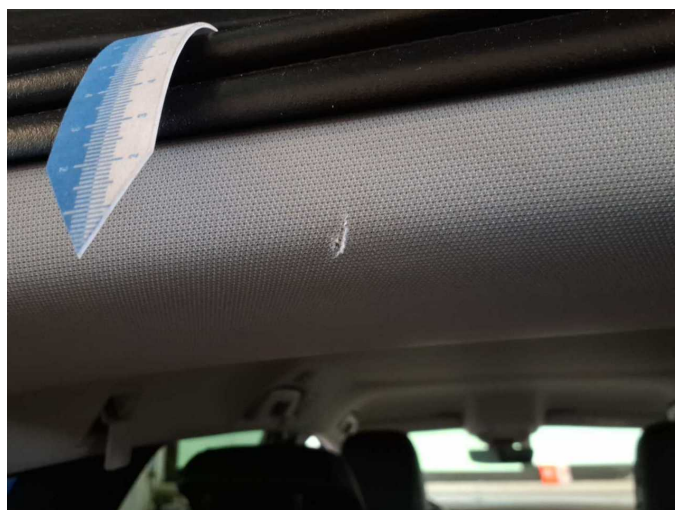
**Damage 2:** Trim / covers: Roof lining - Holes - Smart repair

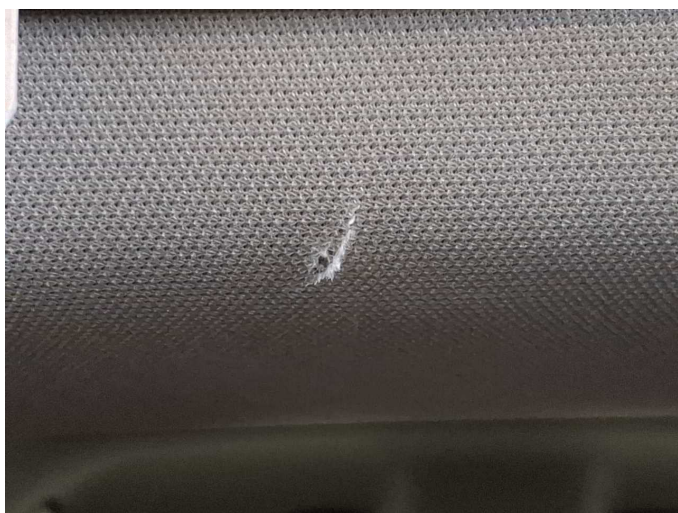
**Damage 2:** Trim / covers: Roof lining - Holes - Smart repair

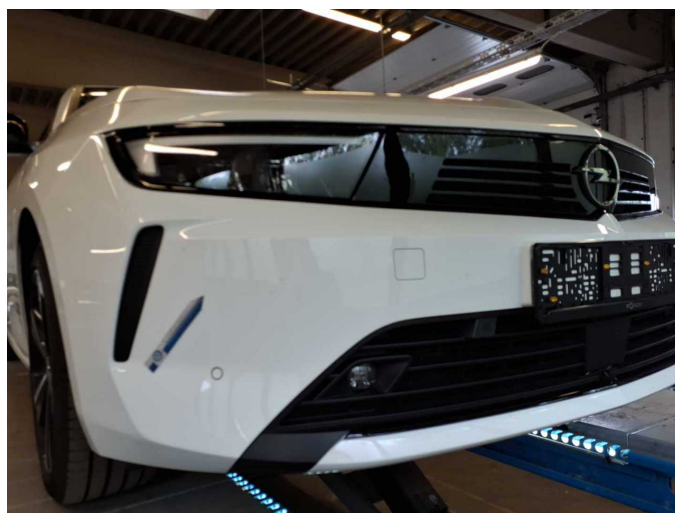
**Wear and tear 1:** Front bumper: Front bumper - Stone chips - No deduction

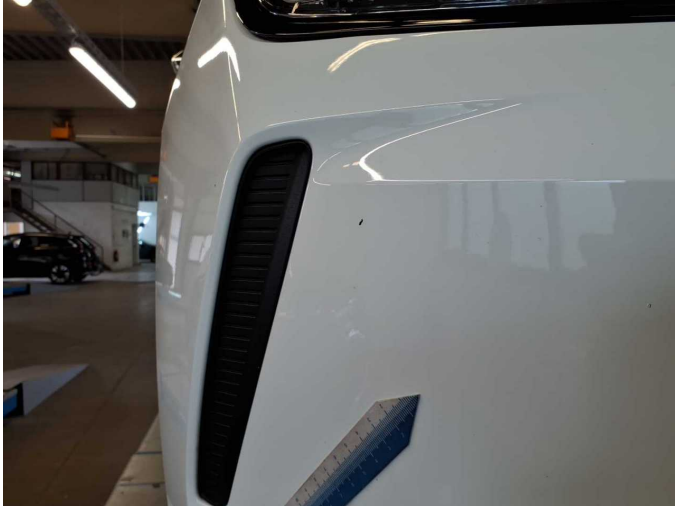
**Wear and tear 1:** Front bumper: Front bumper - Stone chips - No deduction

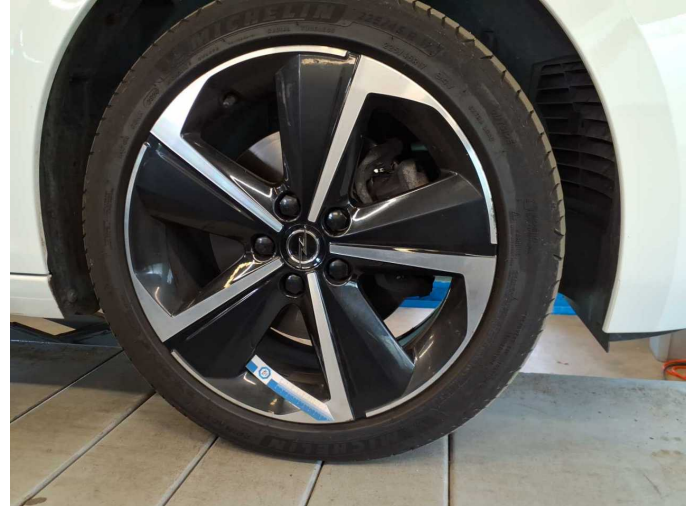
**Wear and tear 2:** Wheel / tyres: Alloy rim - front right side - Scratch(es) - No deduction

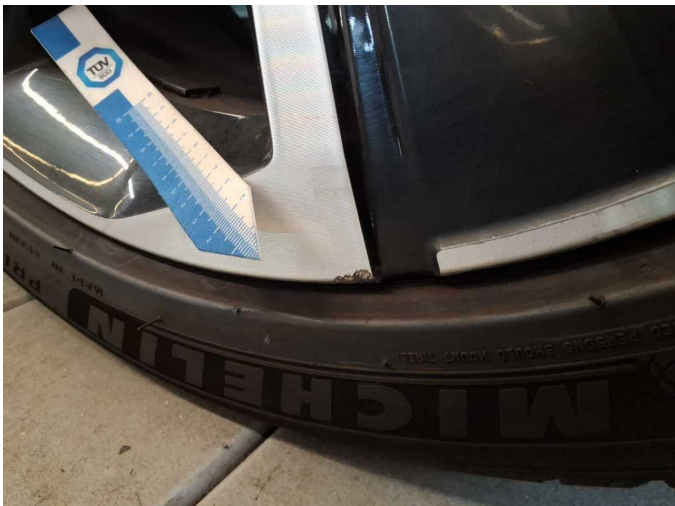
**Wear and tear 2:** Wheel / tyres: Alloy rim - front right side - Scratch(es) - No deduction

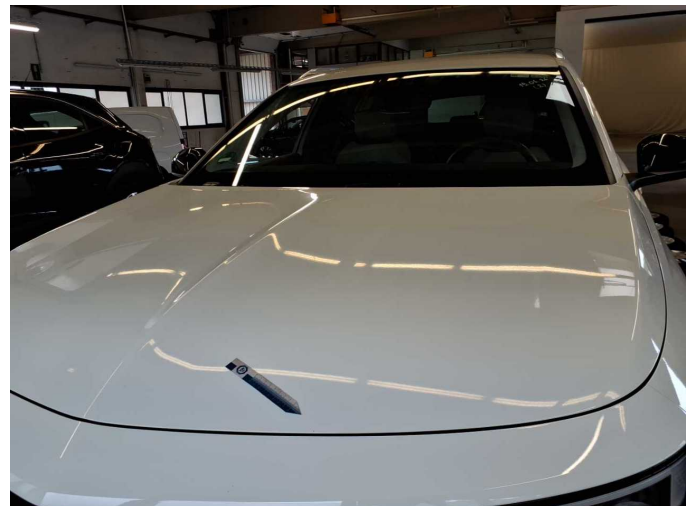
**Wear and tear 3:** Bonnet: Bonnet - Stone chips - No deduction

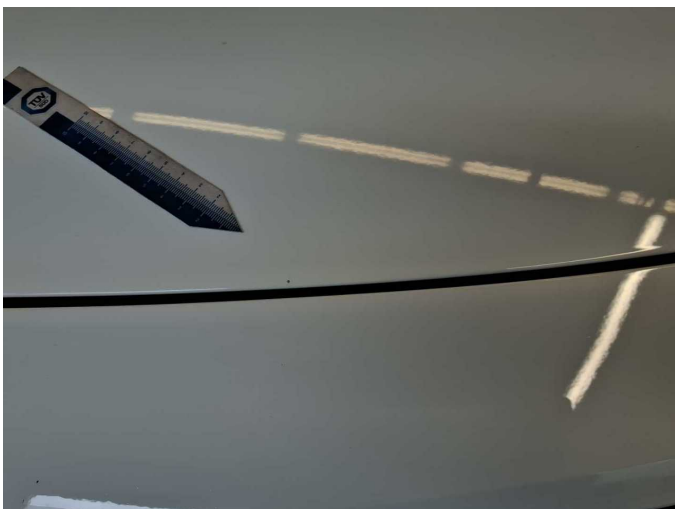
**Wear and tear 3:** Bonnet: Bonnet - Stone chips - No deduction

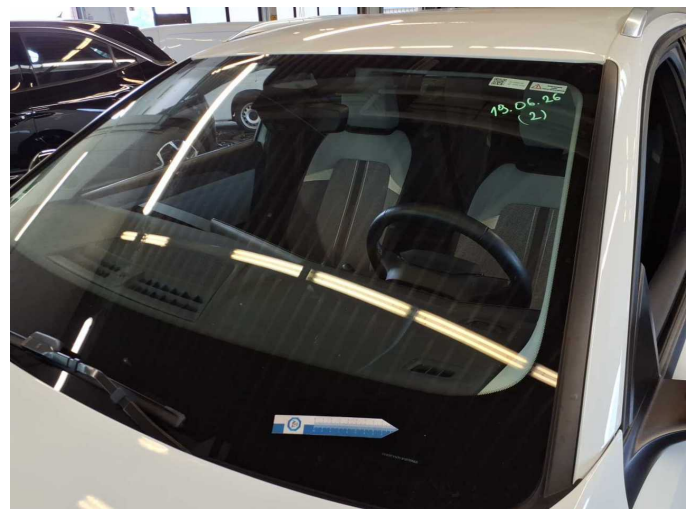
**Wear and tear 4:** Vehicle glazing: Windscreen - Stone chips - No deduction

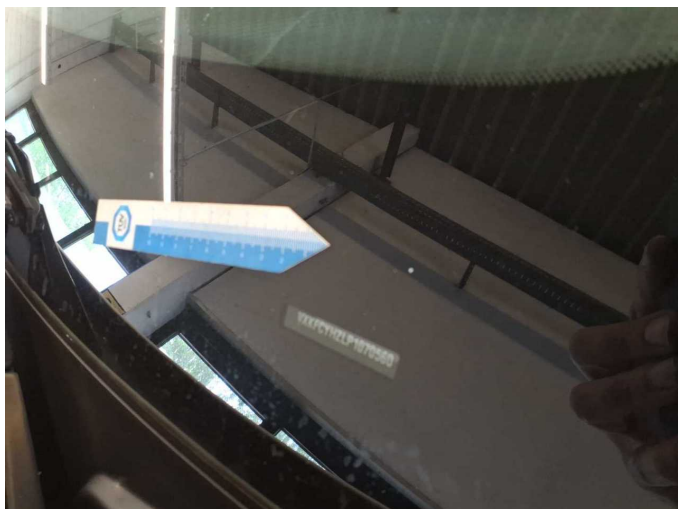
**Wear and tear 4:** Vehicle glazing: Windscreen - Stone chips - No deduction
