Expertise

Protocol number: 46253879  
Order No. / Reference: 26595211  
Inspection date: 30 Jun 2026

Manufacturer: Mercedes-Benz

Model: E 220 d T 9G-TRONIC Avantgarde

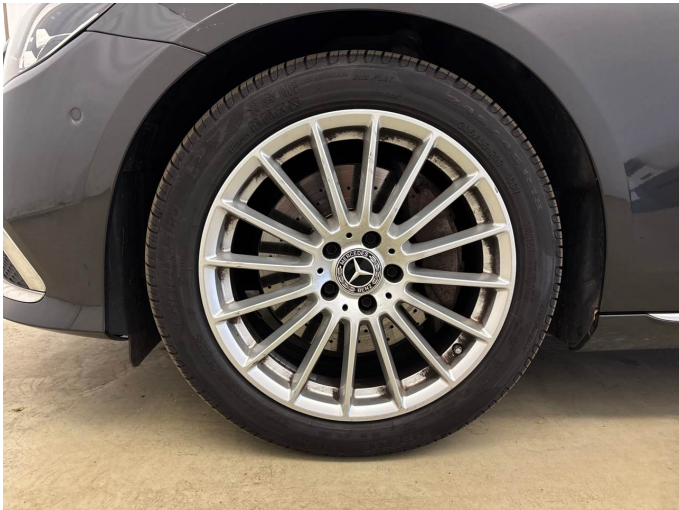
Figure 12: Mounted tyres

| # | Tyre size | Type of tyre | Manufacturer | Tread depth |
|---|---|---|---|---|
| 1) | 245/45 R18 100Y | Summer tires (with run-flat tires) on Light alloy | Pirelli | 4mm / 4mm |
| 2) | 245/45 R18 100Y | Summer tires (with run-flat tires) on Light alloy | Pirelli | 5mm / 5mm |

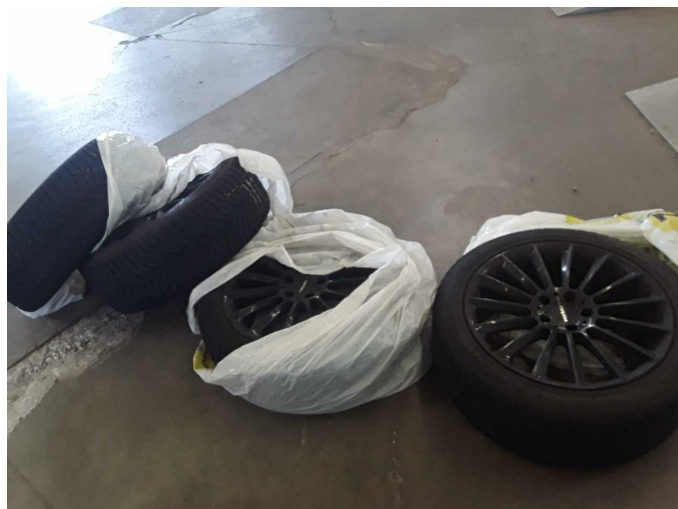
Figure 14: Additional tyres

| # | Tyre size | Type of tyre | Manufacturer | Tread depth |
|---|---|---|---|---|
| 1) | 245/45 R18 100V | Winter tyres on Light alloy | Dunlop | 5mm / 5mm |
| 2) | 245/45 R18 100V | Winter tyres on Light alloy | Dunlop | 5mm / 5mm |

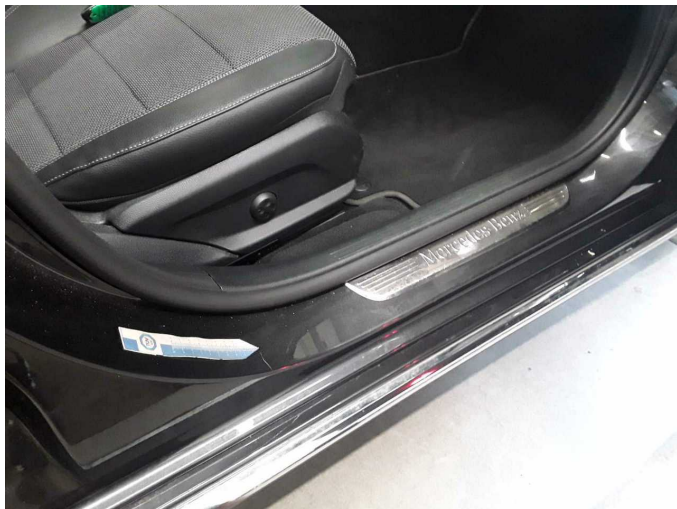
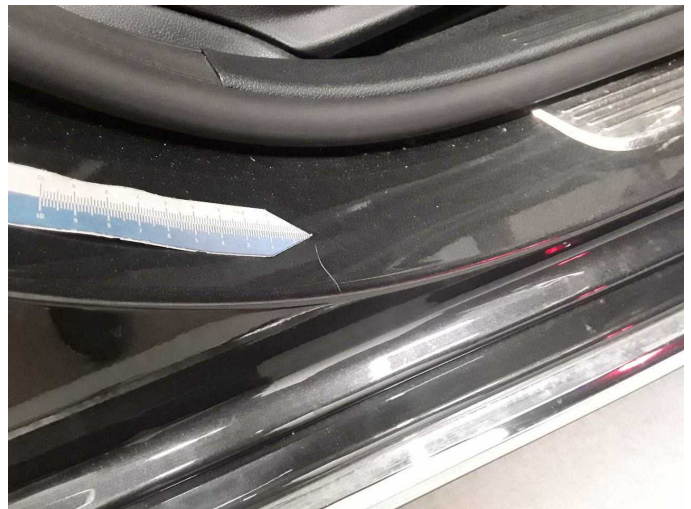
Damage 1: Sill - right side: Sill - Scratch(es) - Smart repair

| No. | Component group | Description |
|---|---|---|
| 1 | Sill - right side | Sill - Scratch(es) - Smart repair |

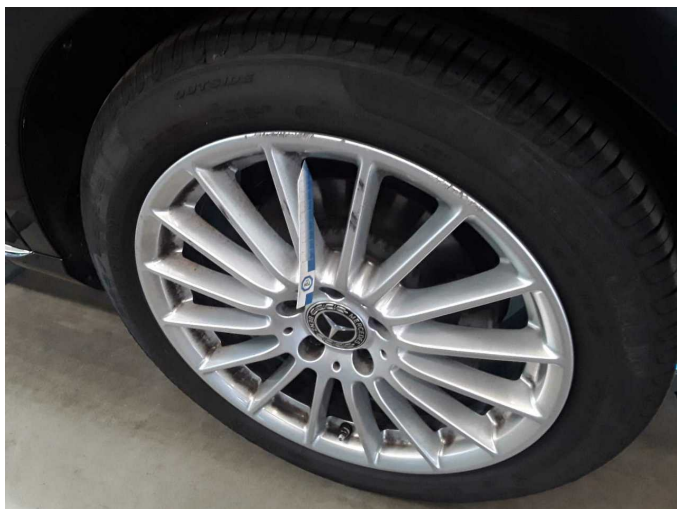
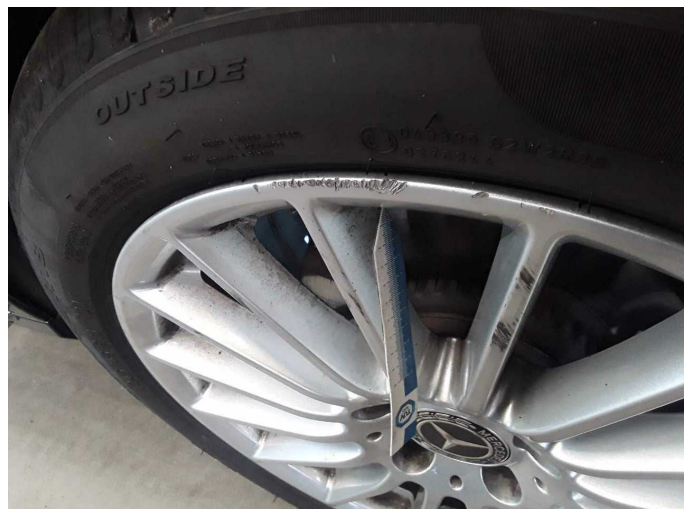
Damage 3: Wheel / tyres: Alloy rim - rear left side - Scratched - Loss in value

| No. | Component group | Description |
|---|---|---|
| 3 | Wheel / tyres | Alloy rim - rear left side - Scratched - Loss in value |

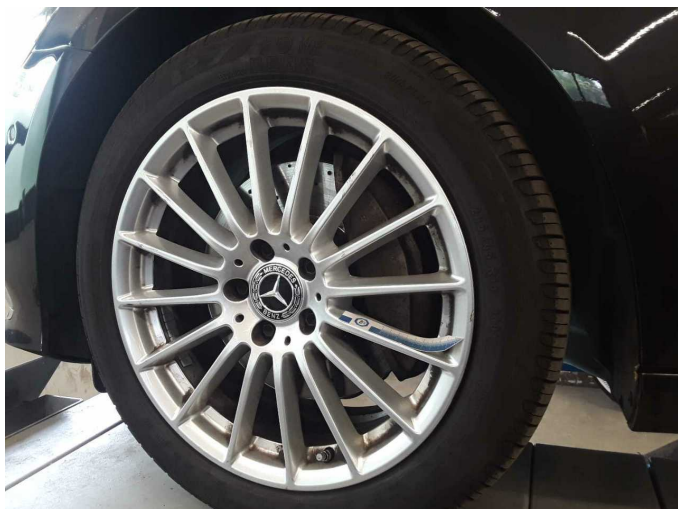
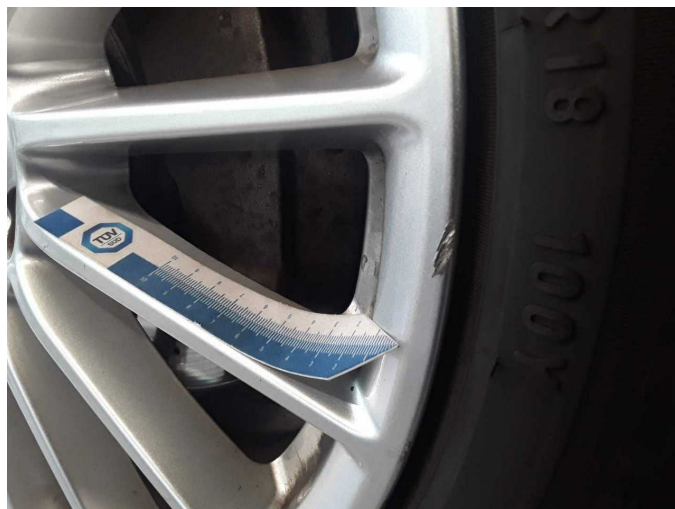
**Damage 4:** Wheel / tyres: Alloy rim - front left side - Scratch(es) - Loss in value

| No. | Component group | Description |
|---|---|---|
| 4 | Wheel / tyres | Alloy rim - front left side - Scratch(es) - Loss in value |

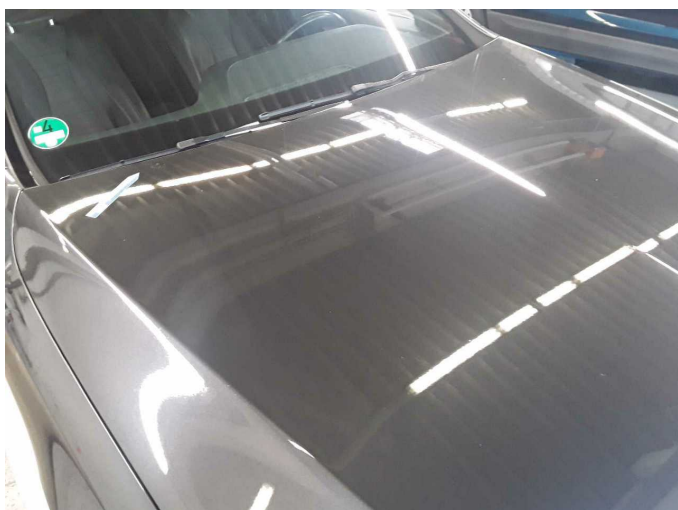
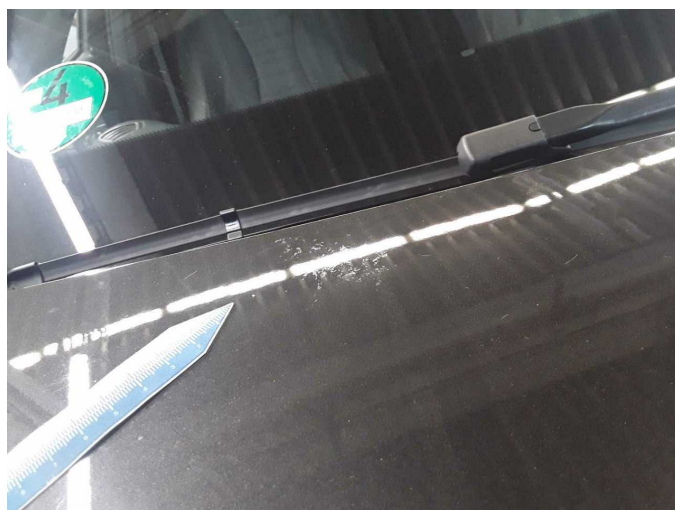
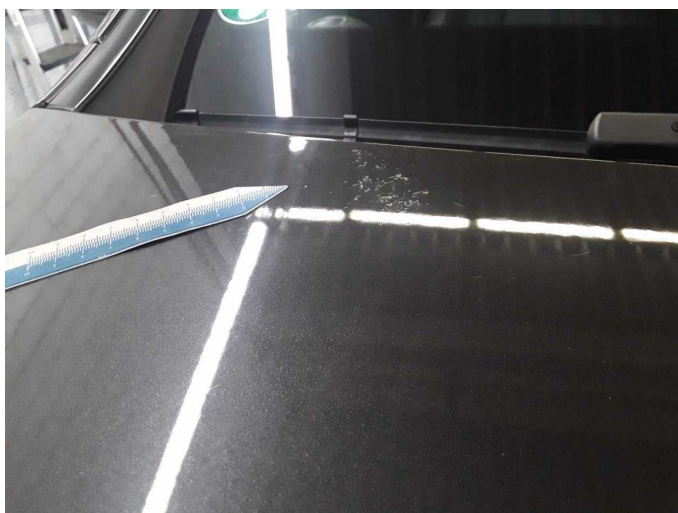
**Damage 5:** Bonnet: Bonnet (Vogelkot eingebrannt) - Paint defect - Paint

| No. | Component group | Description |
|---|---|---|
| 5 | Bonnet | Bonnet (Vogelkot eingebrannt) - Paint defect - Paint |

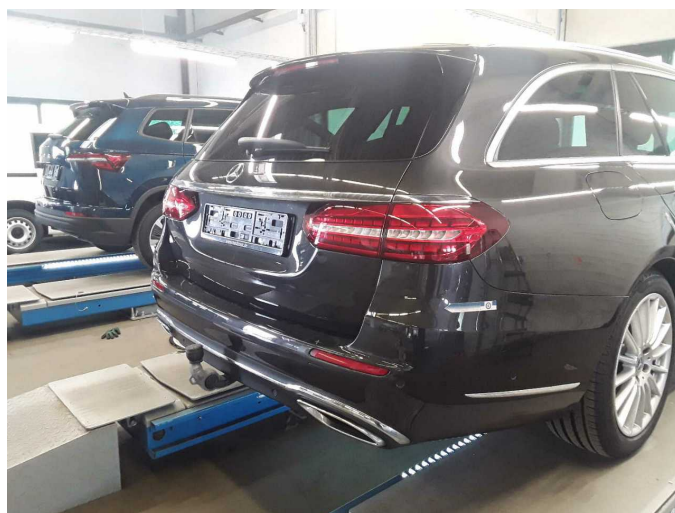
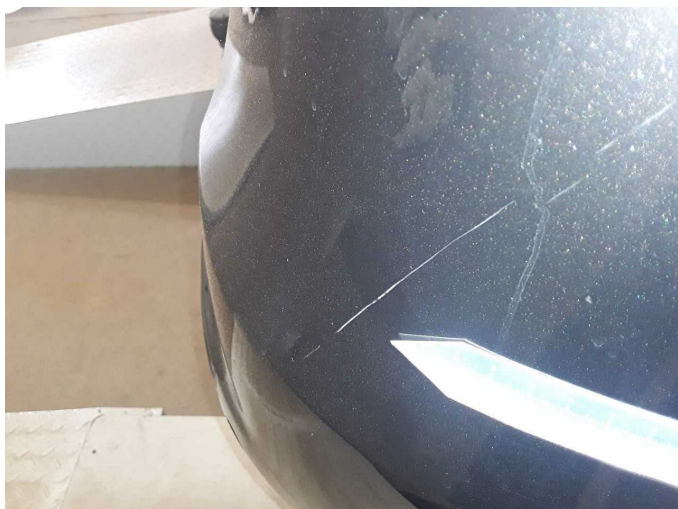
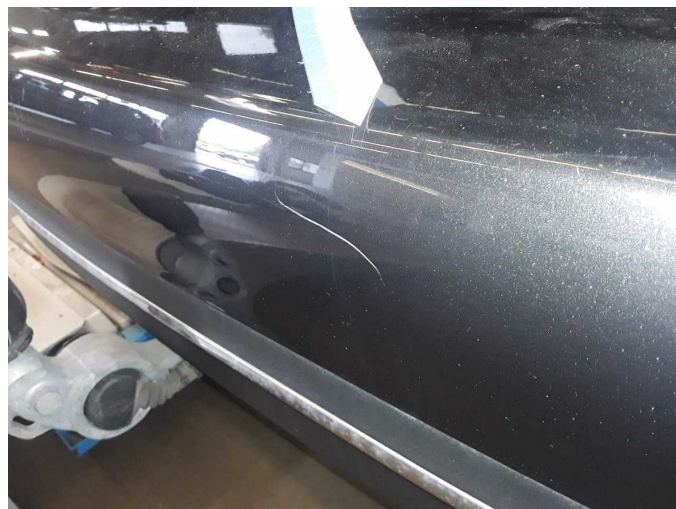
**Damage 6:** Rear bumper: Rear bumper - Scratch(es) - Paint

| No. | Component group | Description |
|---|---|---|
| 6 | Rear bumper | Rear bumper - Scratch(es) - Paint |

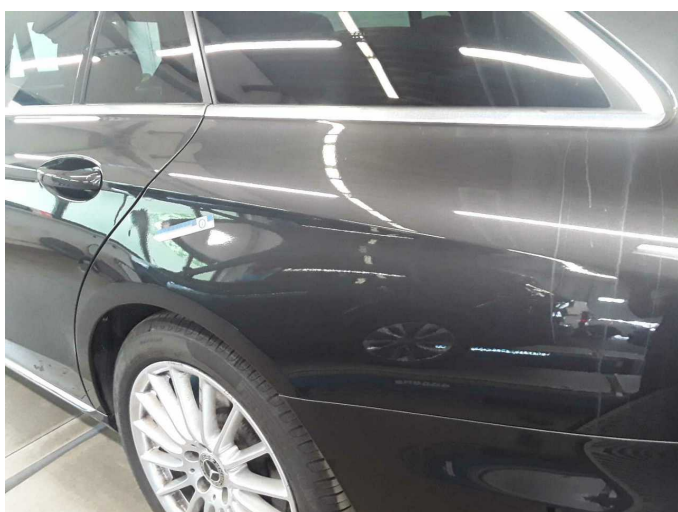
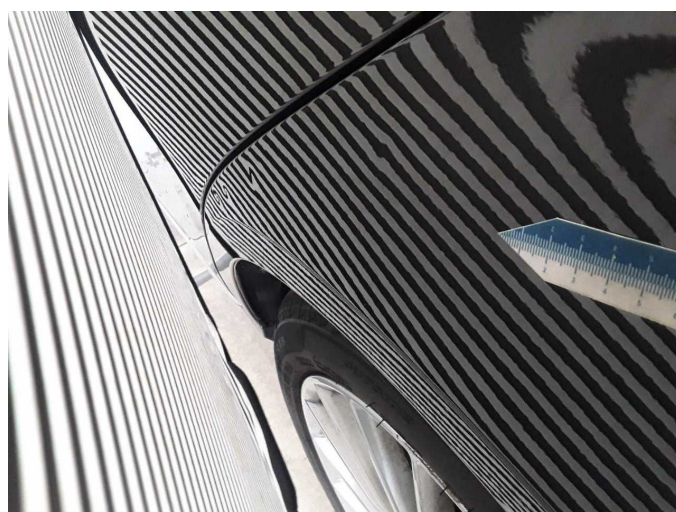
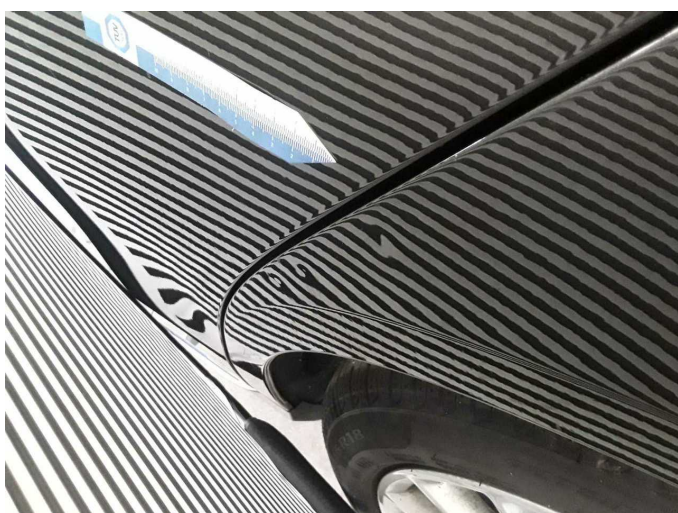
**Damage 7:** Side panel - rear left side: Side panel - Deformed - Repair and paint

| No. | Component group | Description |
|---|---|---|
| 7 | Side panel - rear left side | Side panel - Deformed - Repair and paint |

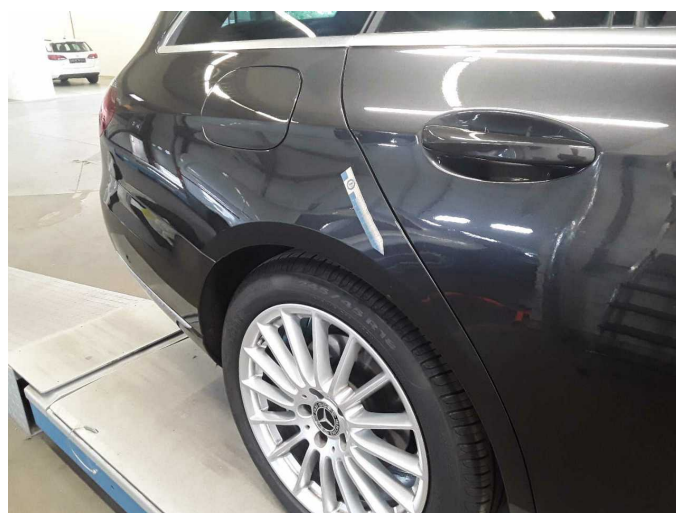
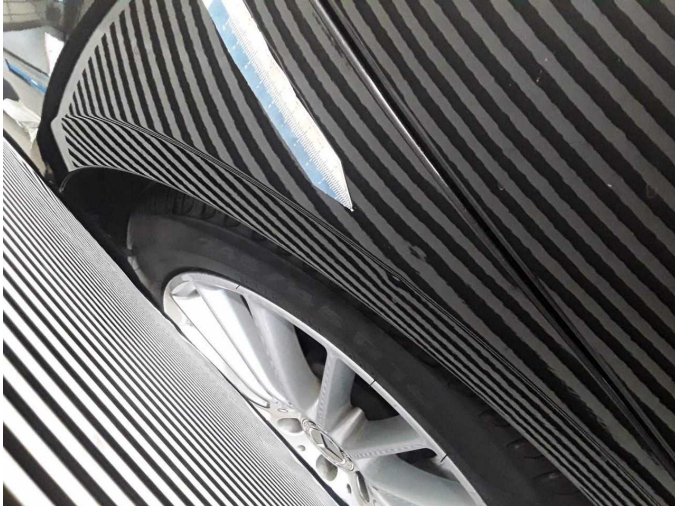
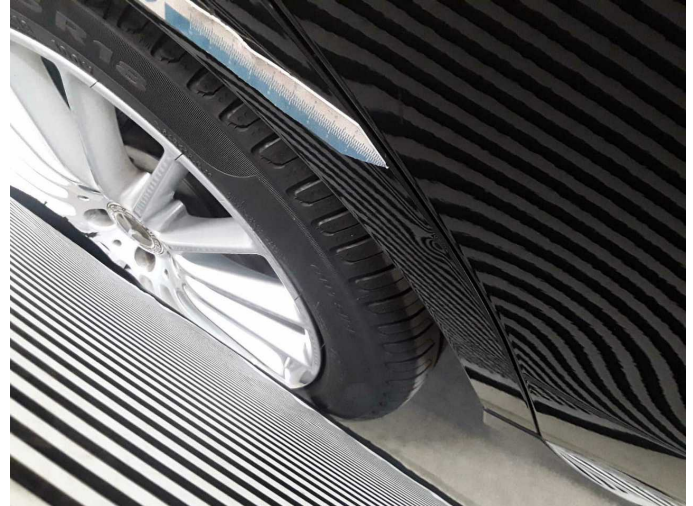
**Damage 8:** Side panel - rear right side: Side panel - Deformed - Repair and paint

| No. | Component group | Description |
|---|---|---|
| 8 | Side panel - rear right side | Side panel - Deformed - Repair and paint |

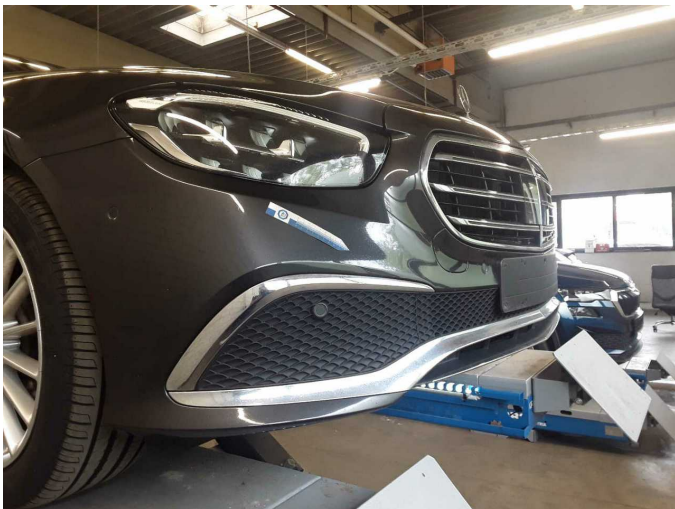
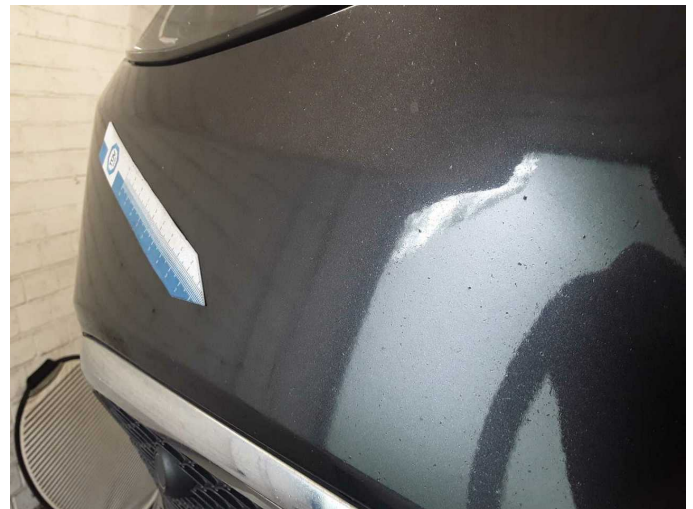
**Wear and tear 2:** Front bumper: Front bumper - Stone chips - No deduction

| No. | Component group | Description |
|---|---|---|
| 2 | Front bumper | Front bumper - Stone chips - No deduction |

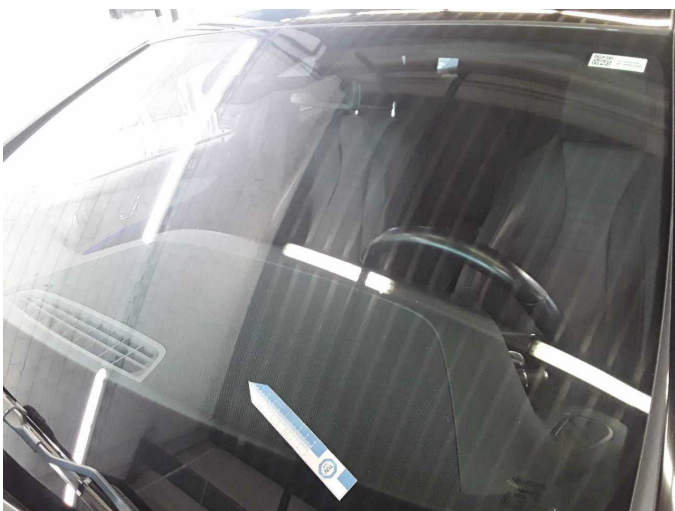
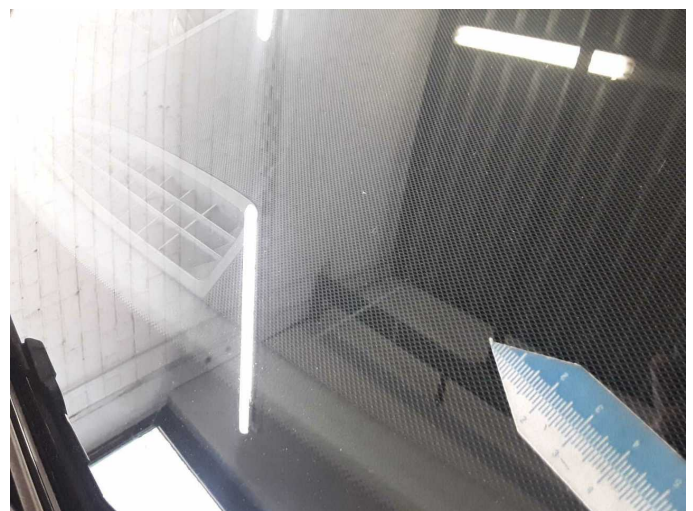
**Wear and tear 3:** Vehicle glazing: Windscreen - Stone chips - No deduction

| No. | Component group | Description |
|---|---|---|
| 3 | Vehicle glazing | Windscreen - Stone chips - No deduction |

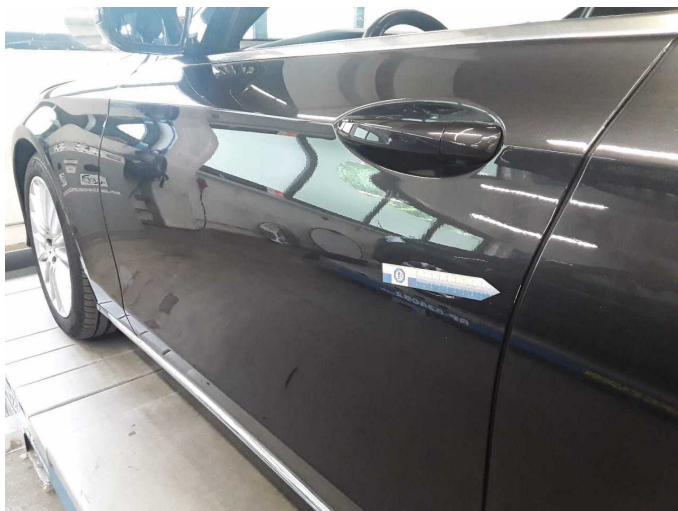
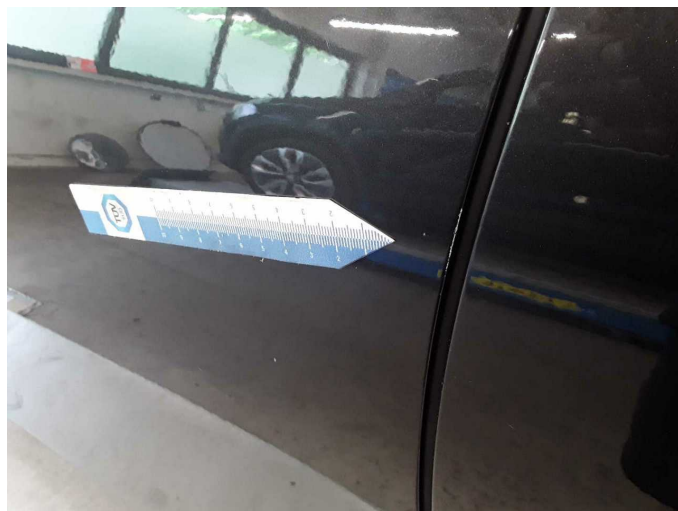
**Wear and tear 4:** Door - front left side: Door - Scratch(es) - Smart repair

| No. | Component group | Description |
|---|---|---|
| 4 | Door - front left side | Door - Scratch(es) - Smart repair |
